**BAKKEN OIL EXPRESS
PIPELINE PROJECT**

INTERIM CONSTRUCTION INSPECTION REPORT

Inspector Name: Dave Hennen, ProSource Technologies	Inspection Date: 3-12-14	Report Number: PU-13-825
Weather: Sunny, 45 degrees F	Precipitation: 0.00

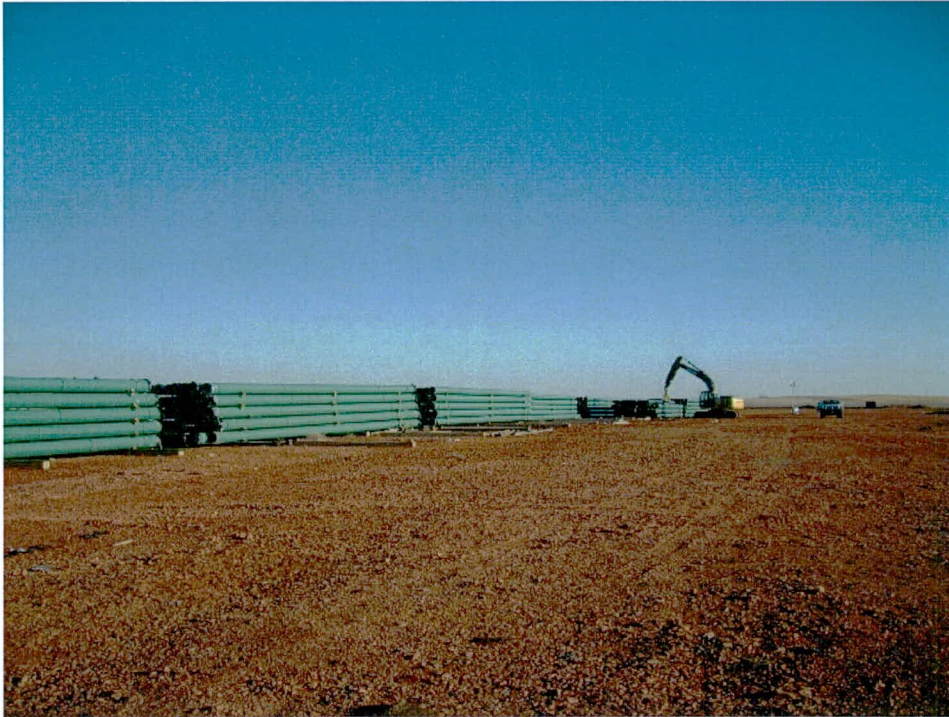
Mr. Dave Hennen, ProSource, met with Mr. Tom Stark, the Chief Inspector from MBF Inspection Services, Inc. for the construction inspection. Following the morning inspection meeting, Mr. Hennen inspected the pipe storage yard. Current activities at the pipe storage yard included loading pipe for delivery to the right-of-way and inventory management tasks. No issues were observed at the pipe storage yard.

Photo 1 – Pipe Storage Yard

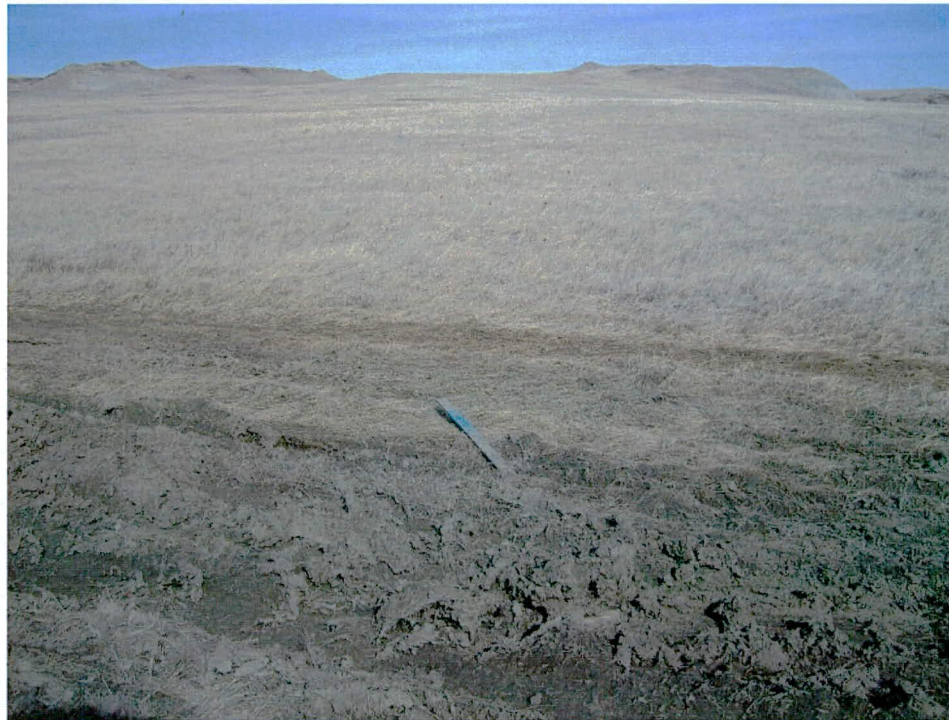
Photo 2 – Construction Staking to be Replaced

- Construction workspace markers (Photo 2)
 - Monitor and replace workspace boundary identification markers.
- Mixing of topsoil and subsoil piles (Photos 3-4)
 - Allow for space between topsoil and subsoil piles to avoid mixing.
- Rutting in several locations (Photos 5-6)
 - Discussed mitigation measures including the placement of additional timber mats.
- Lack of silt fence (Photo 7-8)
 - After the ground thaws, consider placing silt fence adjacent to water resources and HDD spoil piles.
- Spoil placement outside of identified work areas (Photos 9-10)
 - Contain work activities to staked right-of-way boundaries.

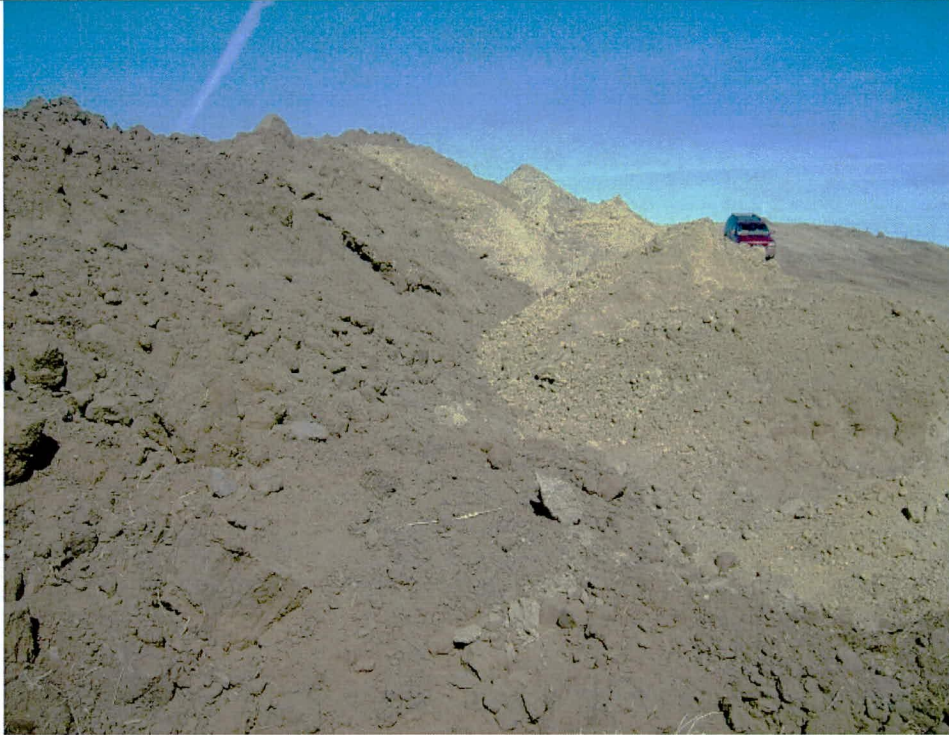
Photo 3 – Mixing of Topsoil & Subsoil Piles

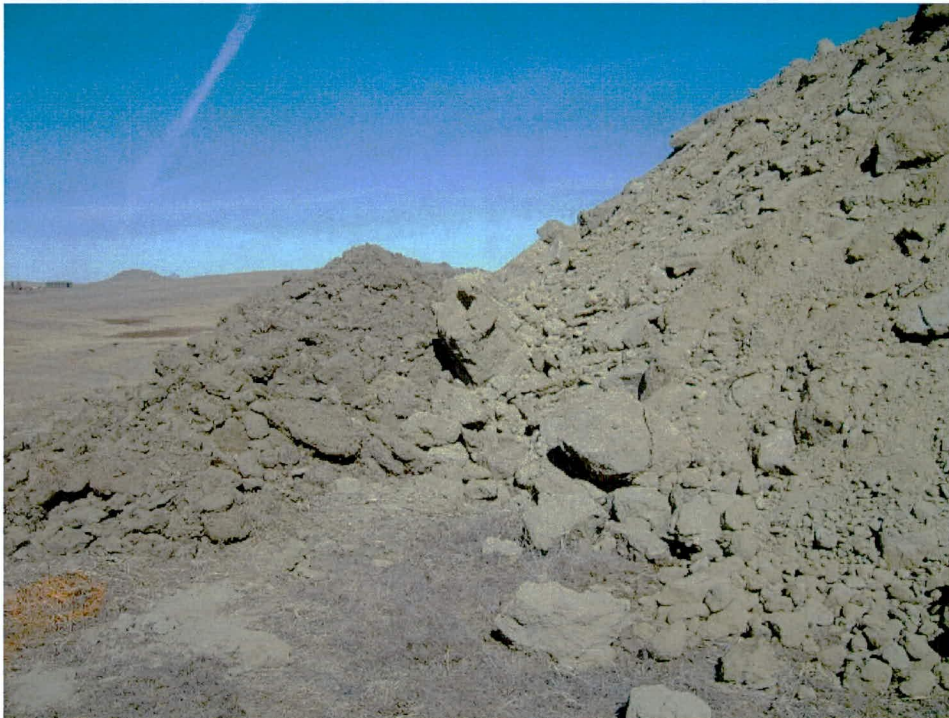
Photo 4 – Mixing of Topsoil & Subsoil Piles

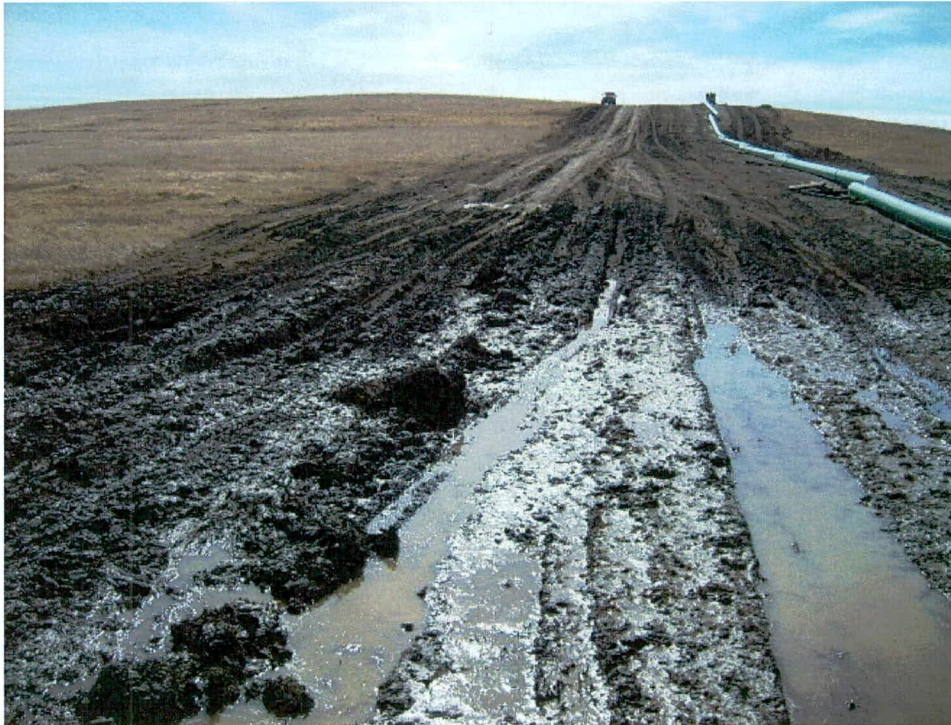
Due to the time of year and the changing weather conditions from extreme cold to above freezing temperatures, rutting was observed in multiple locations. Mr. Hennen and Mr. Stark discussed the placement of additional timber mats in areas of significant rutting, specifically adjacent to waterbody crossing locations. Silt fence was not observed along the Project route because of the frozen ground conditions, and construction work area identification markers had fallen down in some areas. It is recommended that silt fence be installed where appropriate when the ground conditions are favorable, and right-of-way boundary markers be replaced as necessary.

Photo 5 – Rutting Along the Right-of-Way

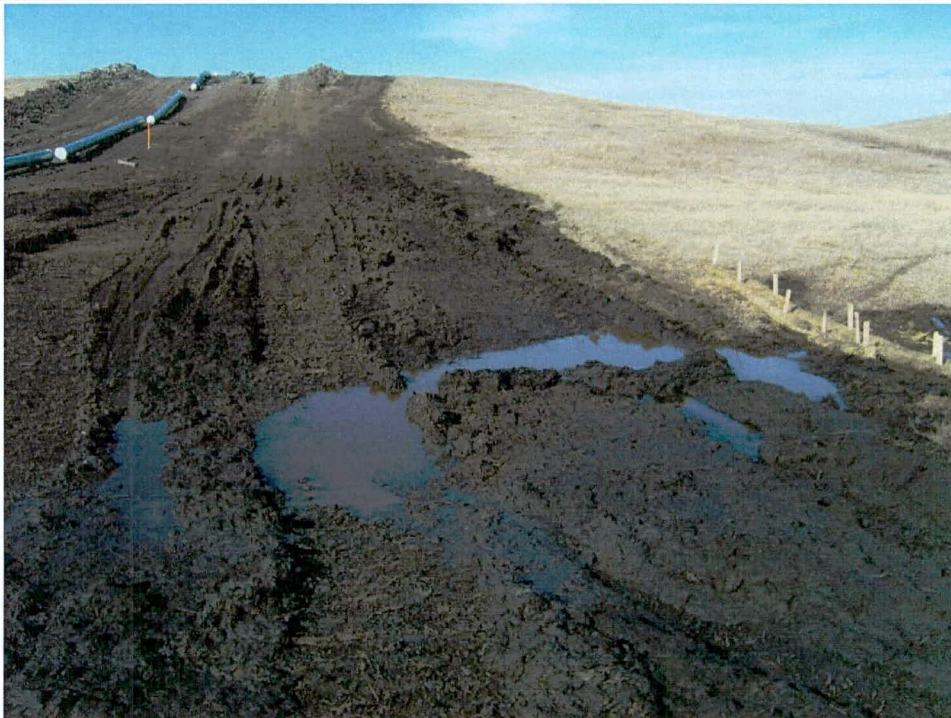
Photo 6 – Rutting and Recommended Placement of Timber Mats

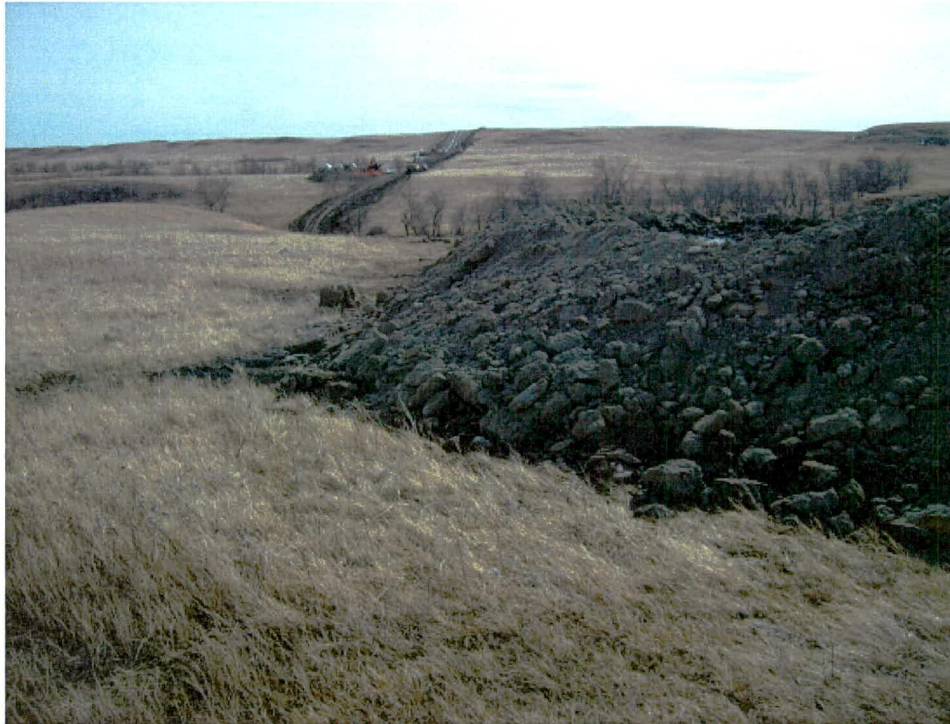
Photo 7 – HDD Spoil Pile with No Erosion Control Devices

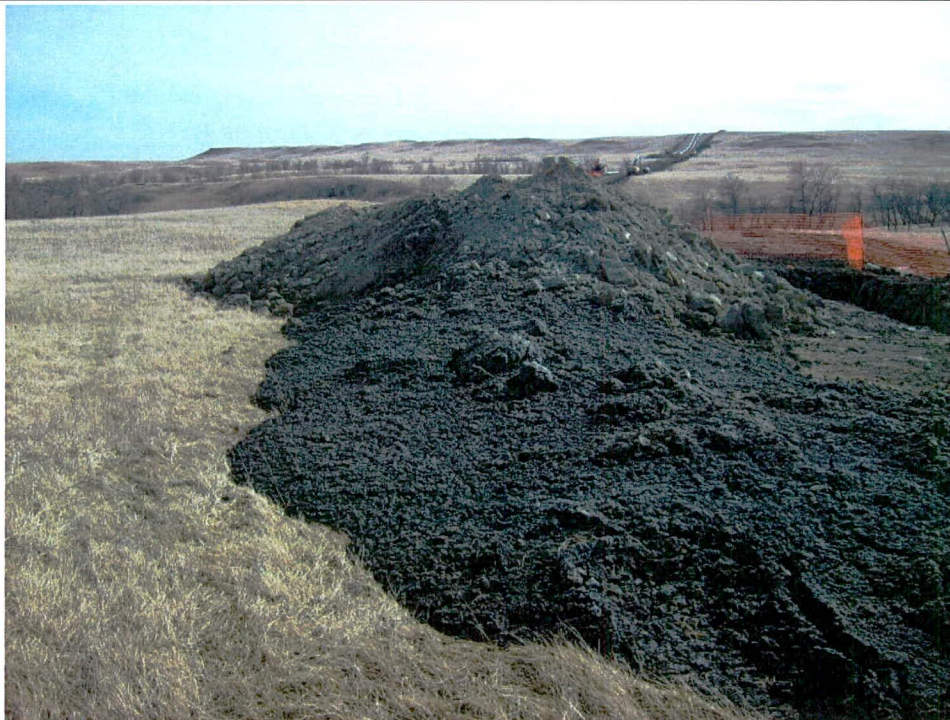
Photo 8 – HDD Spoil Pile with No Erosion Control Devices

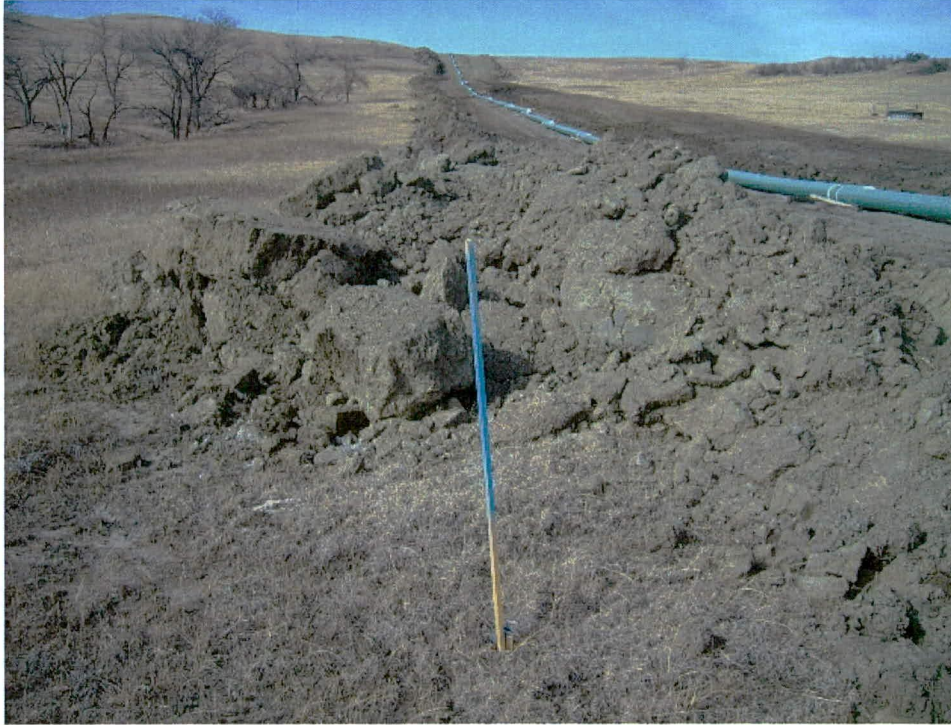
Photo 9 – Spoil Placed Outside of Identified Right-of-Way

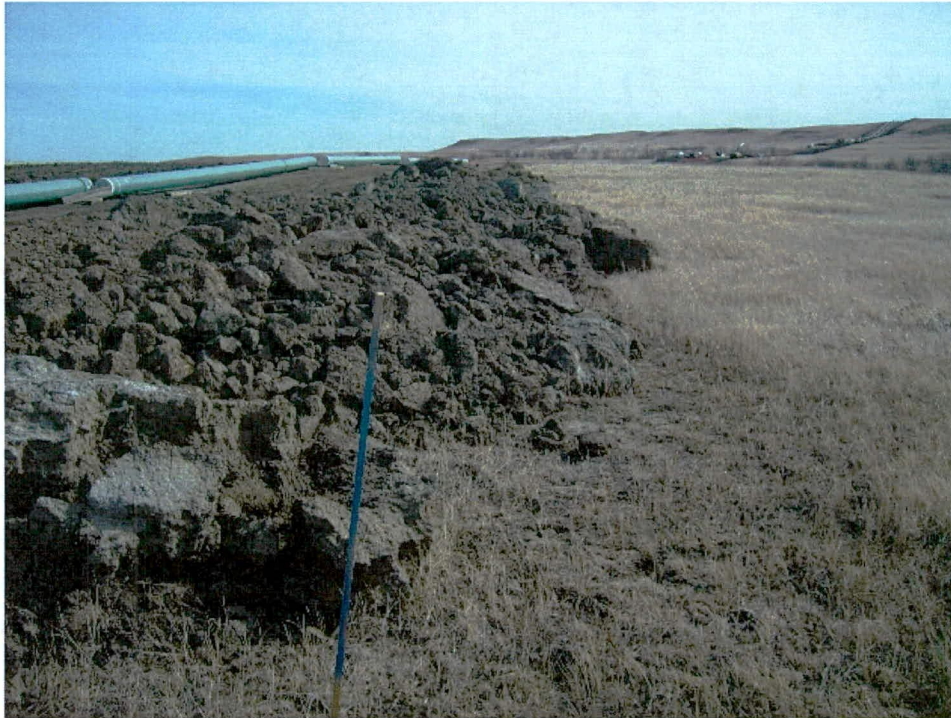
Photo 10 – Spoil Placed Outside of Identified Right-of-Way
