GENERAL INFORMATION		
Inspector Name: Dave Hennen, ProSource Technologies	Inspection Date: 6-5-14	Report Number: PU-13-825
Weather: Mostly sunny, 70 degrees F	Precipitation: Trace in the afternoon	
DAILY CONSTRUCTION ACTIVITIES		
<p>ProSource Technologies (ProSource) conducted the second Interim Construction Inspection on behalf of the North Dakota Public Service Commission for the Bakken Oil Express (BOE) Pipeline Project (Project) on June 5, 2014. The Project will receive crude oil from a pump station southwest of Killdeer, North Dakota, and traverse generally south approximately 38 miles to the BOE Rail Hub, southwest of Dickinson, North Dakota. Construction of the Project commenced on January 13, 2014. At the time of the second Interim Construction Inspection, construction activities had advanced throughout the majority of the project area. According to the Weekly Progress Report for the week ending 5-31-14, pipe stringing was 99% complete and pipe lowering and backfilling activities were 79% complete.</p> <p>Mr. Dave Hennen, ProSource, met with Mr. Tom Stark, the Chief Inspector, along with Mr. Glenn Carpenter, the environmental inspector, for the construction inspection. Foll

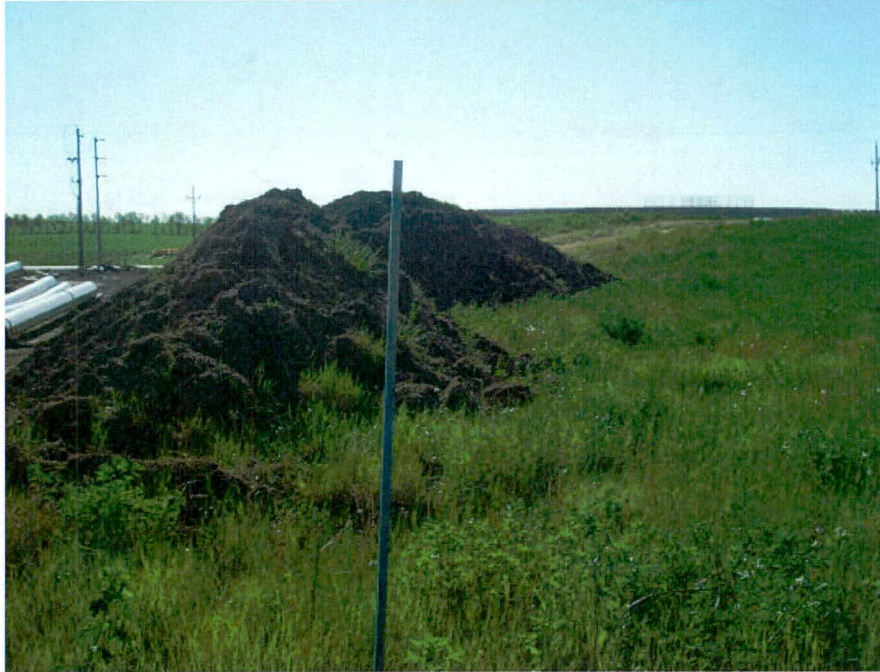
Photo 1 – Spoil Placed Outside of Identified Right-of-Way

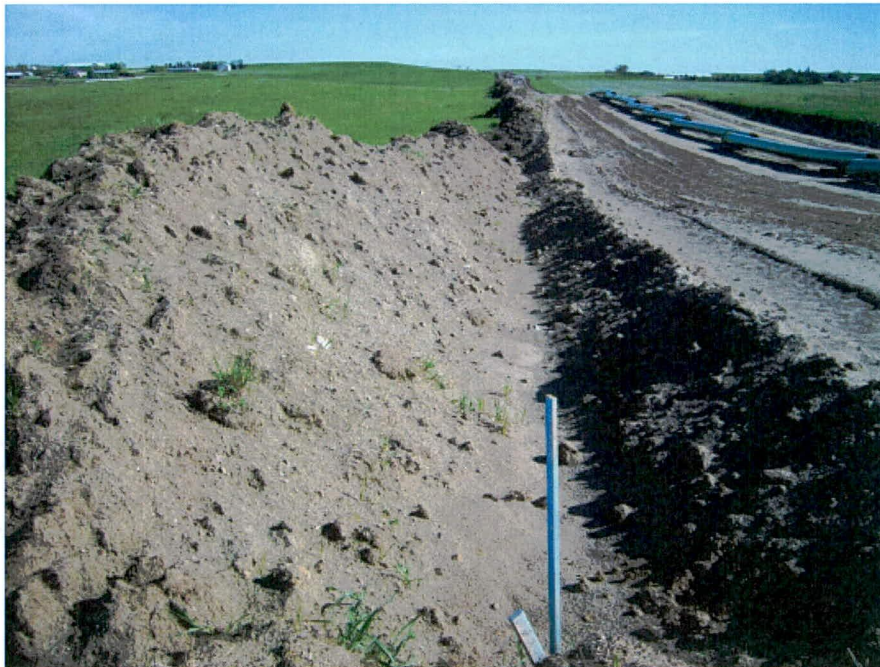
Photo 2 – Spoil Placed Outside of Identified Right-of-Way

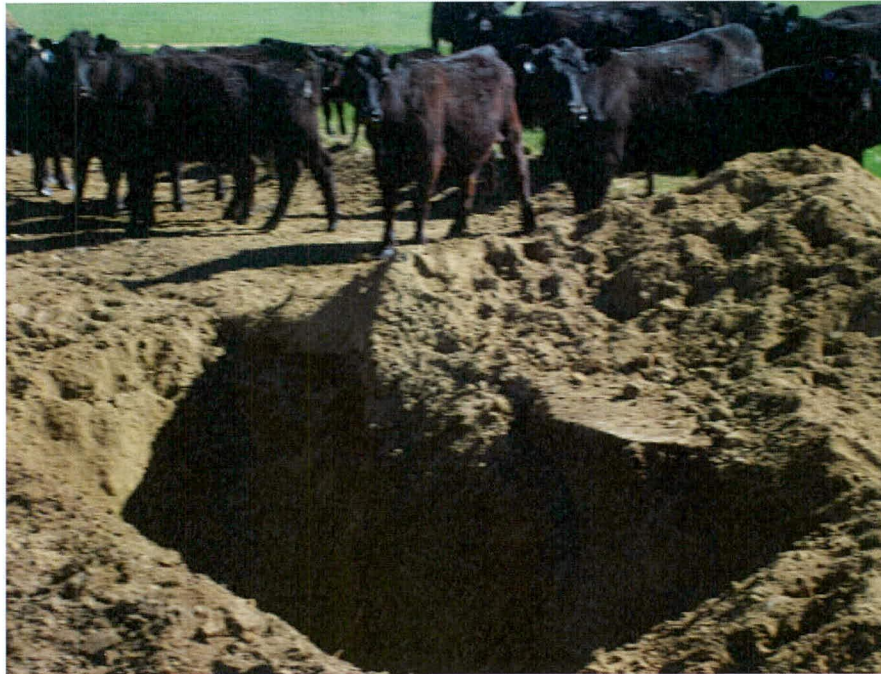
Photo 3 – Unsecured Trench near Livestock

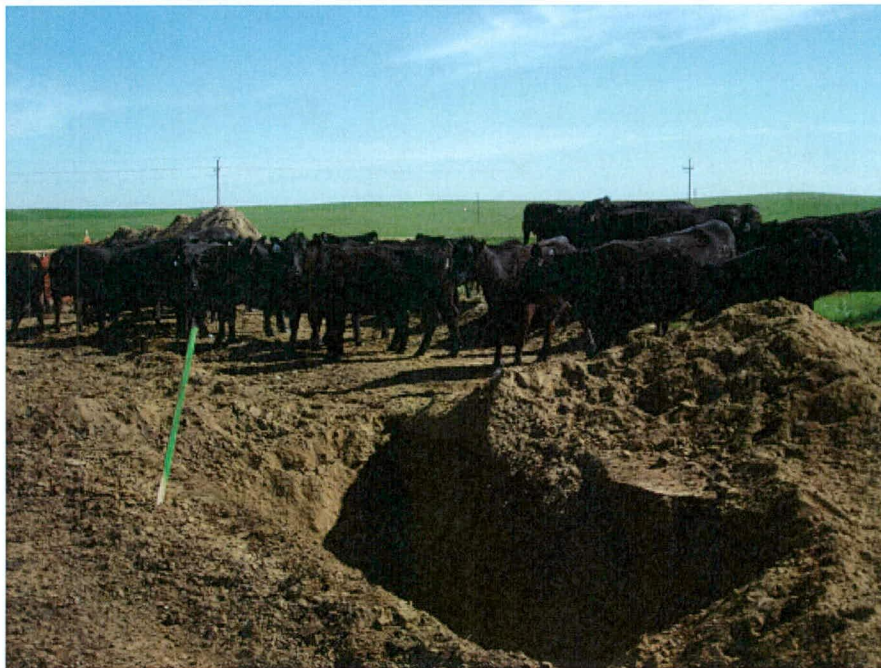
Photo 4 – Unsecured Trench near Livestock

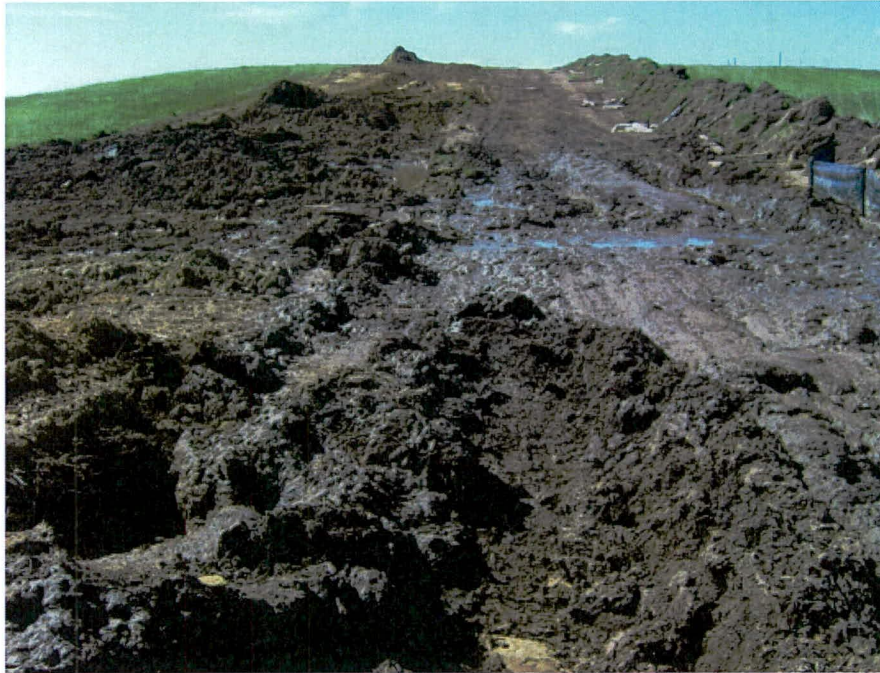
Photo 5 – Rutting Along the Right-of-Way

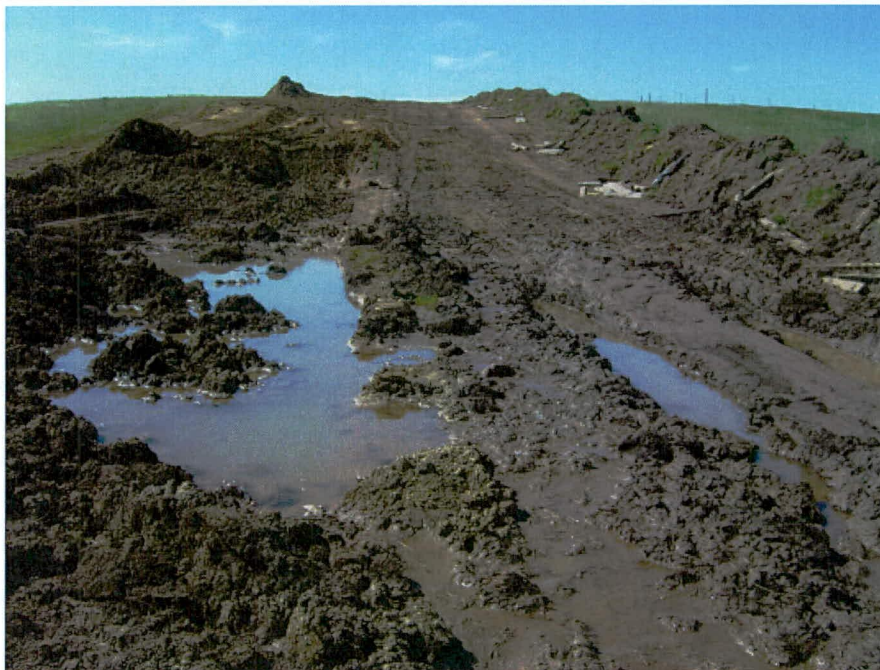
Photo 6 – Rutting Along the Right-of-Way

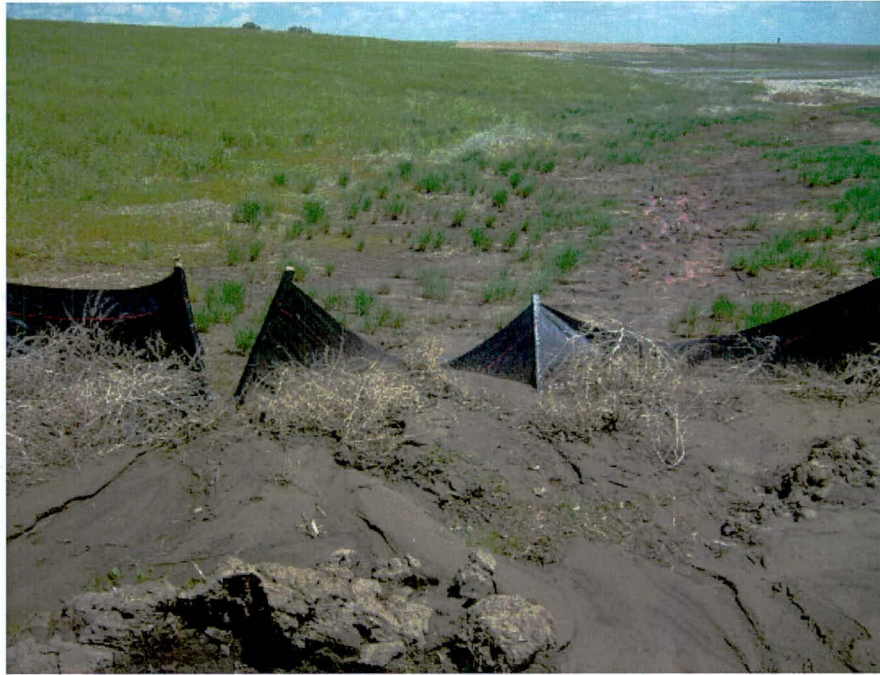
Photo 7 – Silt Fence Repair

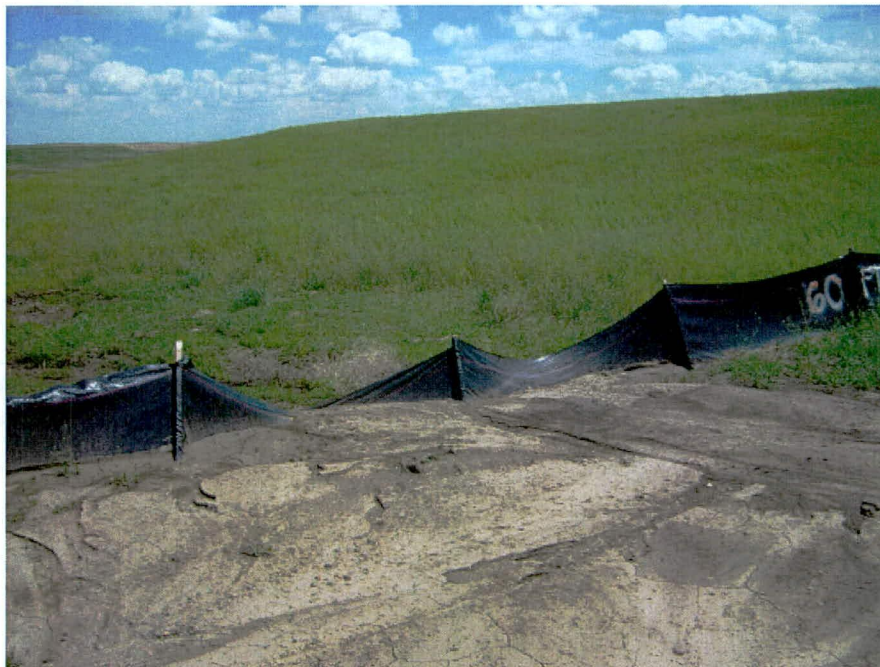
Photo 8 – Silt Fence Repair

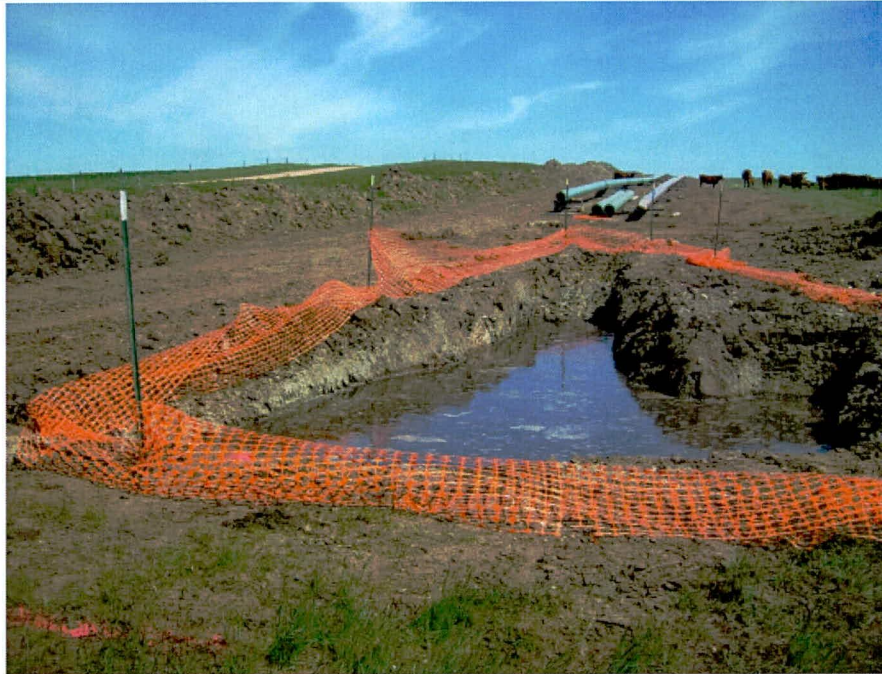
Photo 9 – Construction Fence Repair

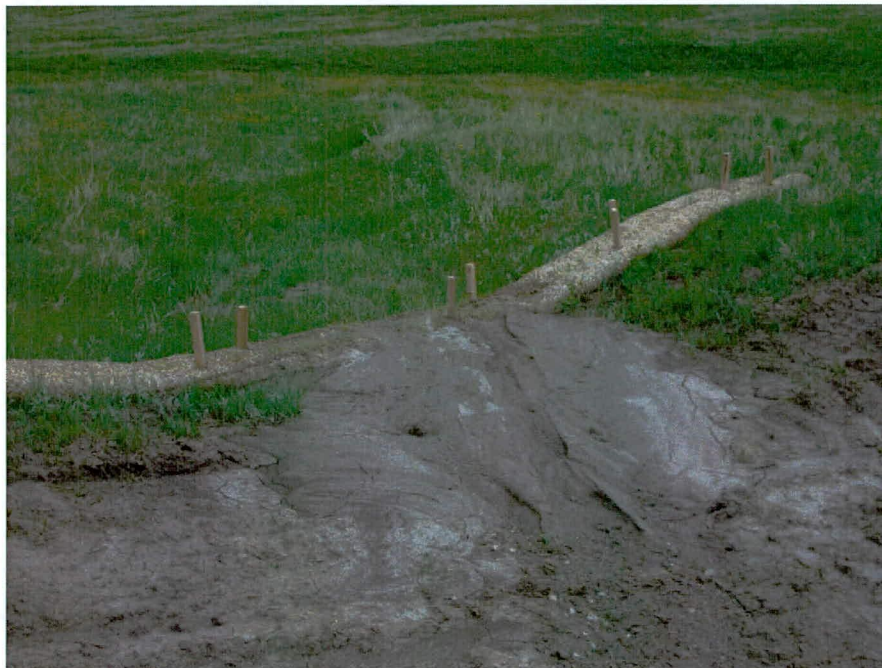
Photo 10 – Erosion Control Repair
