EXHIBIT
tabbles
B22

Case GS-13-886

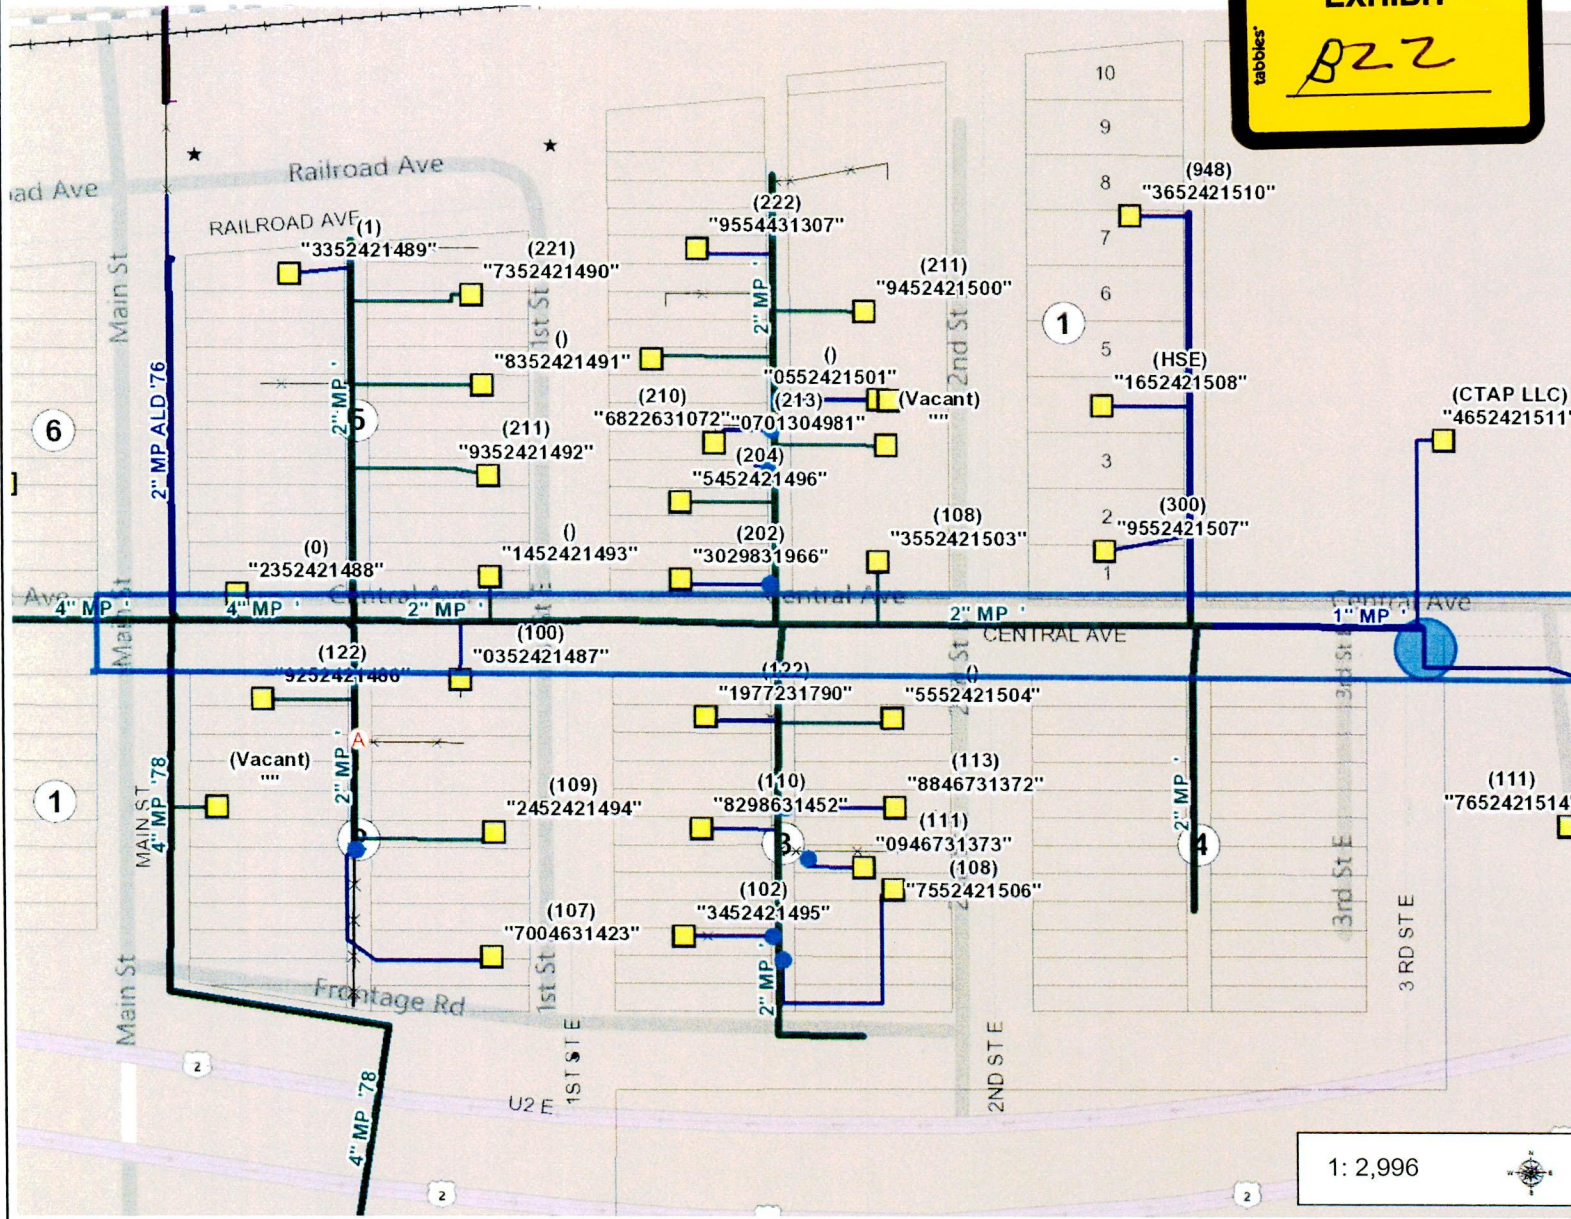
Damage occurred inside Located area.
