December 7, 2015

Carlson McCain, Inc. (CMI) conducted an onsite inspection of the Border Winds Energy Project (Case No. PU-14-031) on December 1, 2015, on behalf of the North Dakota Public Service Commission (PSC). The project consists of installing 75 wind turbines totaling approximately 150 MW of generating capacity and associated facilities in Rolette County, North Dakota.

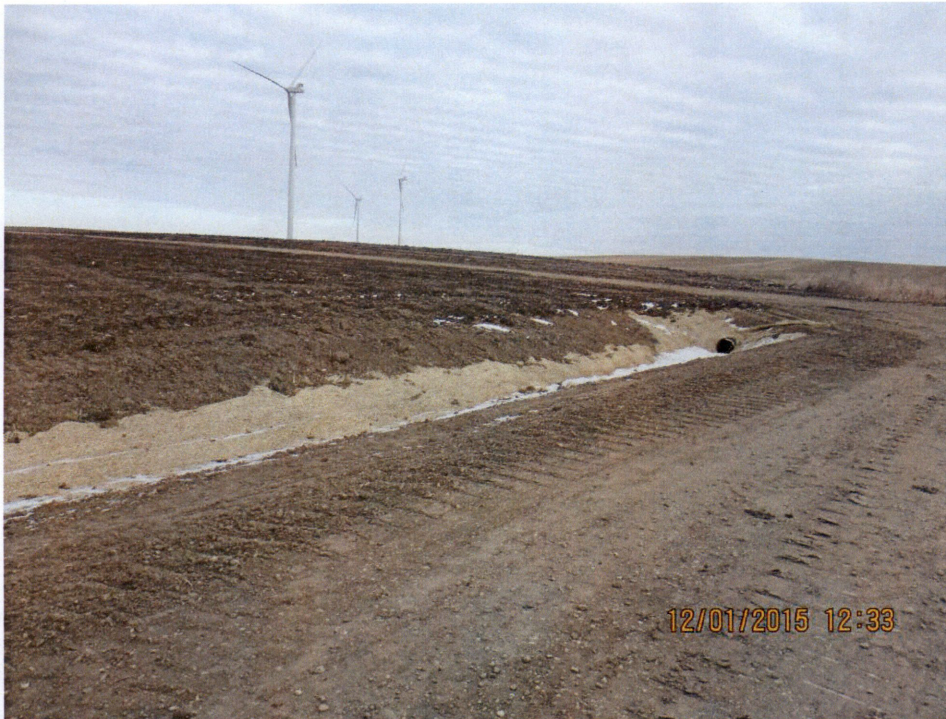
Figure 1. Photo taken of reclaimed service road radii corner. Drainage ditch has been graded, erosion mat in place, and culvert installed.

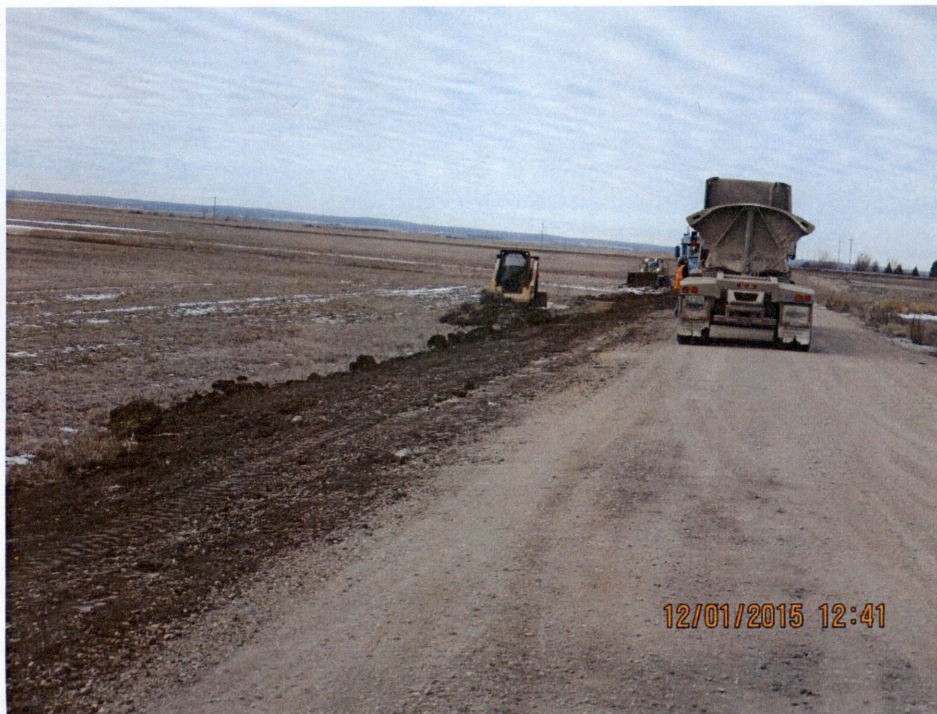
Figure 2. Topsoil being moved back into place and rocks being separated.

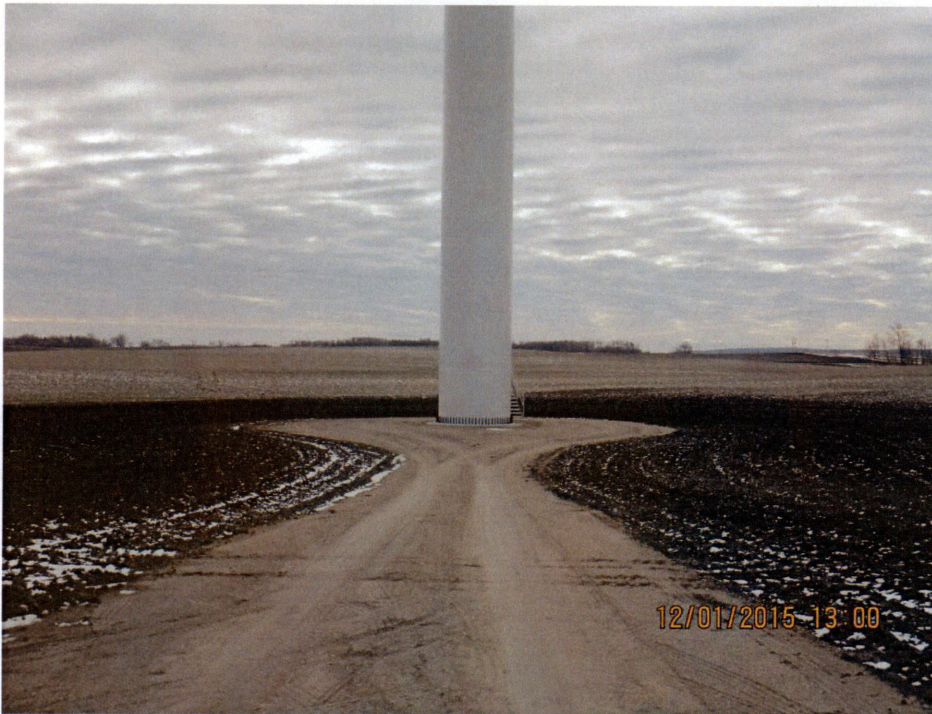
Figure 3. Finished turbine T19 and pad. Topsoil has been disked and service road has a slight taper away from turbine base.

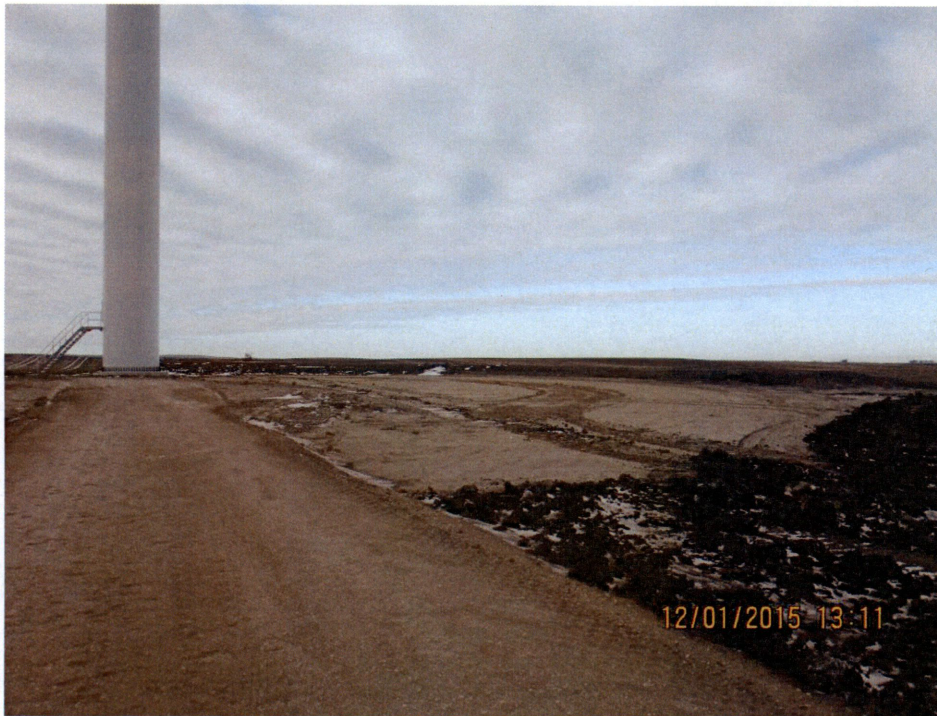
Figure 4. Turbine pad to be reclaimed at T20.

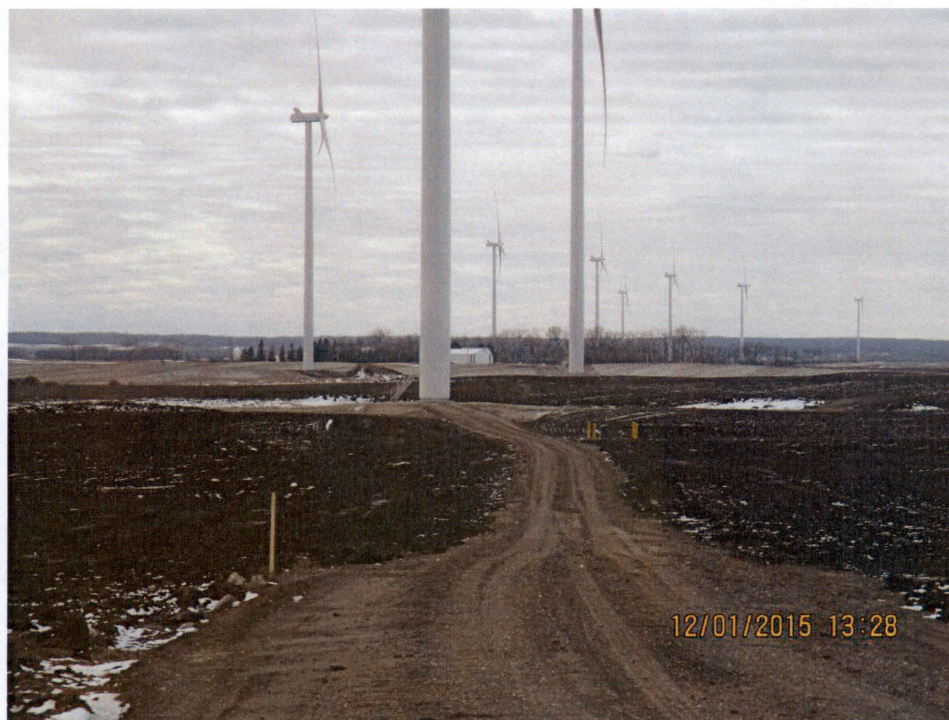
Figure 5. Photo of a service road to be realigned to be in line with the turbine pad at land owner's request.

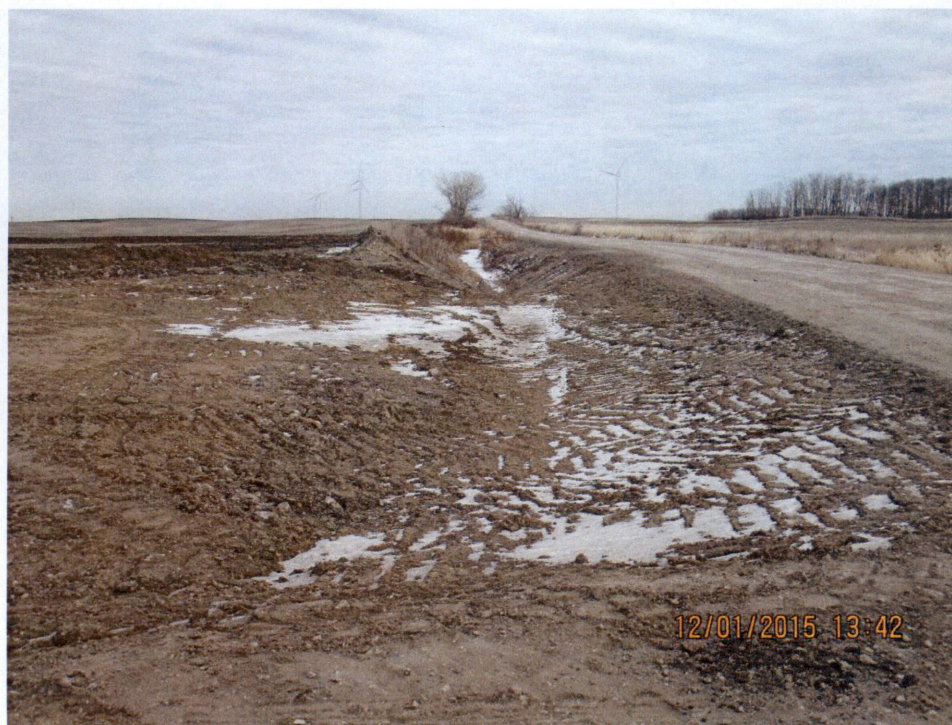
Figure 6. Photo of a ditch to be regraded to establish better runoff collection near T27.

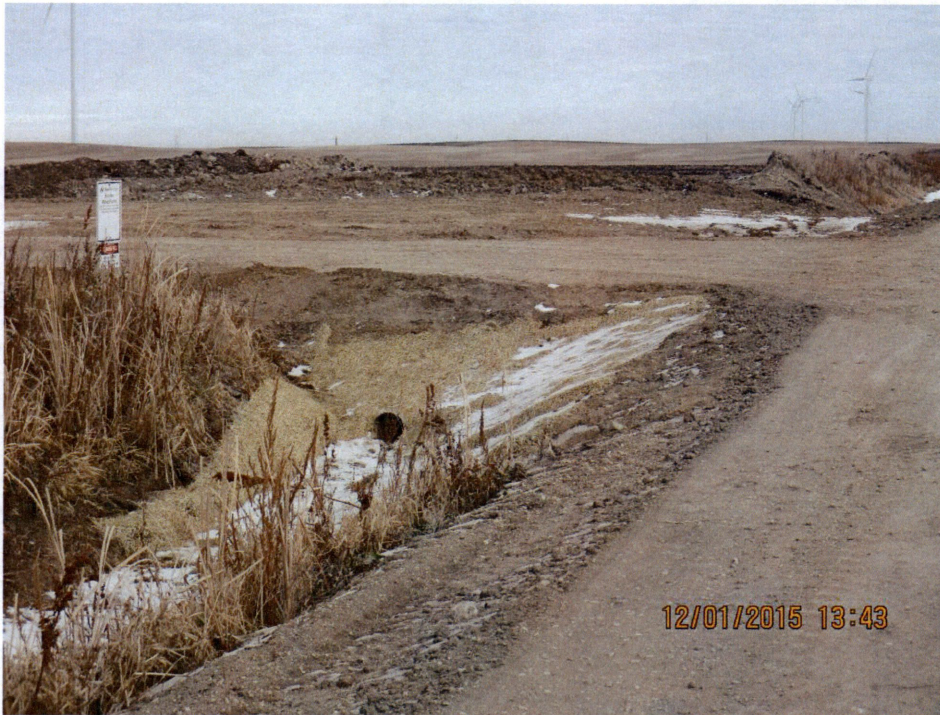
Figure 7. Other side of the service road of T27 with culvert and erosion mat in place.

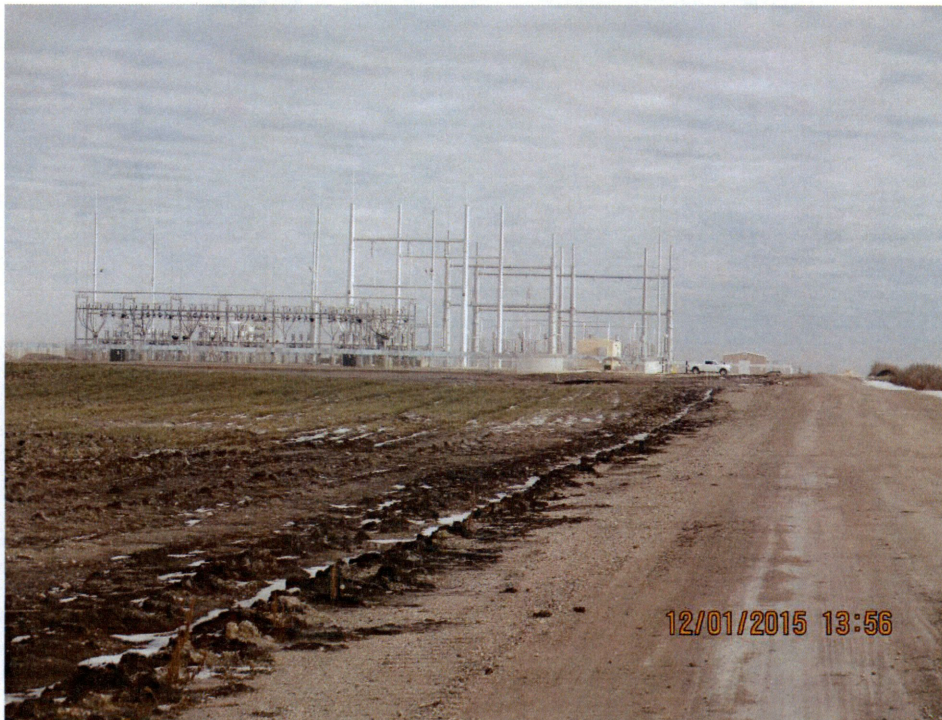
Figure 8. Photo of completed substation and work still needed to reclaim the service road and topsoil around it.

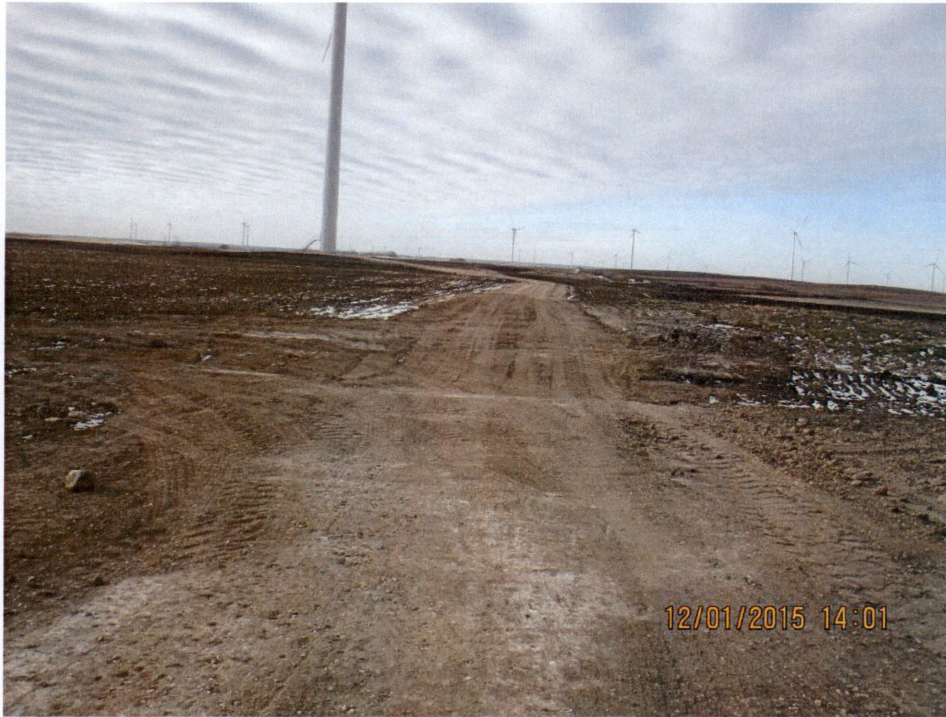
Providing safe access to the turbine locations has been made top priority at this point in the project before the winter comes. There was a partial outage for work to be done on a splice south of T45 in circuit 2. Class 5 rock was hauled in order to restore public gravel roads. There is still work that needs to be done reclaiming topsoil around service roads to the turbines and substation. Service roads were constructed, but not all of the radii corners had erosion control blanket in place due to site conditions. To help alleviate spring runoff and still allow access to the turbines during the winter months, some of the service roads were constructed with a gradual cut running across the road in lower elevated areas.

Figure 9. Photo of the gradual cut in the service road to promote better drainage and still allow safe access to the turbine.
