BORDER WINDS ENERGY PROJECT WEEKLY PROJECT REPORT

Weekly report no:	18
Report for week period ending COB Friday:	11/14/14
Calendar week no:	46

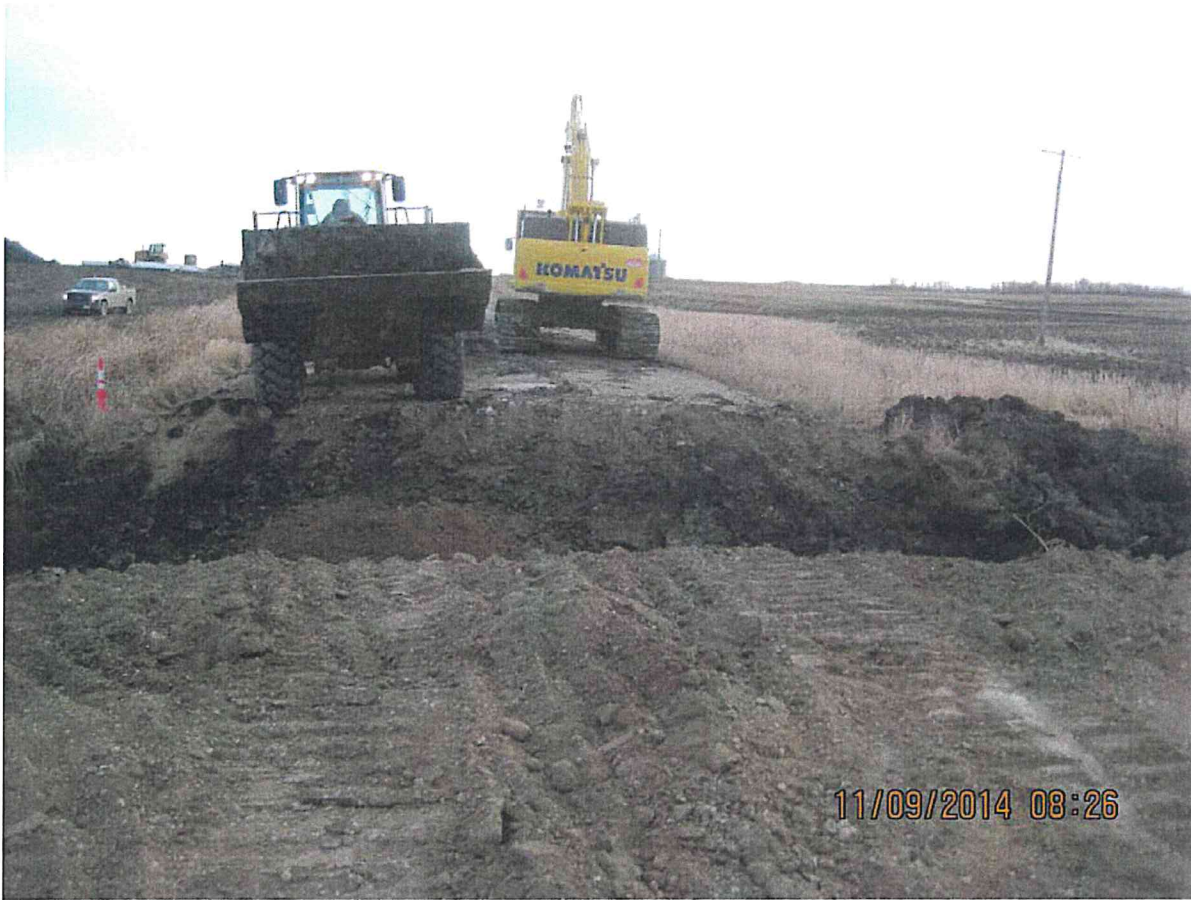
Border Winds – Culvert Installation on 106th Street

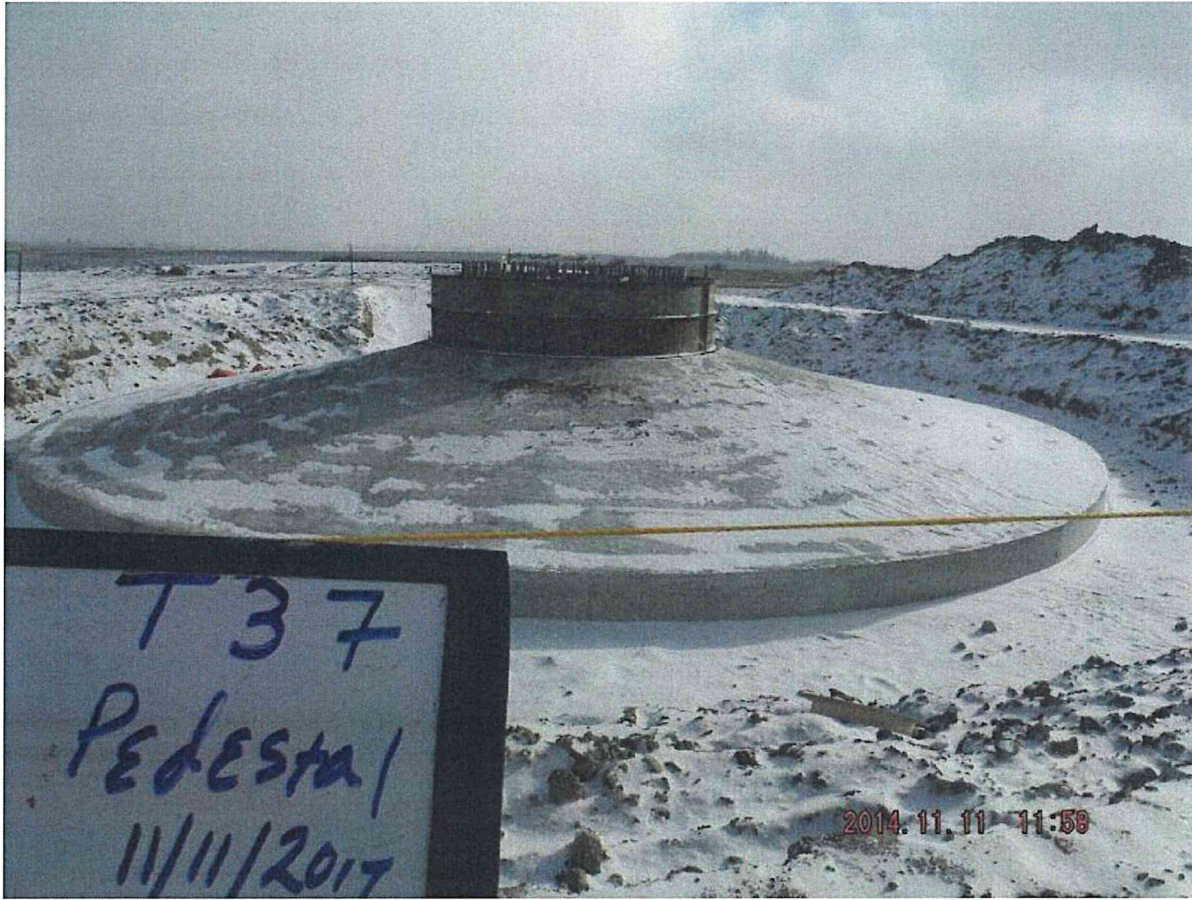
Border Winds – T37 Foundation Pedestal Formed for Pour

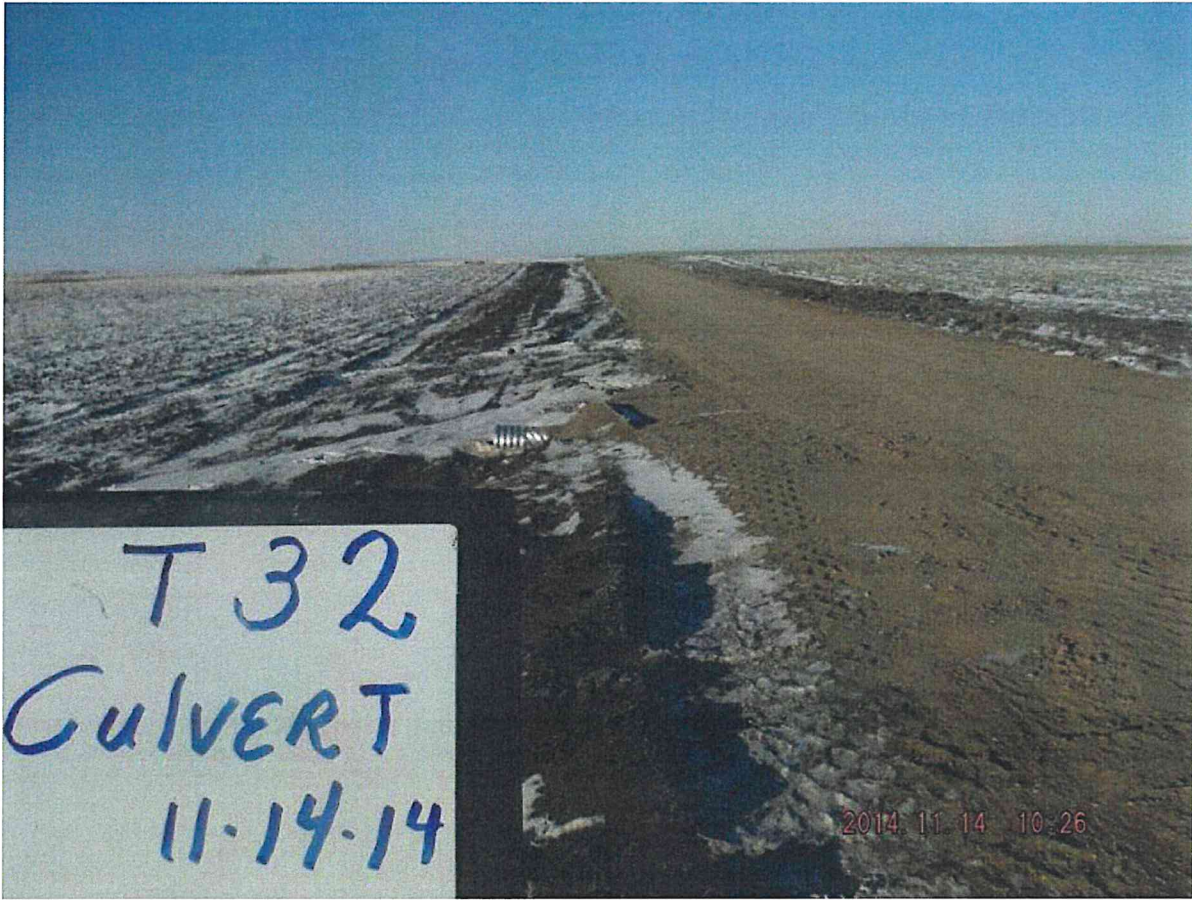
Border Winds – T32 Culvert Installation

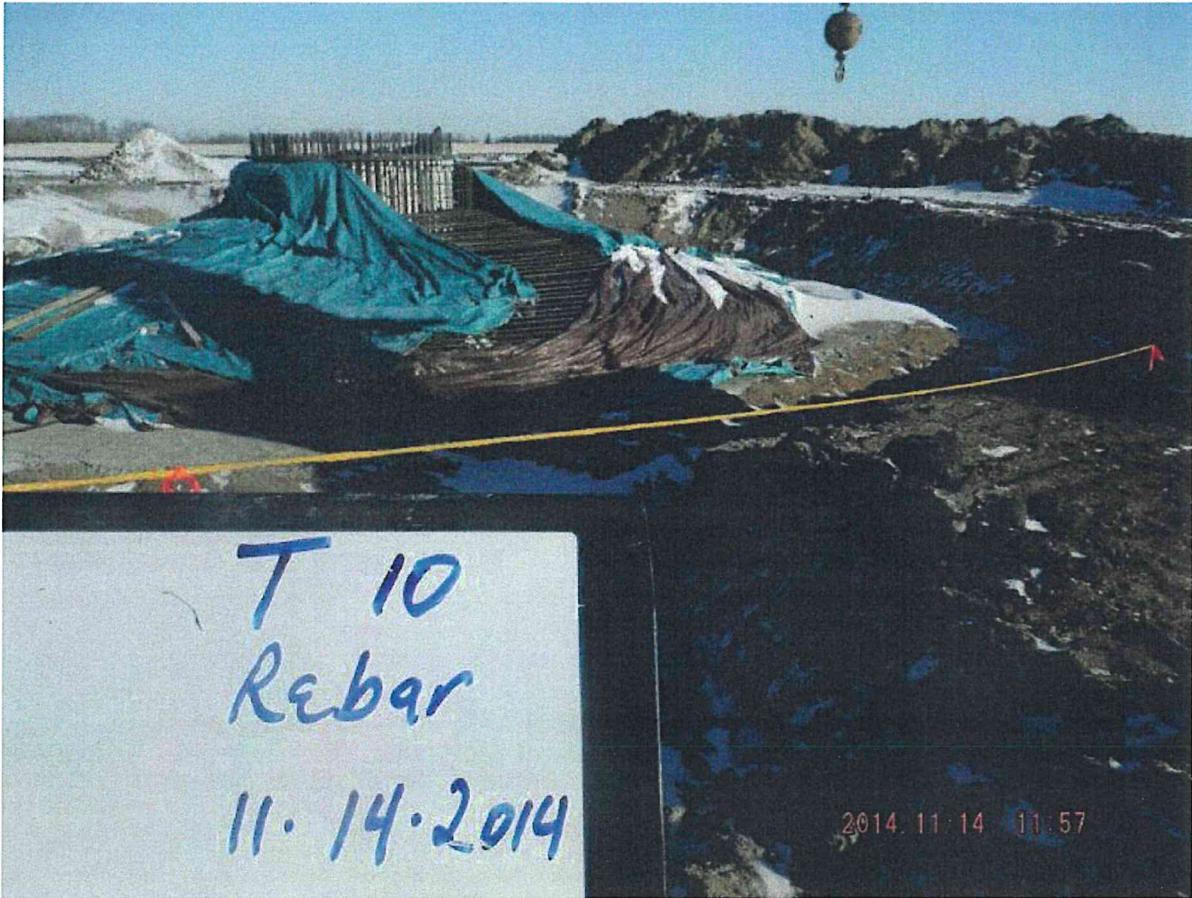
Border Winds - T10 Foundation Rebar Placed

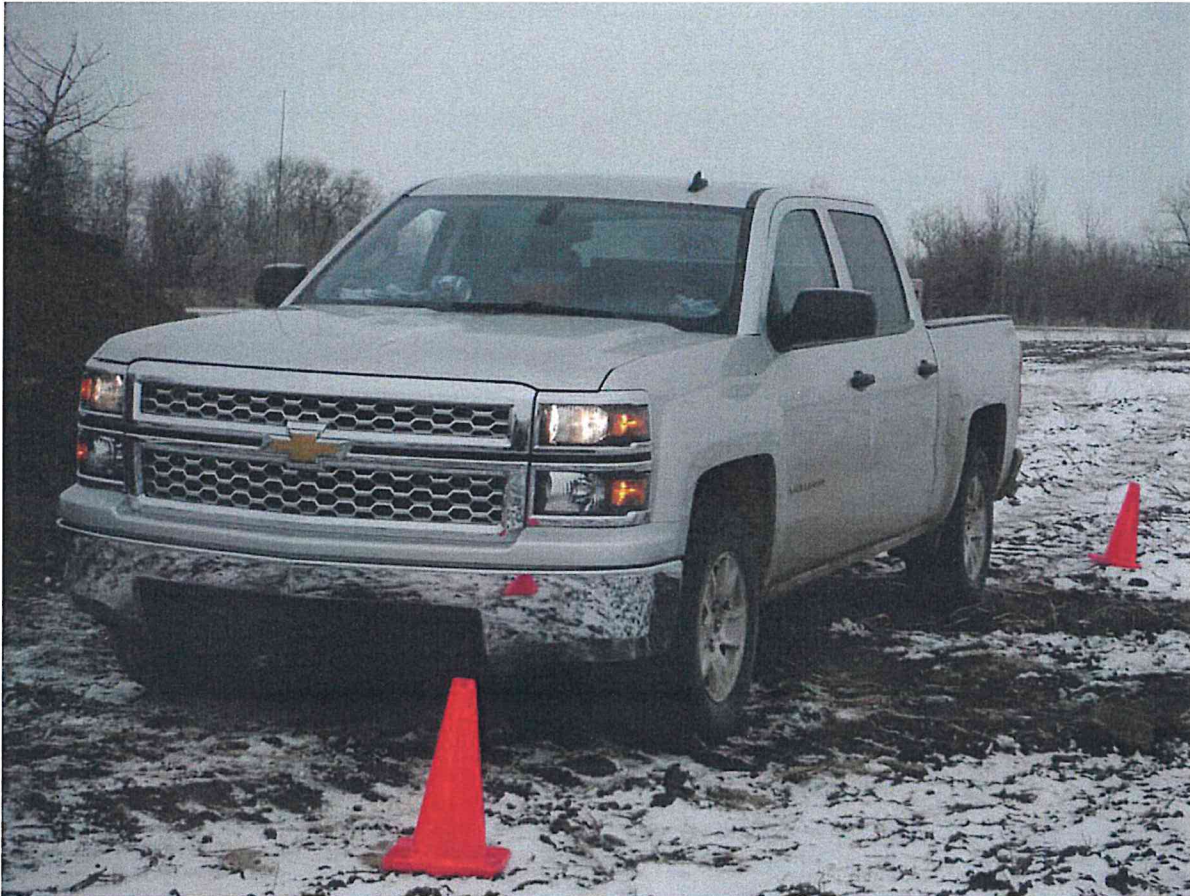
Border Winds – Vehicle Coned Off for Safety

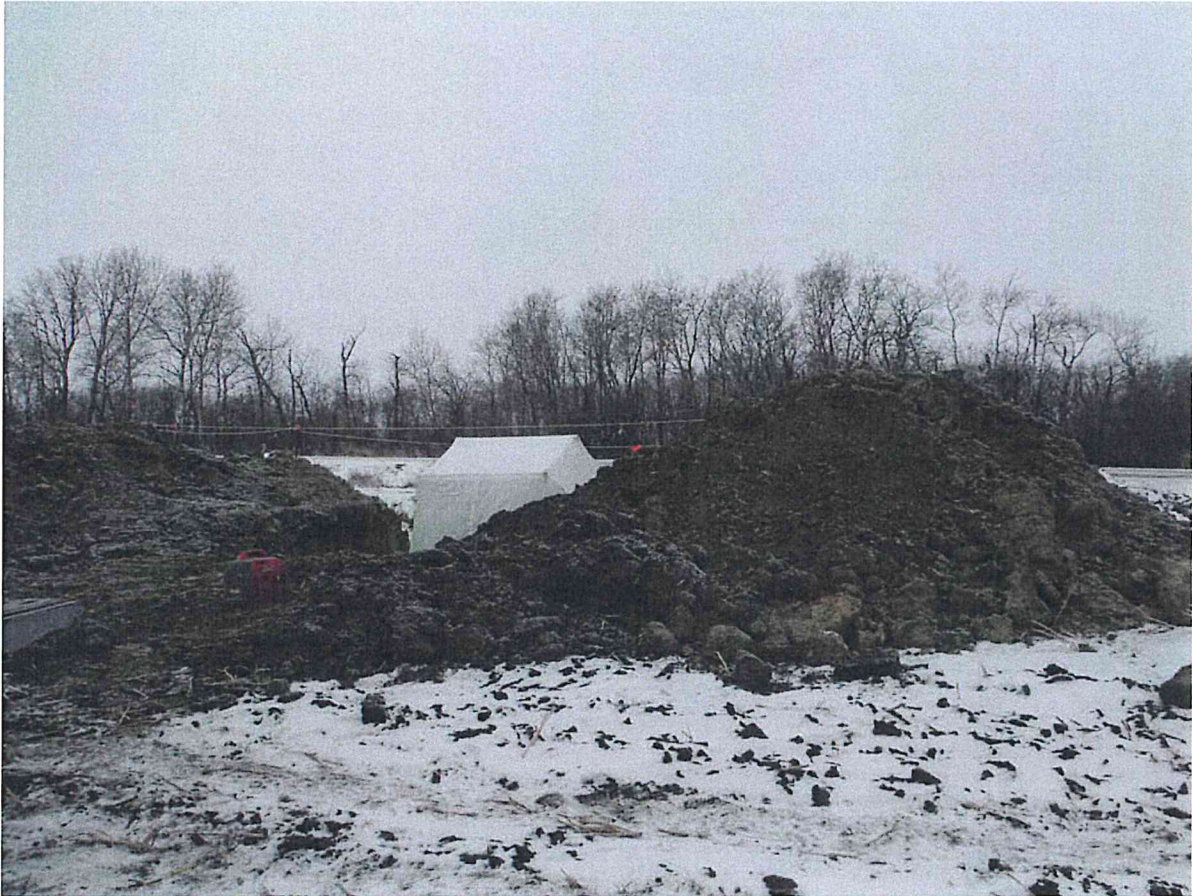
Border Winds – Splice Pit Tent
