BORDER WINDS ENERGY PROJECT WEEKLY PROJECT REPORT

Weekly report no:	22
Report for week period ending COB Friday:	12/12/14
Calendar week no:	50

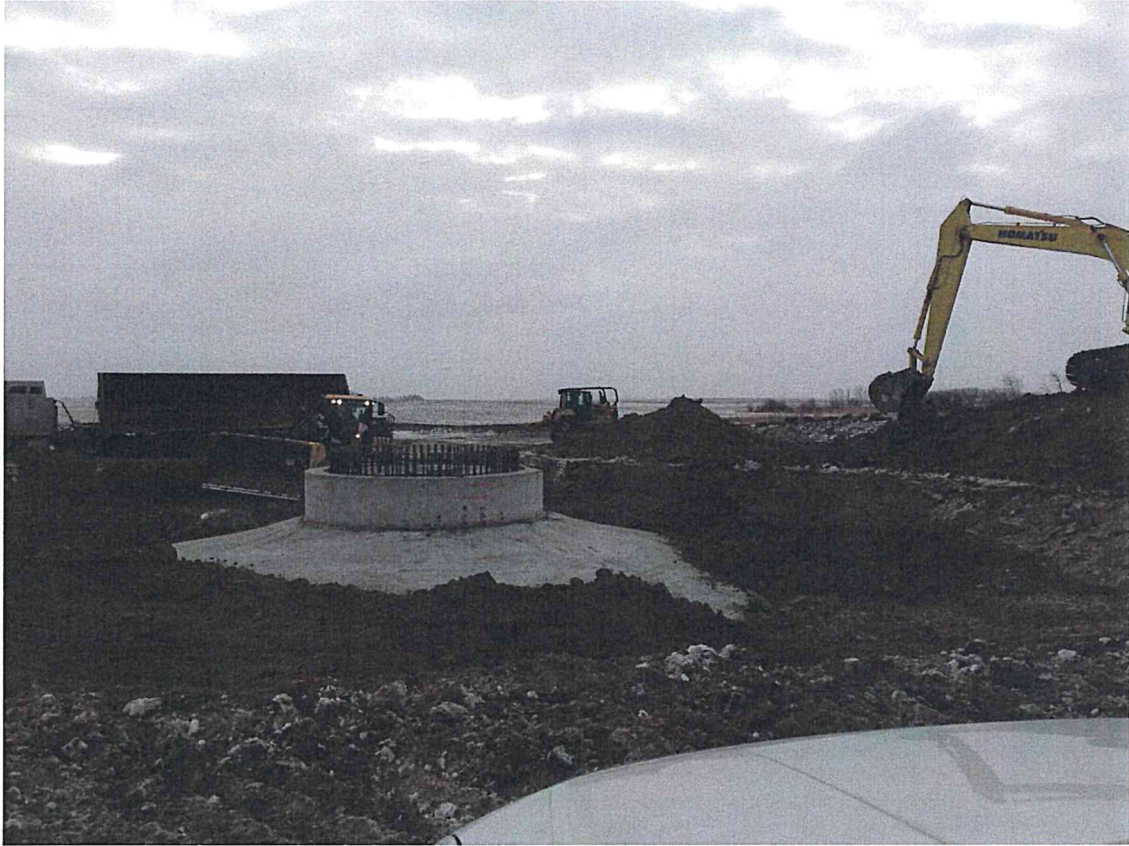
Border Winds: Foundation Backfill

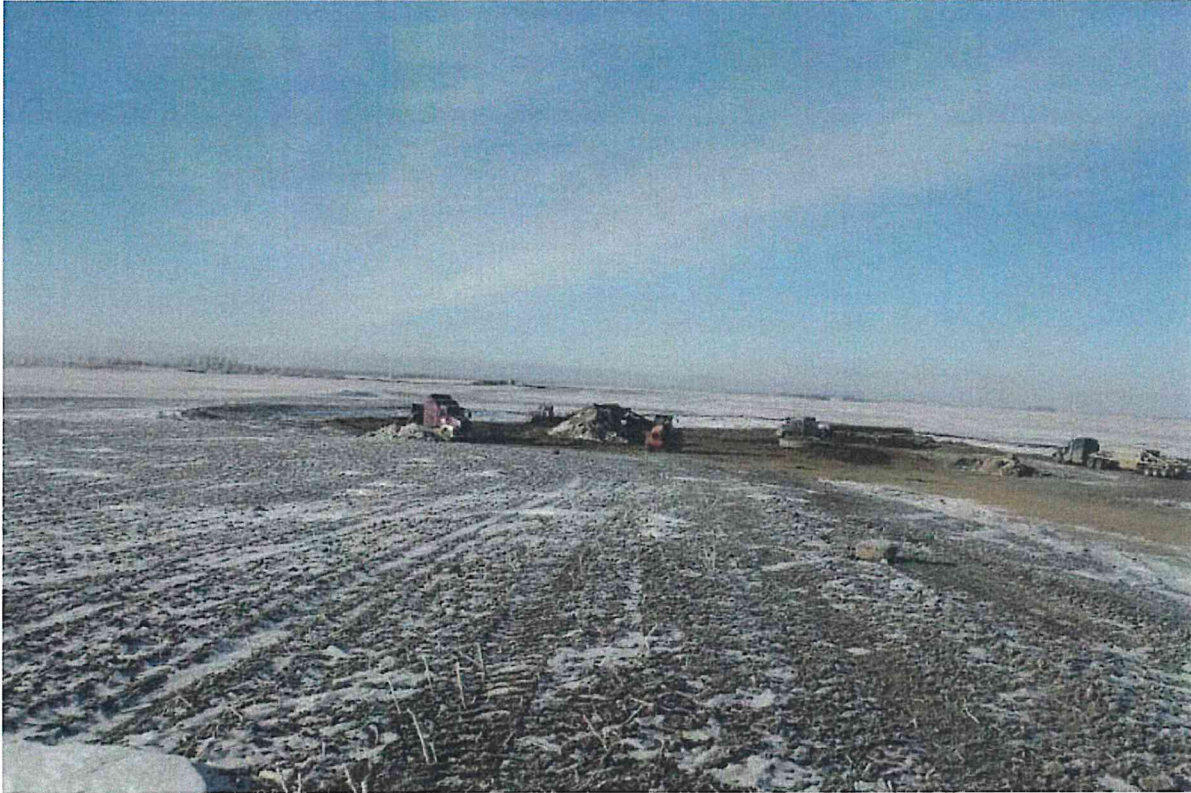
Border Winds: Foundation Backfill

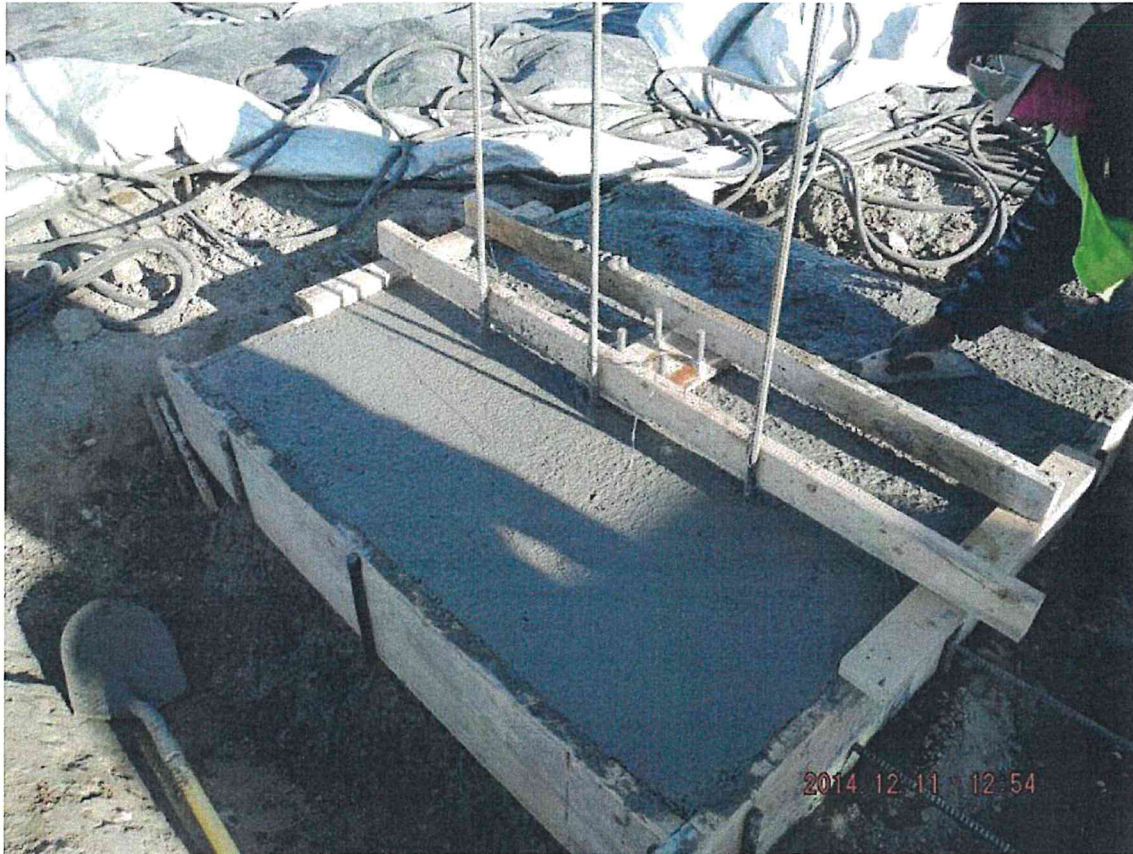
Border Wiinds: O&M Building Interior Foundation Poured
