BORDER WINDS ENERGY PROJECT

WEEKLY PROJECT REPORT

Weekly report no:	28
Report for week period ending COB Friday:	02/06/2015
Calendar week no:	6

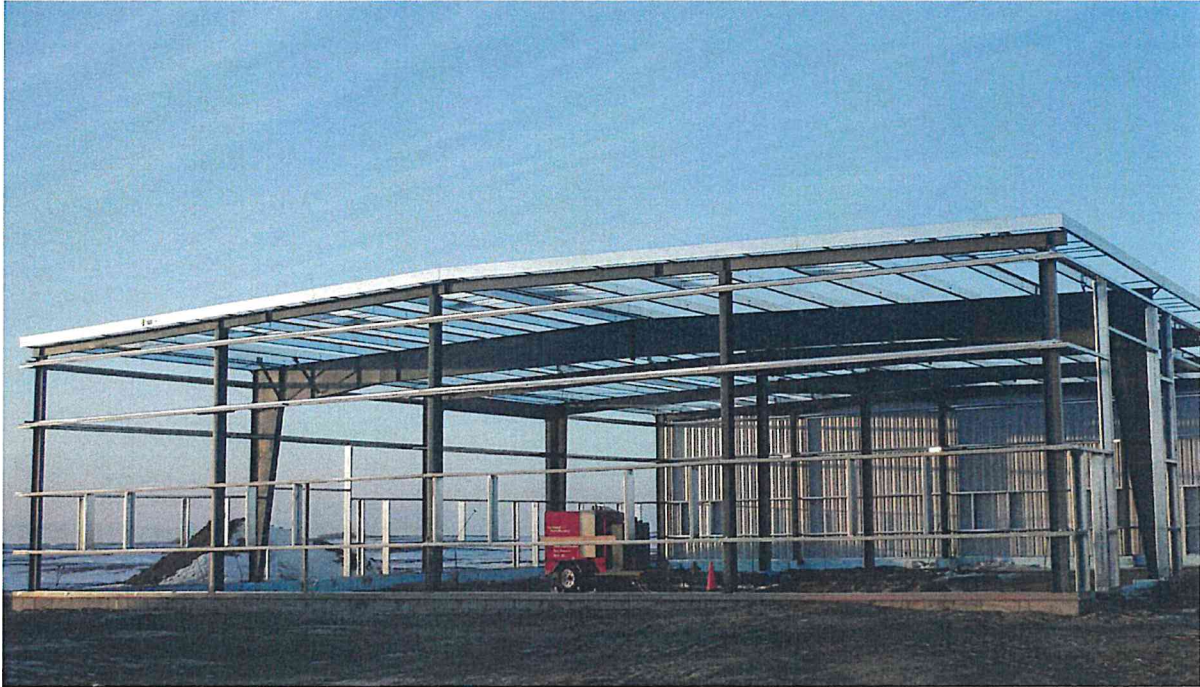
O&M Building Wall Sheeting
