BORDER WINDS ENERGY PROJECT

WEEKLY PROJECT REPORT

Weekly report no:	29
Report for week period ending COB Friday:	02/13/2015
Calendar week no:	7

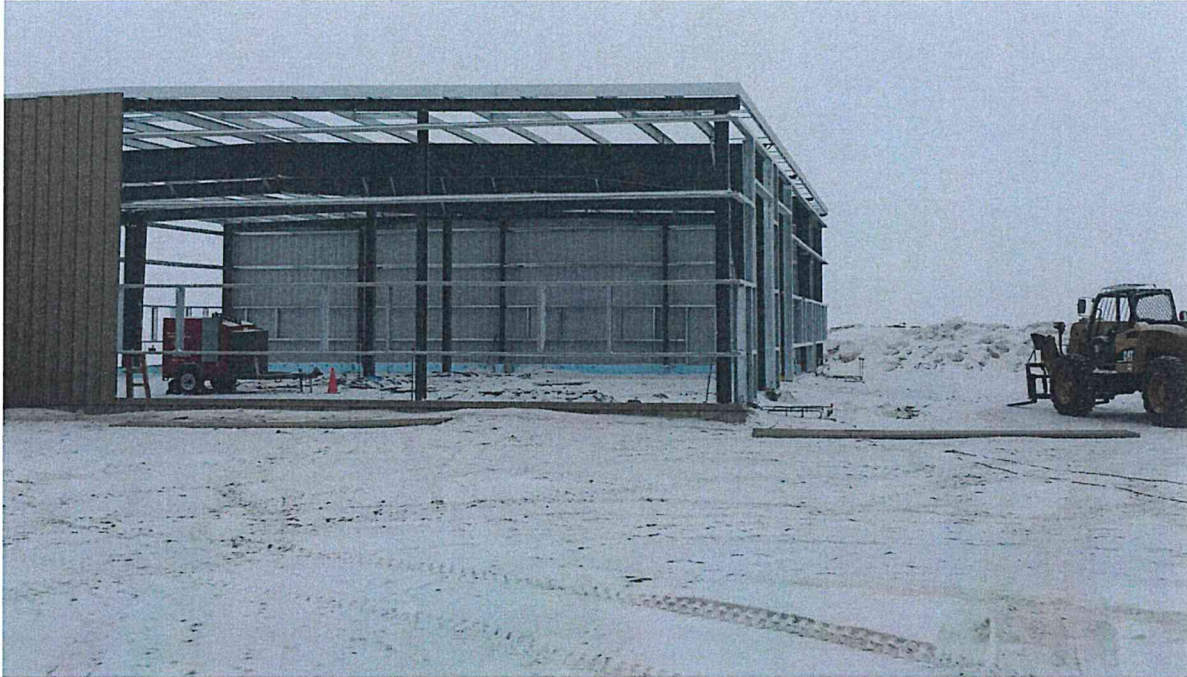
O&M Building North & South Wall Sheeting

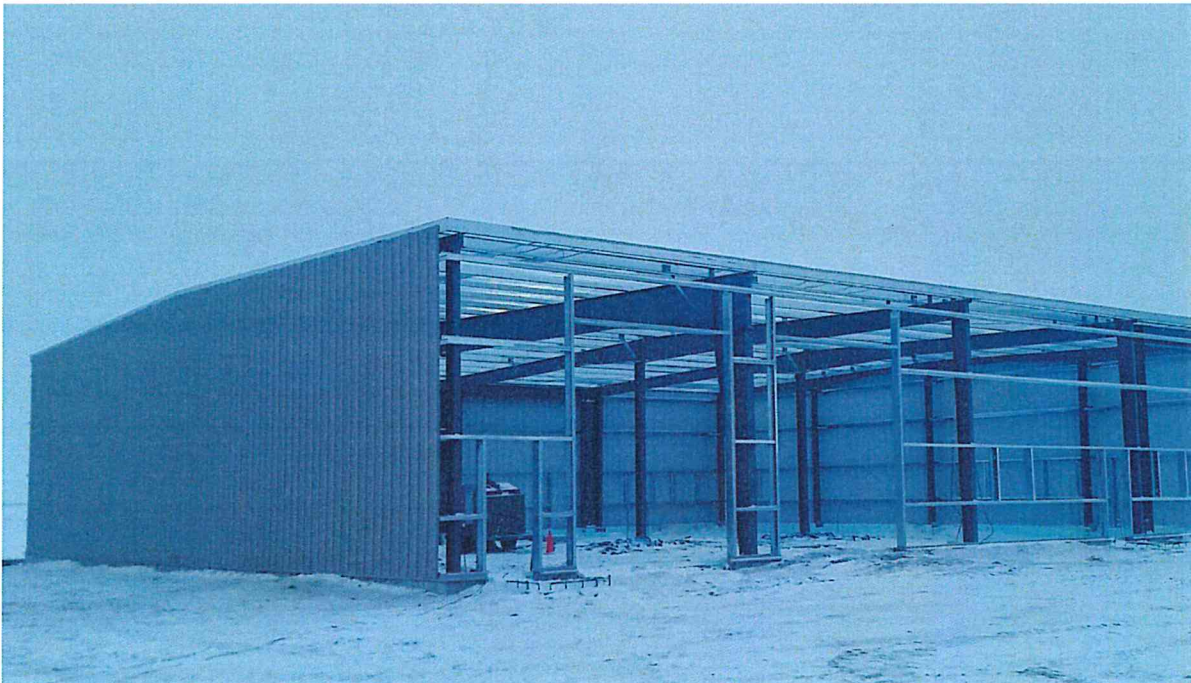
O&M Building East Wall Sheeting

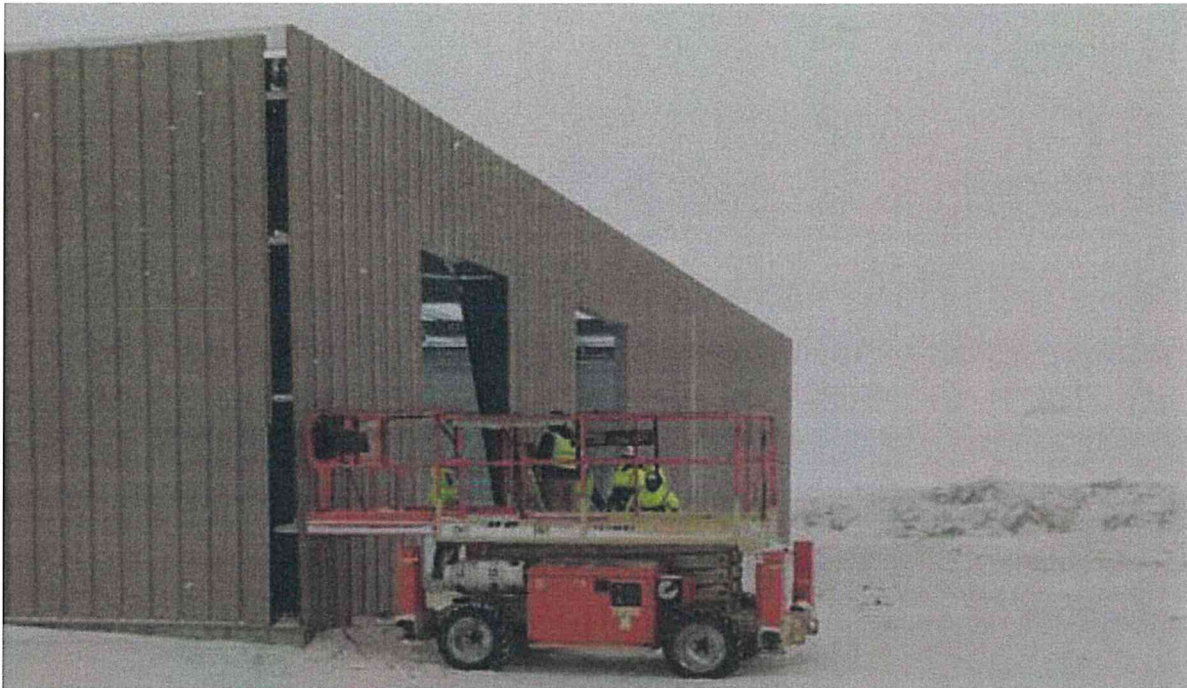
O&M Building West Wall Sheeting

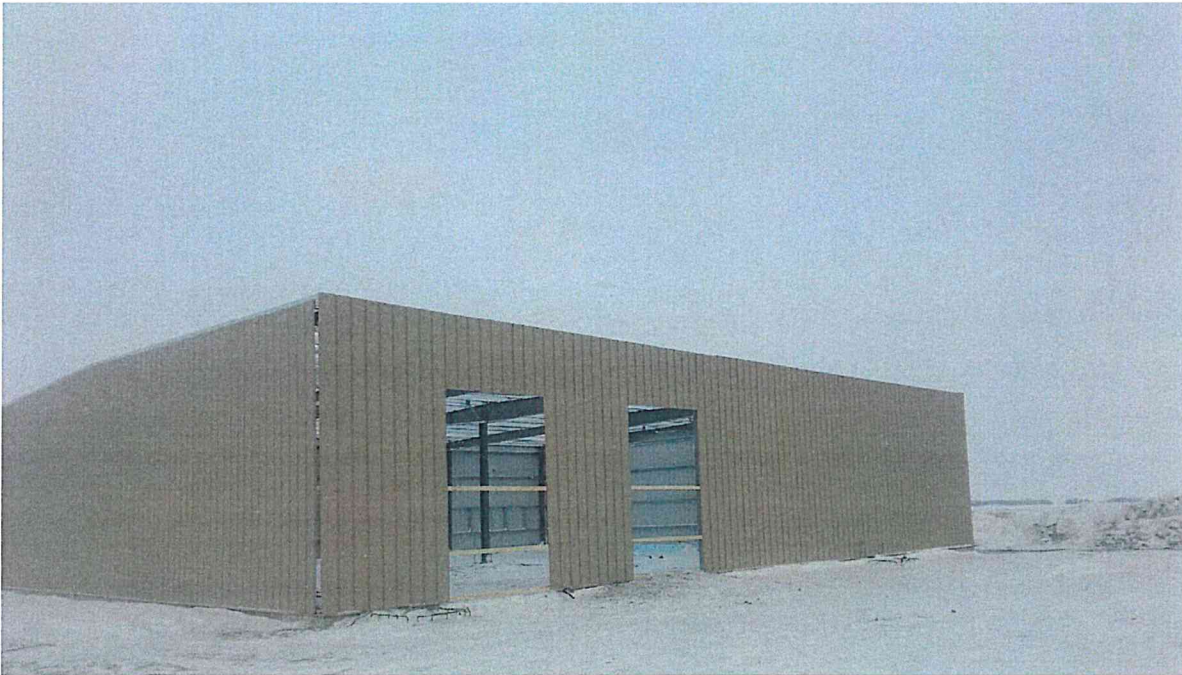
O&M Building Corner Enclosures
