## BORDER WINDS ENERGY PROJECT

### WEEKLY PROJECT REPORT

Weekly report no:	30
Report for week period ending COB Friday:	02/20/2015
Calendar week no:	8

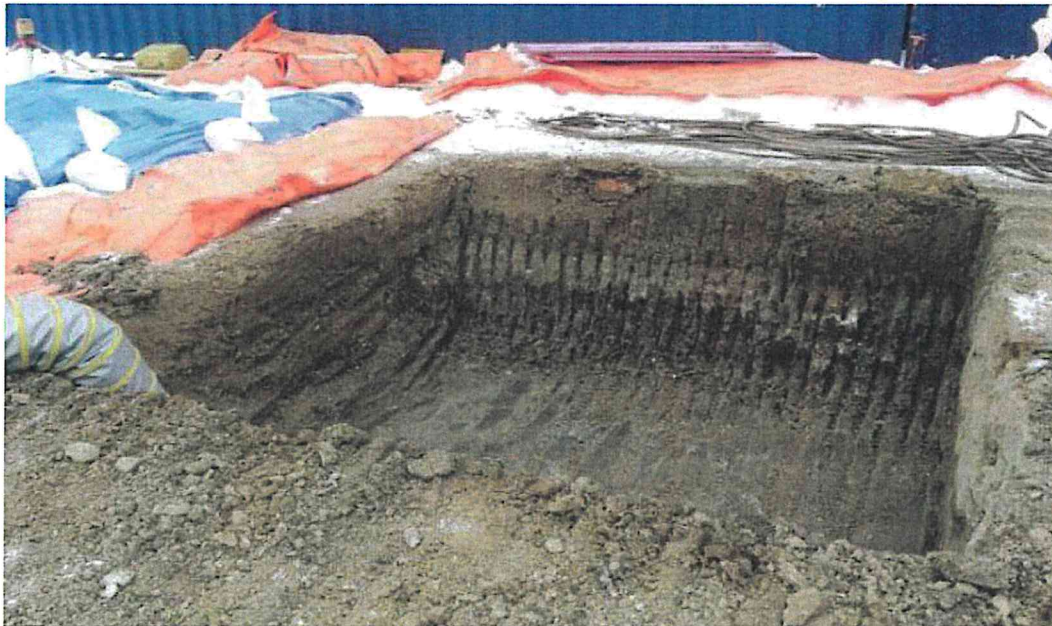
Substation – Foundation excavation

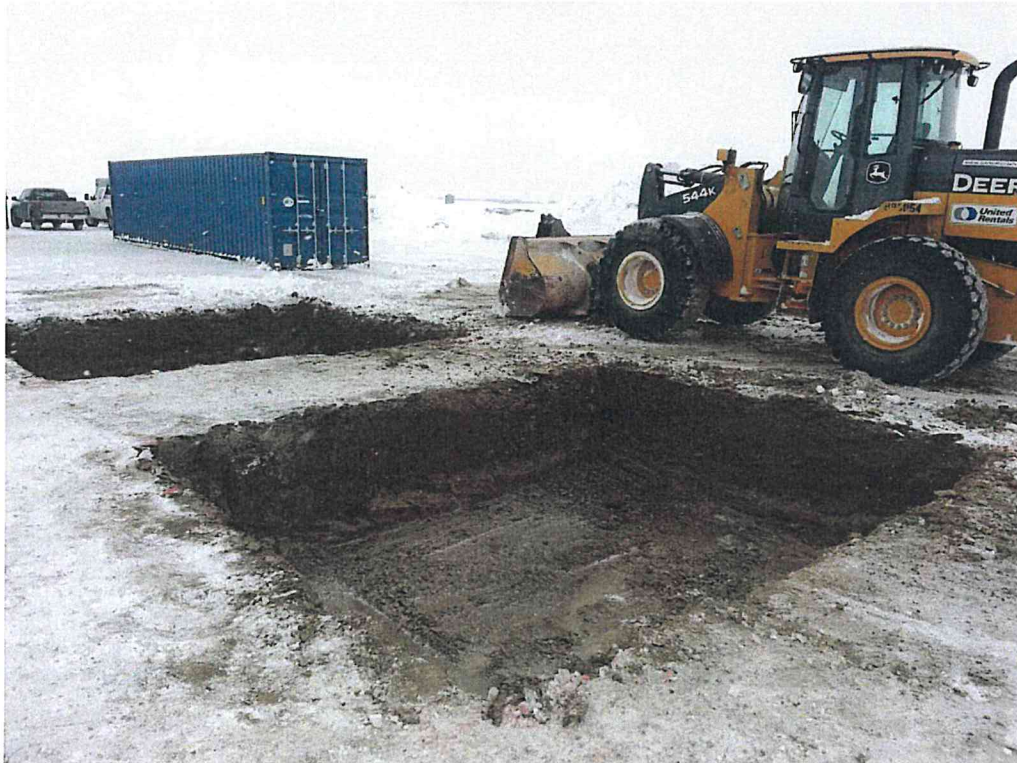
Substation Foundation excavation
