BORDER WINDS ENERGY PROJECT

WEEKLY PROJECT REPORT

Weekly report no:	40
Report for week period ending COB Friday:	05/1/2015
Calendar week no:	18

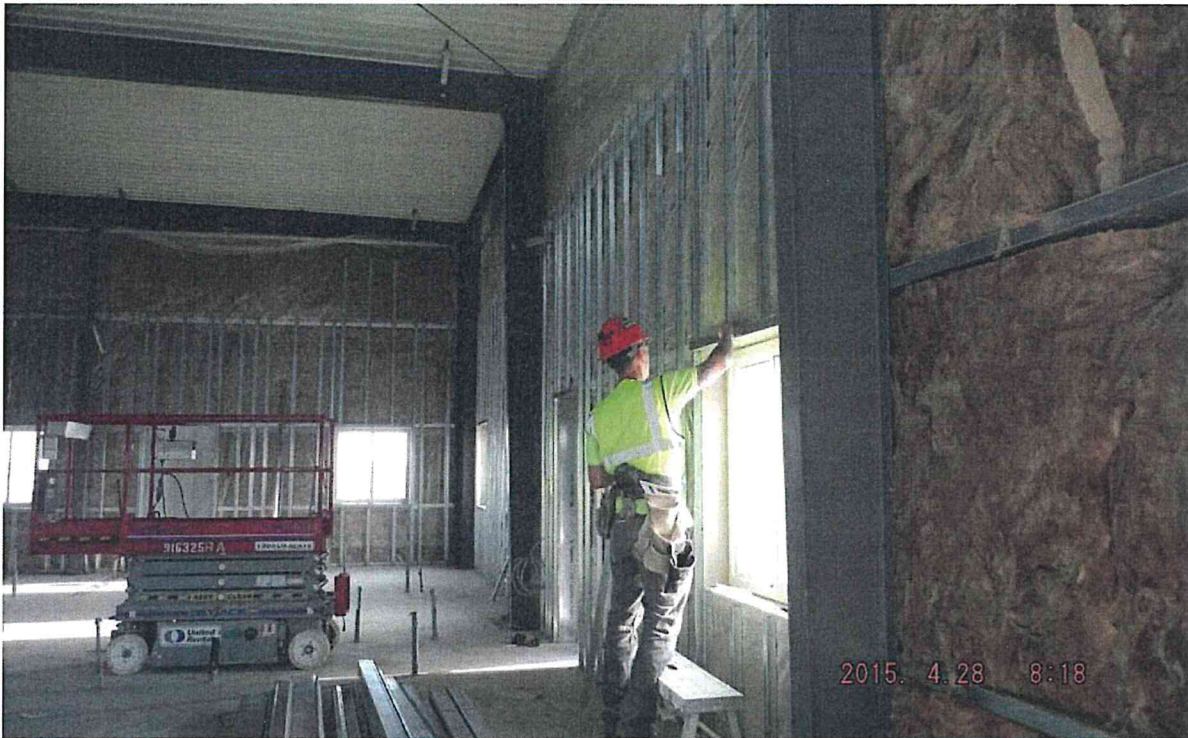
O&M Building – Window Installation

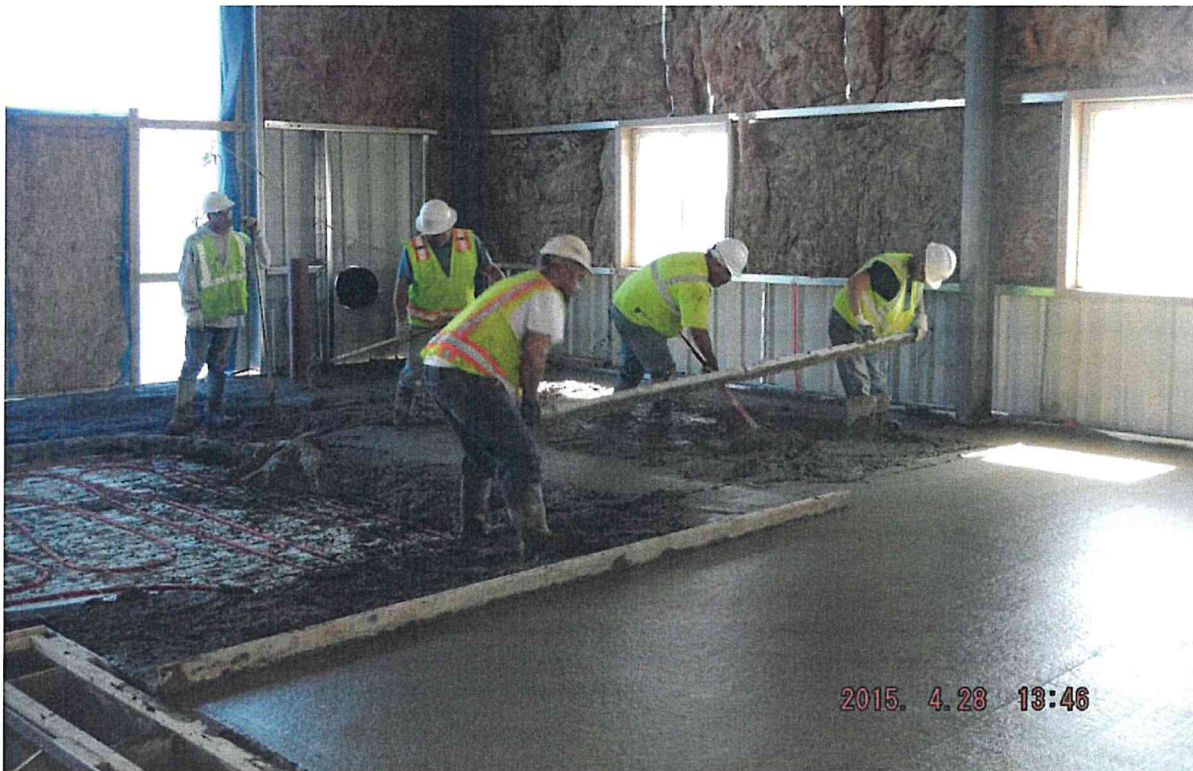
O&M Building – Floor being poured and finished.

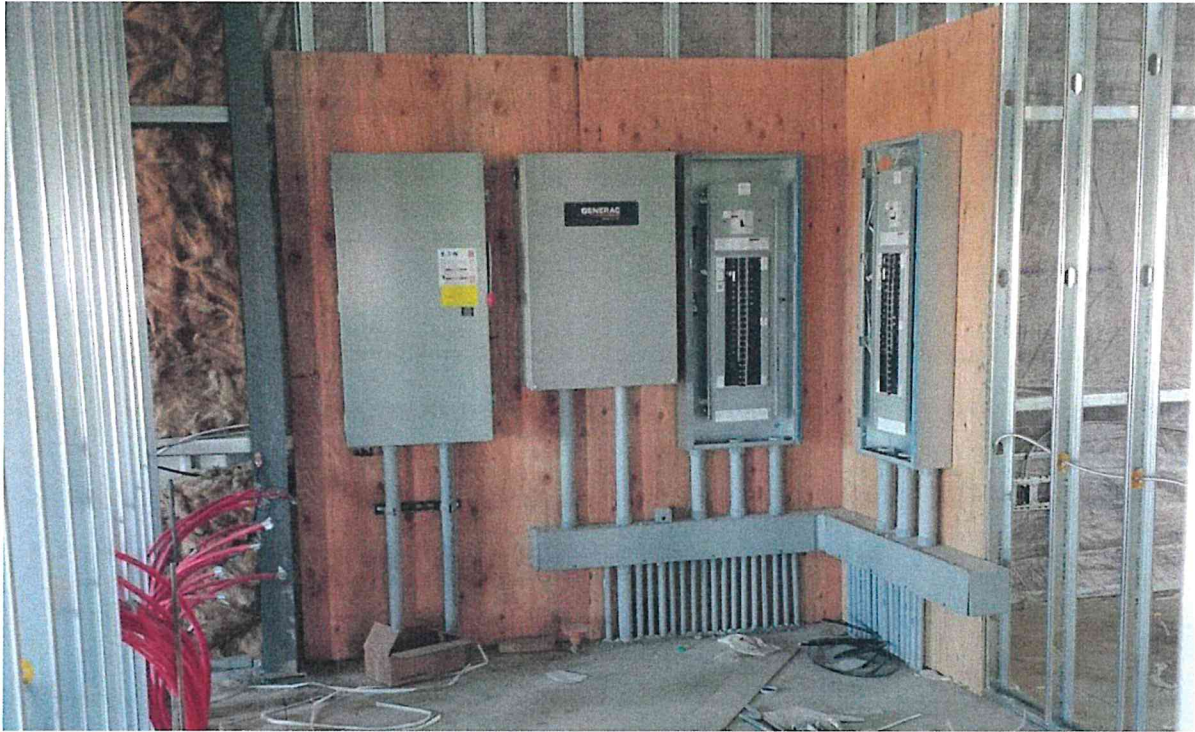
O&M Building – Electric Panels installed.

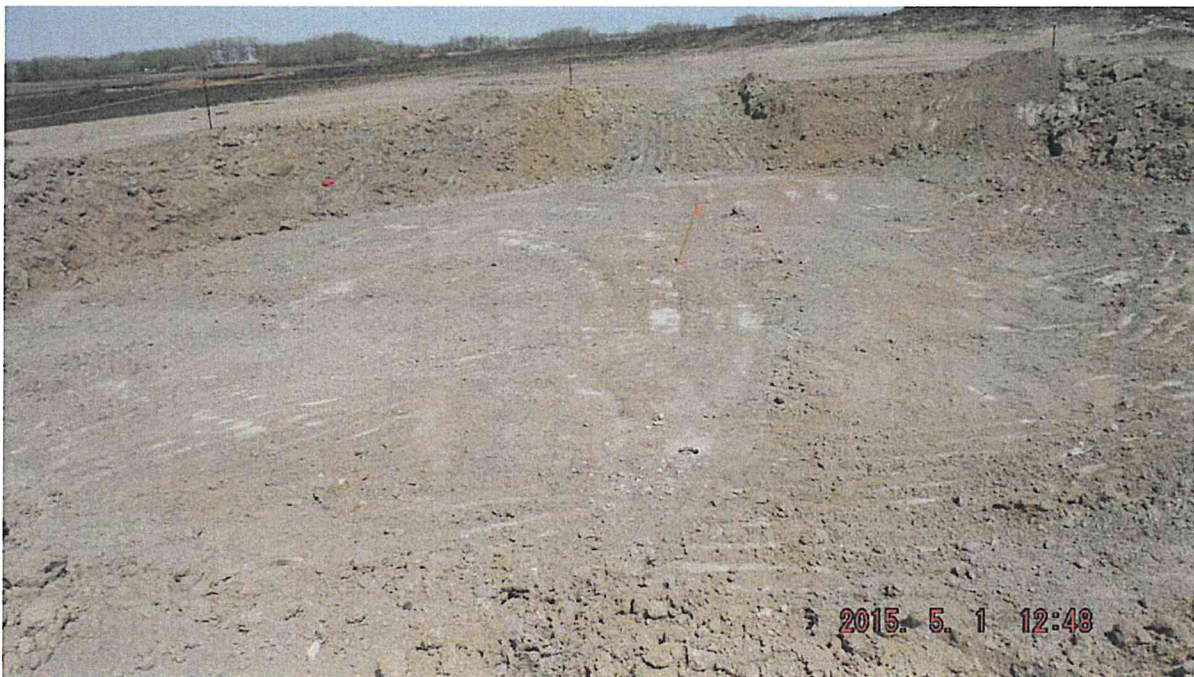
Excavation at T34

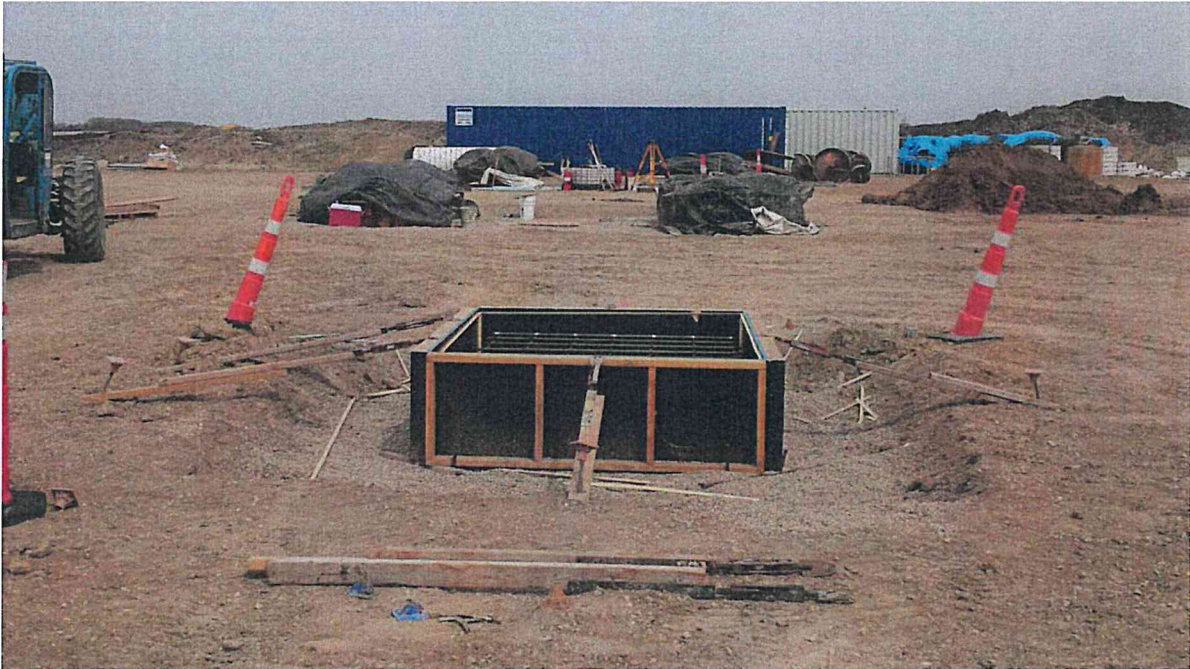
Substation - Foundation work

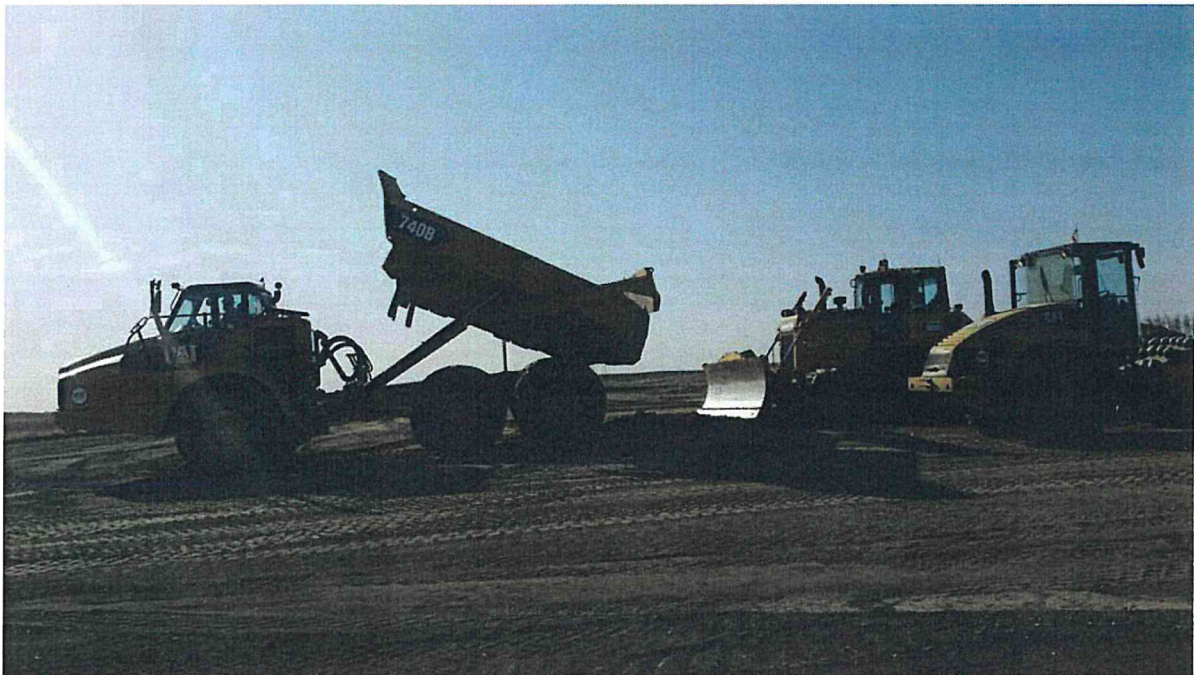
Crane pad subgrade preparation
