## BORDER WINDS ENERGY PROJECT

### WEEKLY PROJECT REPORT

Weekly report no:	41
Report for week period ending COB Friday:	05/08/2015
Calendar week no:	19

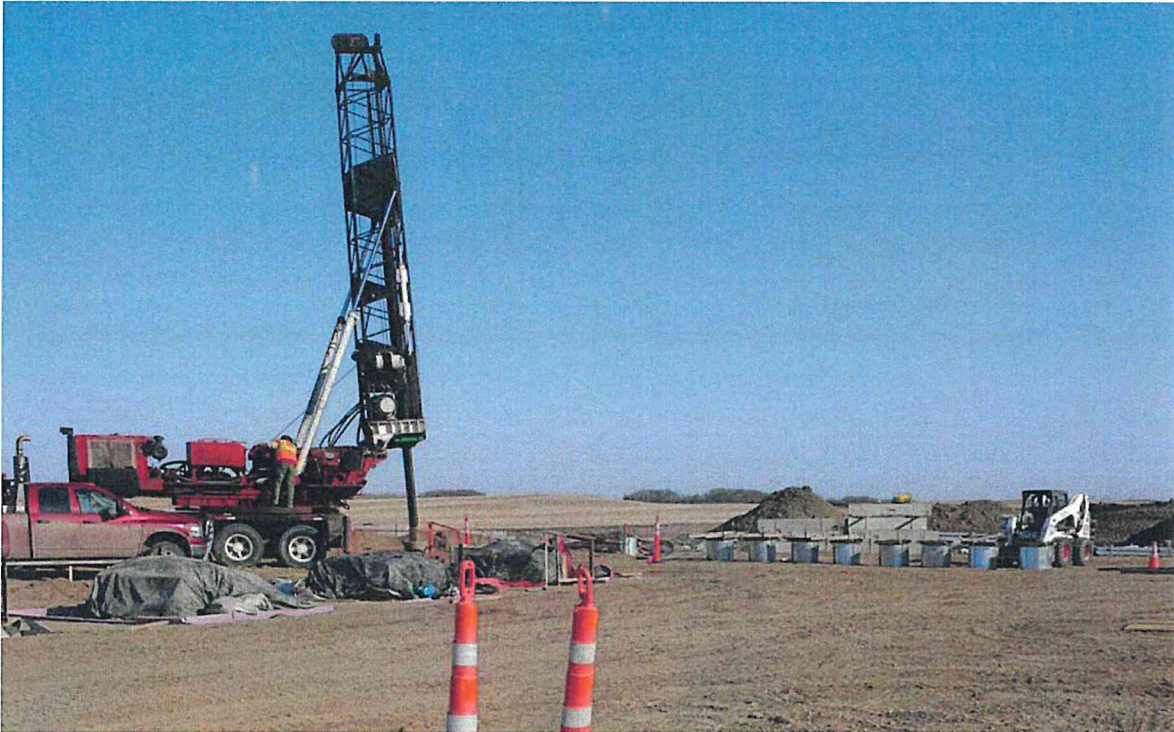
- Main Power Transformer containment pit was excavated and backfilled with pea gravel;
- Completed drilling for five preliminary pier holes. Boulders/rock encountered at average depth of 12-14 feet. REI mobilizing core drilling rig from Colorado which is scheduled to arrive on Friday, May 15, 2015;
- Steel for static mast and dead-end structures was delivered on Friday, 5/8/2015.

Substation – Drilling

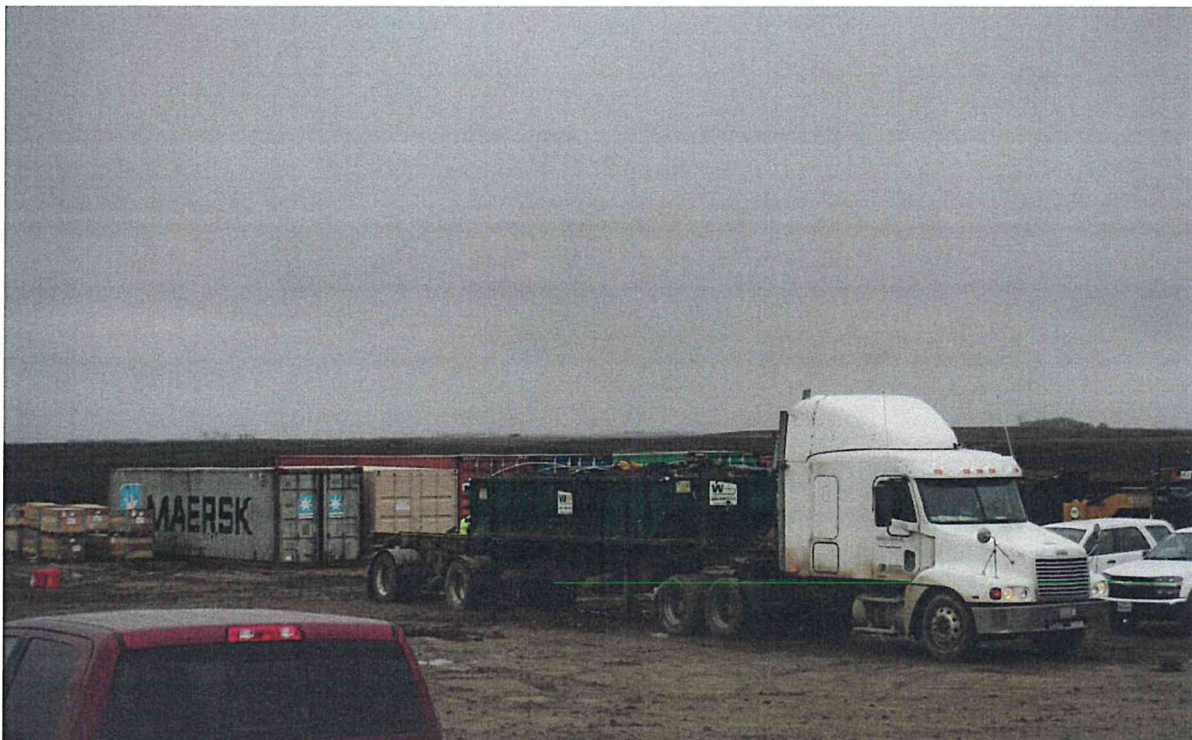
Laydown – Contaminated soil bin removed off site

23053-15-49	Observation	Informational	Waste Management	5/7/2015	The filled contaminated soil bin has been removed off site.	None	Empty contaminated soil bin already on site

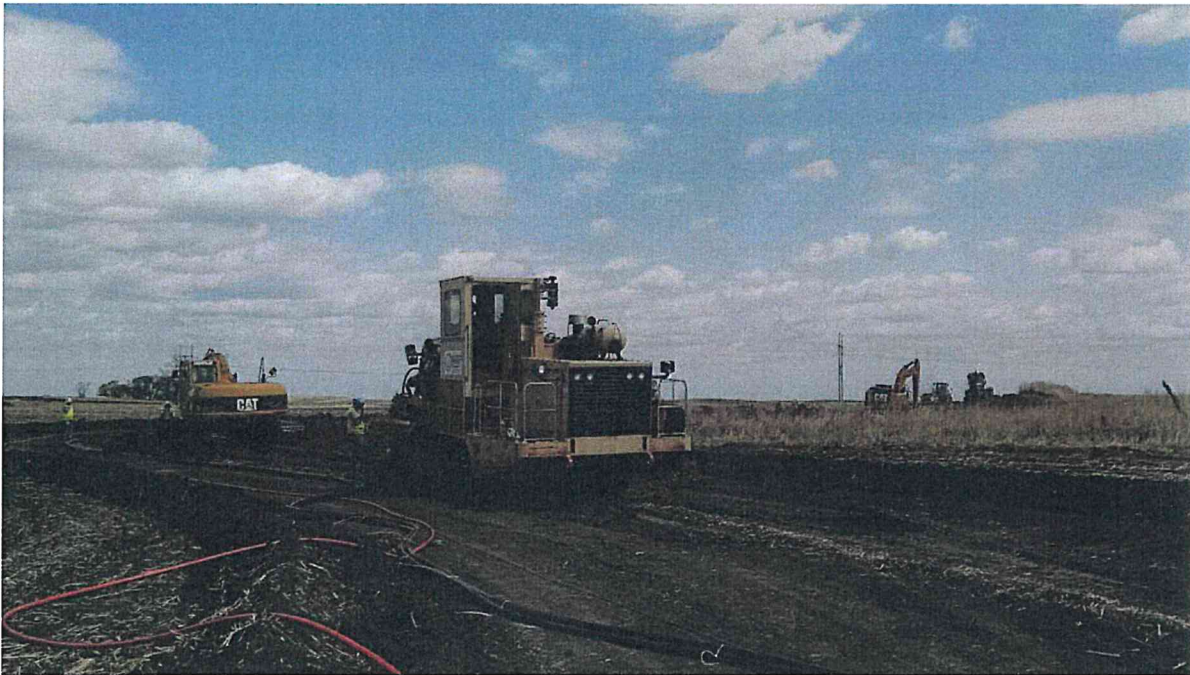
Collection System – Trenching Circuit 6

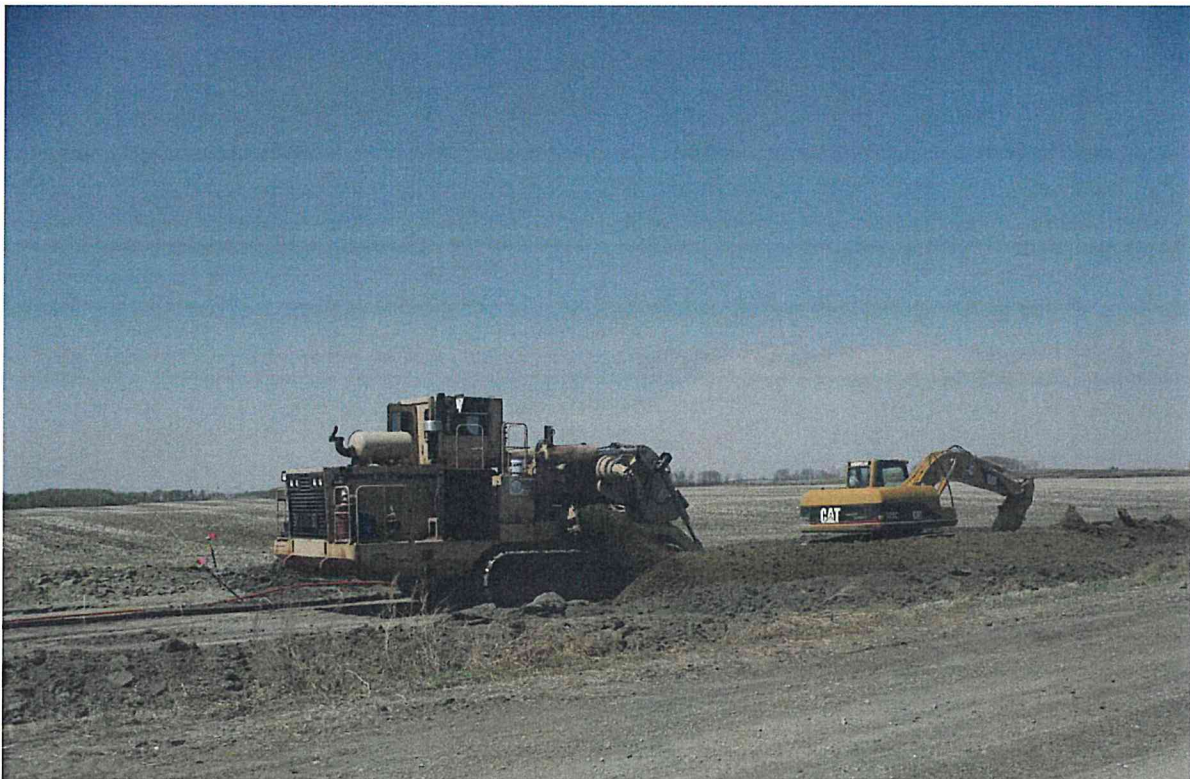
Collection System – Trenching Circuit 6

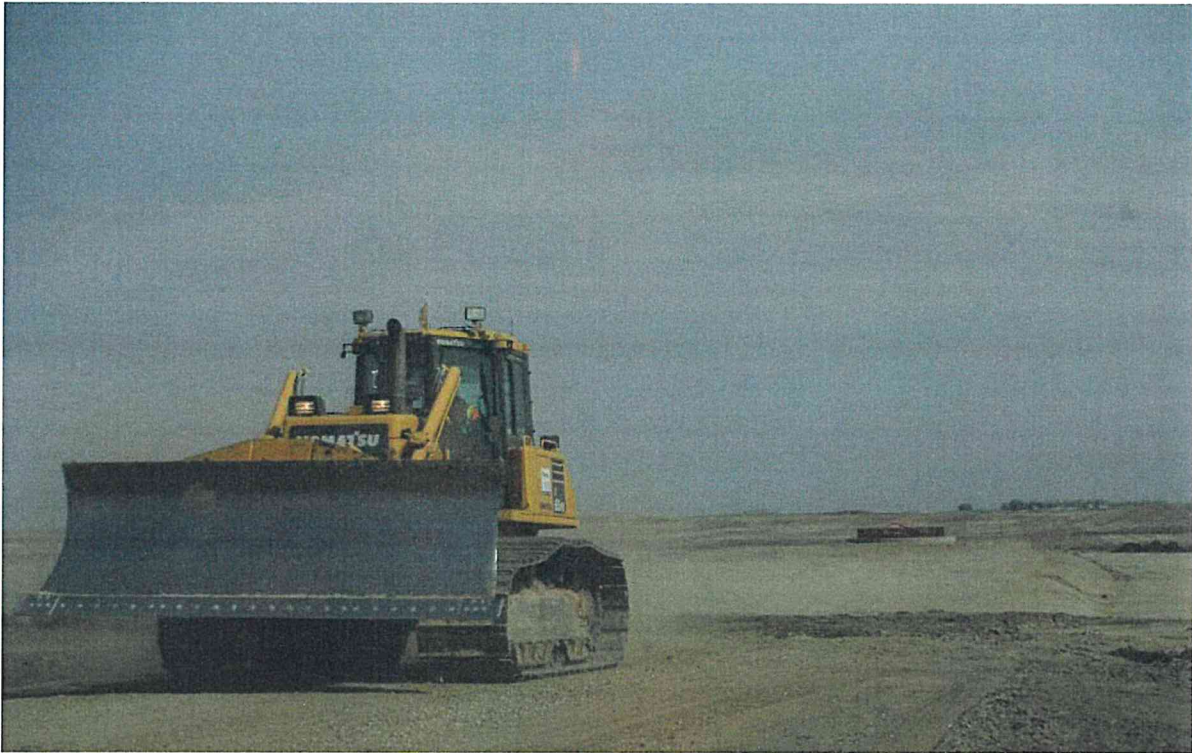
Crane pad – Subgrade preparation at T25

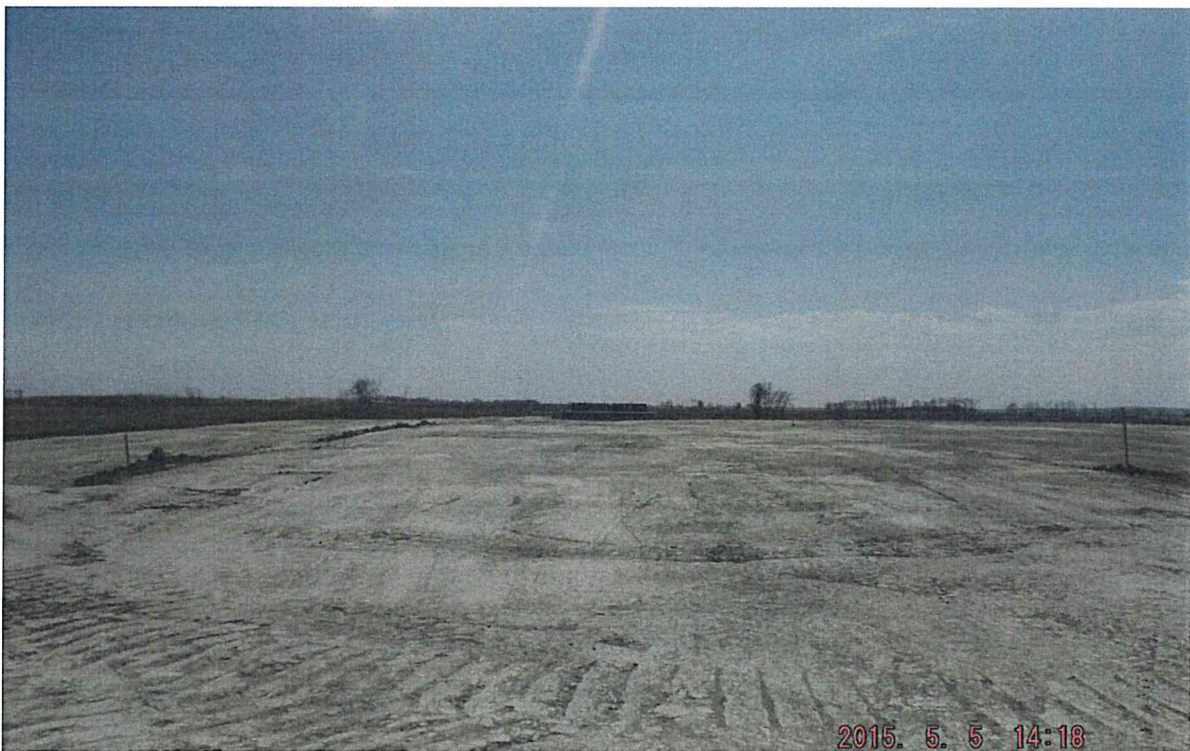
Crane pad – Subgrade at T3

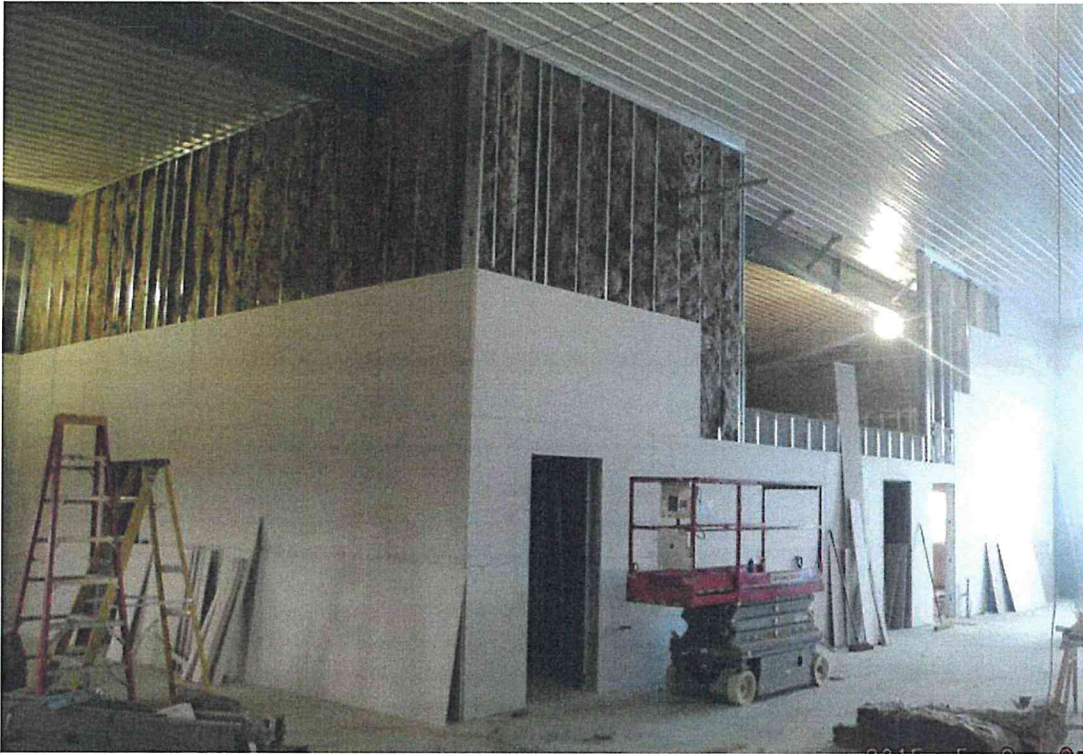
O&M Building – Sheet rock/insulation work

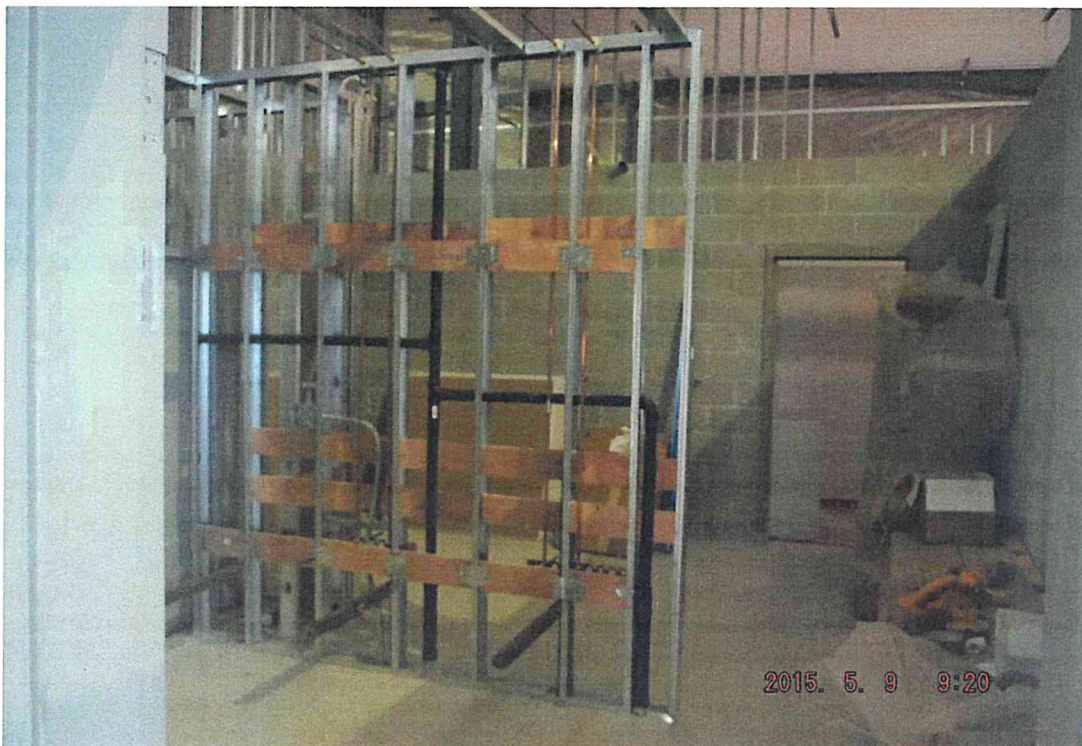
O&M Building – Storm shelter work
