BORDER WINDS ENERGY PROJECT

WEEKLY PROJECT REPORT

Weekly report no:	43
Report for week period ending COB Friday:	05/22/2015
Calendar week no:	21

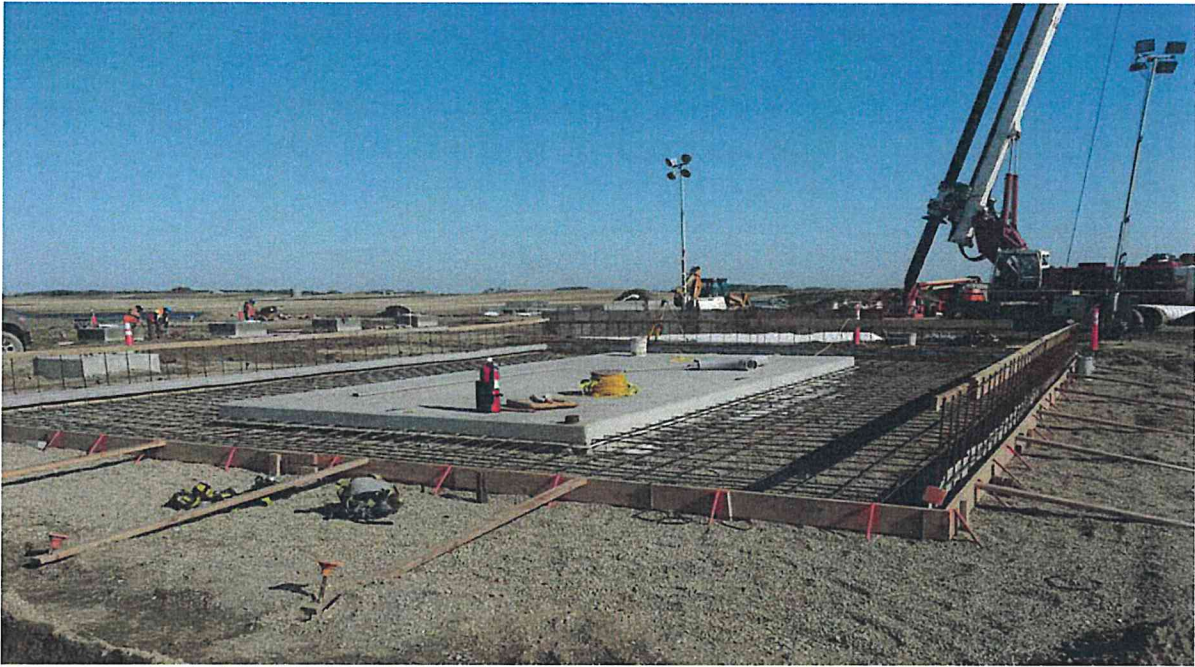
Substation – MPT Foundation

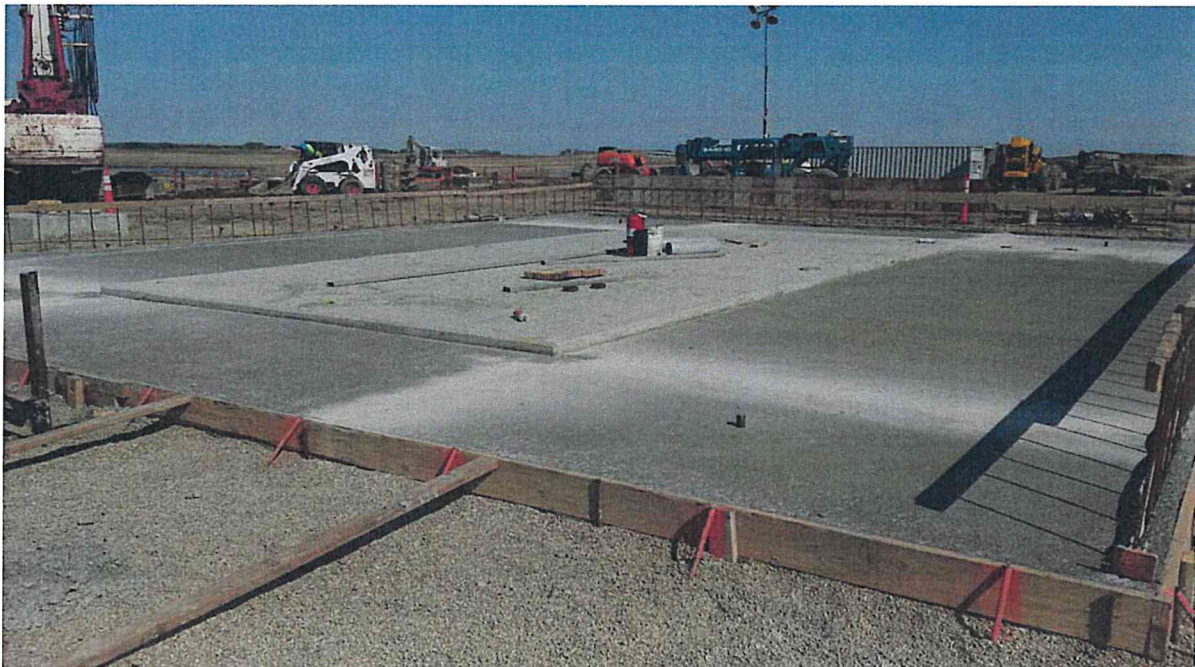
Substation – MPT foundation

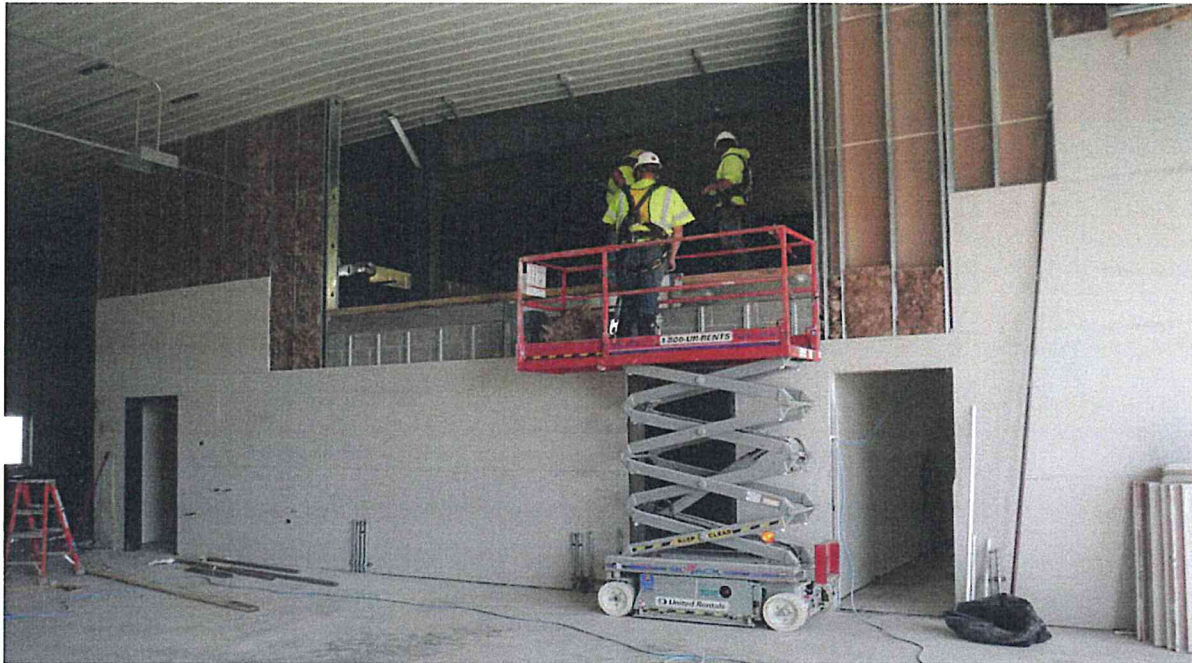
O&M – Drywall in Shop Area

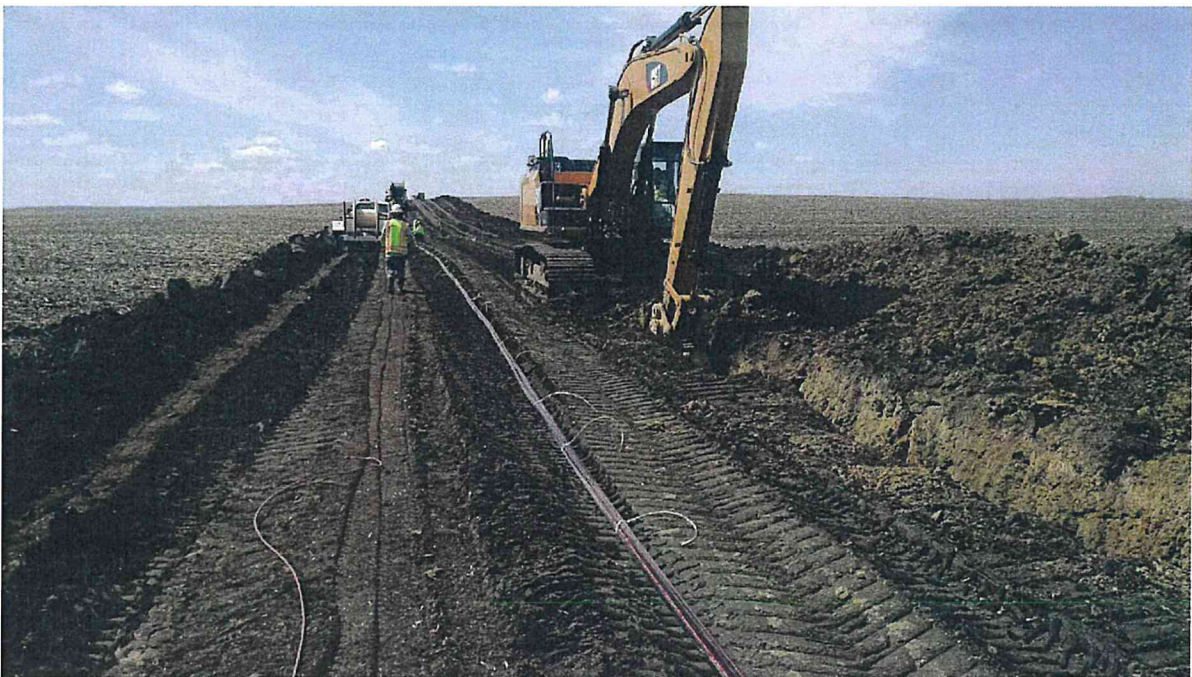
Collection System – Trenching
