## BORDER WINDS ENERGY PROJECT

### WEEKLY PROJECT REPORT

Weekly report no:	45
Report for week period ending COB Friday:	06/05/2015
Calendar week no:	23

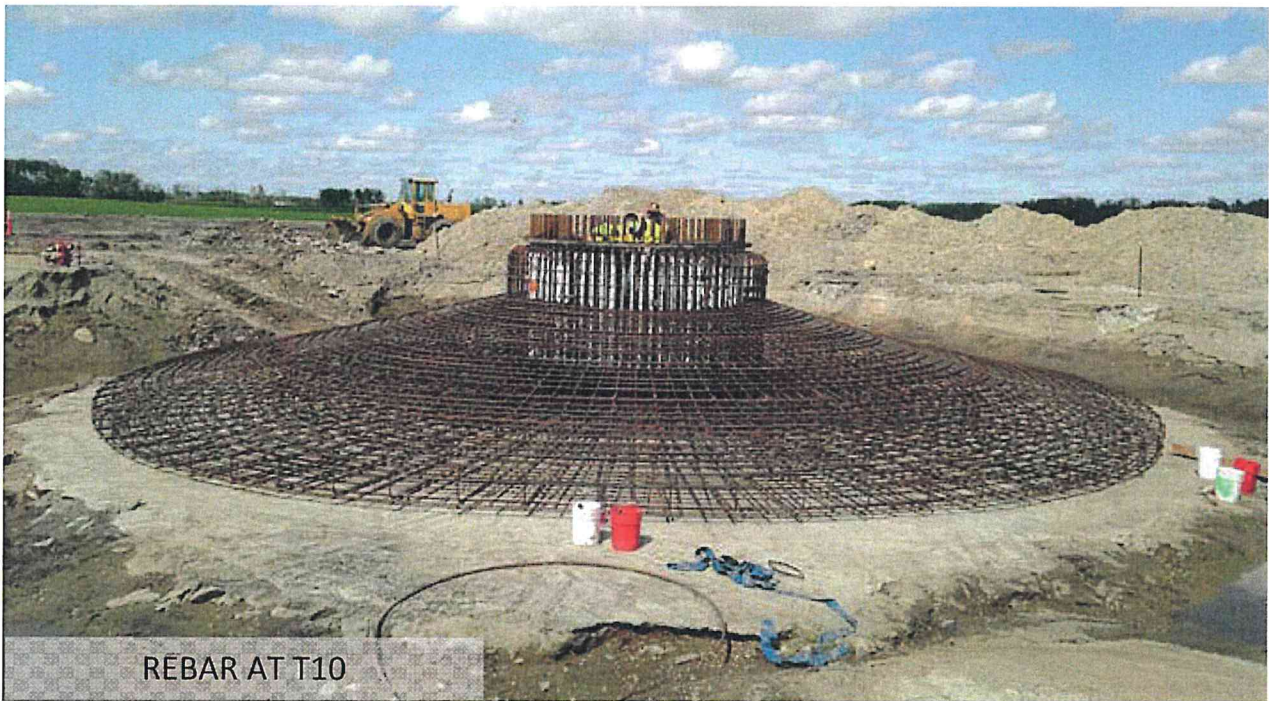
REBAR AT T10

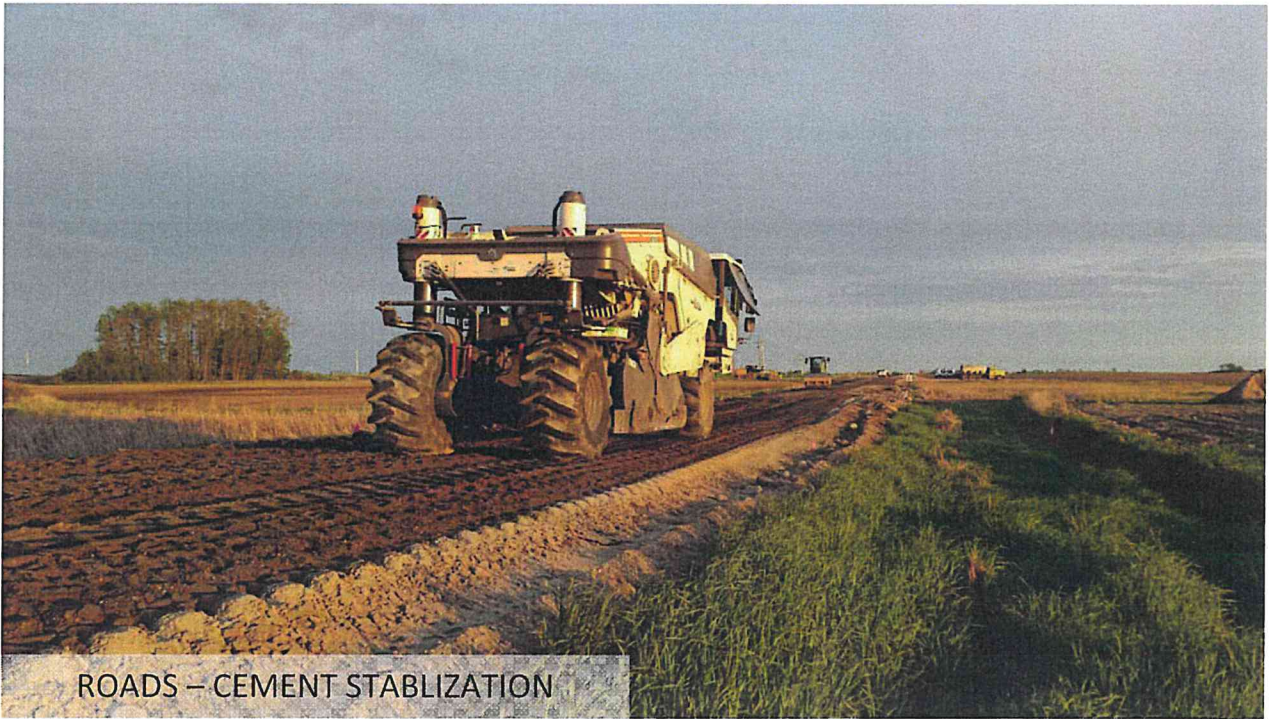
ROADS – CEMENT STABILIZATION

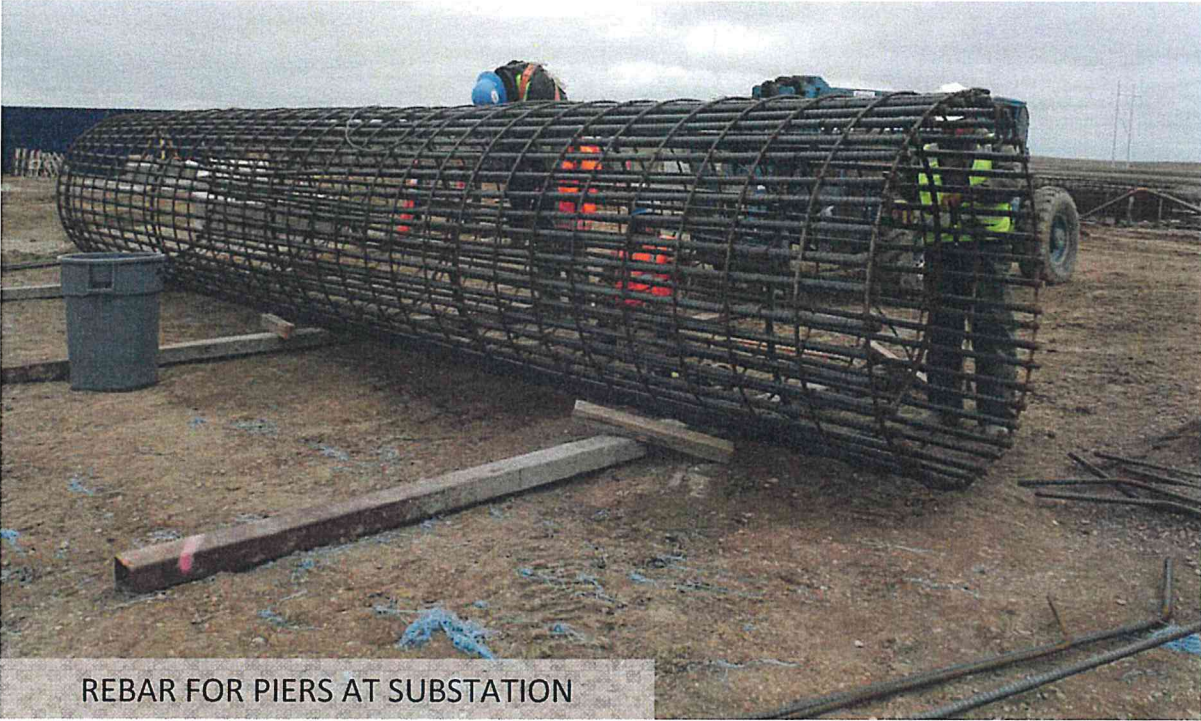
REBAR FOR PIERS AT SUBSTATION

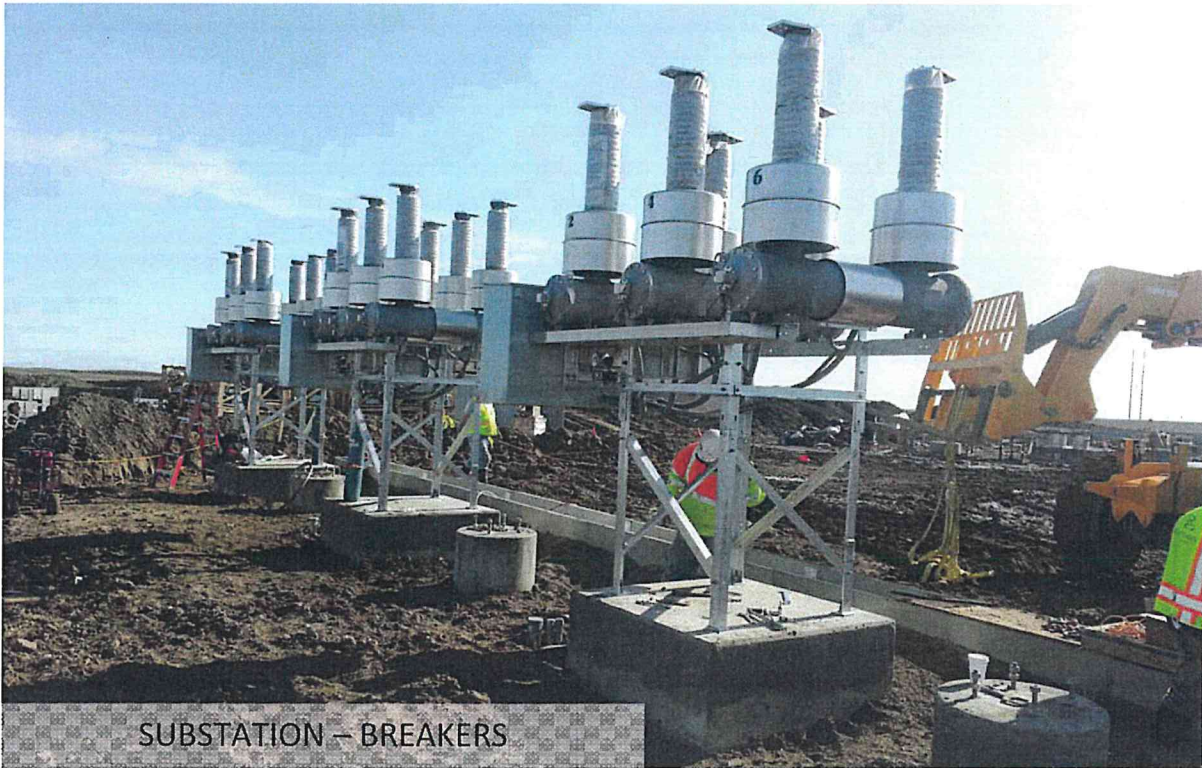
SUBSTATION – BREAKERS

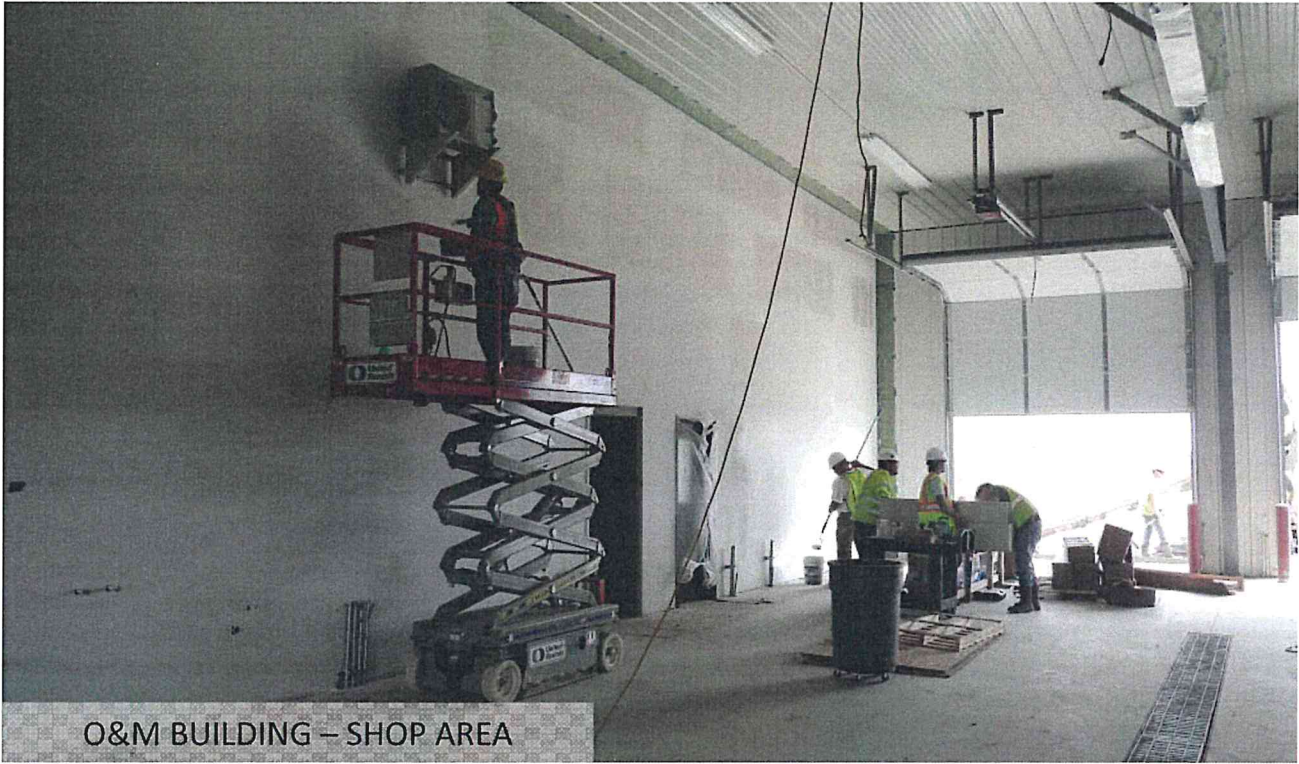
O&M BUILDING – SHOP AREA

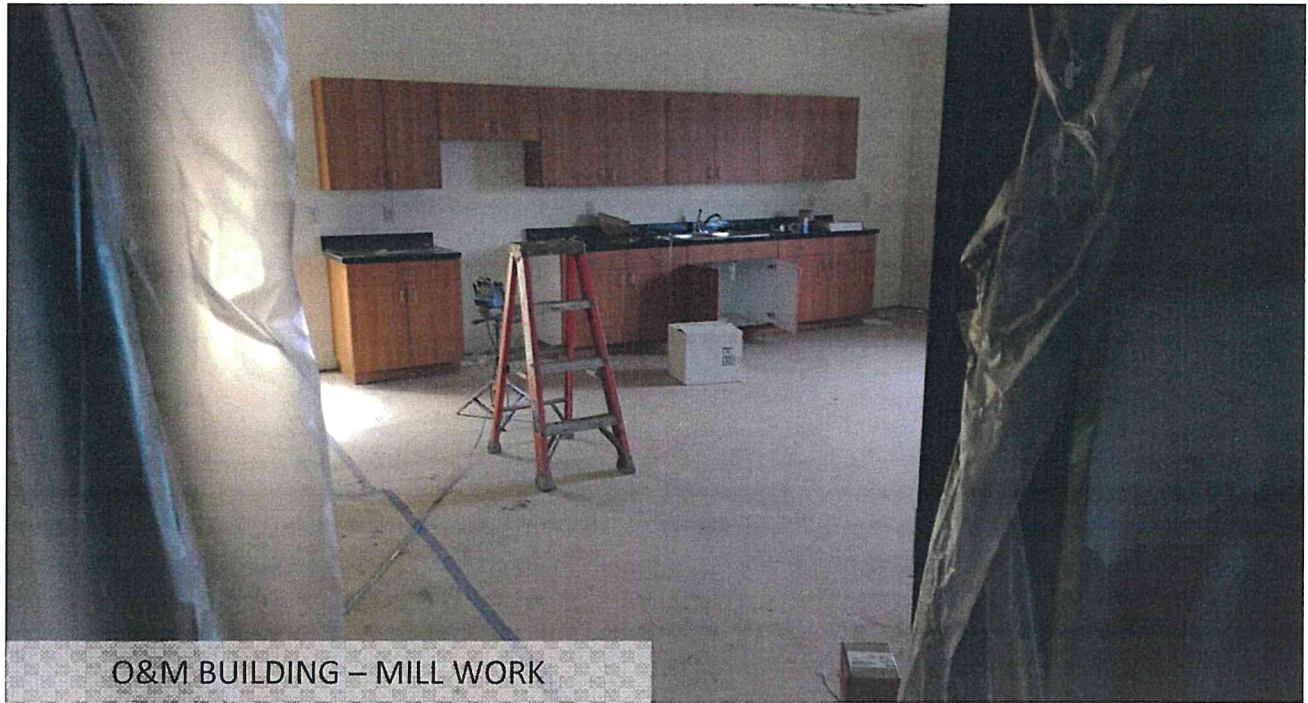
O&M BUILDING – MILL WORK

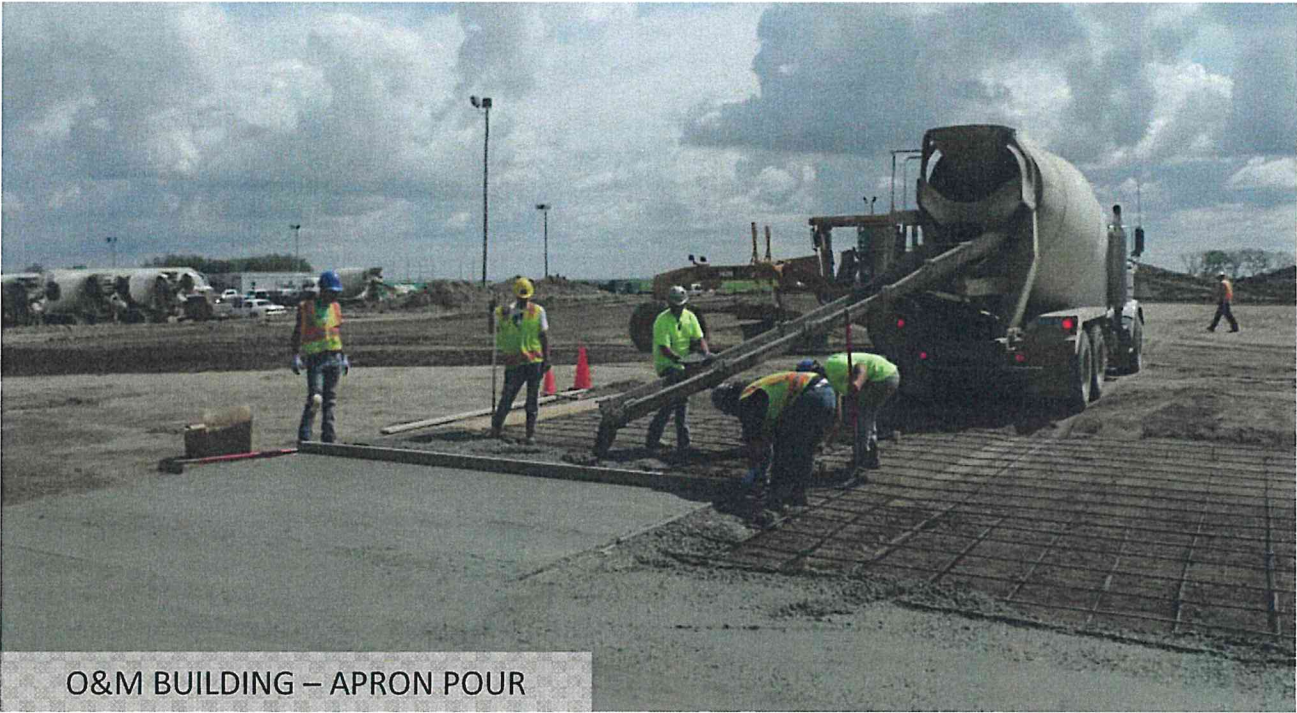
O&M BUILDING – APRON POUR
