BORDER WINDS ENERGY PROJECT

WEEKLY PROJECT REPORT

Weekly report no:	60
Report for week period ending COB Friday:	09/18/15
Calendar week no:	38

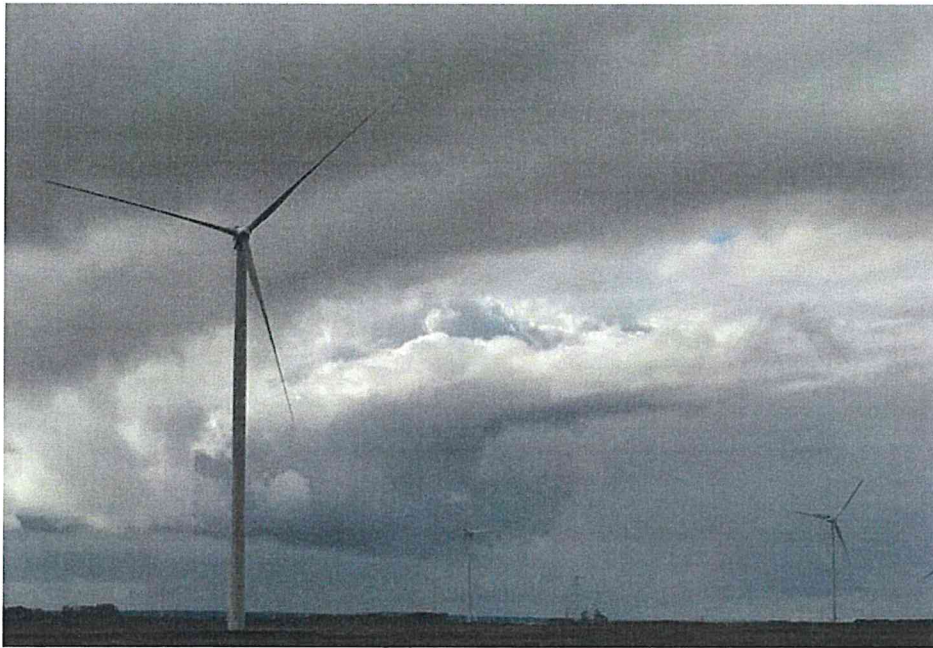
Site view

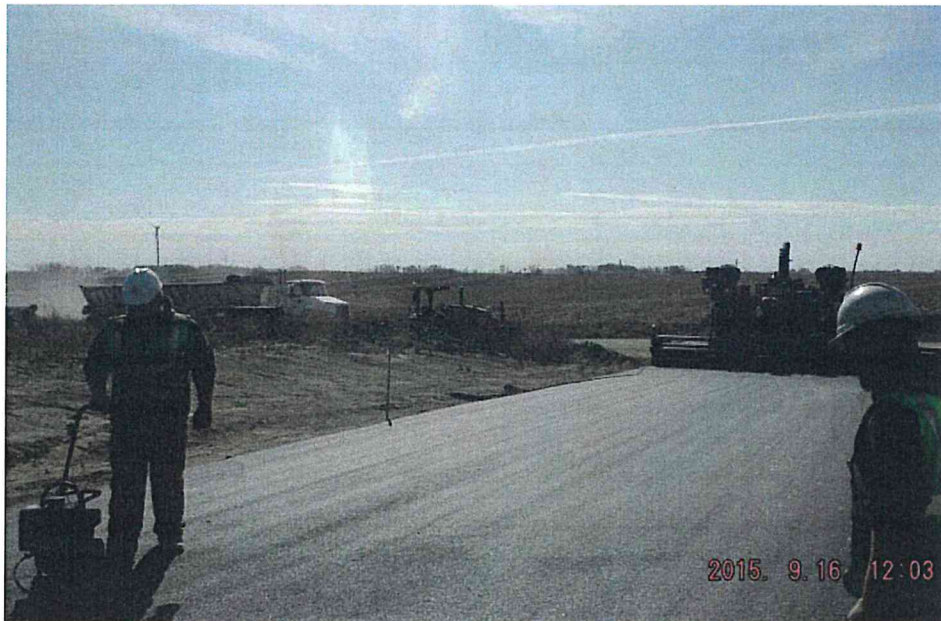
Asphalting at the O&M building

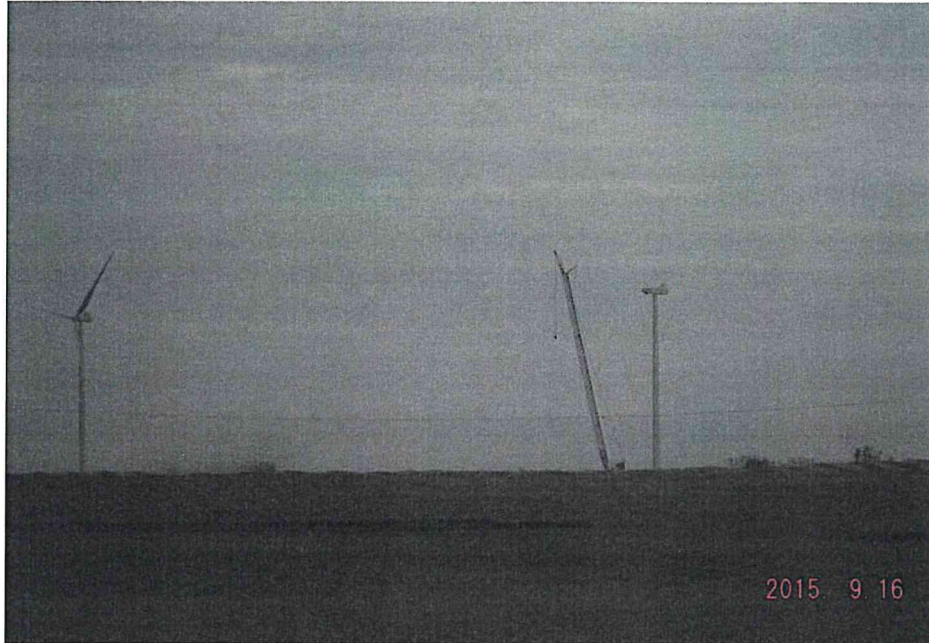
Nacelle installed at T73

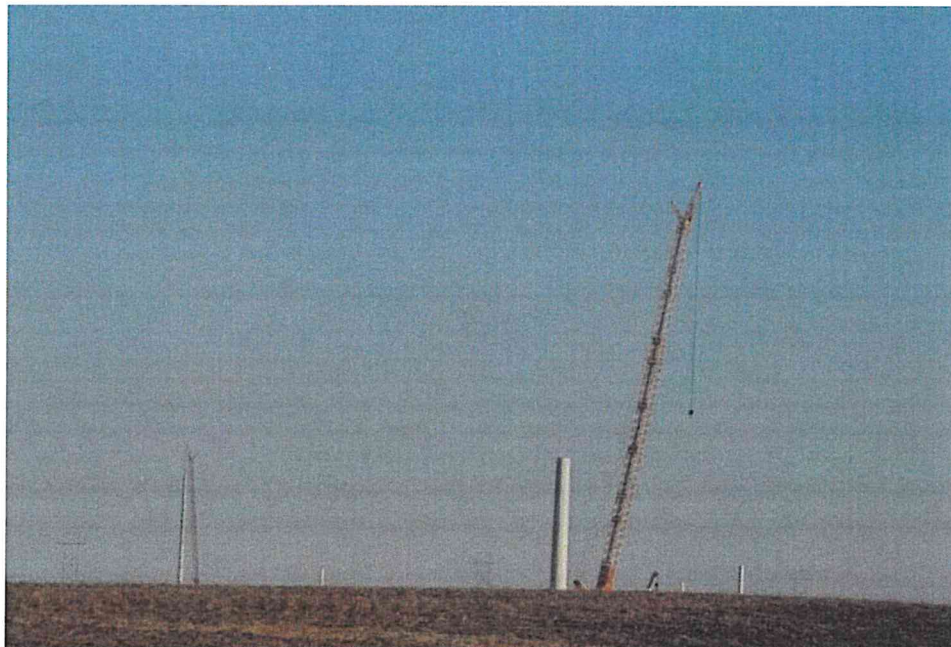
Crane 2 built at T62 & Crane 1 at T73
