BORDER WINDS ENERGY PROJECT

WEEKLY PROJECT REPORT

Weekly report no:	62
Report for week period ending COB Friday:	10/02/15
Calendar week no:	40

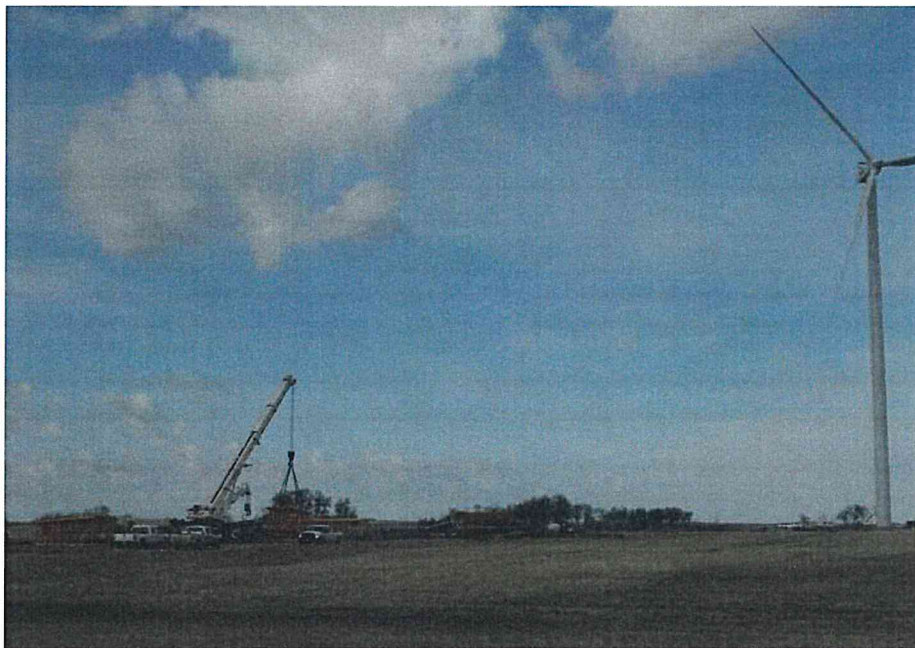
Crane Break down at T60

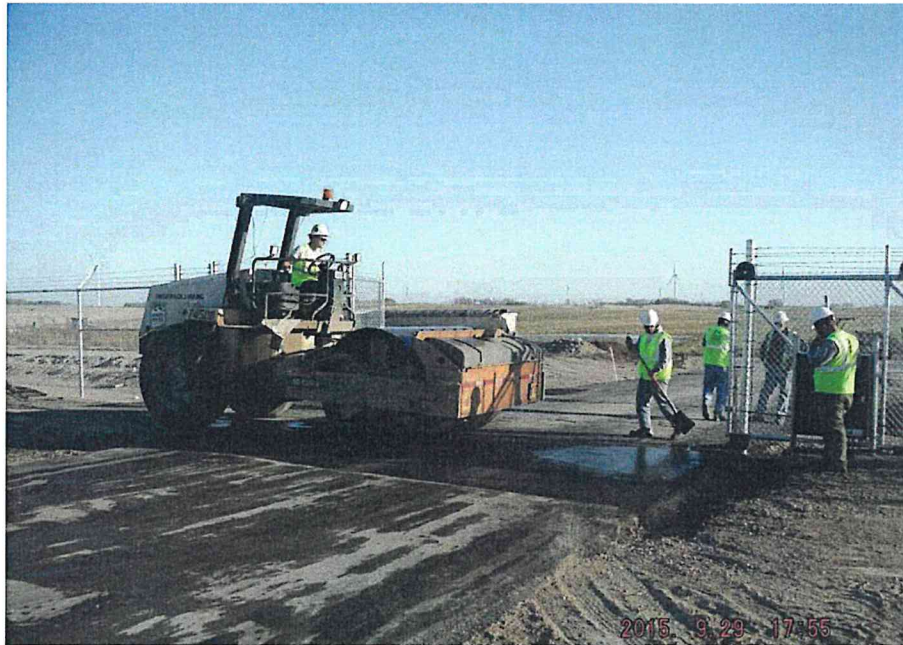
- RES cut the asphalt and re-graded the section to install 3” of asphalt near the O&M building gate. Knife River asphalted the section on 9/29/15 and fog sealed the asphalt on 10/2/15 to correct the exposed coarse aggregate on the asphalt.
- The backfilled area around the pipe connecting the well towards the building on the west side and the septic tank on the south side settled in after rains on 9/23/15. The area has been barricaded and will be compacted and fixed along with the final grading of the O&M building. Awaiting job books from AB Systems.

O&M Building Asphaltting

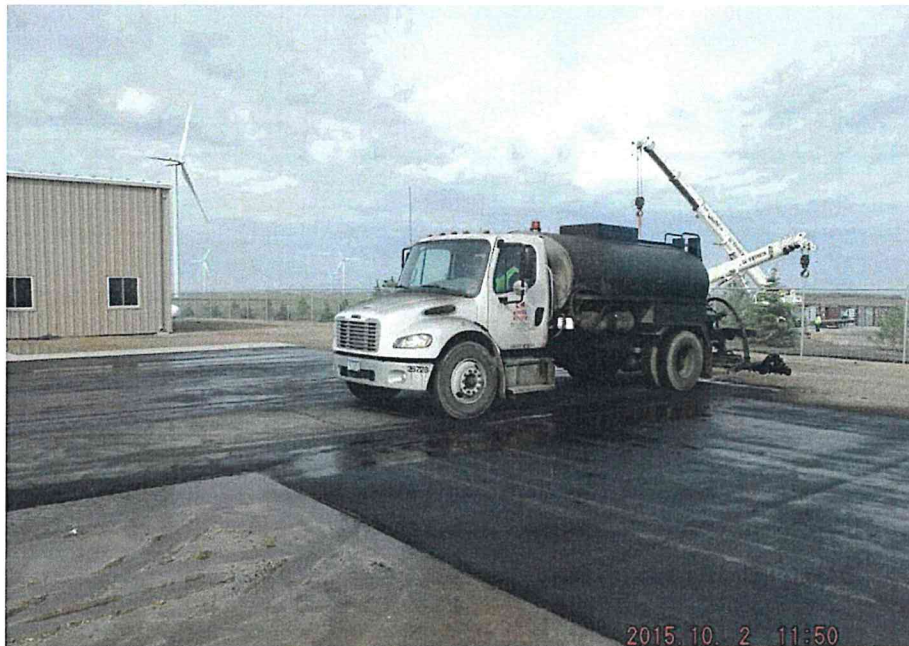
O&M Building Fog Seal
