May 2, 2016

Carlson McCain, Inc. (CMI) conducted an onsite inspection of the Border Winds Energy Project (Case No. PU-14-031) on April 27, 2016, on behalf of the North Dakota Public Service Commission (PSC). The project consists of installing 75 wind turbines totaling approximately 150 MW of generating capacity and associated facilities in Rolette County, North Dakota.

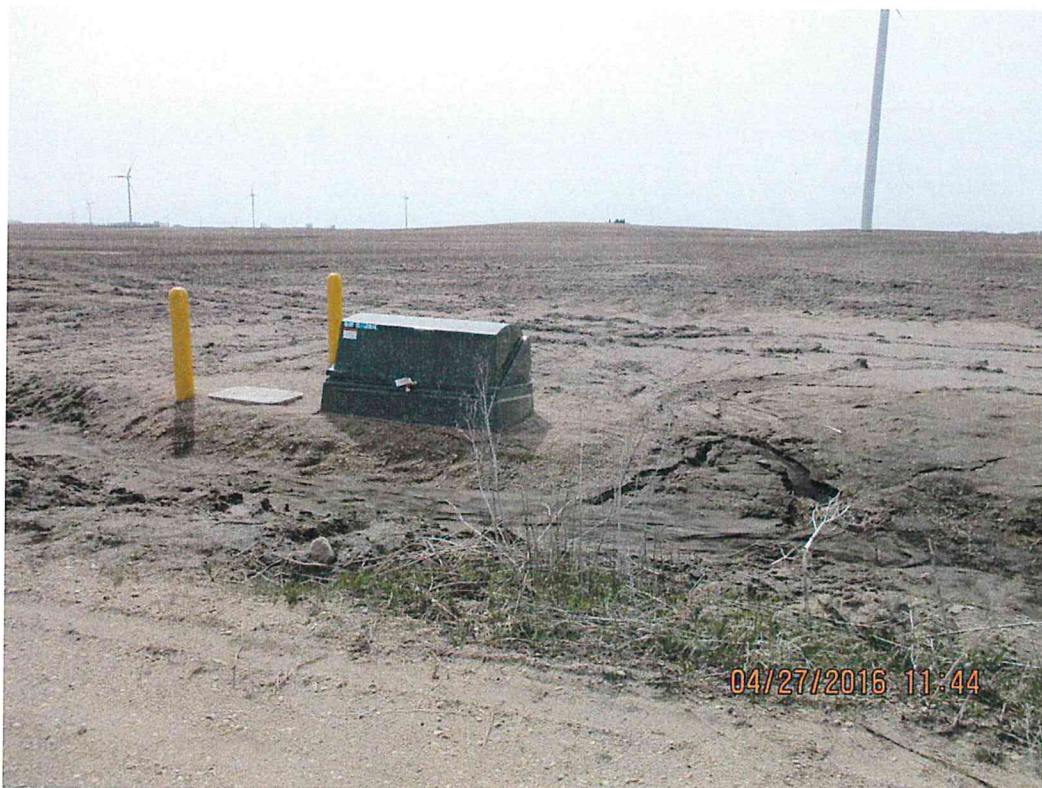
Figure 1. Photo of area surrounding a junction box that needs some maintenance due to runoff and settling.

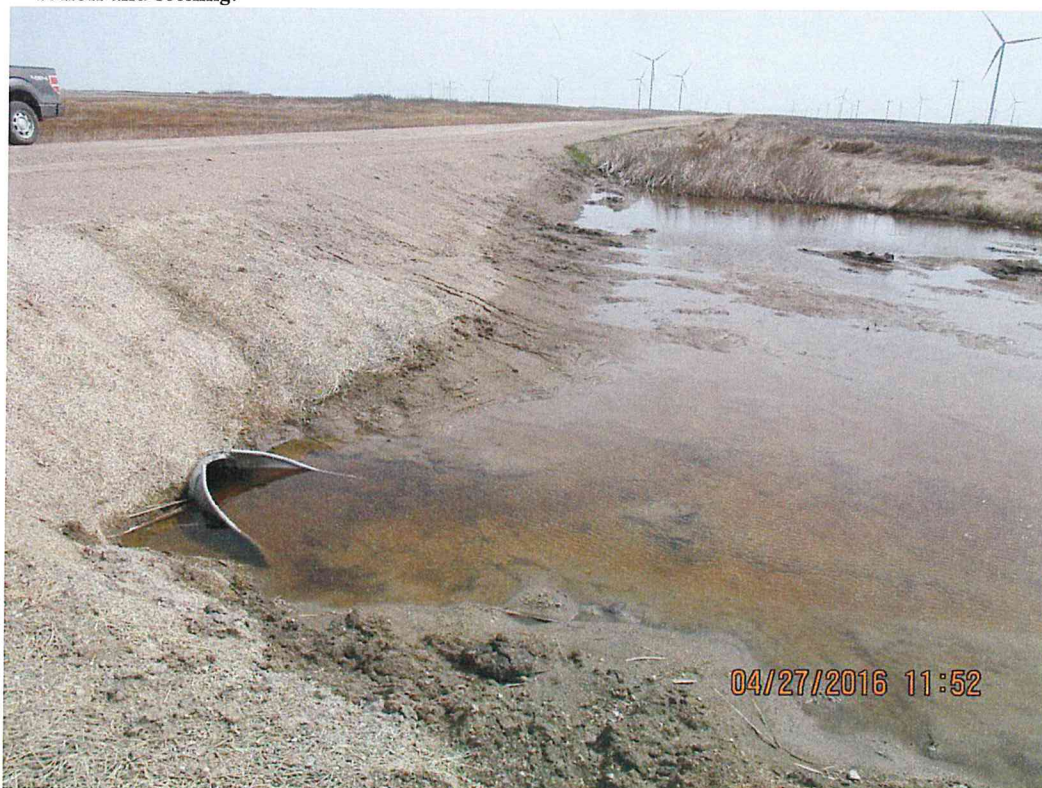
Figure 2. Photo of a turning radii that needs further reclamation. Culvert clean out, replace and add topsoil, score and seed, and lay ECB to existing vegetation.

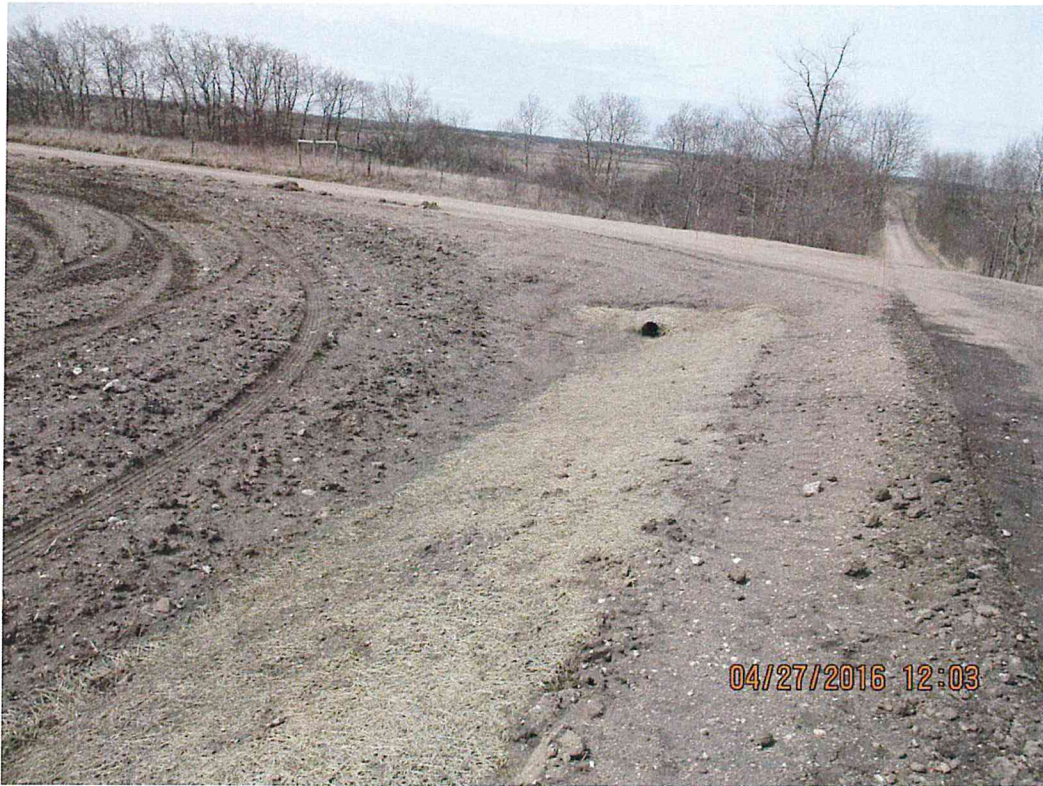
Figure 3. Turning radii that requires more ECB higher up on the shoulder.

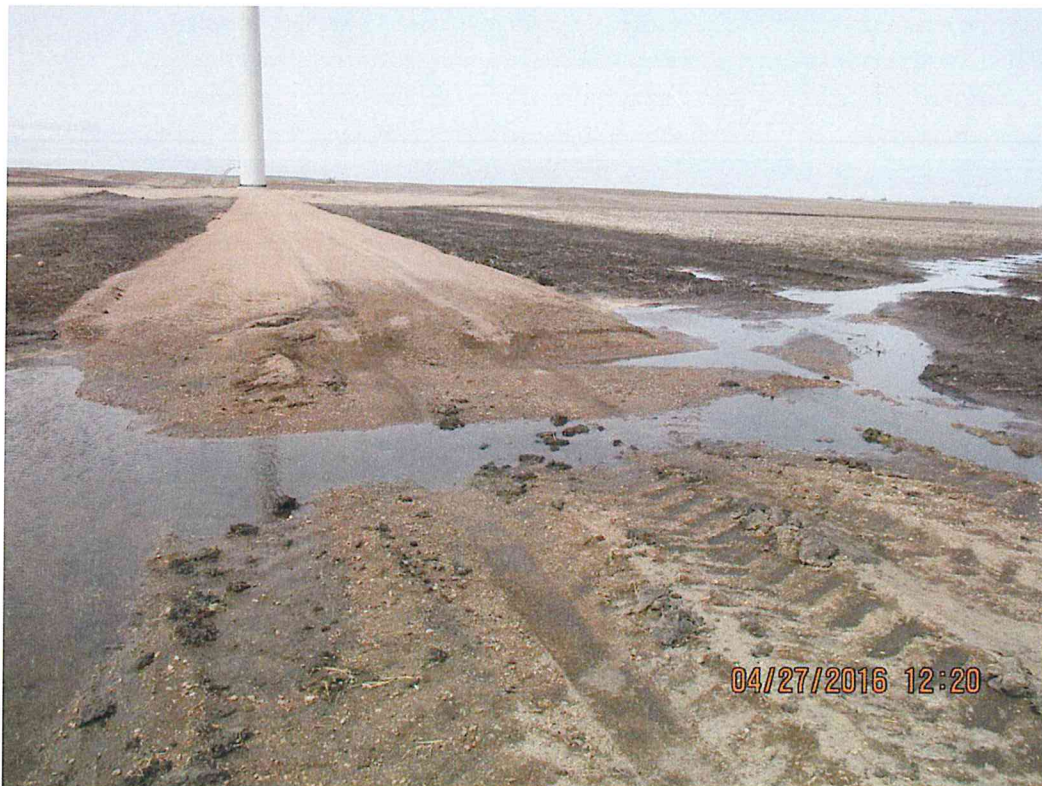
Figure 4. One of the low water crossings that was left in a cut across the road to promote runoff to follow its natural flow.

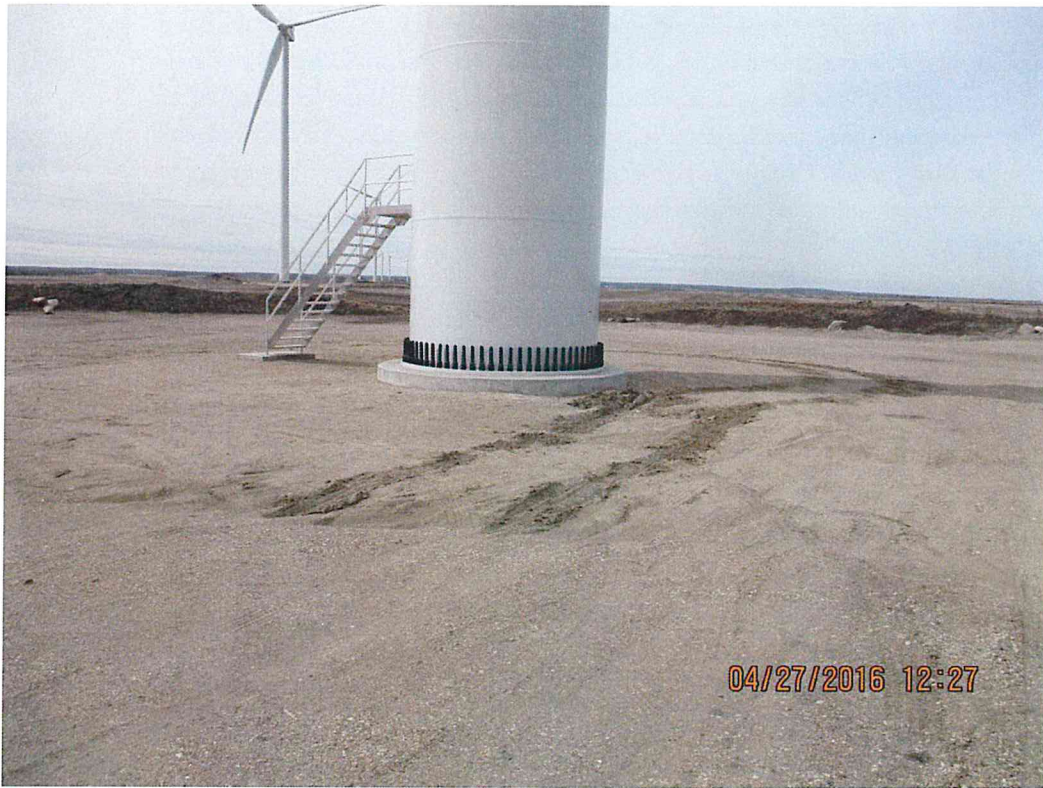
Figure 5. Clay and compaction tests still needed at T10.

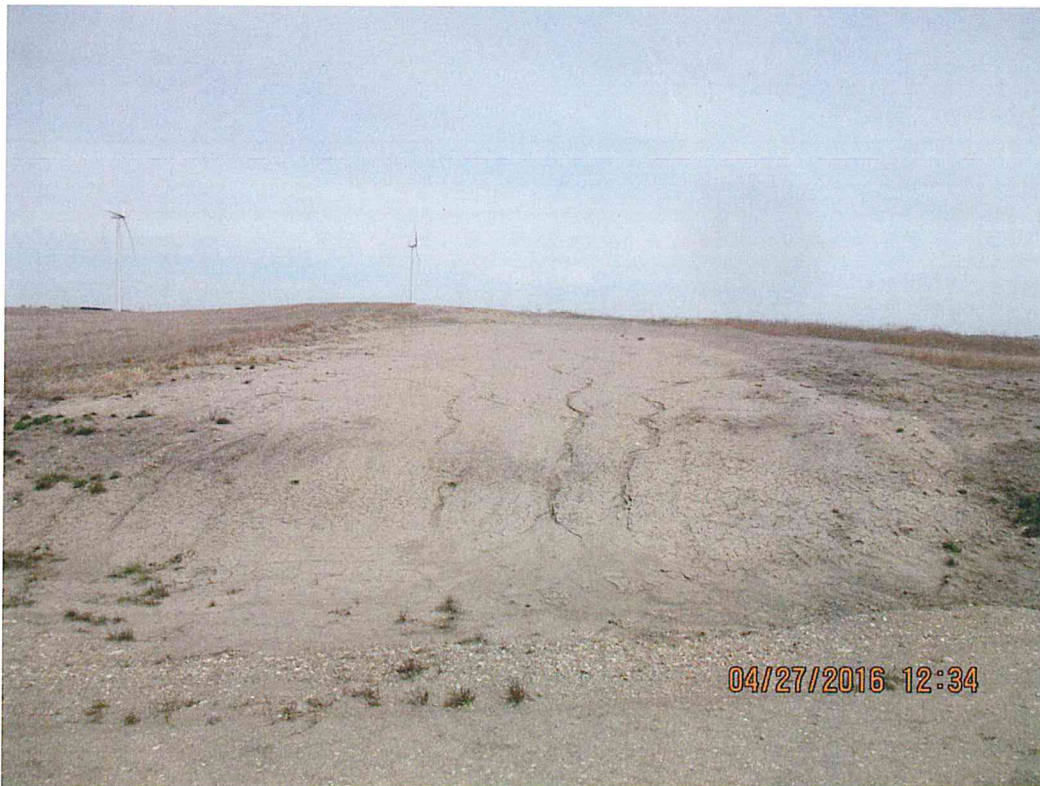
Figure 6. Crane walk area for moving across the road. Ditch will be re-established and the soil removed.

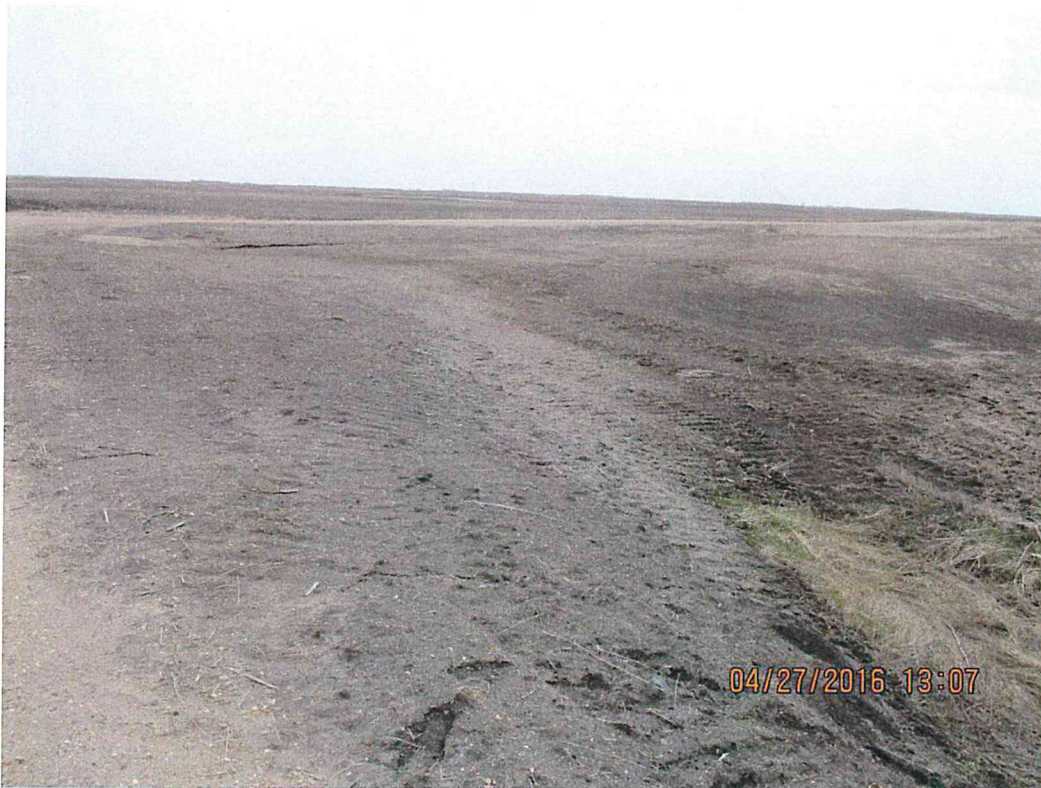
Figure 7. Turning radii that needs to be redone. Establish ditch, new black dirt, seeding, and ECB.

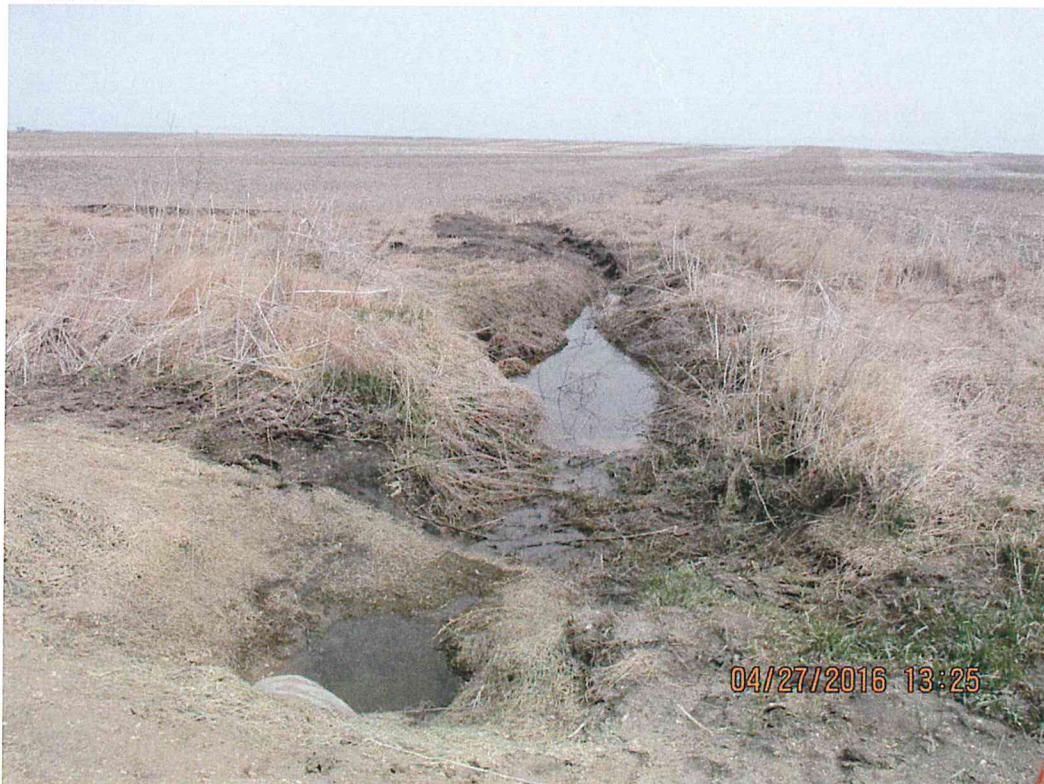
Figure 8. Small trench dug to alleviate water backup at culvert on 53rd Ave NE near T48 and 49.

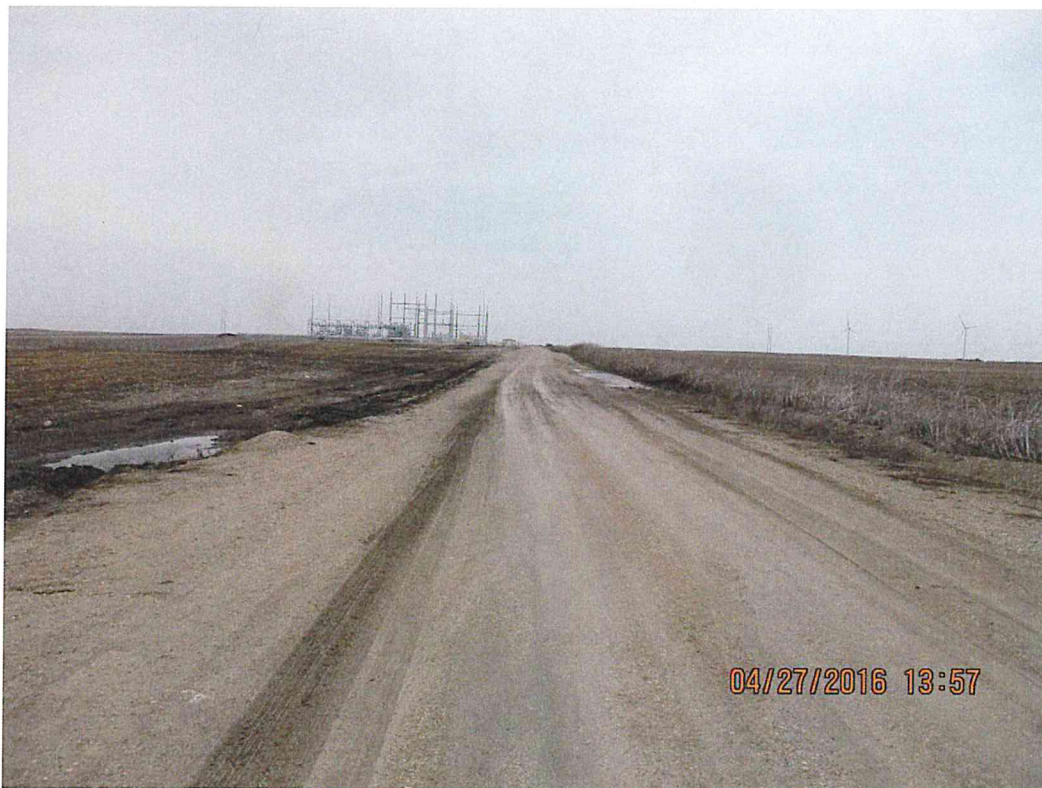
Figure 9. Looking east from the access road to the substation. Work will be done to provide adequate flow from south to north preventing runoff build up along road.

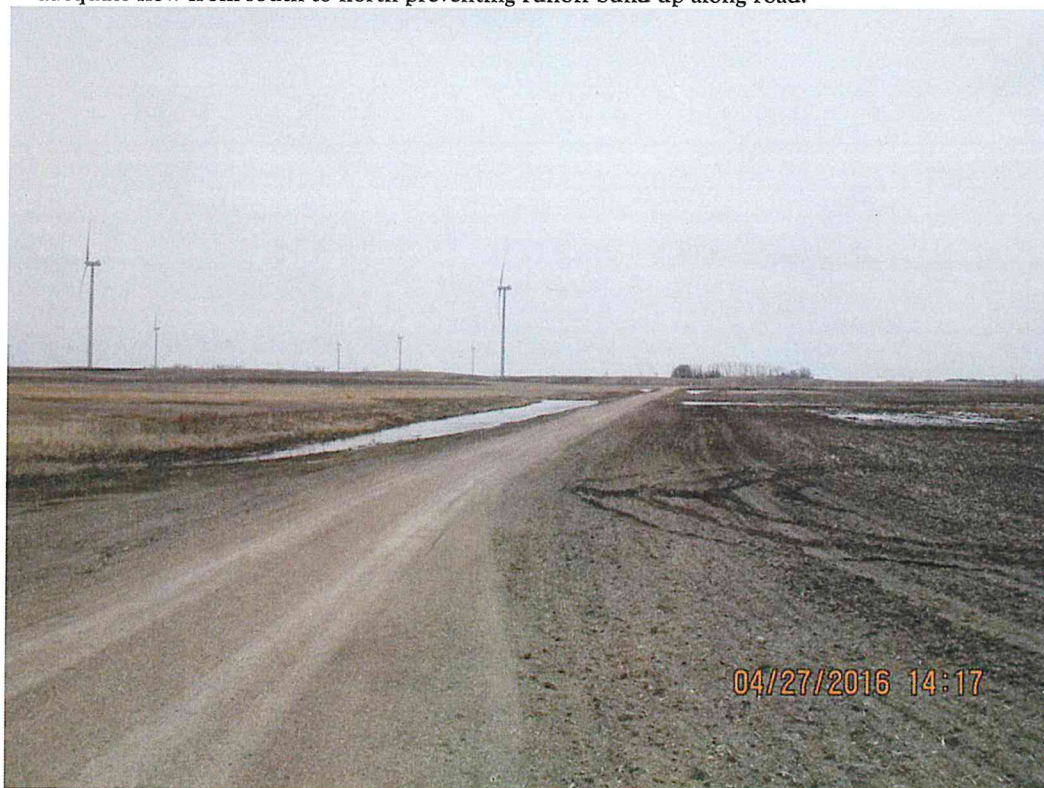
Figure 10. T26 looking south at access road that needs a low water crossing installed to help water move from west to east.

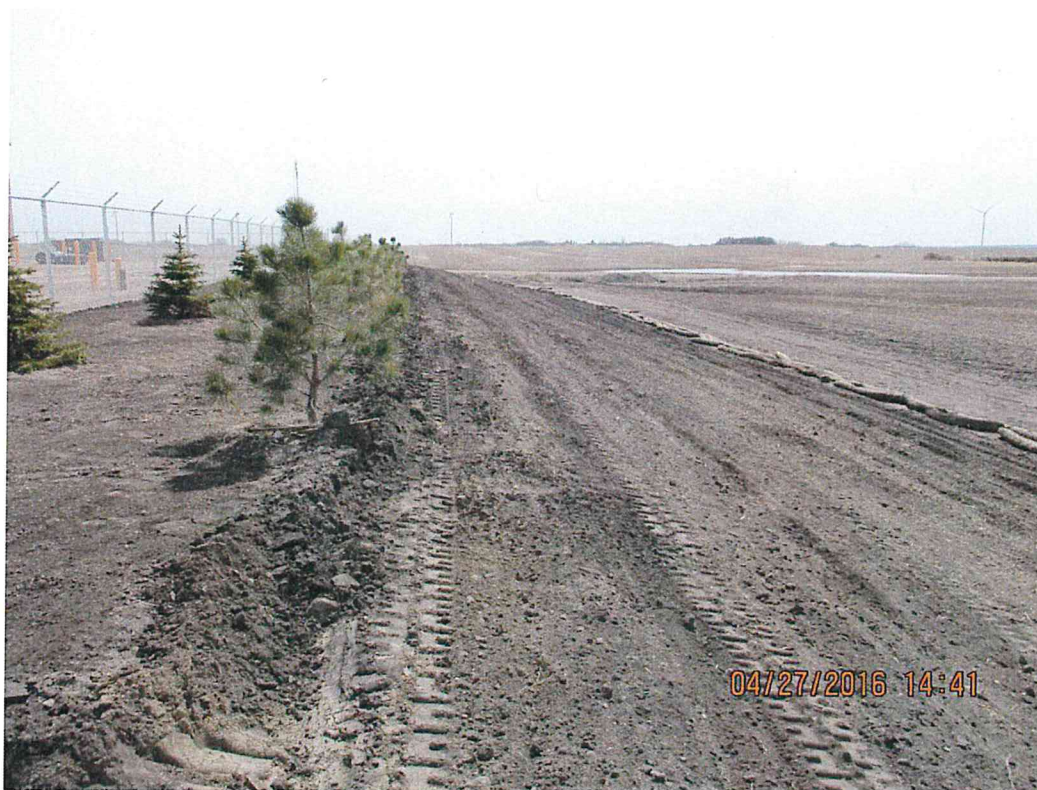
Figure 11. Trees around O&M building planted. Straw swaddles will be moved to the top of the slope once ECB is in place.

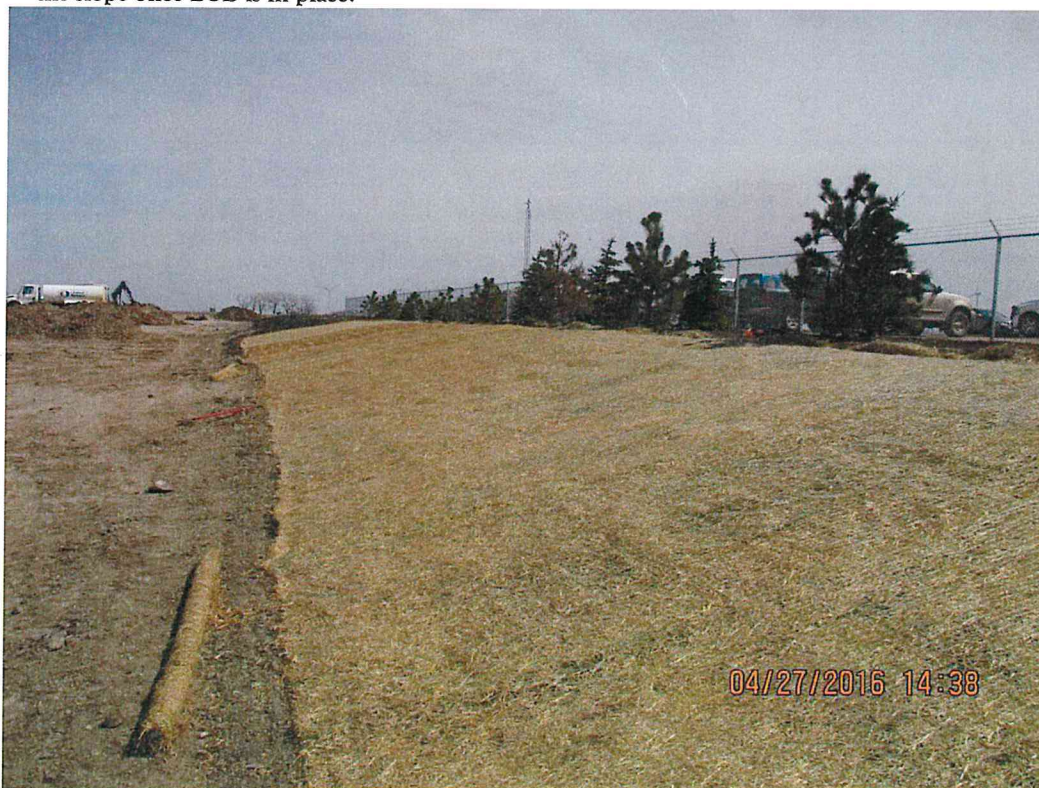
Figure 12. ECB anchored and stapled in place on the slopes surrounding the O&M building.

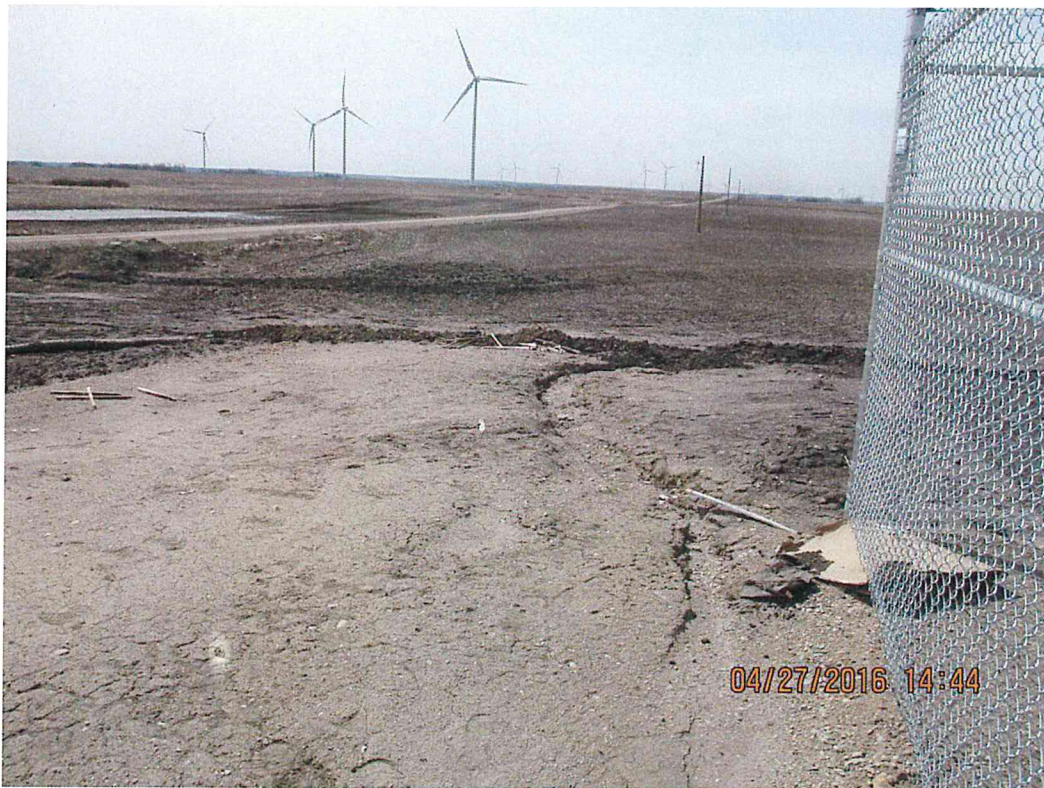
Figure 13. A more permanent channel will be installed to prevent further washouts at this southwest corner of the O&M building.

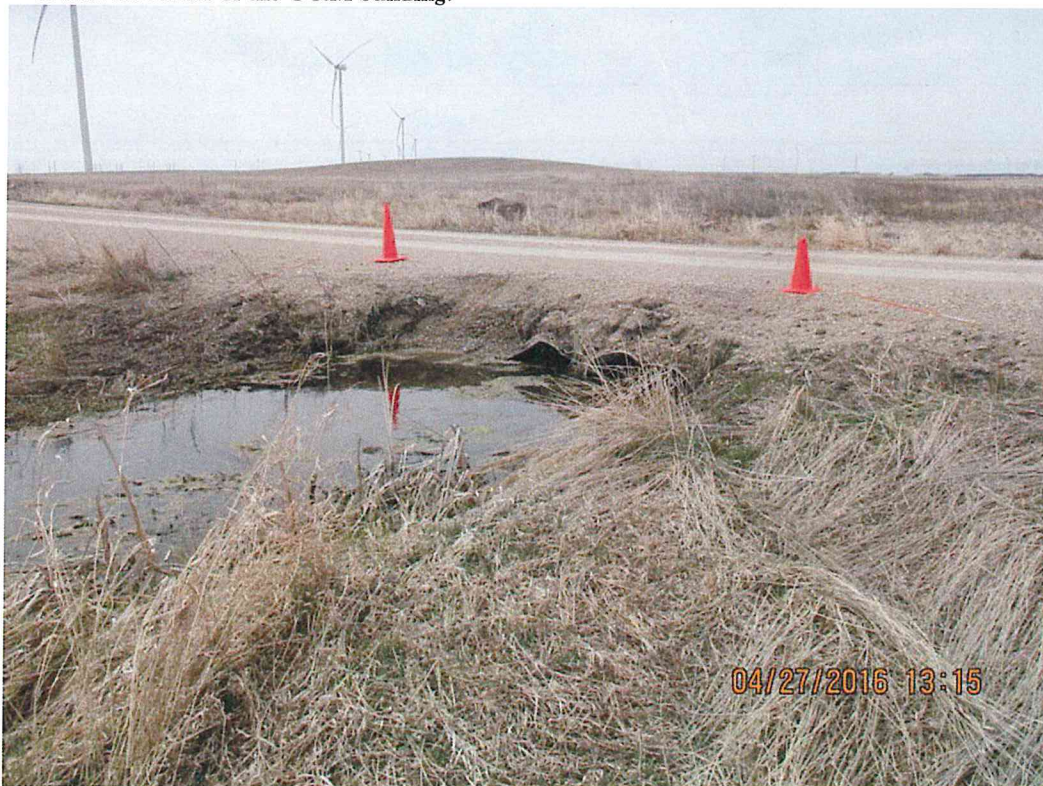
A short length of 53rd Ave NE roadway has been displaced due to heavy traffic on the road near a wetland area. RES-America is working to resolve the situation. In the meantime, the area is clearly marked with traffic cones and some flagging.

Figure 14. Culverts under 53rd Ave NE where road maintenance will be performed.
