November 21, 2017

Jerry Lein
North Dakota Public Service Commission
600 East Boulevard Avenue, Dept. 408
Bismarck, ND 58505-0480

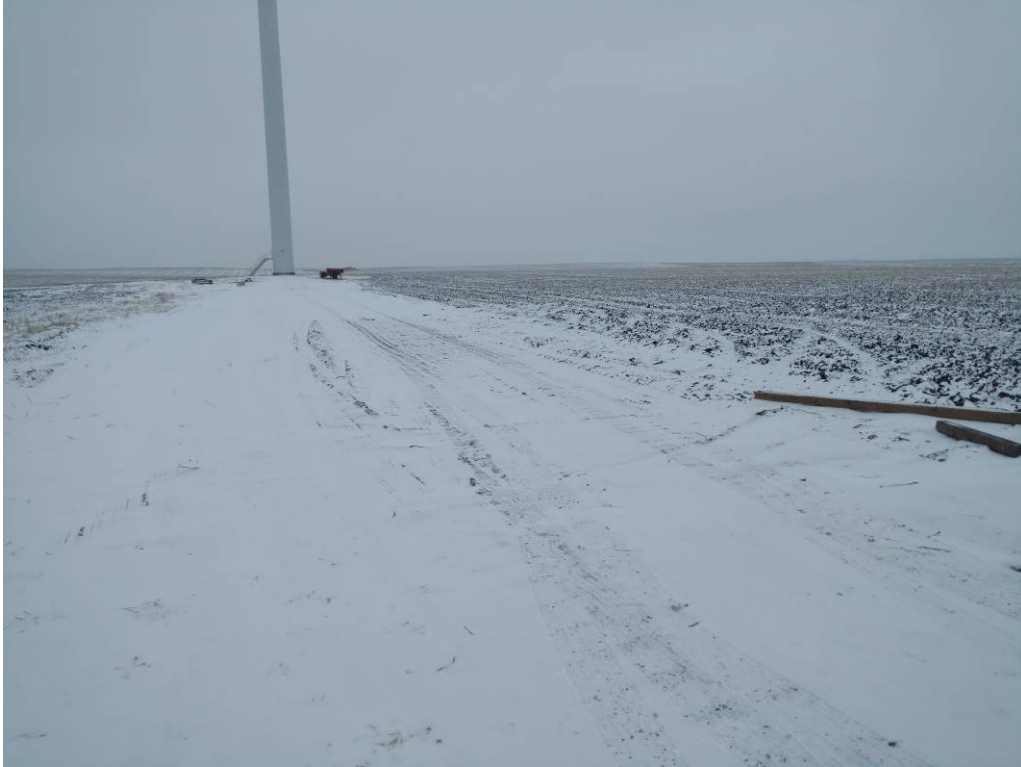
Figure 4. Photo taken looking west towards Turbine 6. This location was noted in the May Construction Inspection report (Figure 4) as needing fixing. A revetment mat has been placed in the low-water crossing. Construction debris is due to generator replacement that occurred a few days prior.

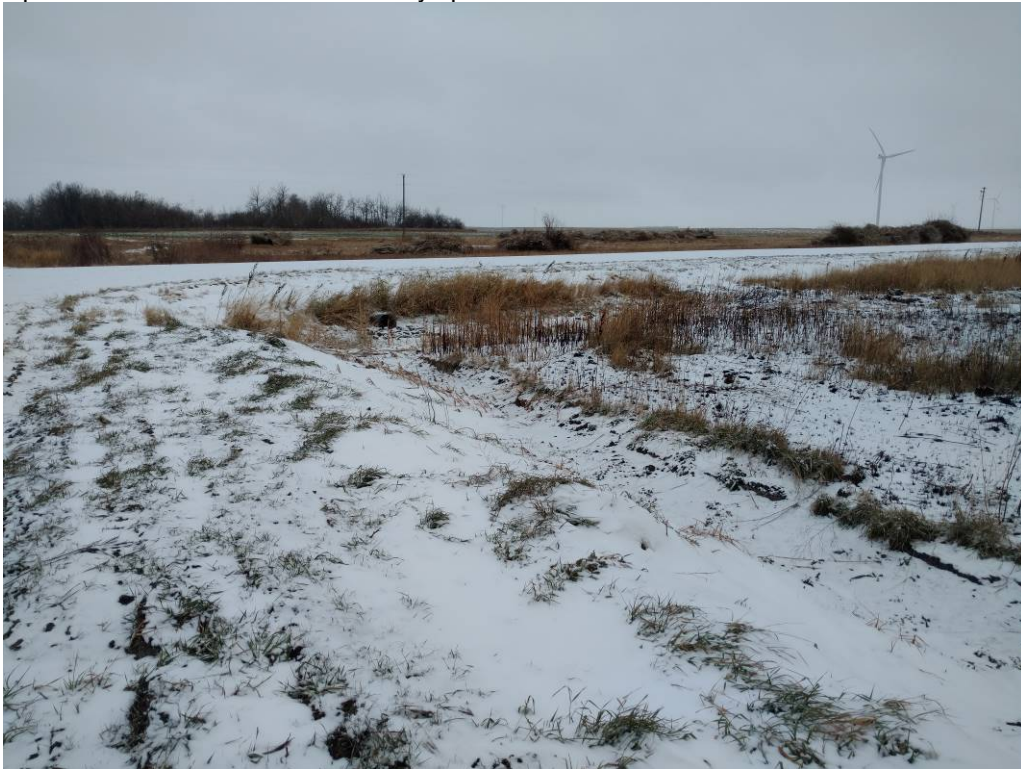
Figure 5. Photo facing north at intersection of 107th St NE and 47th Ave NE. Intersection had been widened to facilitate transport trucks. Radius has been removed and road ditch has been revegetated.

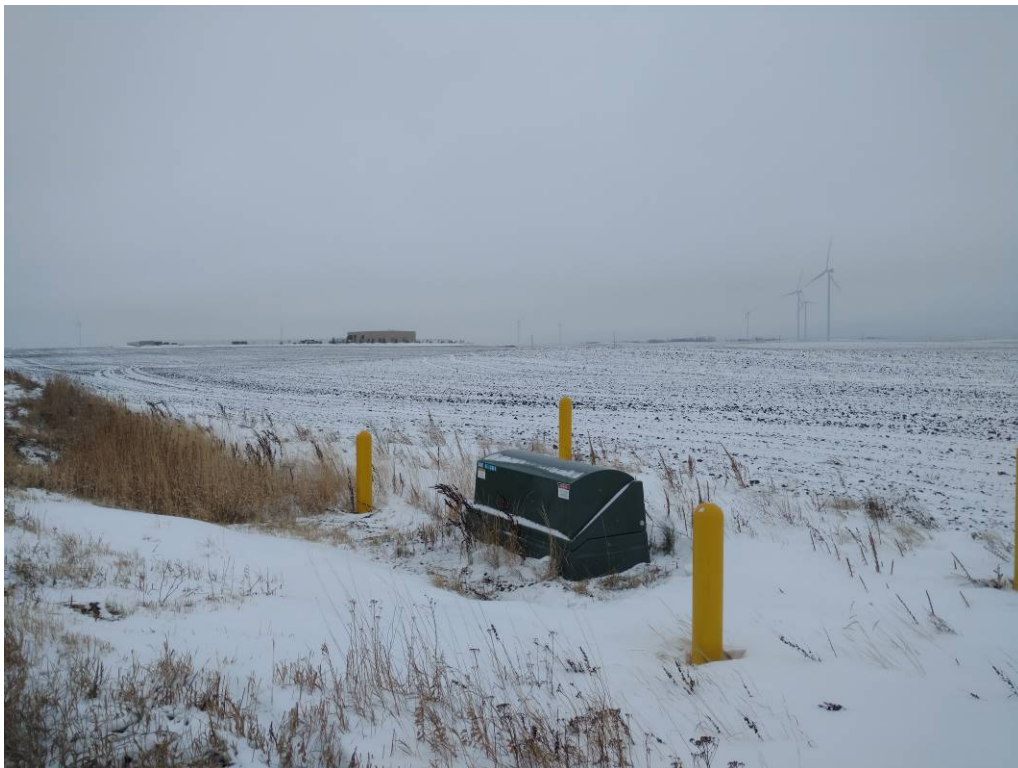
Figure 10. Photo taken facing southwest from Kyle Road towards facility office. View is across laydown yard which has been restored to original condition.

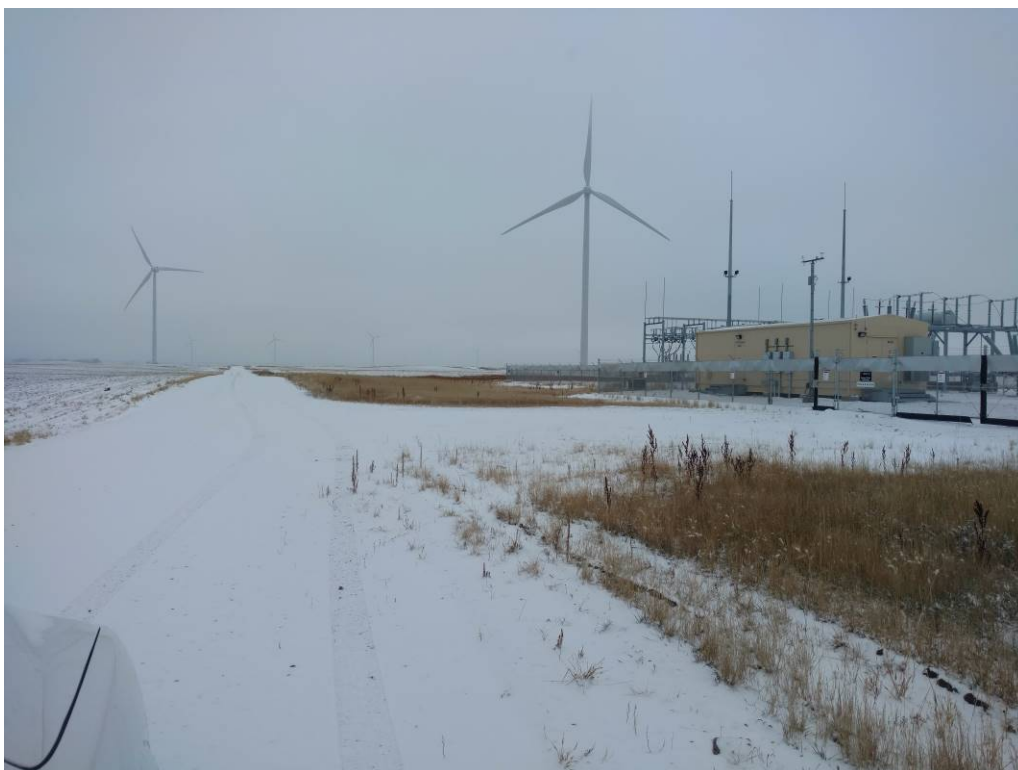
Figure 11. Photo taken facing west along access road to substation. Area surrounding substation has been revegetated.
