December 7, 2015

Carlson McCain, Inc. (CMI) conducted an onsite inspection of the Sunflower Wind Project (Case No. PU-14-105) on December 3, 2015, on behalf of the North Dakota Public Service Commission (PSC). The project consists of installing 52 2.0-MW Vestes wind turbines and substation that will connect to the U.S. Department of Energy, Western Area Power Administration's Dickinson-Mandan 230 KV transmission line.

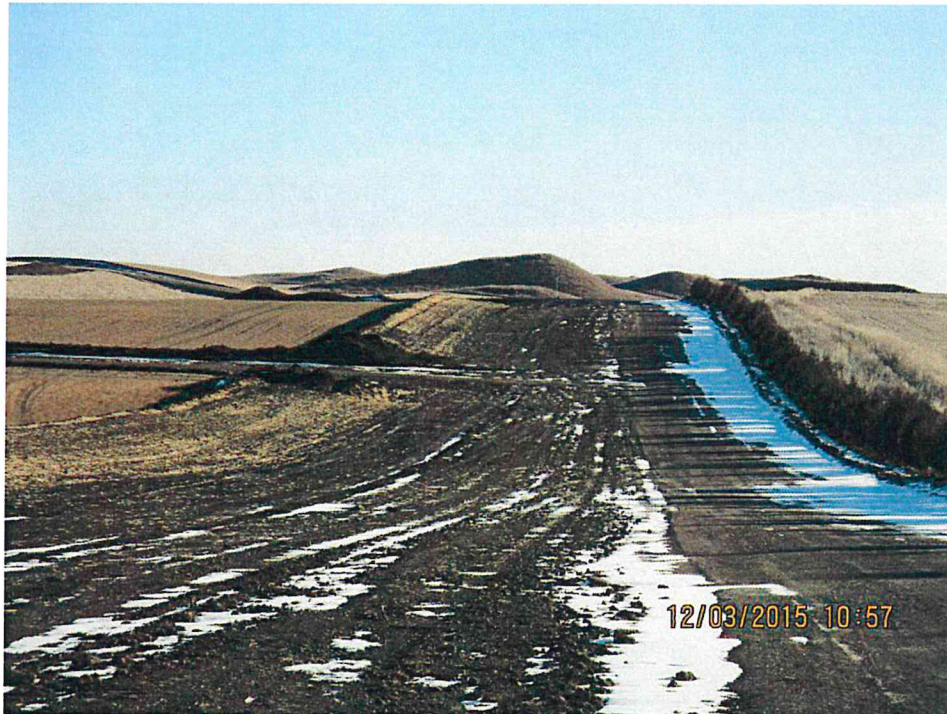
Figure 1. Photo of cleared topsoil along service road ROW. Mulch anchored in for erosion protection.

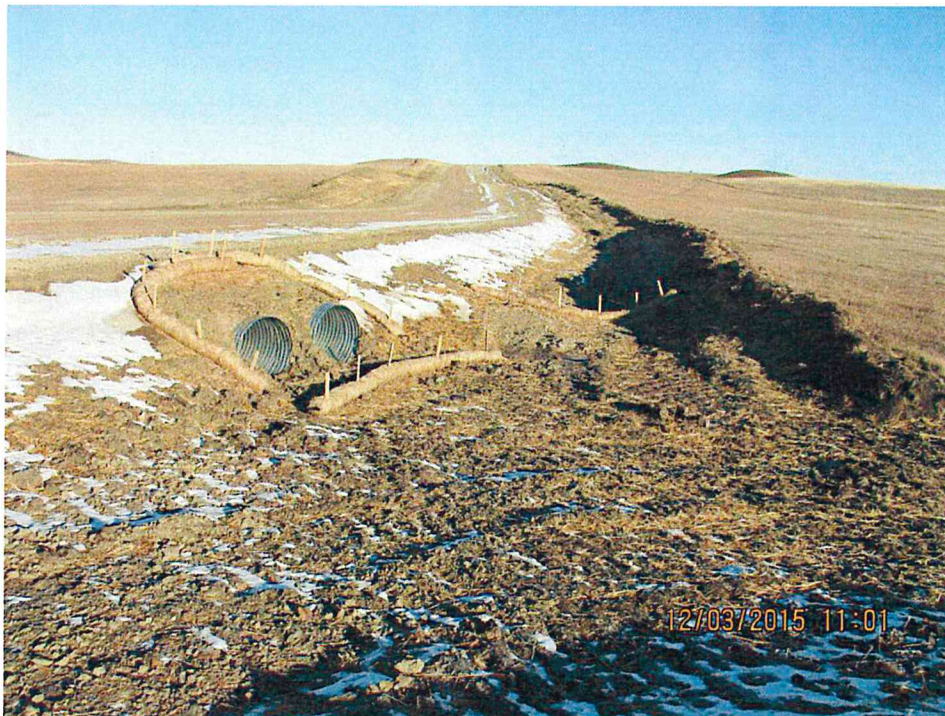
Figure 2. Two new culverts installed on service road between T3 and T4. ECDs properly installed to prevent erosion problems.

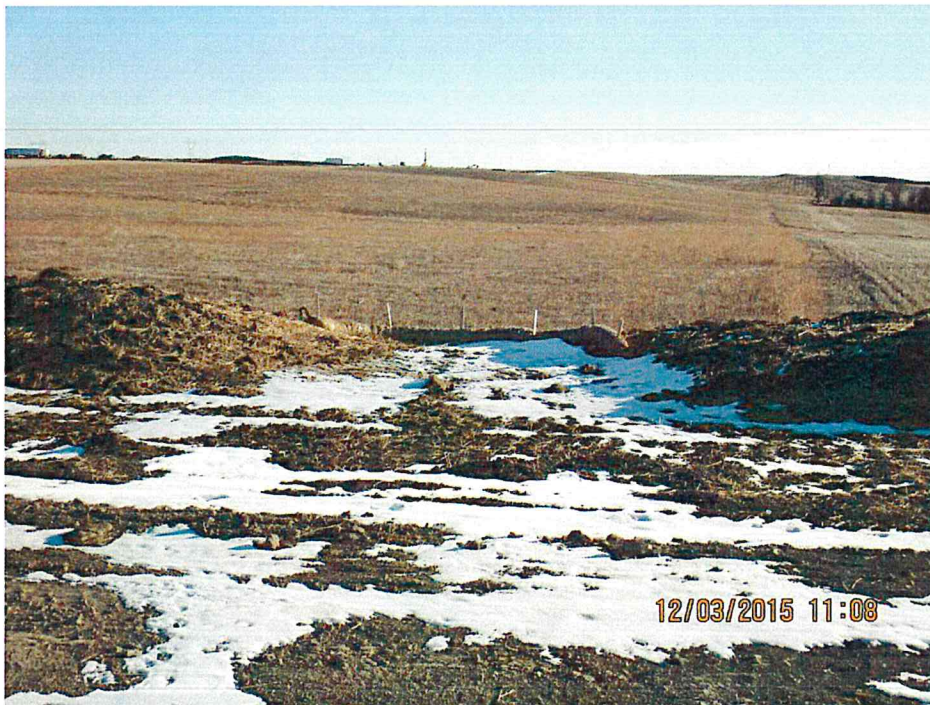
Figure 3. Break in the topsoil berm to alleviate storm water runoff. Straw swaddle in place to prevent sediments from exiting working area.

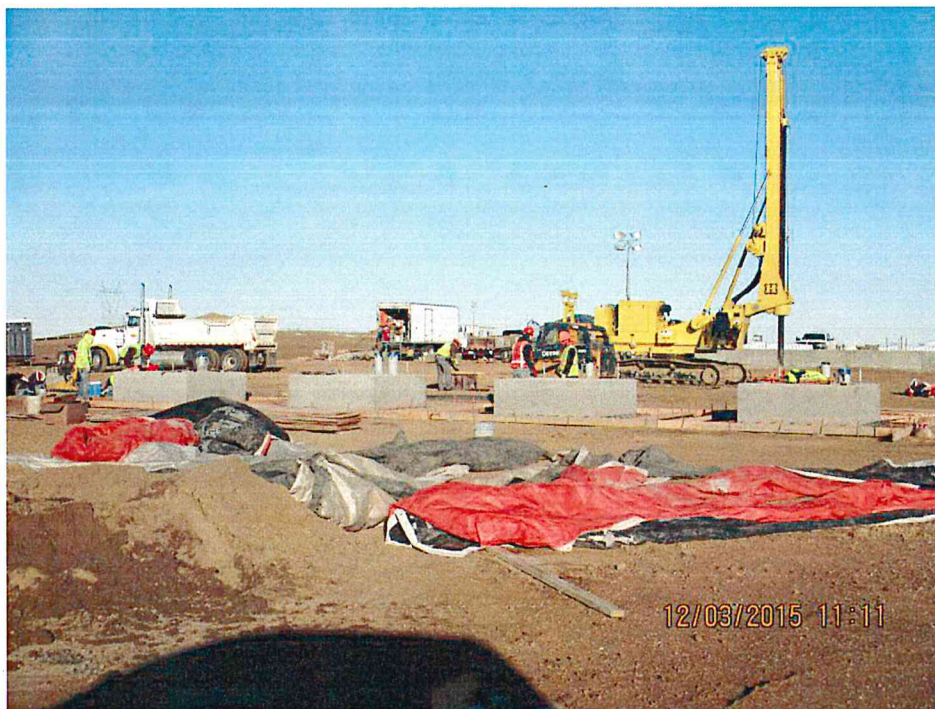
Figure 4. Construction of substation and secondary containment for grounding transformers.

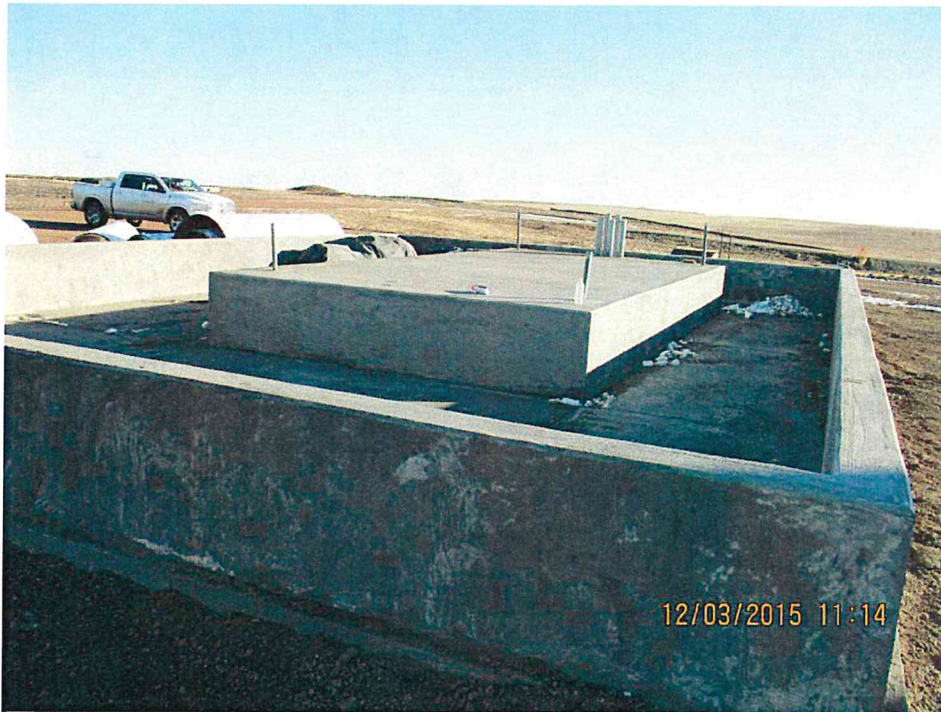
Figure 5. Construction of substation and secondary containment of the step up transformer.

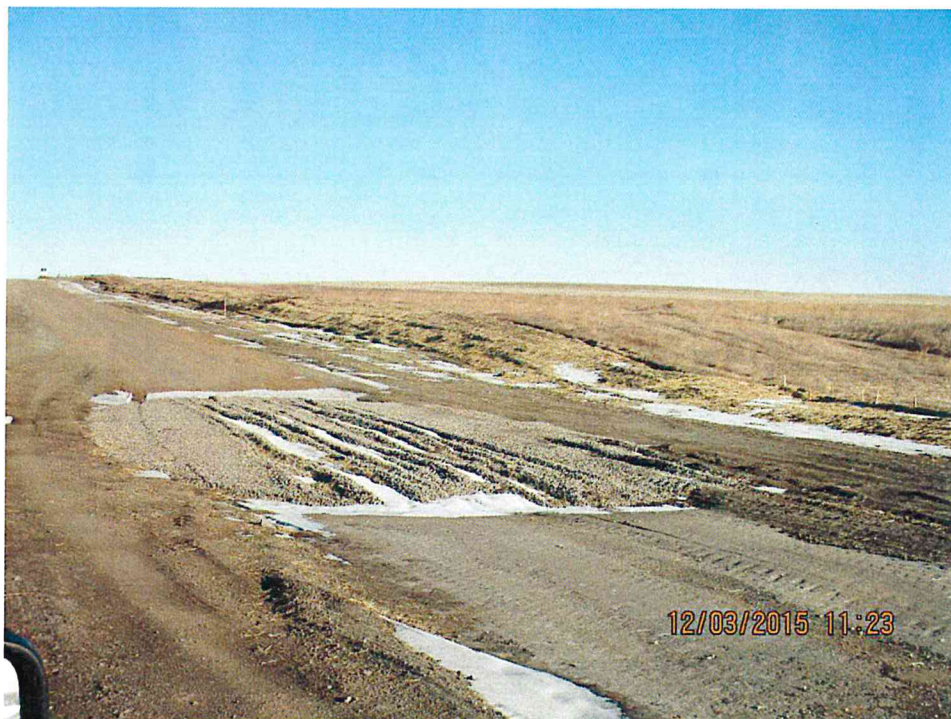
Figure 6. French drain installed in the service road perpendicular to the drainage path crossing the project area.

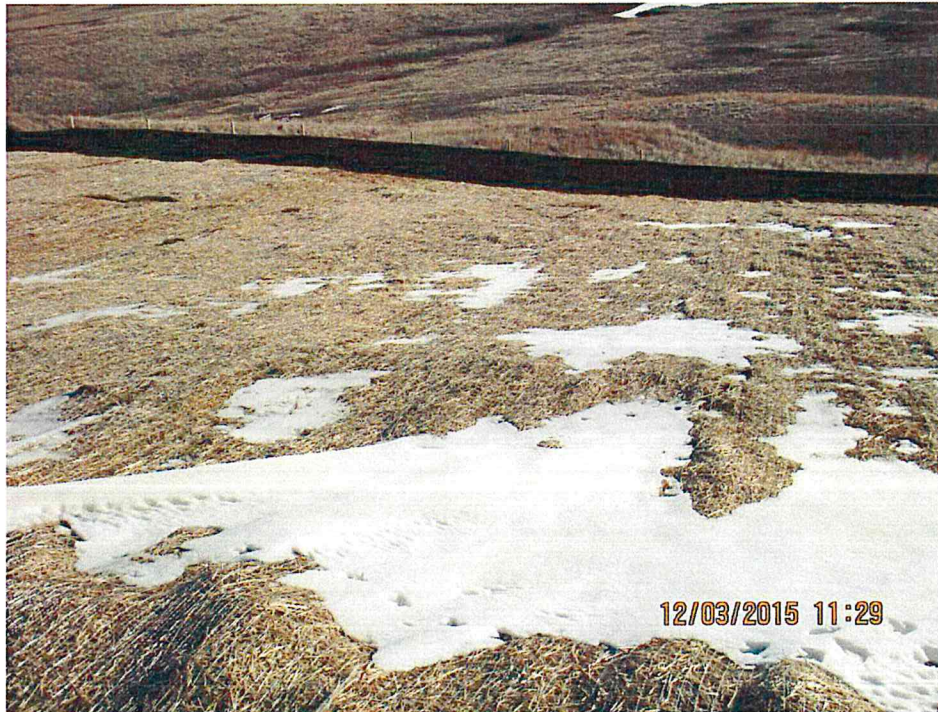
Figure 7. ECDs installed on back slope of T20.

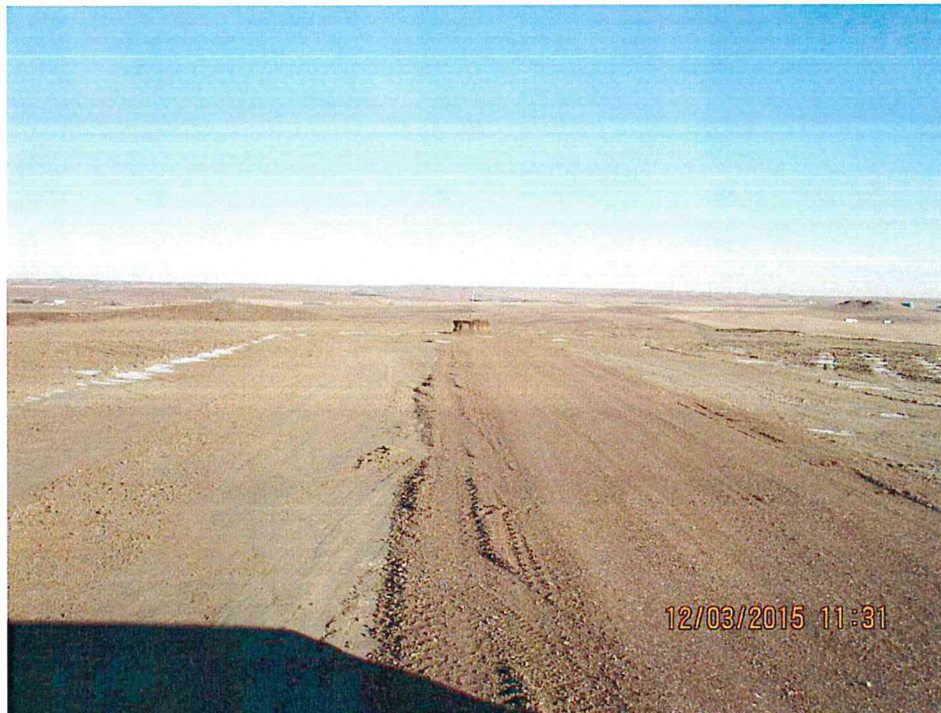
Figure 8. Photo of preliminary grading of the turbine pad at T20.

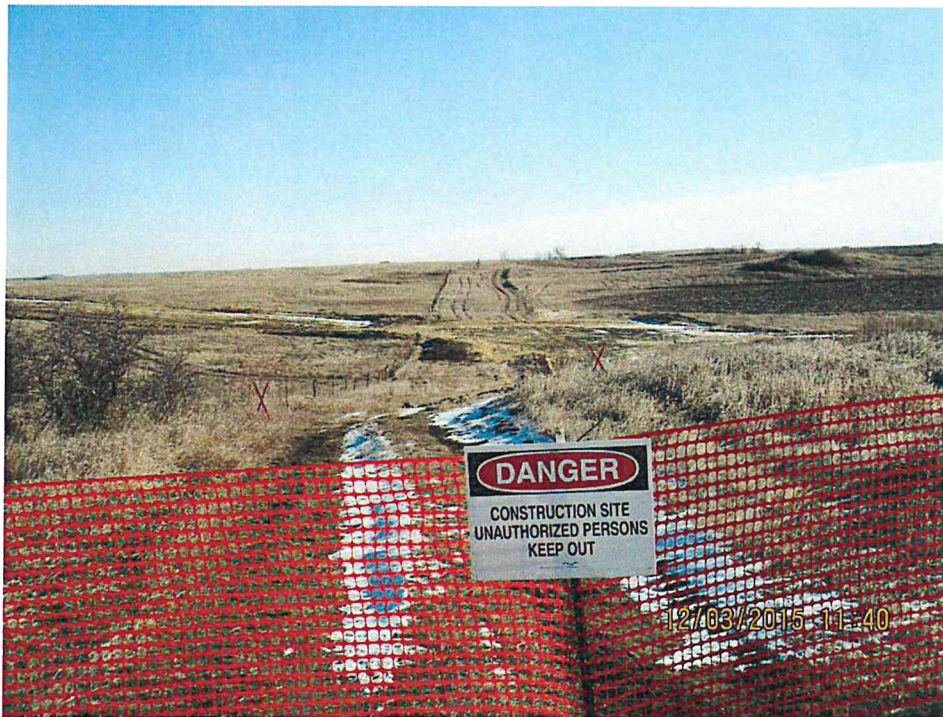
Figure 9. End of construction work area for the winter. ECDs and safety barrier in place.

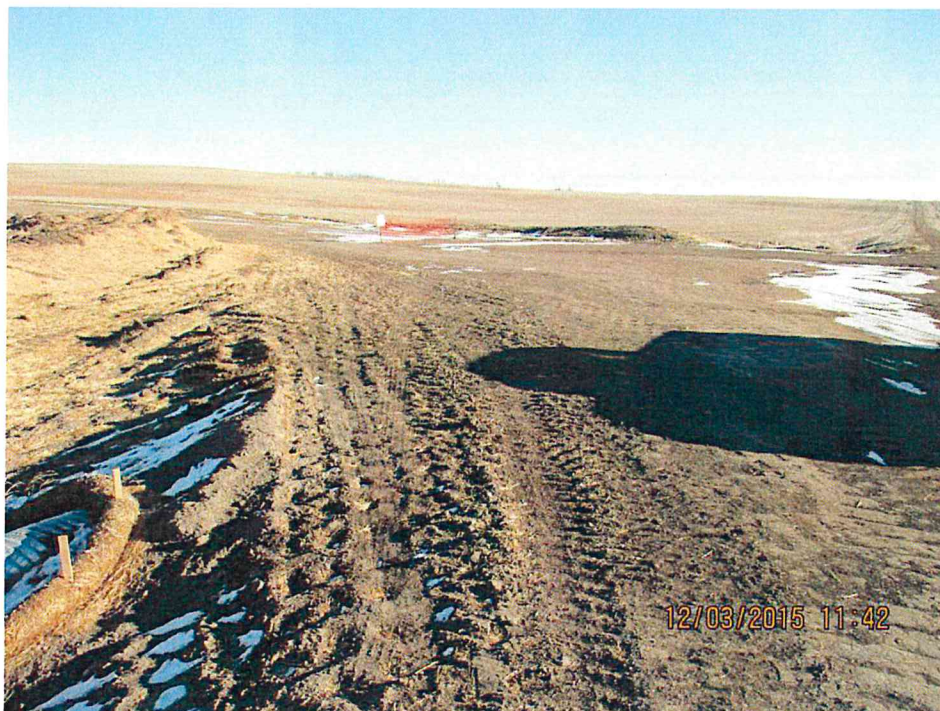
Figure 10. Access road radii increased to accommodate turbine deliveries for turbines T17-T20. These will be regraded and reclaimed at the end of construction.

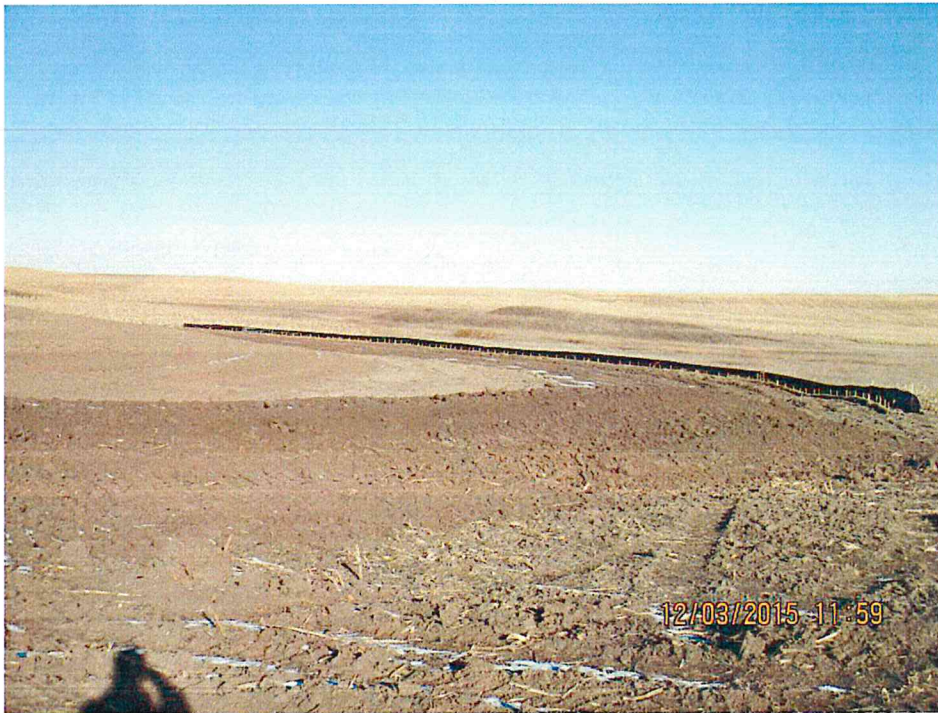
Figure 11. ECDs installed at the edge of working area preventing sediment from leaving the working area.

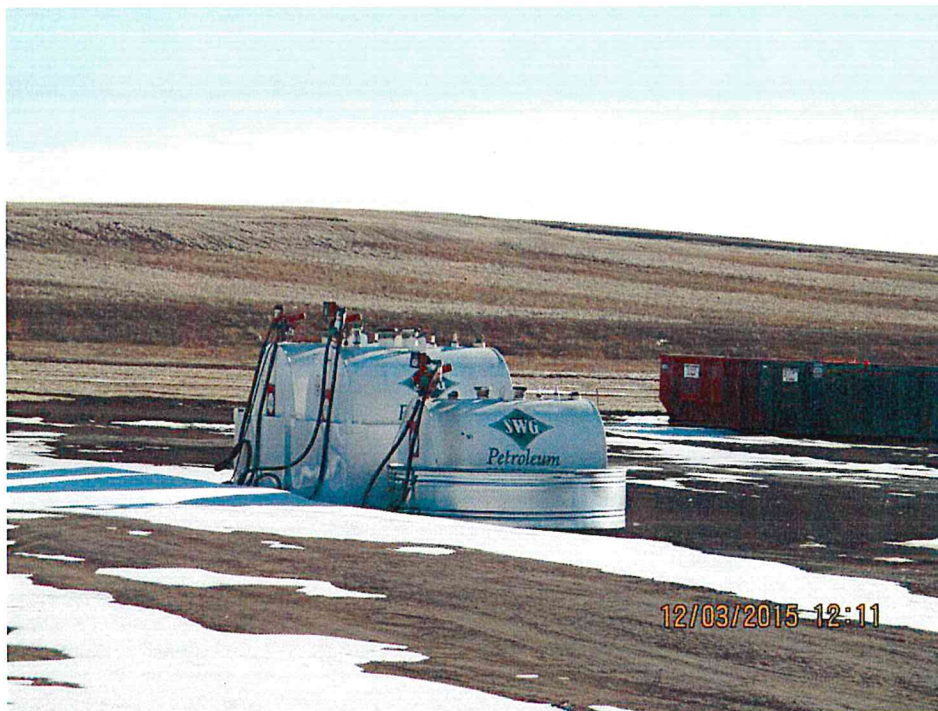
Figure 12. Fuel tanks in containment at laydown yard.
