Carlson McCain, Inc. (CMI) conducted a construction inspection of the Sunflower Wind Project (Case No. PU-14-105) on November 15, 2016, on behalf of the North Dakota Public Service Commission (PSC). The project consists of installing 52 2.0-MW Vestes wind turbines and substation that will connect to the U.S. Department of Energy, Western Area Power Administration's Dickinson-Mandan 230 KV transmission line.

*Construction Inspection Summary*  
*PSC Case No. PU-14-105*

PSC Case No. PU-14-105

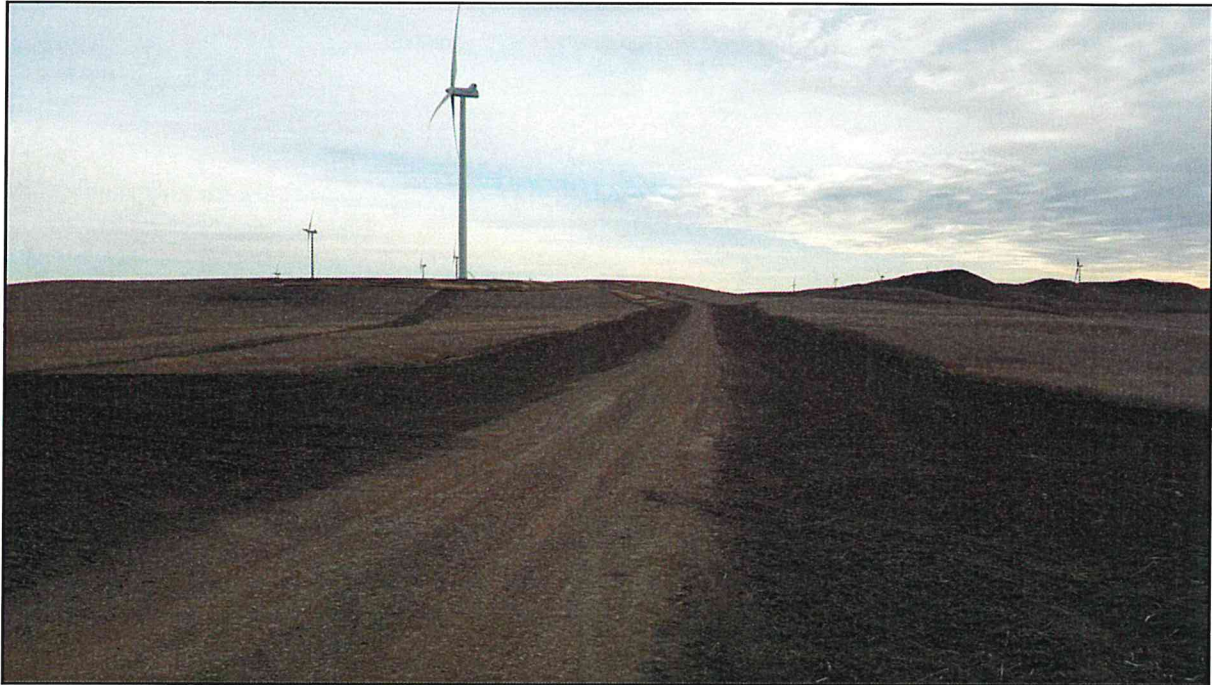
Figure 1. Photo of reclaimed access road between T1 and T2. Seeding was complete where grasslands were adjacent to the ROW.

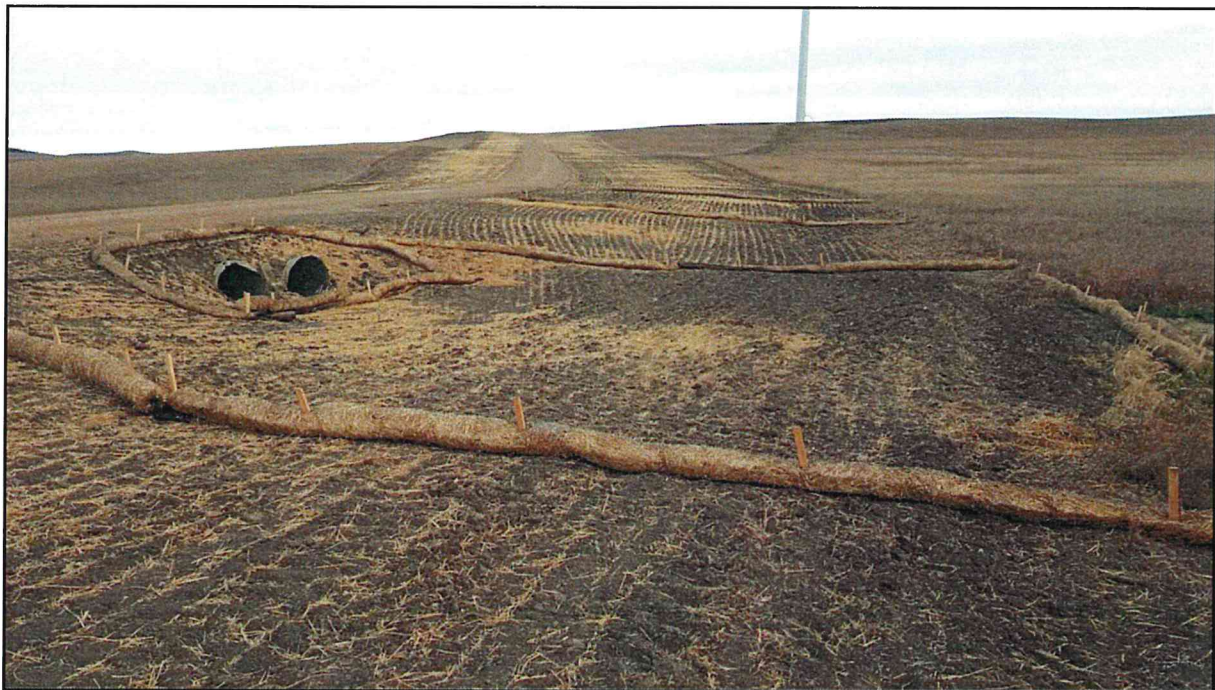
Figure 2. Culverts found between T3 and T4. ECDs were properly installed to prevent erosion.

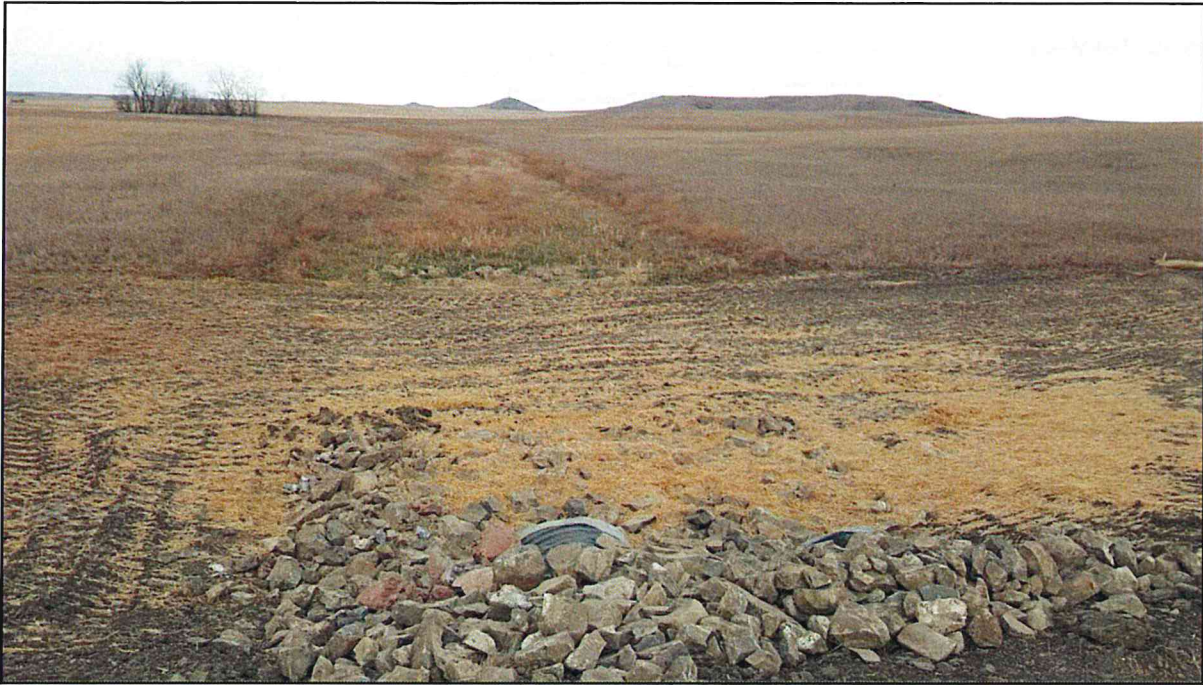
Figure 3. Rip-rap that was installed up-drain of the culvert found between T2 and T3.

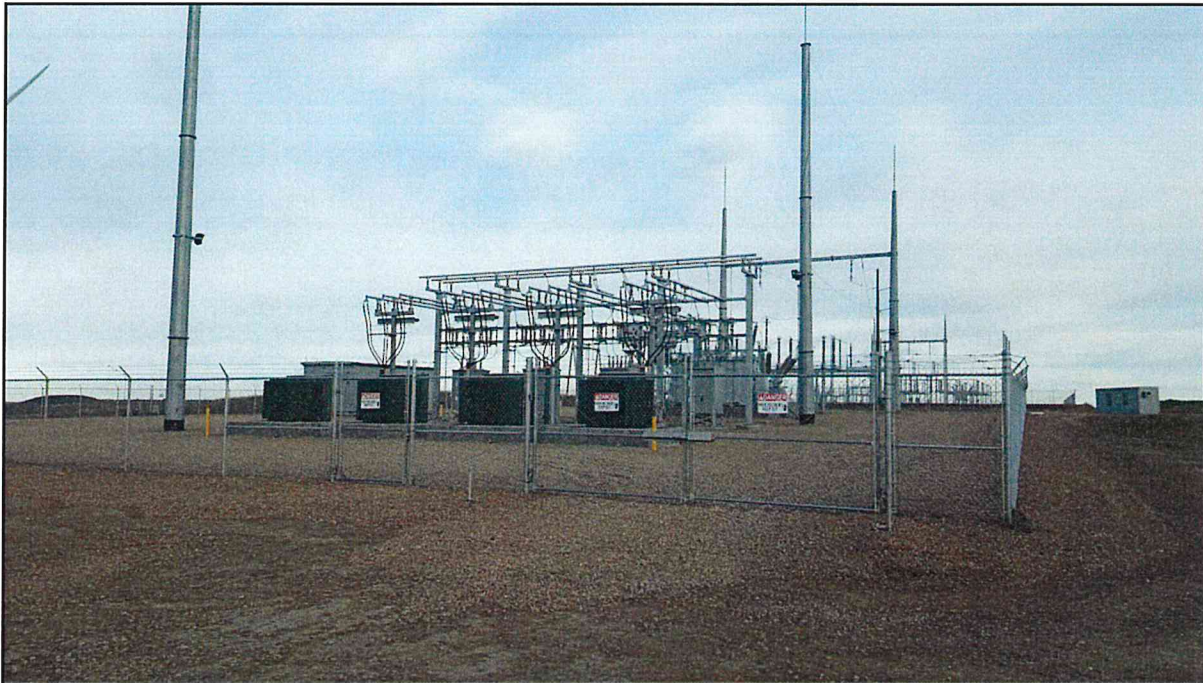
Figure 4. Finished substation.

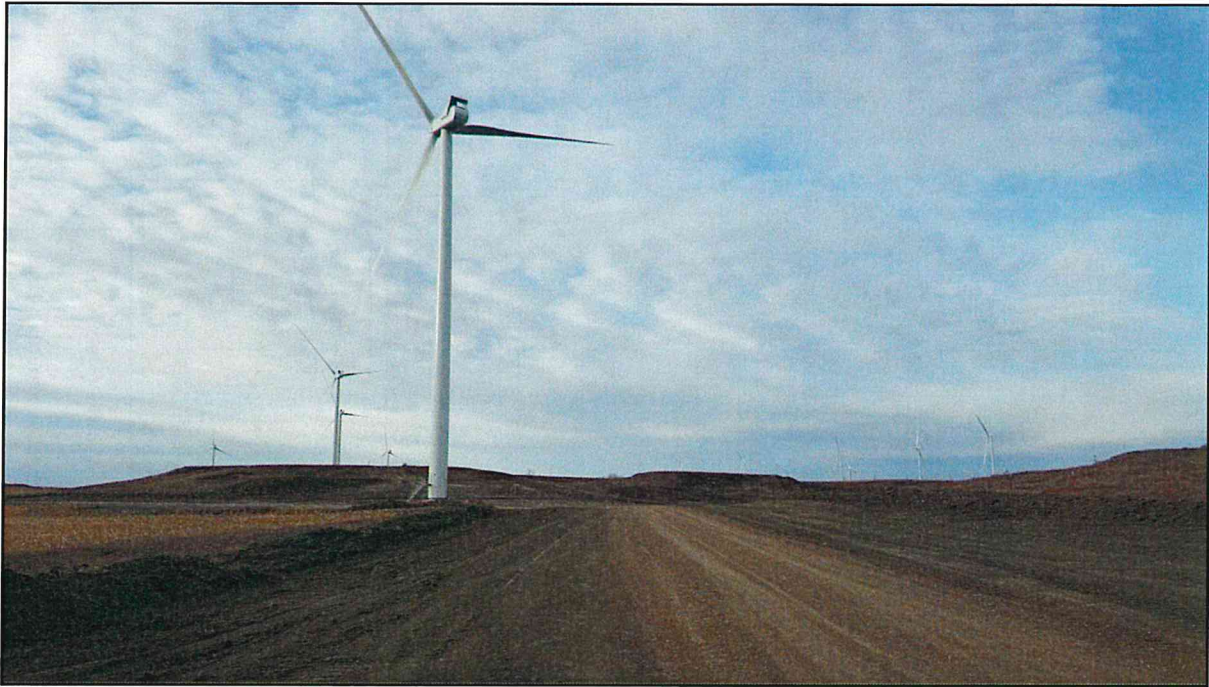
Figure 5. All 52 turbines have been completed and put in place. Only 4 of the 52 turbines are yet to be mechanically completed.

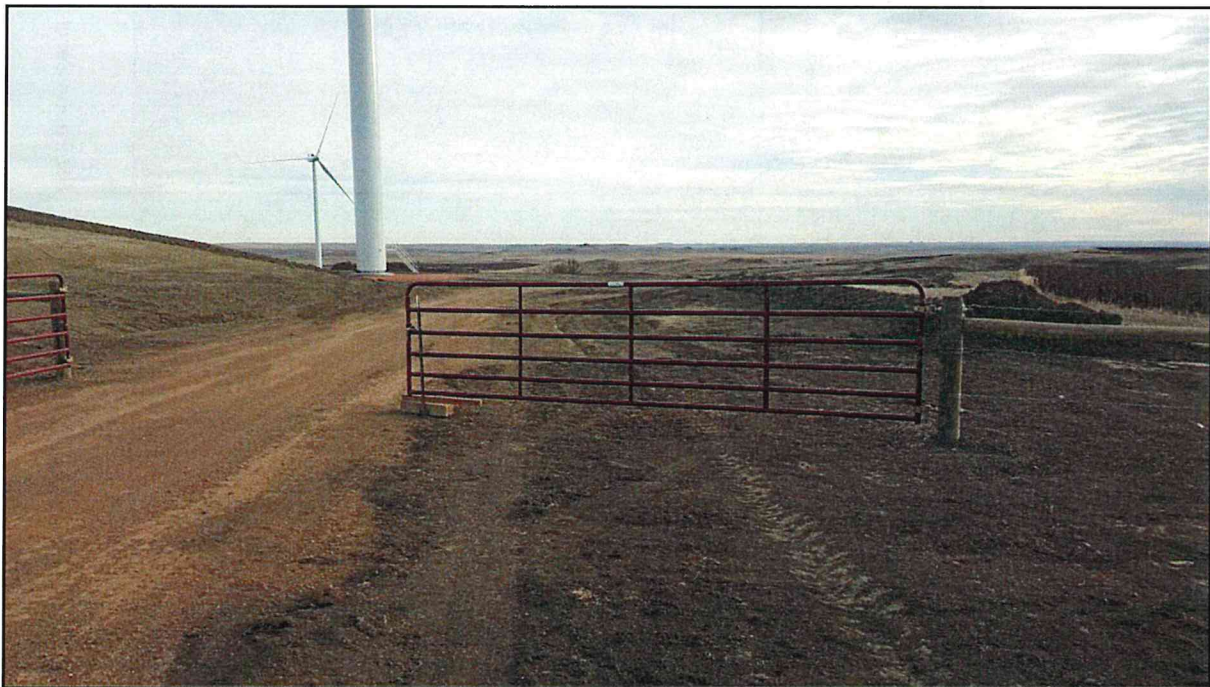
Figure 6. Gates were installed at the intersections with existing fence lines.
