RE: Reclamation Inspection  
PU-14-105, Sunflower Wind Project

147 PU-14-105 Filed 11/02/2018 Pages: 5  
Reclamation Inspection Report  
Carlson McCain, Inc.  
Todd Hartleben, Principal Engineer

**Photo Locations**  
**Reclamation Inspection**  
**Sunflower Wind Project**  
**ND Public Service Commission**

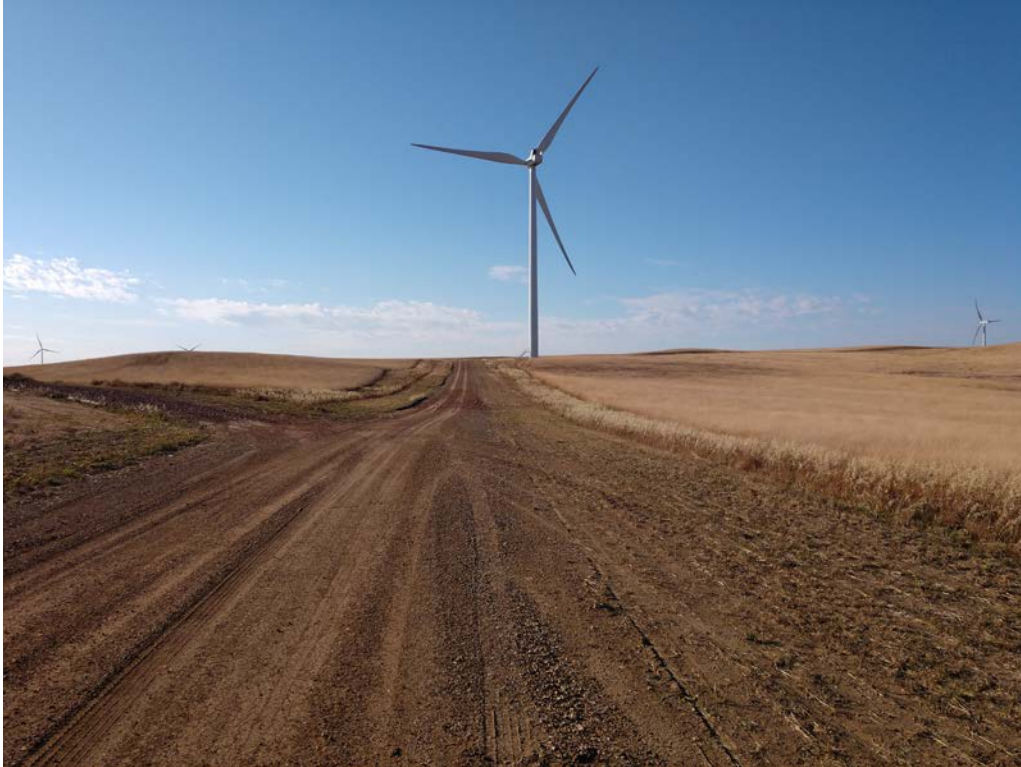
Photo 1. Photo taken facing south toward Turbine T6.

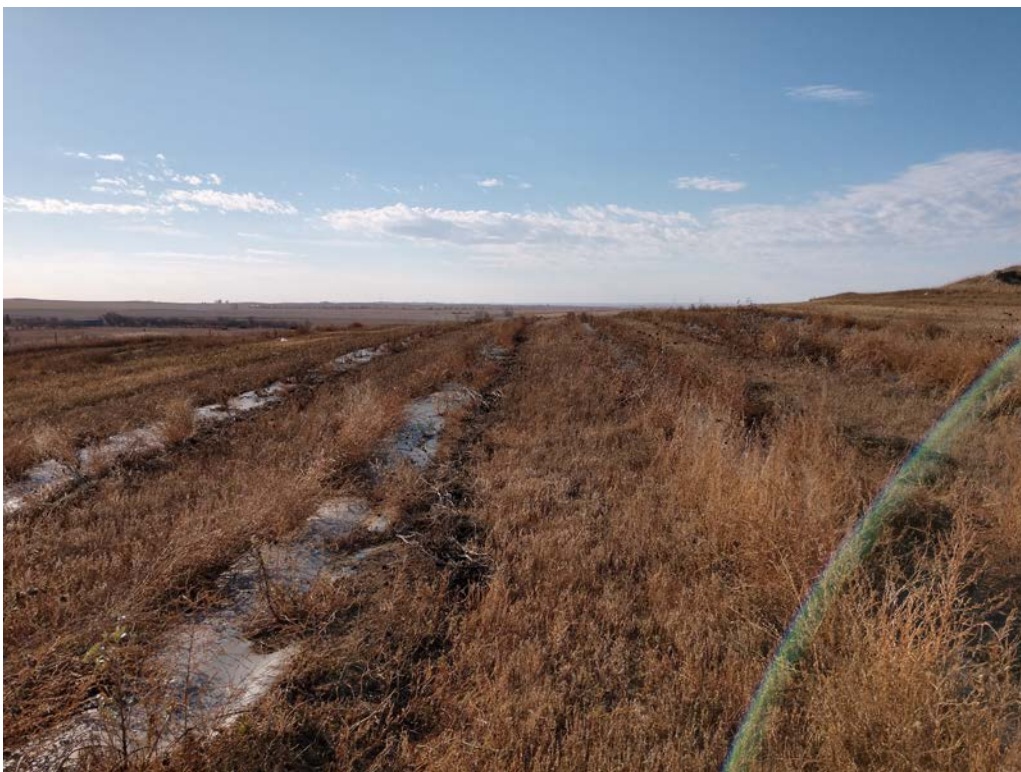
A tree and shrub inspection report summarizing the condition of plantings after one year was filed by Solas Energy Consulting in September 2018. It was noted that some trees were replanted in 2018. Continued monitoring of tree survival is recommended to determine planting success.

Photo 2. Photo of tree planting near Turbine T1. Continued monitoring of tree survival is recommended.

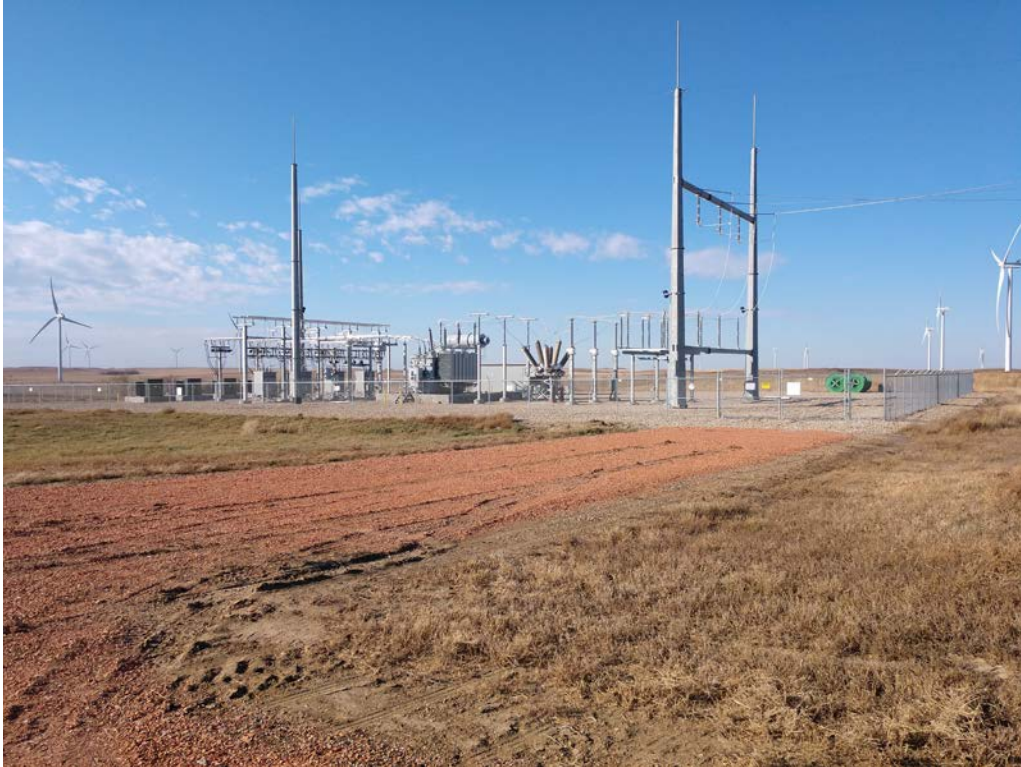
Photo 3. Photo of substation taken facing southwest.

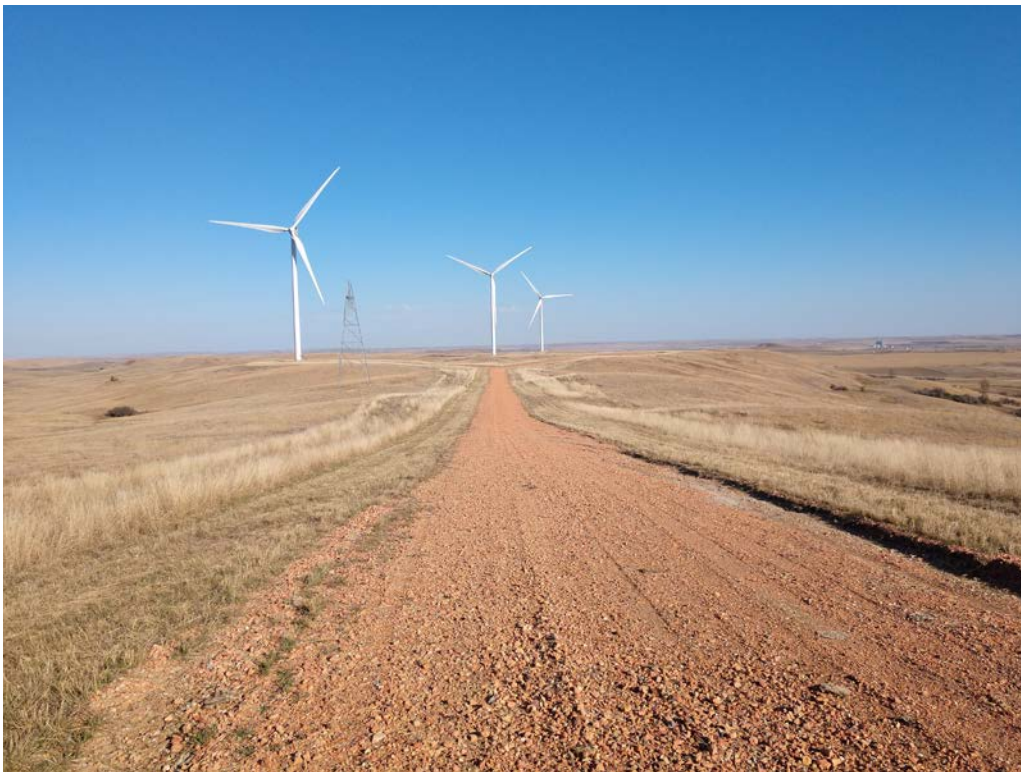
Photo 4. Photo taken facing north along access road to Turbine T18.

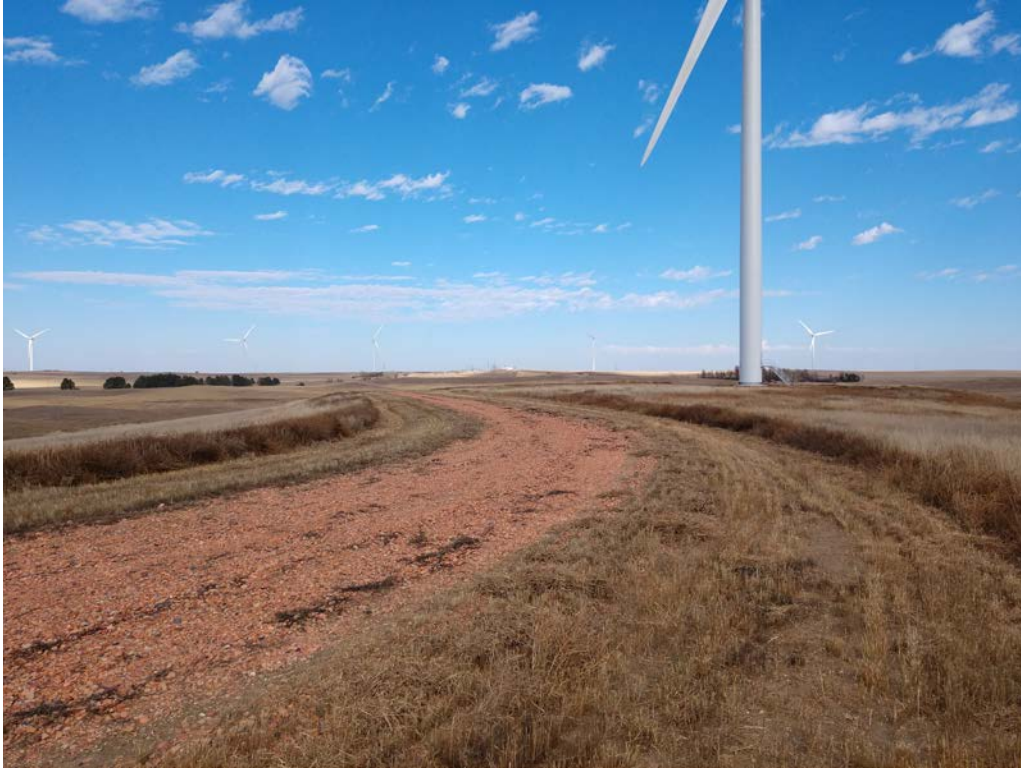
Photo 5. Photo taken facing north along access road. Turbine T26 is on the right side.

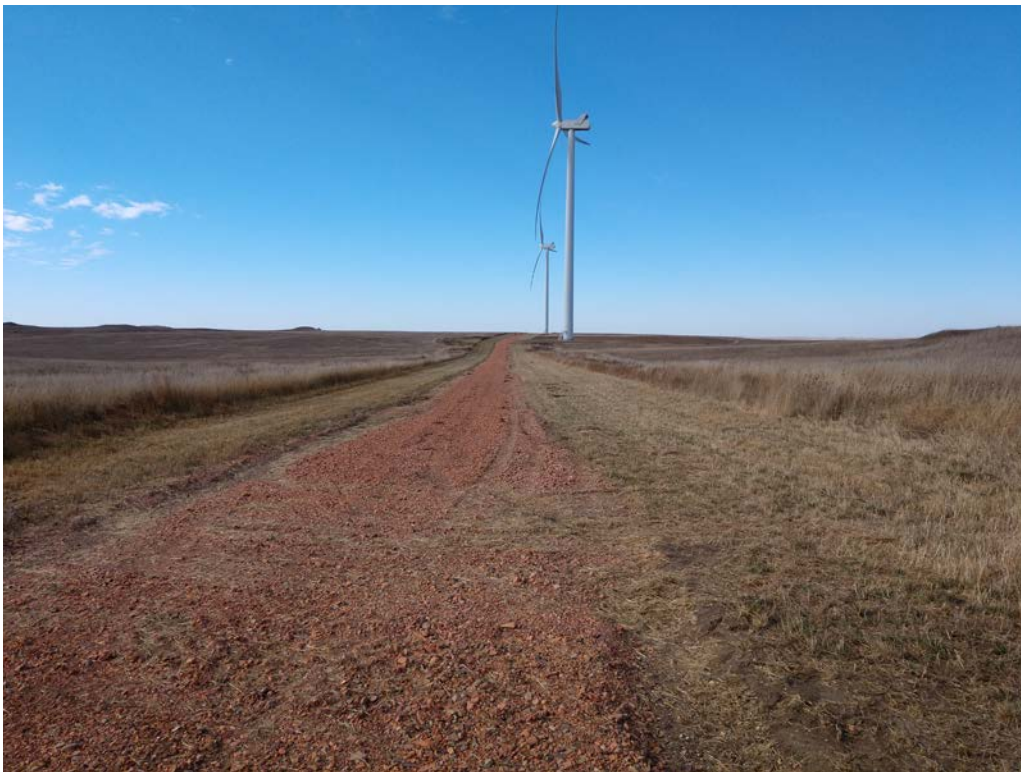
Photo 6. Photo taken along access road to Turbine T49 (facing west).
