**10-Inch Crude Oil Pipeline – Belle Fourche Pipeline Company (PSC Case No. PU-14-135)**

Permit Compliance / Construction Inspection Review

NDPSC Contract No.: PU-702-14-EE

Reporting Period: January 14, 2015 – April 8, 2015

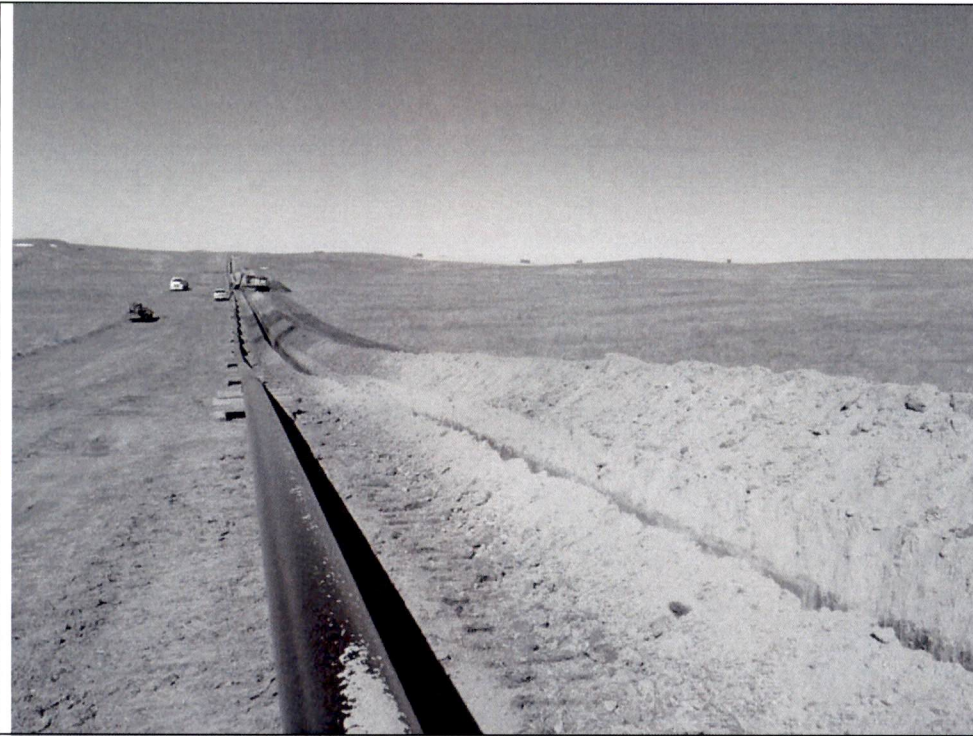
**Photo 1:** Active trench areas.

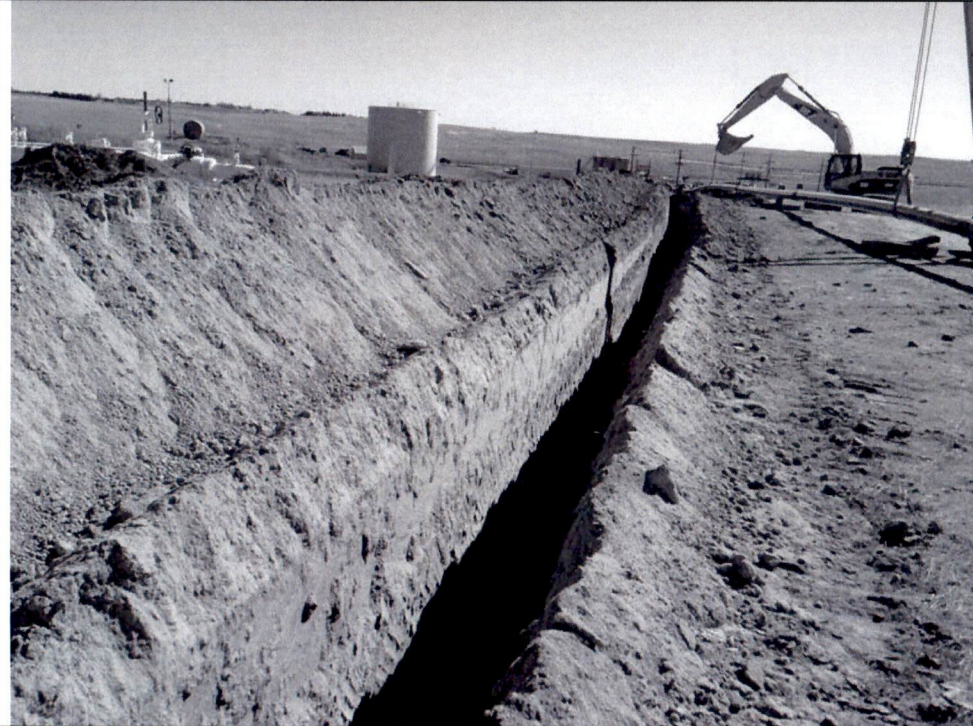
**Photo 2:** Active trenching areas and topsoil separation (background)

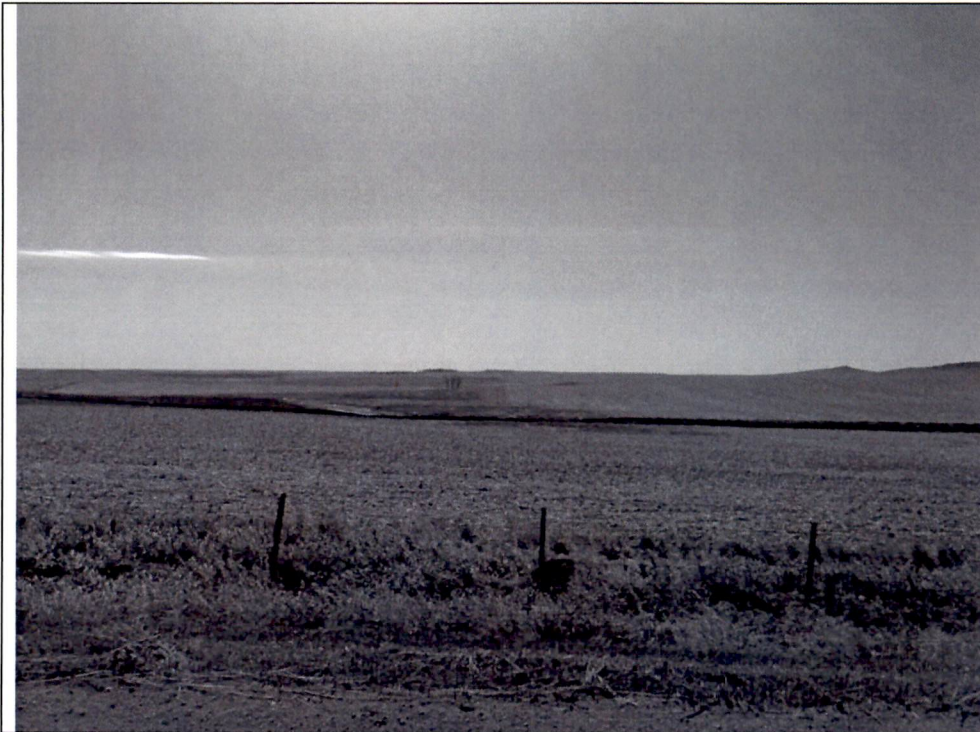
**Photo 3:** Active trenching area.

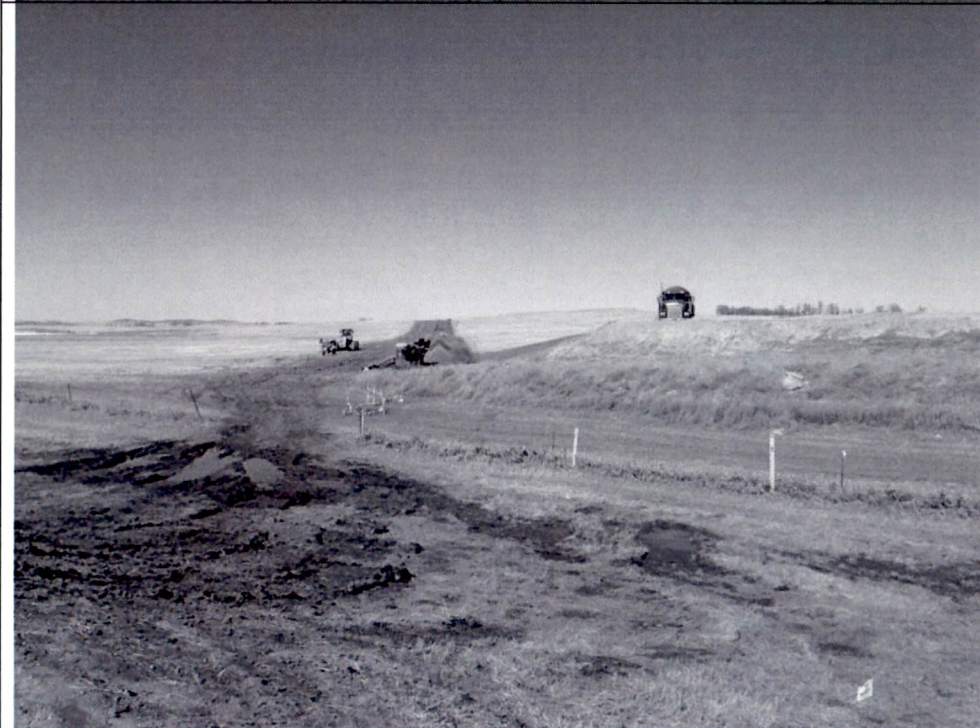
**Photo 4:** Recently completing boring and open trenched areas, awaiting reclamation / restoration activities.

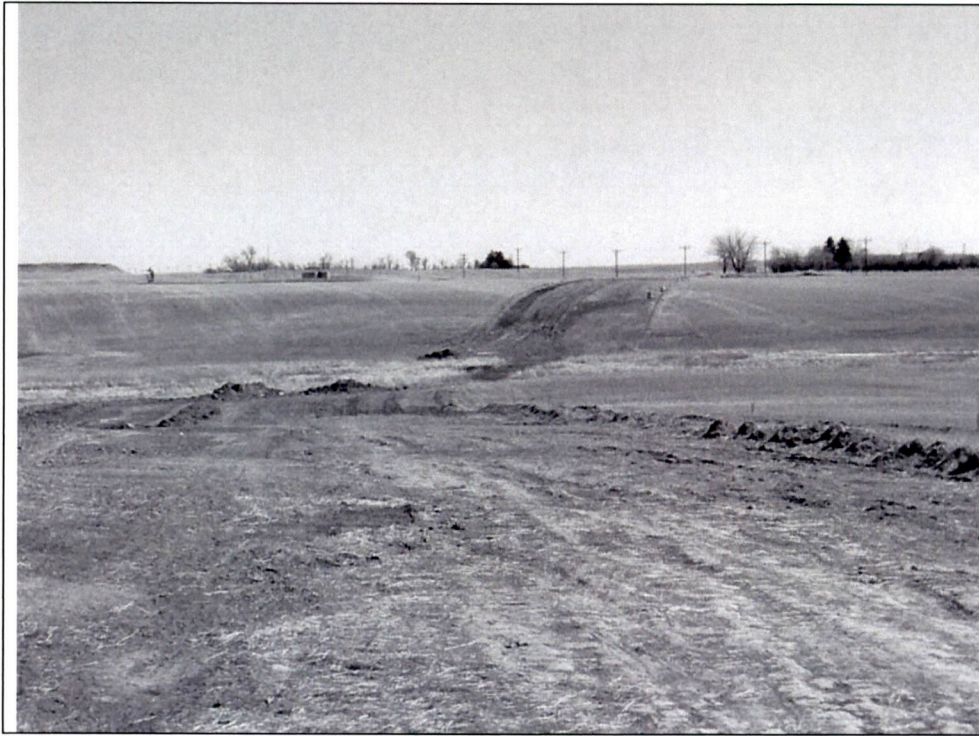
**Photo 5:** Stream boring area.
