**10-Inch Crude Oil Pipeline – Belle Fourche Pipeline Company (PSC Case No. PU-14-135)**

Permit Compliance / Construction Inspection Review

NDPSC Contract No.: PU-702-14-EE

Reporting Period: April 9, 2015 – June 9, 2015

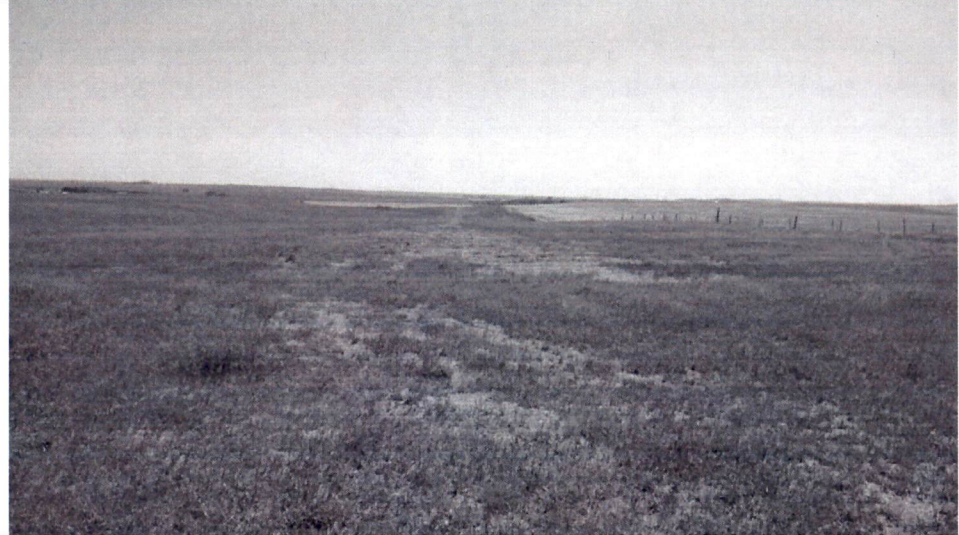
<p><b>Photo 1:</b> Revegetated ROW near northwest end of project.</p>

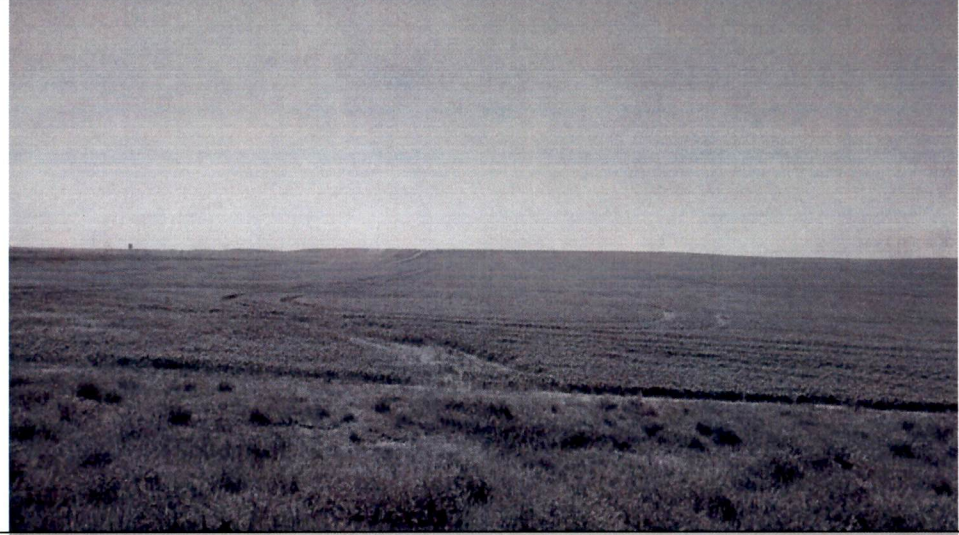
<p><b>Photo 2:</b> Reestablished row crop within ROW.</p>

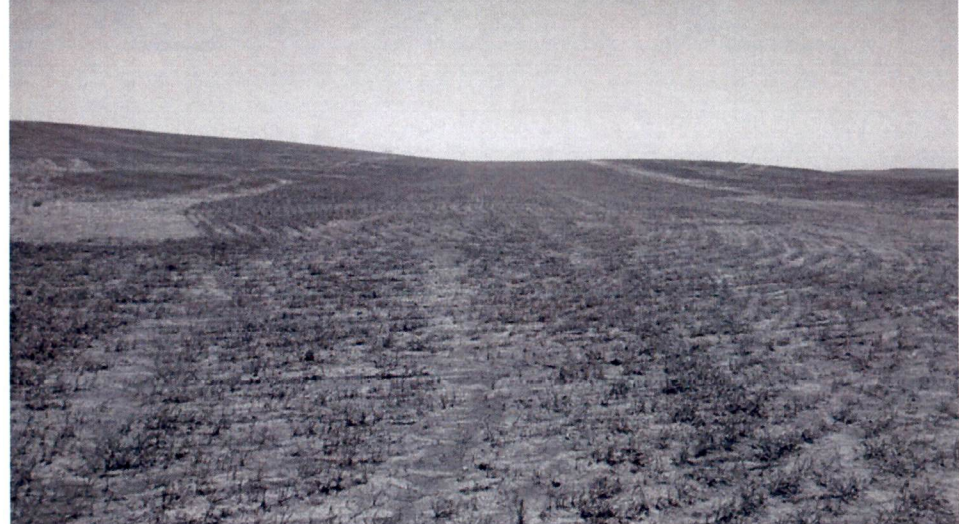
<p><b>Photo 3:</b> Temporary cover crop has emerged within ROW. Adjacent land is row cropped.</p>

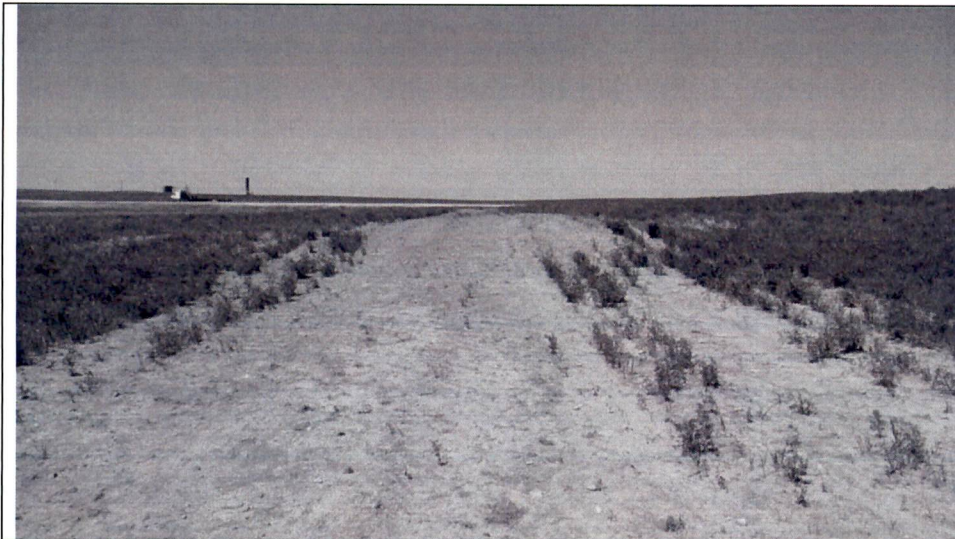
Based on all site inspections performed by HEI staff to date, the project is currently compliant with the permit. In consideration of the revegetation efforts, some areas may take longer to reestablish vegetation or may need to be reseeded at a future date. These areas will be further inspected in the fall of 2015 to assess vegetative establishment, and will recommended any remedies at that time if necessary.

**Photo 4:**  
Area of delayed  
revegetation  
along section  
line.

An additional site visit will be completed in the fall of 2015 to further observe reclamation / restoration activities.

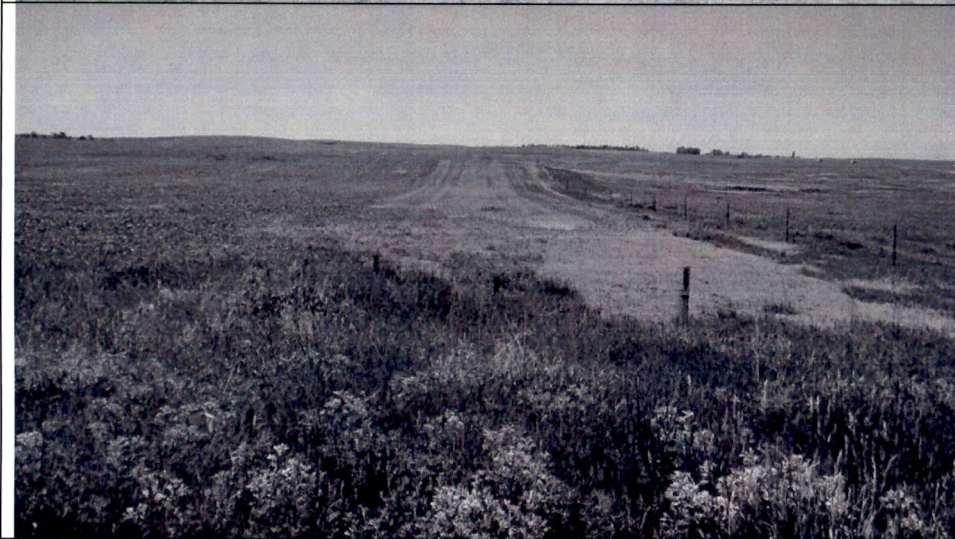
**Photo 5:**  
ROW returned to  
row crop  
production.

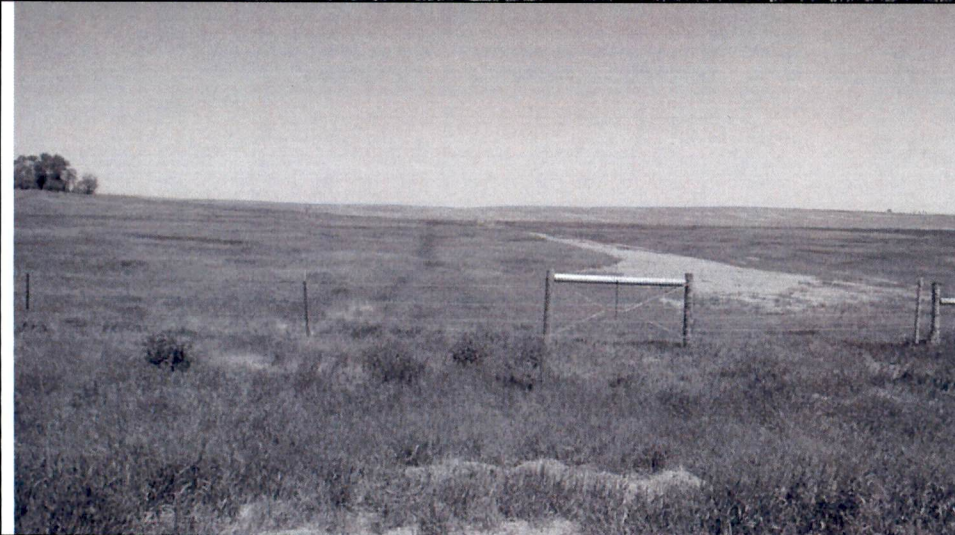
**Photo 6:**  
Revegetated  
pasture land

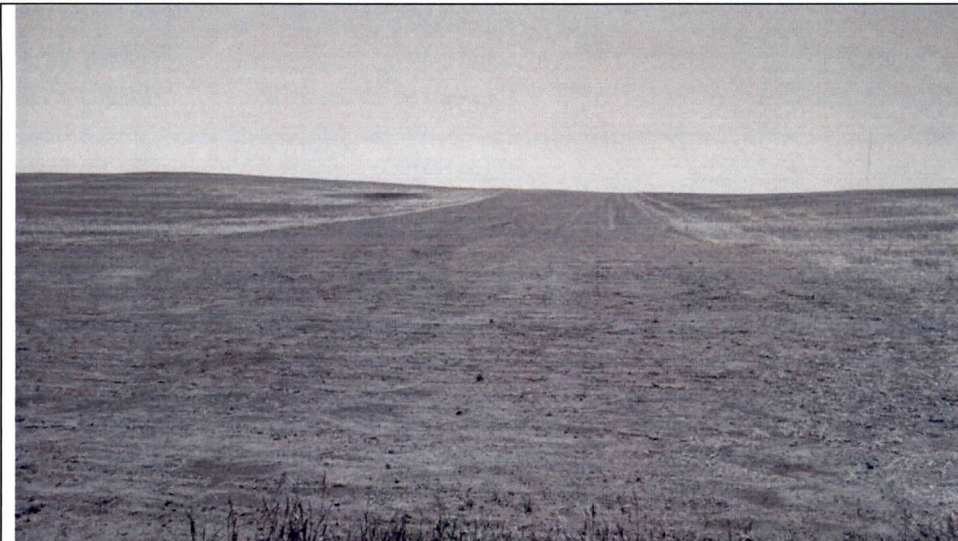
**Photo 7:**  
ROW returned to  
row crop  
production

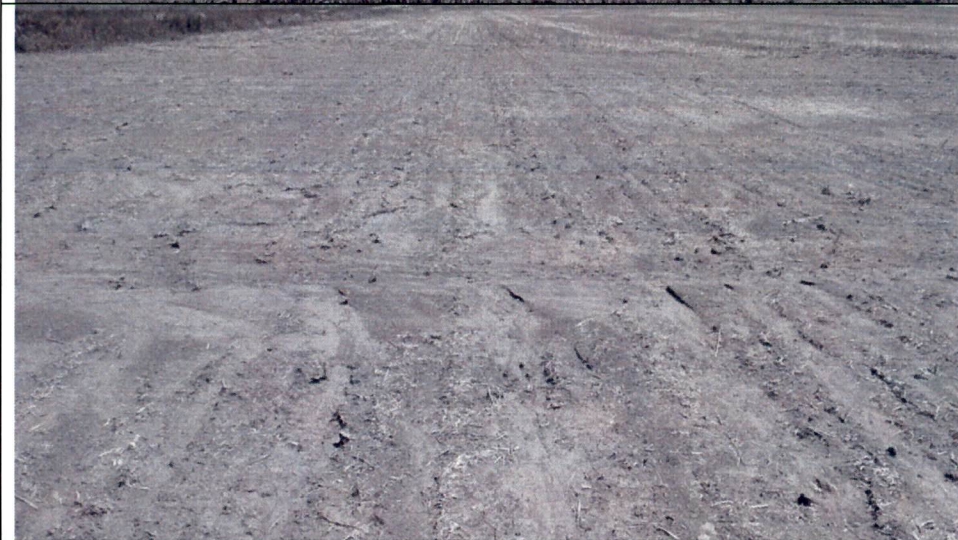
**Photo 8:**  
Planted row crop  
has emerged.

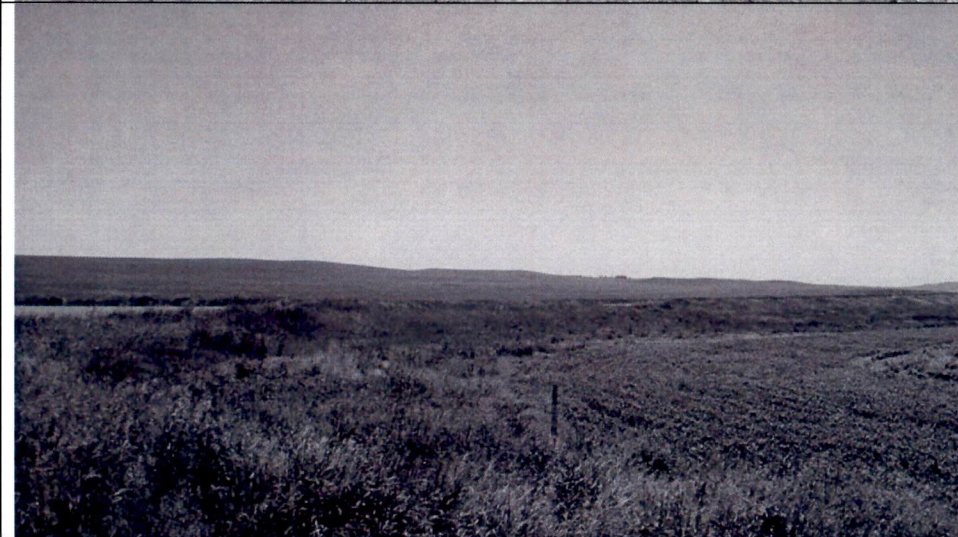
**Photo 9:**  
ROW returned to  
row crop  
production.

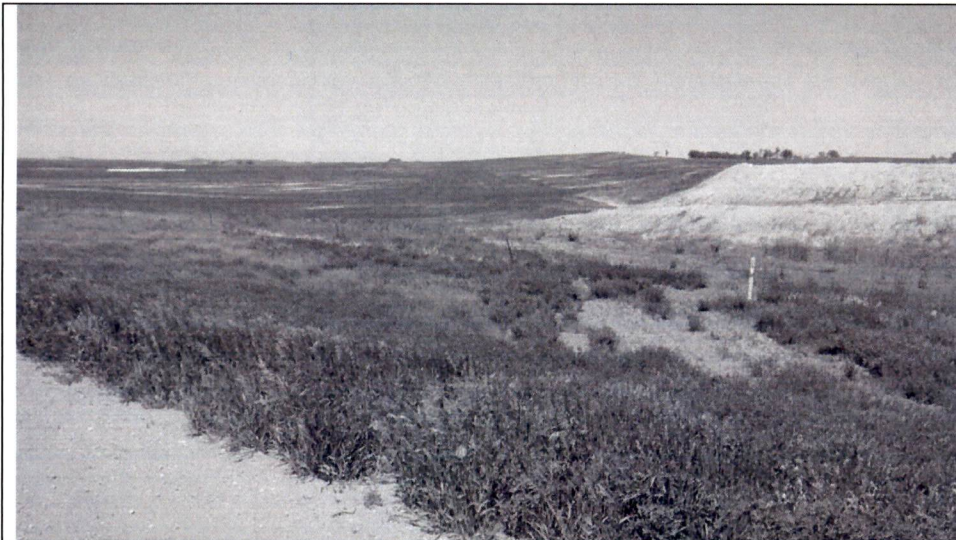
**Photo 10:**  
Belle Fourche  
ROW extends  
out from center  
of the photo.

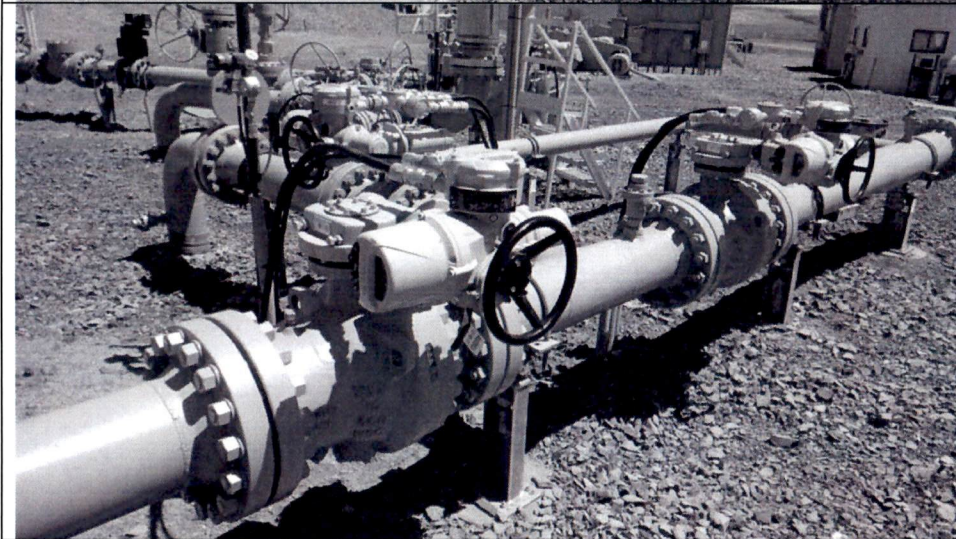
**Photo 11:**  
Valve station at  
southeast extent  
of project.
