# 10-INCH CRUDE OIL PIPELINE (PU-14-135) Permit Compliance Final Inspection Report

The North Dakota Public Service Commission (Commission) retained Houston Engineering, Inc. (HEI) to complete a construction inspection of the 10-inch Crude Oil Loop Pipeline project in Billings, Dunn, and Stark Counties, North Dakota (ND), owned and operated by Belle Fourche Pipeline Company. Construction of the Project was completed in May 2015. HEI reviewed all project documents to identify those aspects that required compliance and visually inspected the project area on March 10, 2015, June 8, 2015, and most recently July 18, 2016.

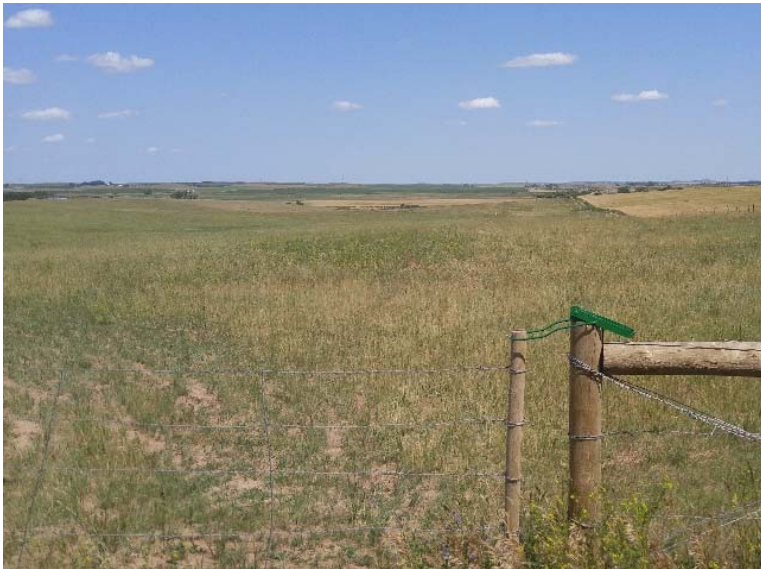
**Photograph 1** was taken at the start of the project at the first roadway crossing. Reclamation was observed and appeared successful as it was not obvious where the pipeline had been installed until identified by Mr. Clark from Belle Fourche. The corridor was identified by the slight thinning of grasses that were not fully established yet at the time of inspection. In another area of the route, a section of grass failed to reestablish in a pasture (**Photograph 2**). At this site, evidence of livestock activity was observed, which may contributed to the lack of established vegetation.

**Photo 1:** Reclamation at beginning of project (facing East). 7-18-16

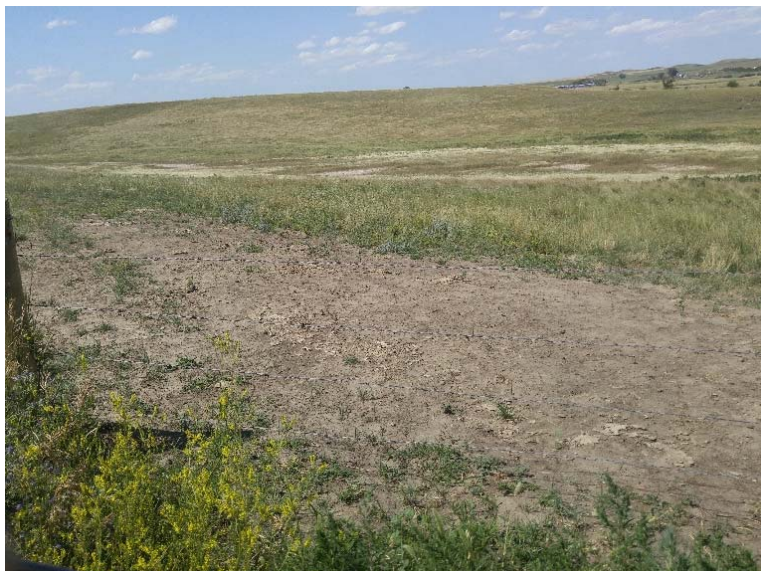
**Photo 2:** Area lacking vegetation establishment (facing North). 7-18-16

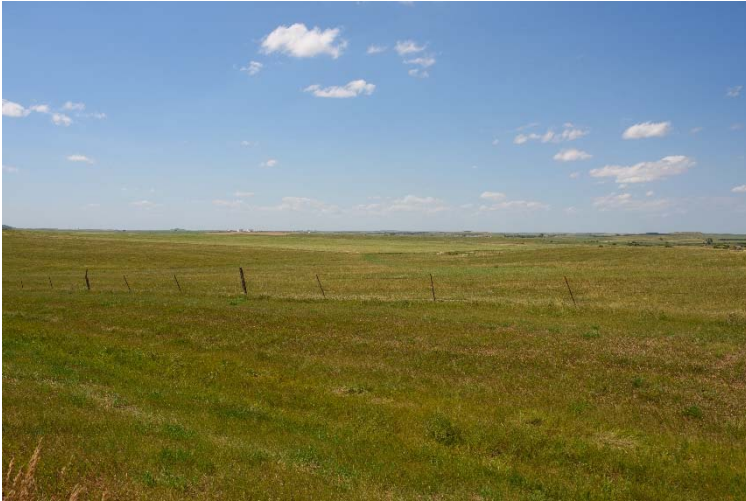
Reclamation in other areas was characterized by an influx of weeds in the areas disturbed during construction. **Photographs 3 and 4** show some evidence of weed growth. Mr. Clark discussed some spraying of weeds has been conducted in their continuing efforts to establish native grasses.

**Photo 3:** Reclamation – from center of image to right side (facing Northwest) 7-18-16.

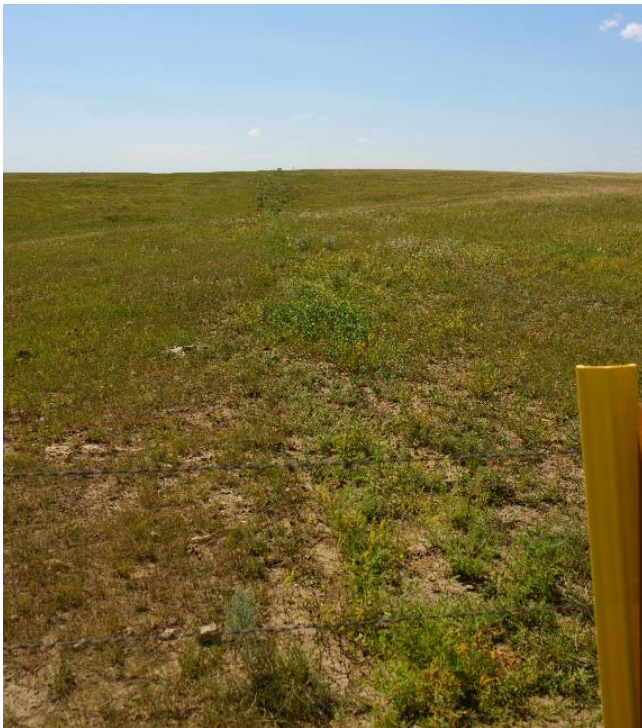
**Photo 4:** Reclamation from center of image to bottom (facing Northwest). 7-18-16

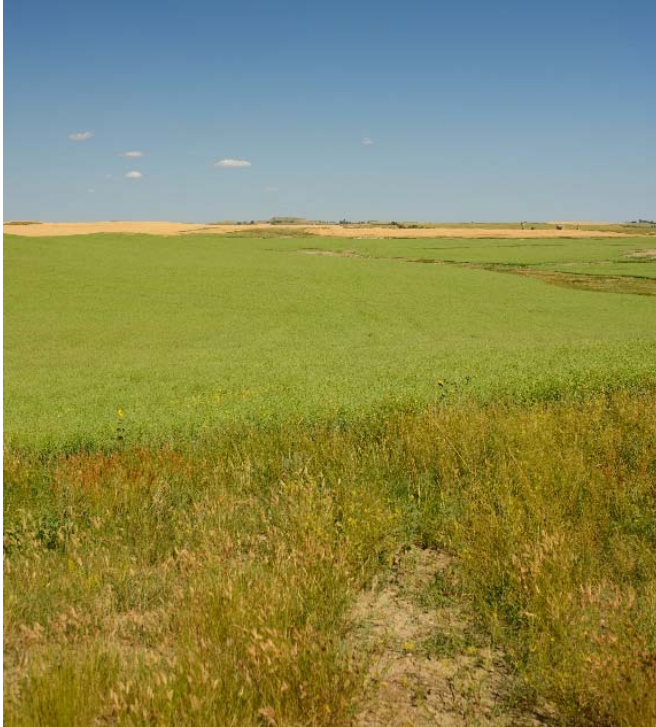
No active farmland is being converted as a result of this Project. The pipeline is buried and all farmland has been returned to their pre-construction land uses. This was confirmed during the site inspections. In addition, all farmland taken out of production has returned to its previous agricultural use (see **Appendix A**, Photos 5, 7 and 9)

**Photo 5:** Reclamation through wetland (facing Southeast).

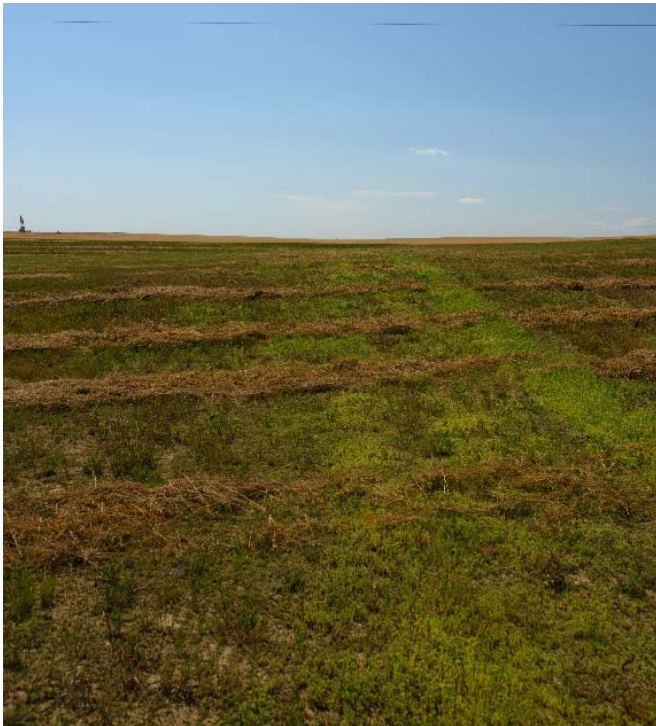
**Photo 6:** Reclamation of wetland (facing West). 7-18-16

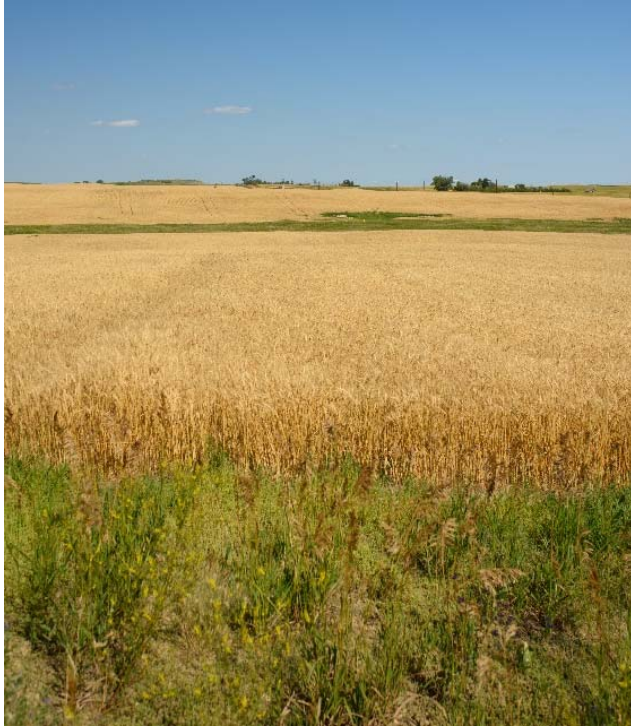
Photo 7: Reclamation of wetland  
(facing East). 7-18-16

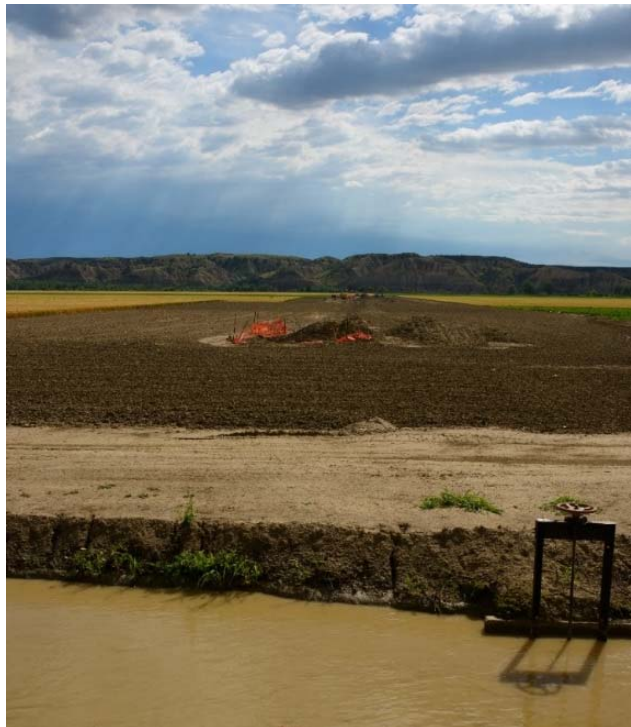
**Photo 8:** Reclamation of wetland -  
pipeline runs from left to right -  
across picture (facing North).

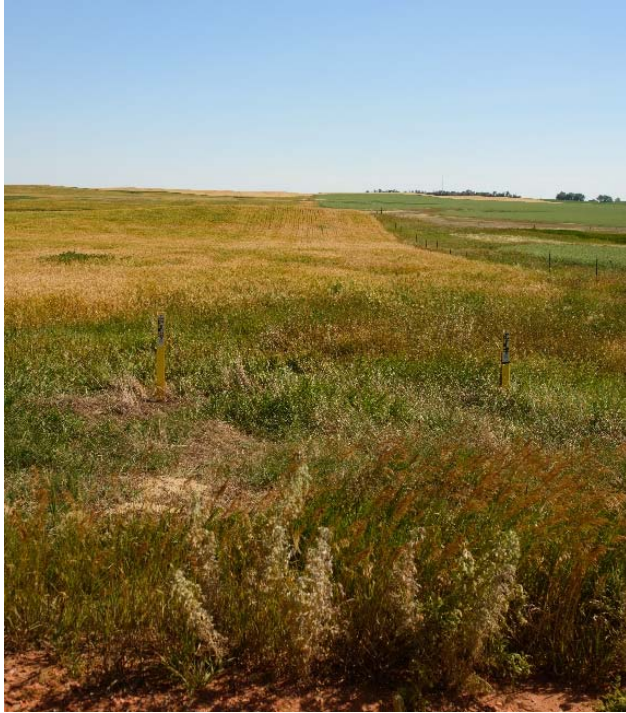
**Photo 9:** Reclamation (facing South). 7-18-16

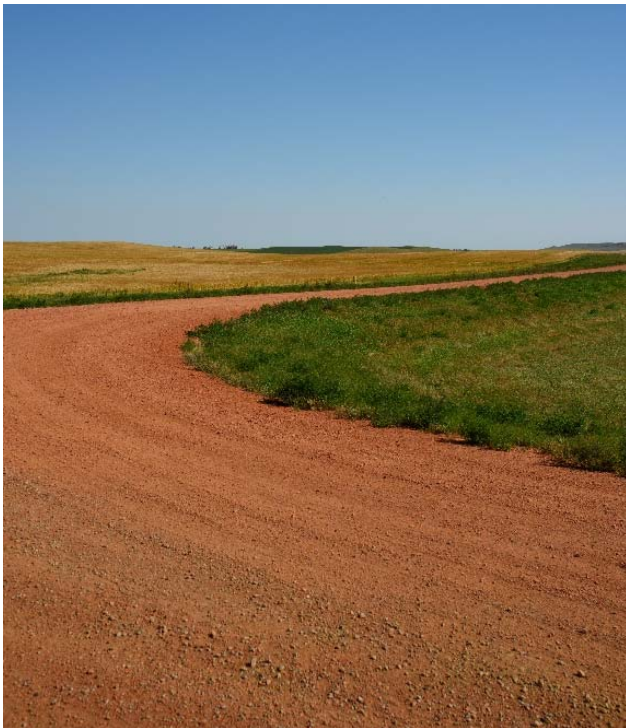
The Project requires bypass of several existing roadways. All roadways bisecting the pipeline were directional bored and returned to their pre-construction condition. Roads accessing the site appeared to be in a condition typical for the area and do not appear to have been negatively impacted during construction (see **Appendix A**, Photos 10, 11, 16).

**Photo 10:** Reclamation (facing Southeast). 7-18-16

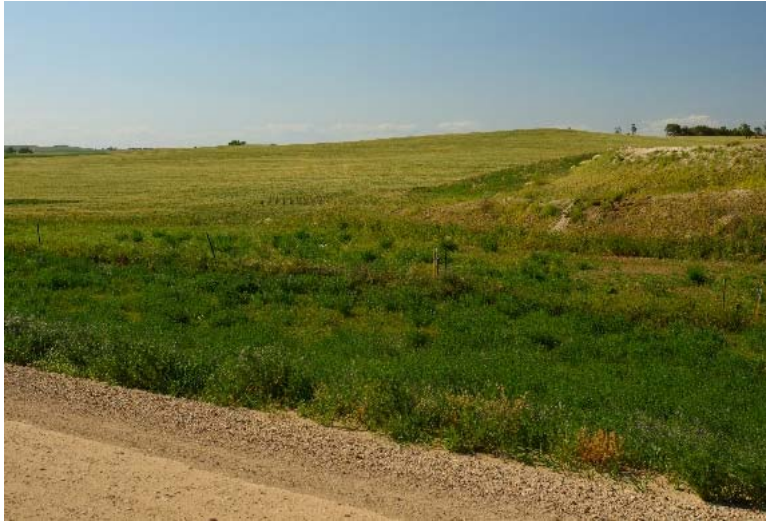
**Photo 11:** Reclamation (facing Northwest). 7-18-16

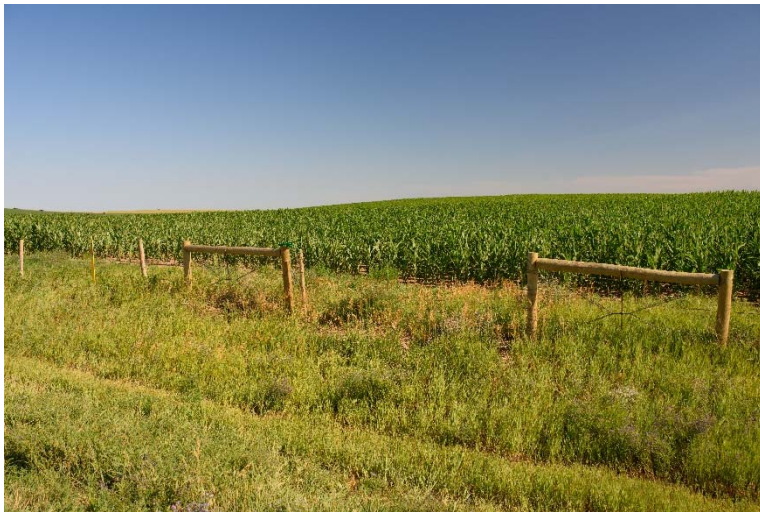
Impacts on cropland were minimal. In one location, a farmer was using the smoothed areas over the pipeline to access his hay field. This had a negative impact on the revegetation efforts, but these impacts were unrelated to the project construction activities. All fence crossings were repaired to equal or better standards. Each crossing had a gate installed with a metal hand latch (**Photograph 12**), which allows Belle Fourche employees to access the pipeline in the future without any impacts to the fence.

**Photo 12:** Installed fence repair and gate (facing Southeast).

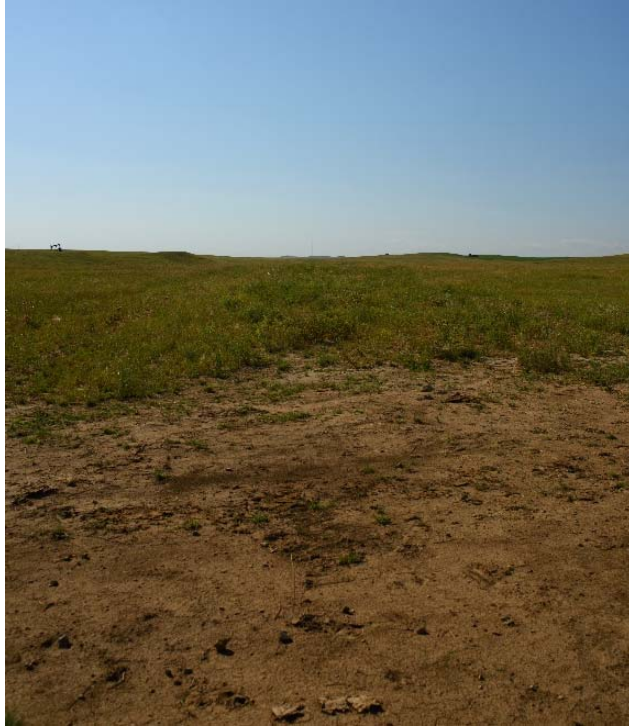
Near the end of the Project route, the pipeline crossed another larger pipeline owned by a different company. At this intersection, valves were installed aboveground for the other company's line. In this location, large bare spots were observed which are related to construction of the adjacent valves. (See **Photographs 13 and 14**)

Photo 13: Reclamation near valve (facing Northwest).

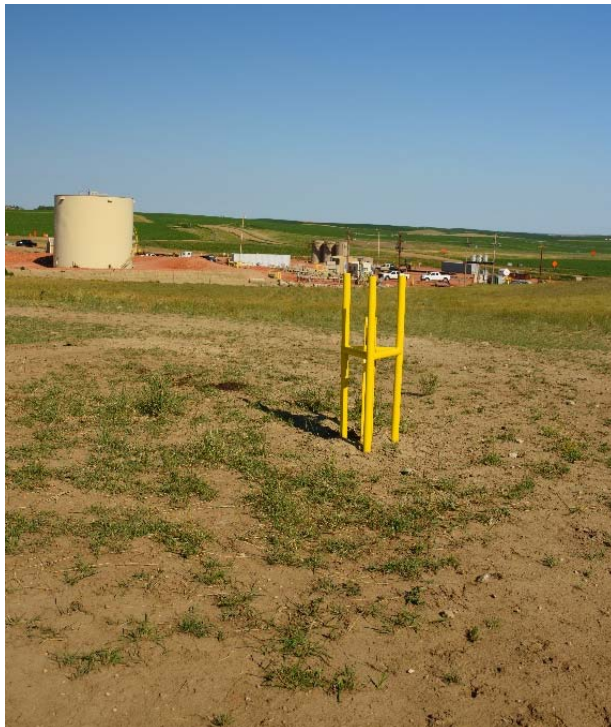
**Photo 14:** Reclamation near valve (facing Southeast). End of project.

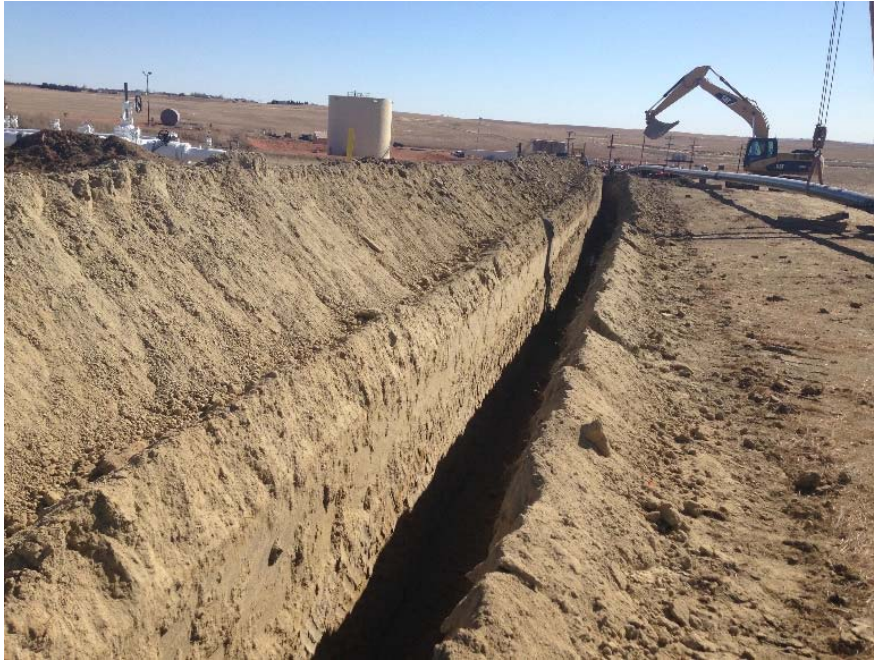
A new 10-inch pipeline has been installed and buried (see **Appendix A**, Photo 15). During active construction, burial depths were visually confirmed. HEI consulted the as-built documents to verify that the constructed pipeline conforms to the project depth specifications.

**Photo 15:** 3- During construction burial depths were visually confirmed.

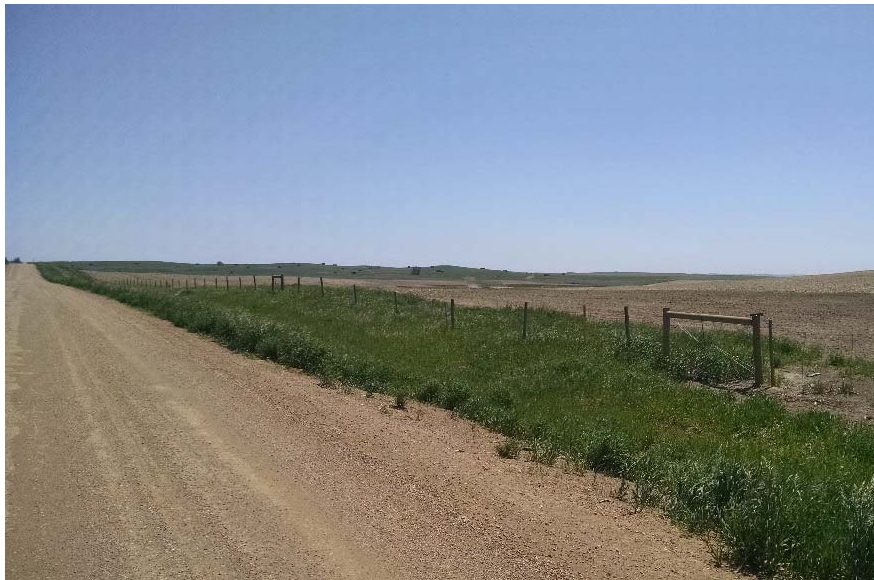
**Photo 16:** Post-construction road condition.
