MONTANA-DAKOTA

THIRD PARTY DAMAGE COMPLAINT

Date and Time of Event 2/18/14, 1500 hours	Address of the Excavation and/or Damage 621 E 42nd St			
County Williams	City Williston	State ND	Zip Code 58801

Type of Facility Involved Gas Distribution Main Line	Operator of Facility and Contact Person (if known) Montana-Dakota Utilities Co., Paul Riely			
Address 220 2nd Ave East	City Williston	State ND	Zip Code 58801	
Telephone Number 701-572-1614	Email Address (if known) paul.riely@mdu.com			
Brief Description of Facility Involved loop fed 2" PE medium pressure natural gas distribution main line

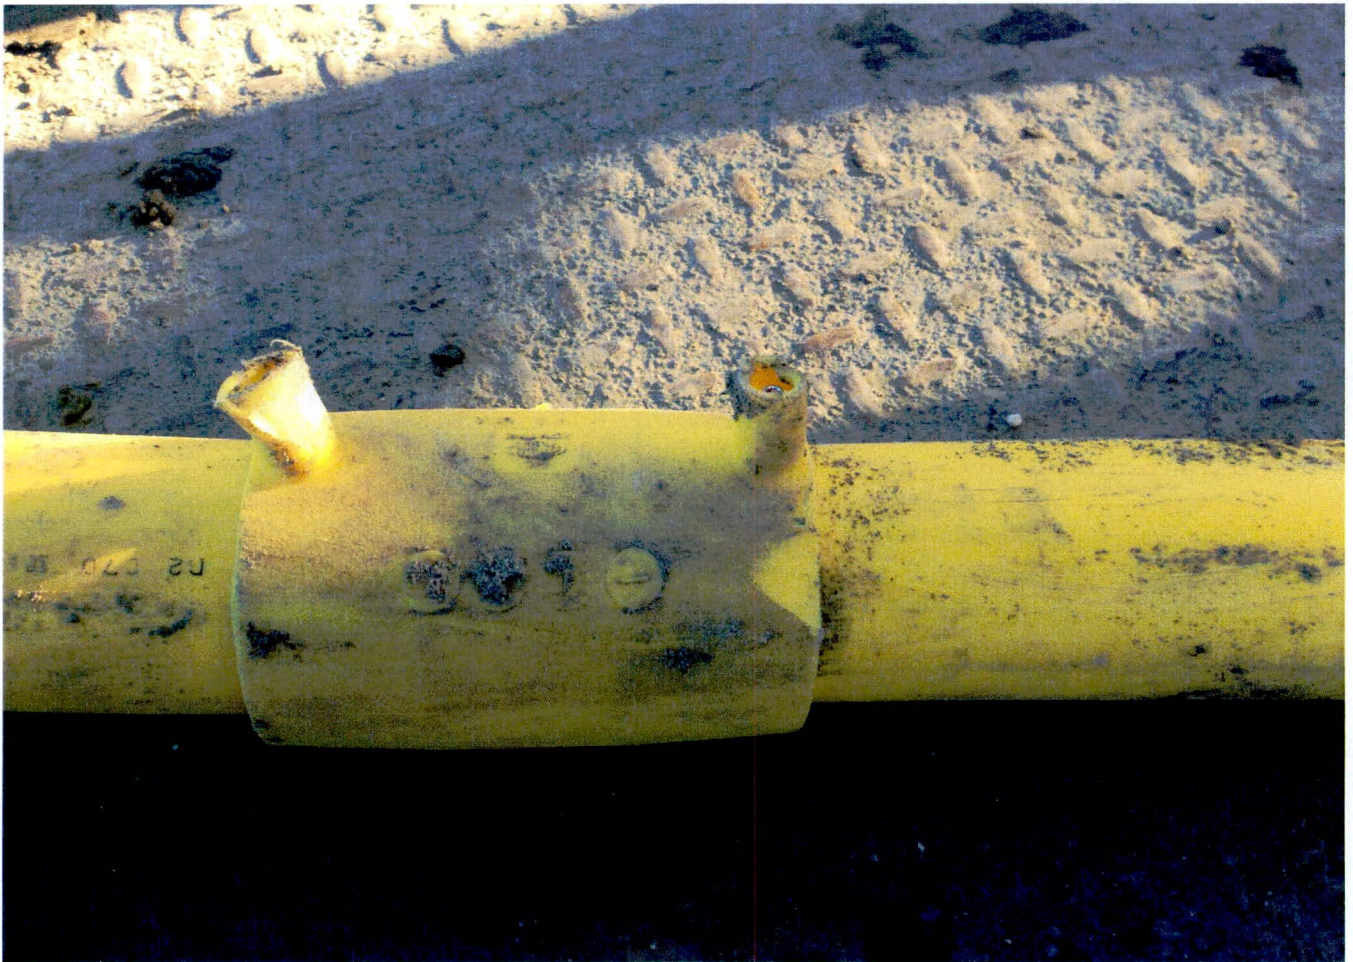
Damage 1

When I arrived on scene, I looked at the multiple damages and photographed the damages for our records. The following is an explanation of the type and location of the damages: The first damage was to a repair coupling located on the East side of the excavation, the coupling was damaged, but no gas loss took place. The second damage was to a second repair coupling 3 feet to the east. The coupling was severely damaged, but no gas loss took place. The third damage was to the gas main 10 feet to the east of the second. This damage caused a gas release through an approximate 2" diameter hole. The fourth damage was two feet from the third, with gas loss from a 2" diameter hole. The fifth damage was to the gas main about 15 feet from the fourth damage. This damage caused a gas release through a 1/2" x 3' crack in the plastic main. The operator continued to dig in the vicinity of the gas release, the entire time, even during the repair of the gas main. When MDU's gas crew foreman talked with the equipment operator, the operator had a very nonchalant attitude about the damage, and gave off a do not care attitude. It was very apparent, that they did not follow the 2' had dig zone during this project. That afternoon I left a message with the Project manager for Plote Construction, Maurice Schurger. I also left a message with Larry Plote, the ND Division Manager. I was able to speak with Maurice on 19 February 2014 at 0940 hours. During the conversation he would not admit any fault, and appeared to attempt to push the blame back on the utility. I have not yet received a return call from Larry Plote.
