LONESOME CREEK GAS PLANT PROJECT (PU-14-218) Permit Compliance Final Inspection Report

1 EXECUTIVE SUMMARY

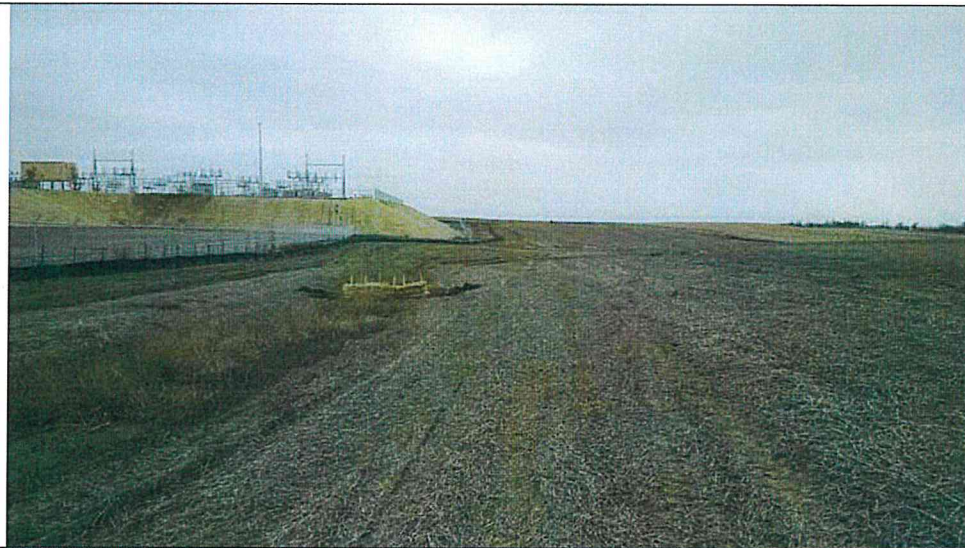
Photo 1:
Downstream
extent of project,
showing erosion
control
measures.

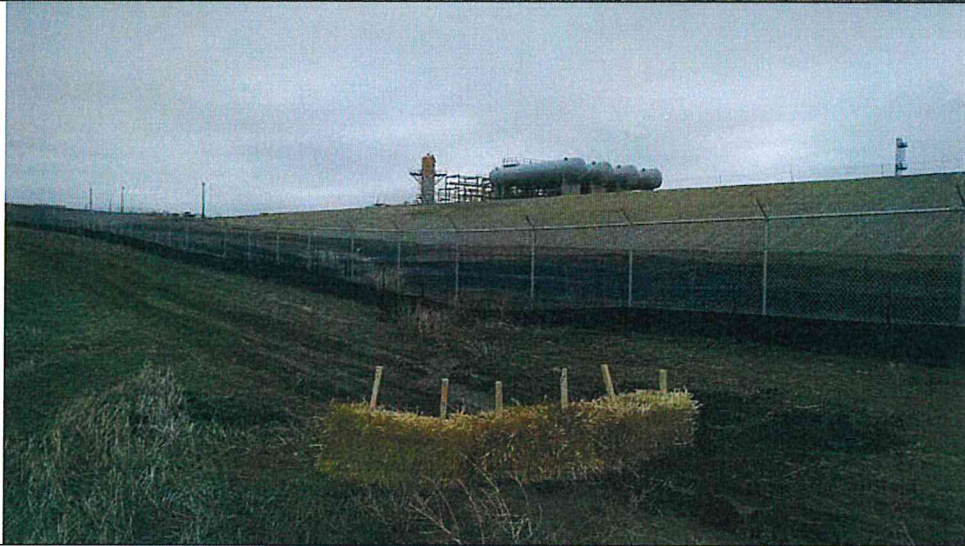
Photo 2:
Looking
upstream at silt
fence and straw
bales across the
primary drainage
from the onsite
activities.

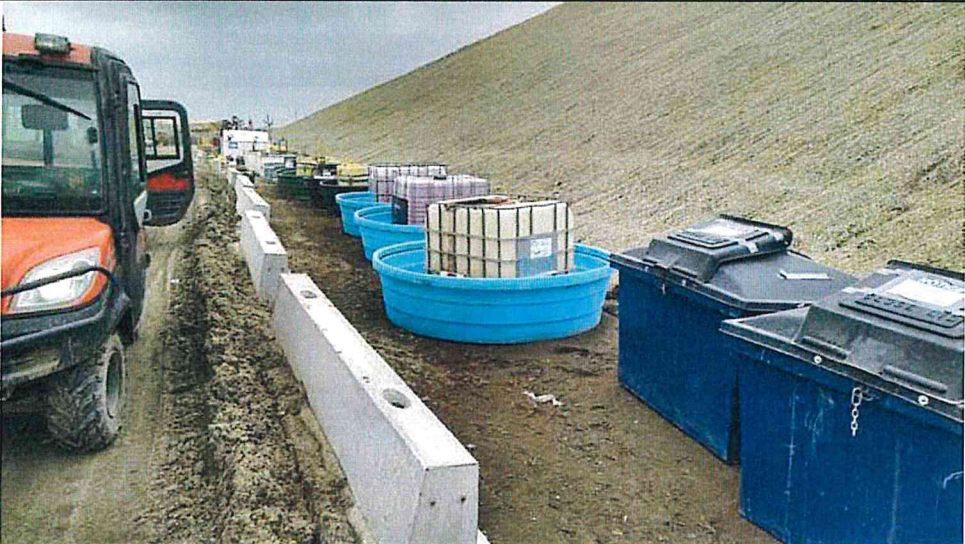
Photo 3:
Barriers and
secondary
containment
systems in place
to prevent spills.

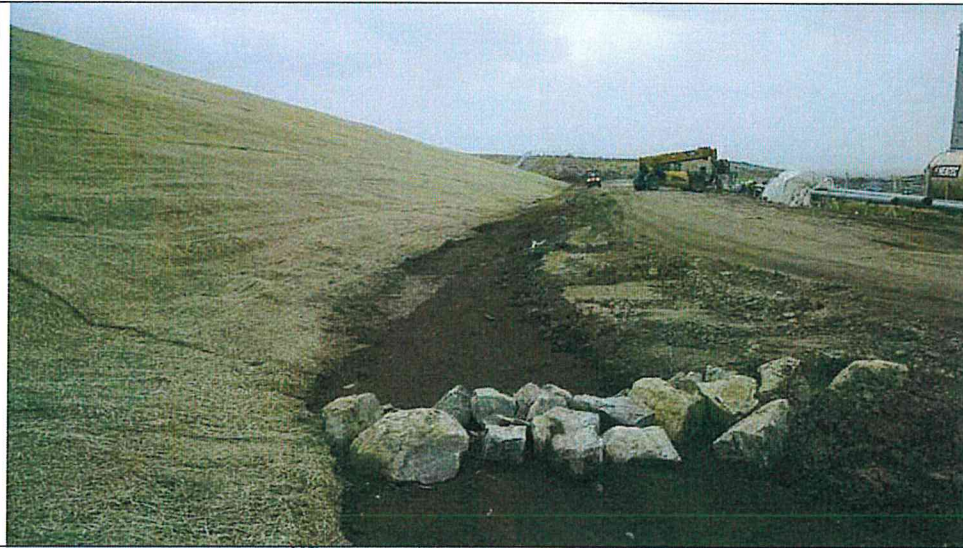
Photo 4: Rock checks in interior drainage ditch.

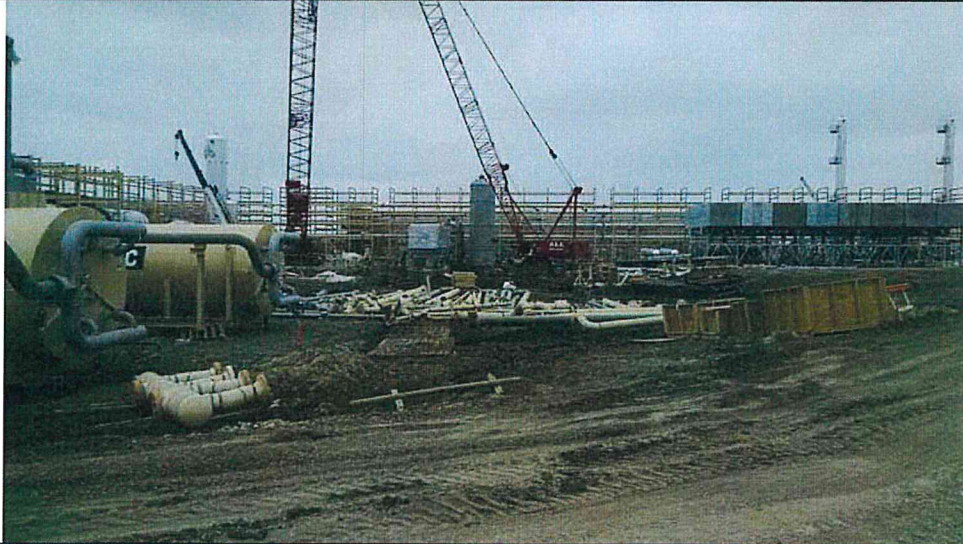
Photo 5: Interior construction area.

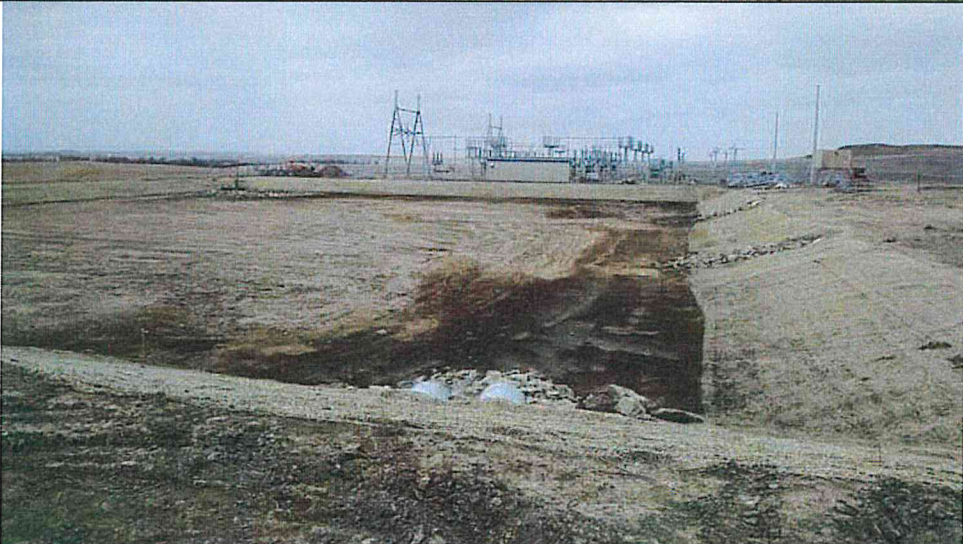
Photo 6: Stormwater pond, which will receive interior drainage, and provide spill containment onsite during operation.

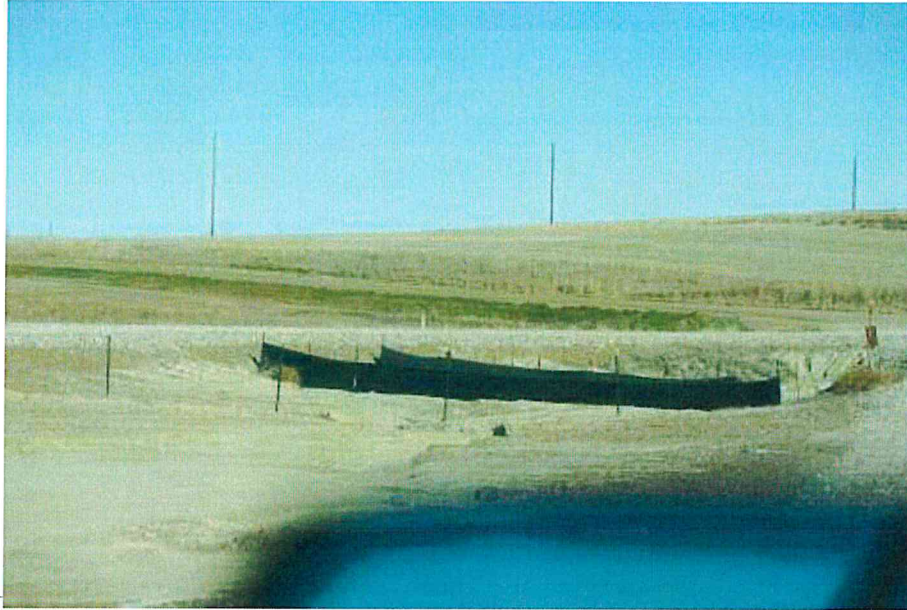
Photographs 1 and 2 were taken at the site entrance. This area has not been restored and considerable erosion was evident. The silt fence in this area was observed to be in disrepair. The sediment appears to have been removed from behind the silt fence and it appears to be preventing sediment from leaving the site.

- The entrance of the site has not been seeded and there is considerable erosion. The silt fence in this area has not been maintained, though it appears to be functional and is preventing sediment from leaving the site.

Photo 1: Entrance to facility, silt fence (facing northeast).

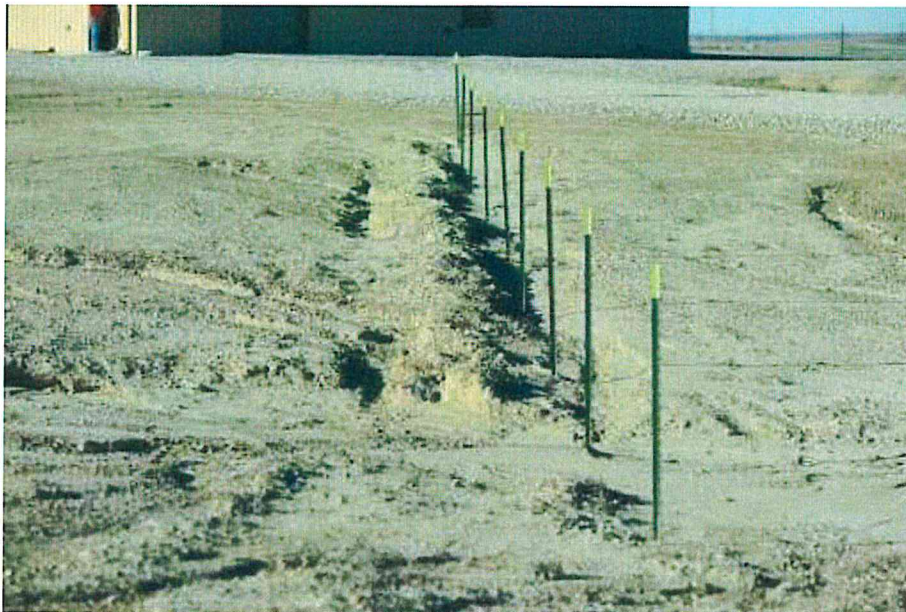
Photo 2: Facing north entrance to facility, erosion from parking lot runoff.
