LONESOME CREEK GAS PLANT PROJECT (PU-14-218)

Permit Compliance - Addendum to the Final Inspection Report

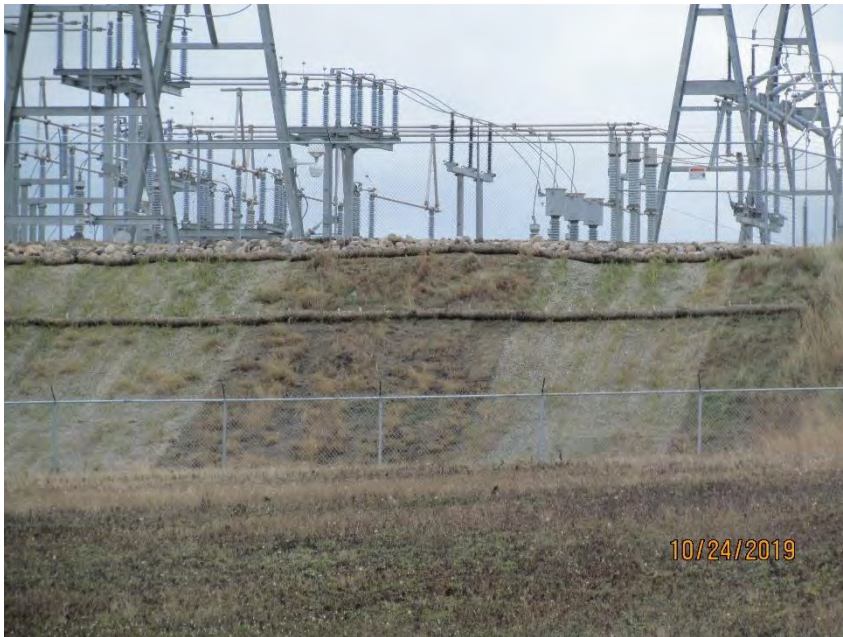
Photo 1:

Viewing BMPs on slopes and assessing reestablishment of vegetation.

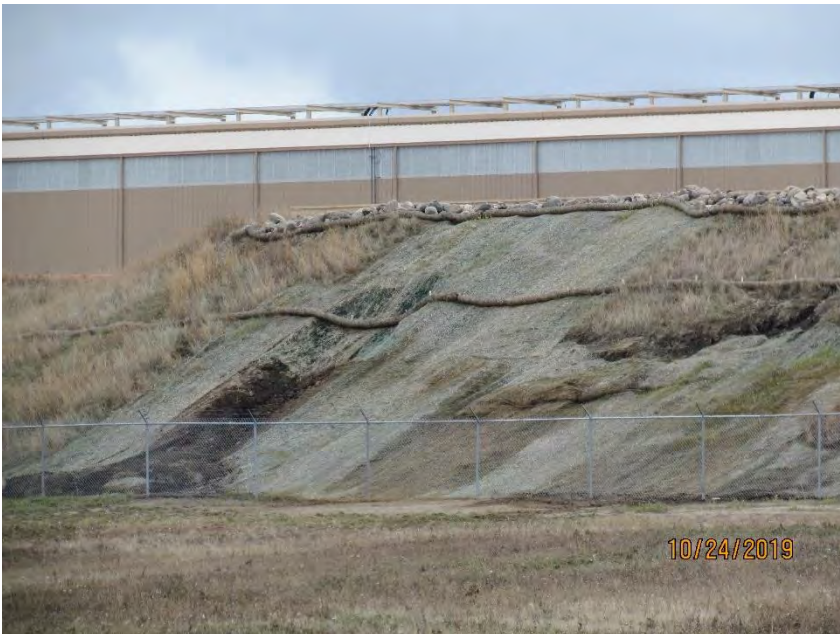
Photo 2:

View of slope failure and need for reestablishing and/or enhancing BMPs

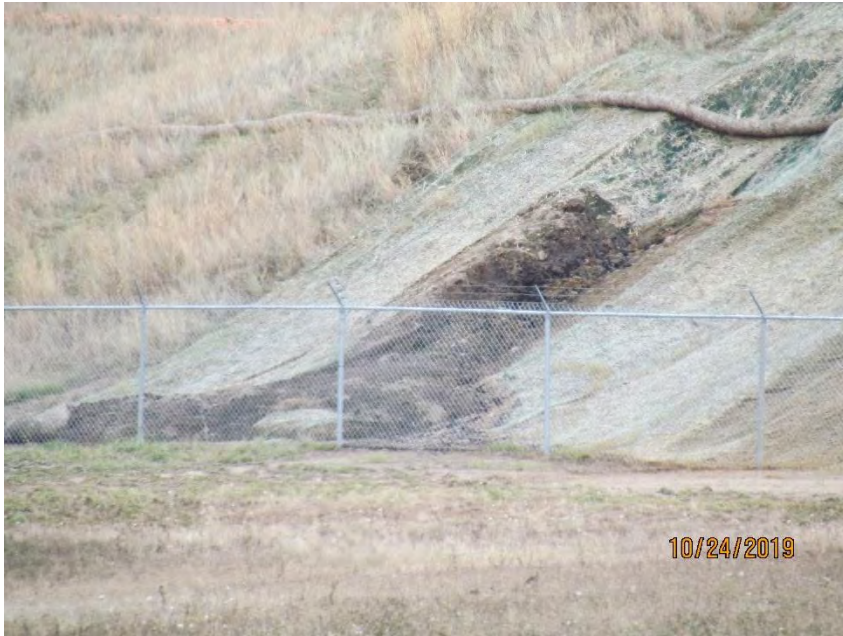
Photo 3:
Slope failure.
10-24-2019

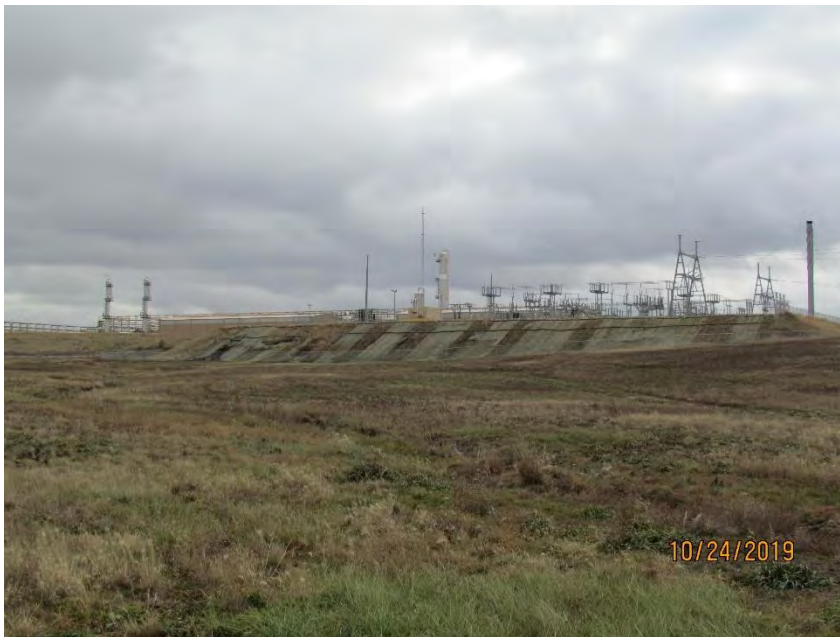
Photo 4:
Facing south, view of the
northwest corner of the
facility.
10-24-2019

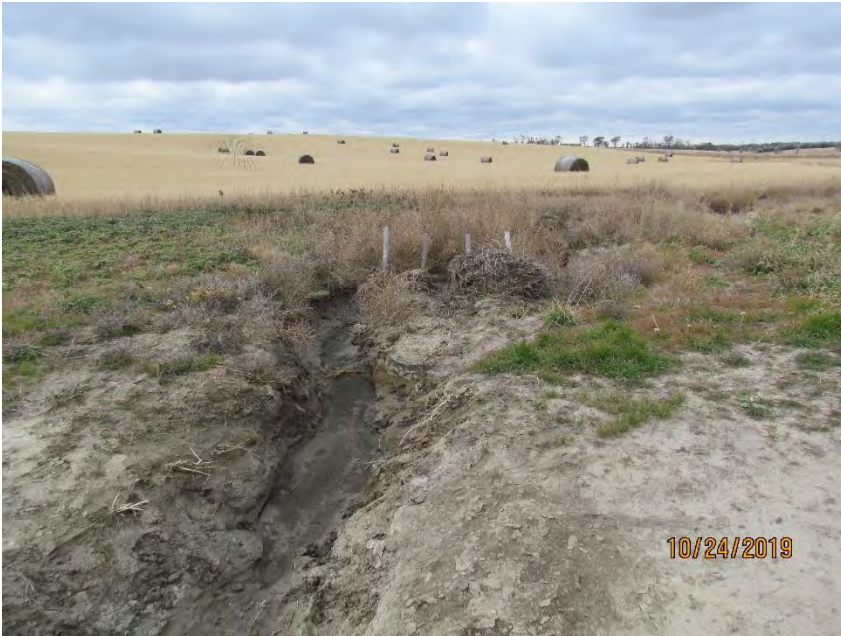
Photo 5:
Gully formation at northwest
portion of site.

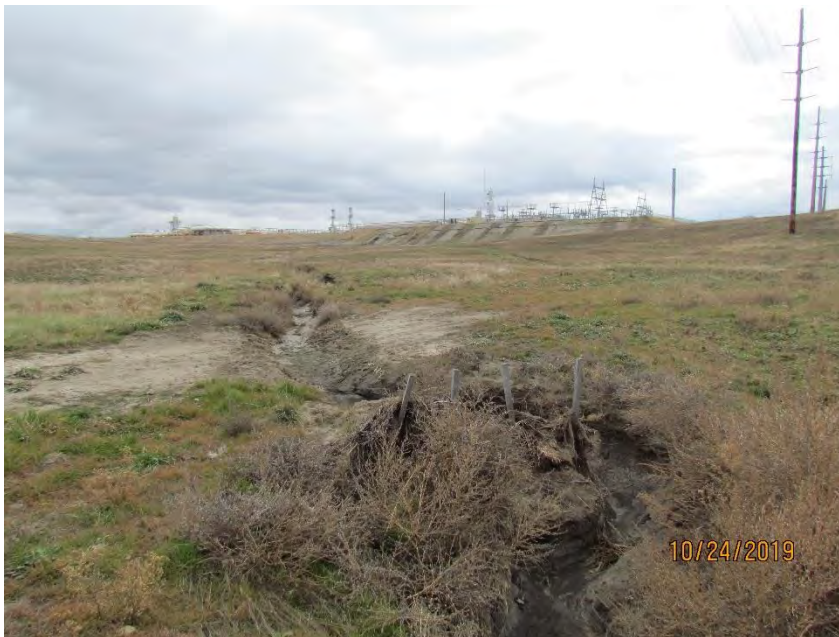
Photo 6:
Gully formation at northwest
portion of site.

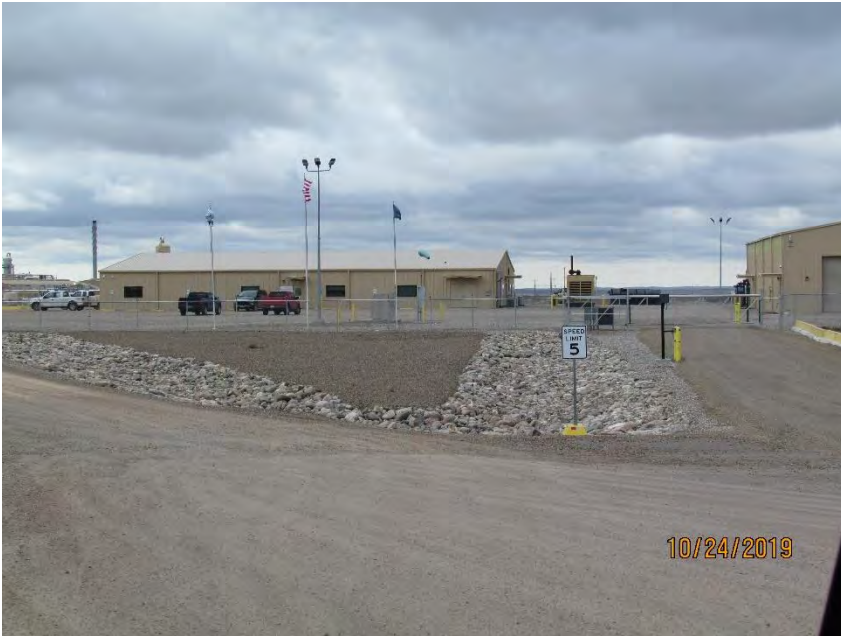
Photo 7:
Lonesome Creek Gas Plant
facility entrance
10-24-2019

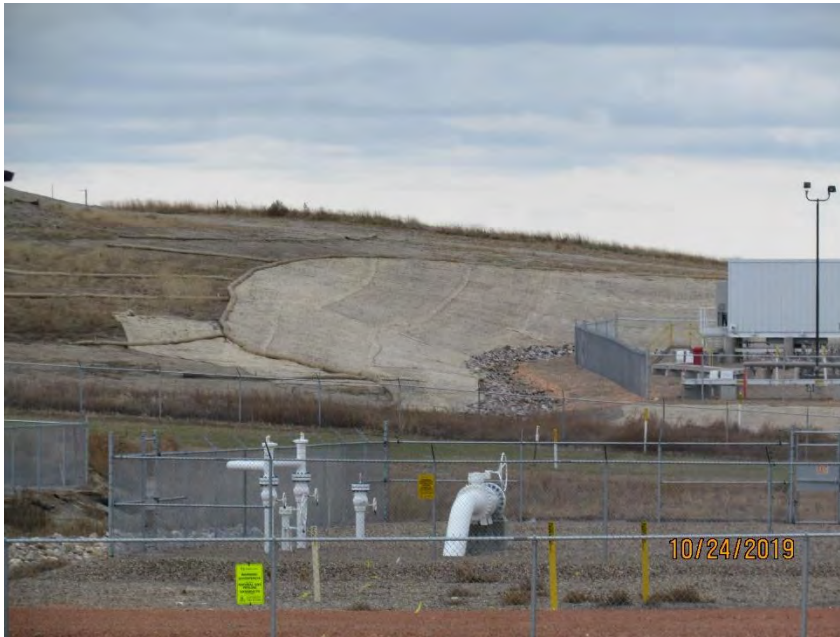
Photo 8:
BMPs on slopes, east side of
project site looking west
10-24-2019

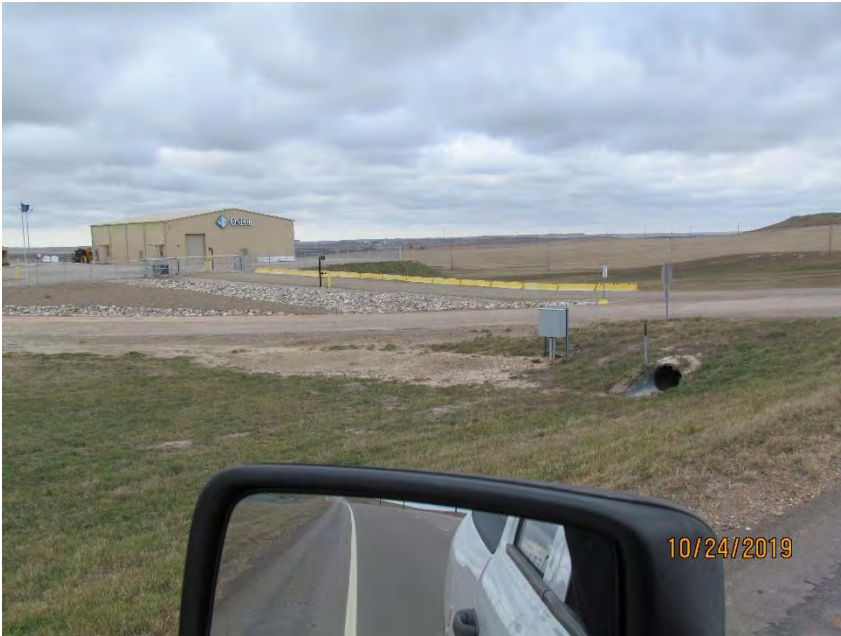
Photo 9:

View of facility along the eastern side of the site facility along 138th Ave. NW

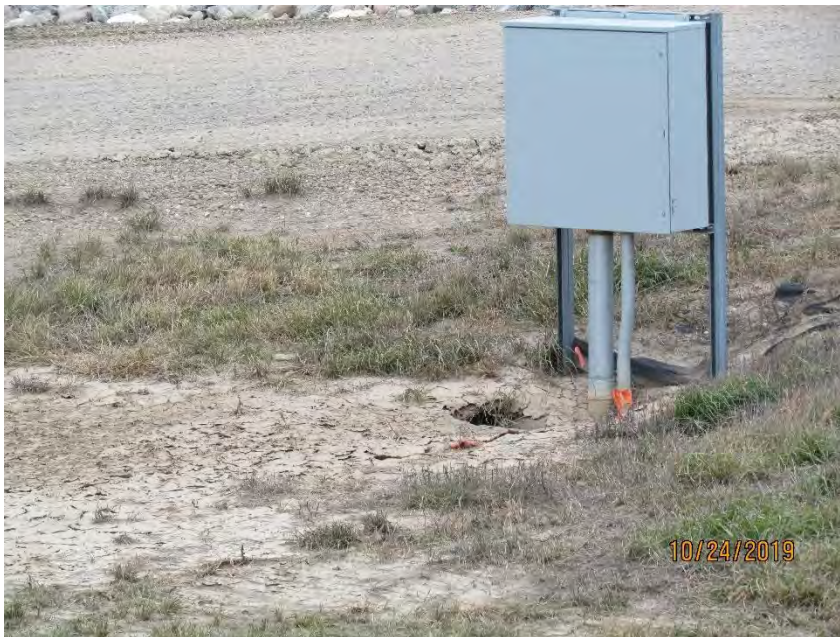
Photo 10:

Utility box along 138th Ave. NW

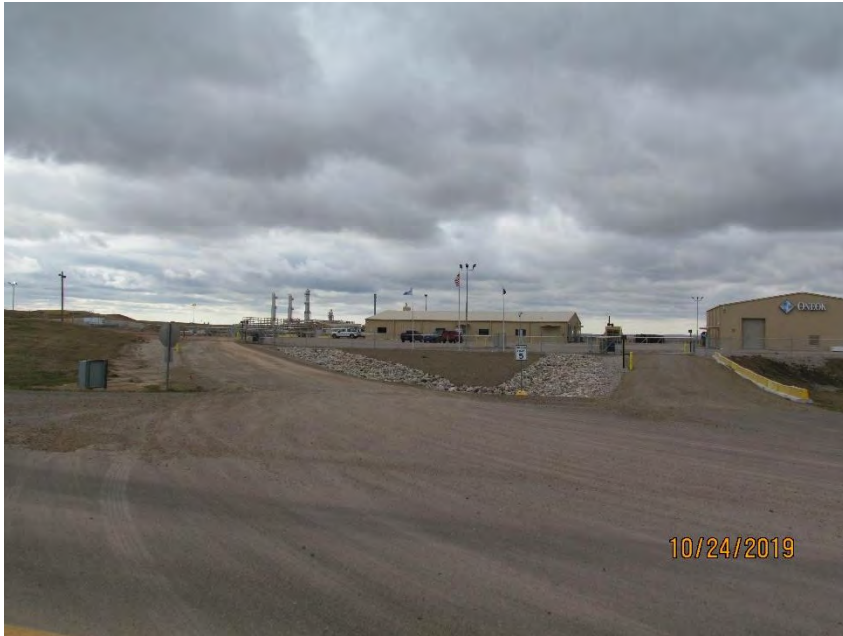
Photo 11:
Lonesome Creek Gas Plant
facility entrance

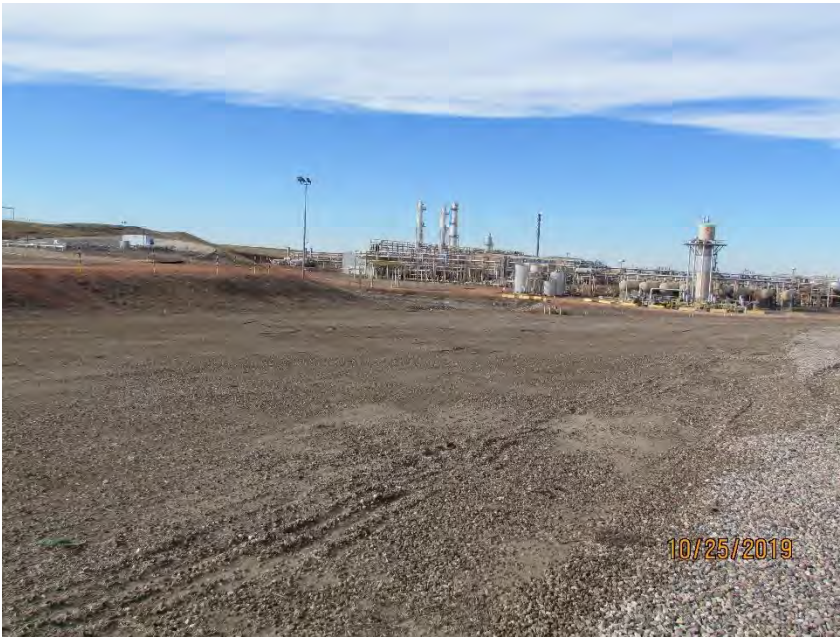
Photo 12:
Inside the north portion of the
facility.

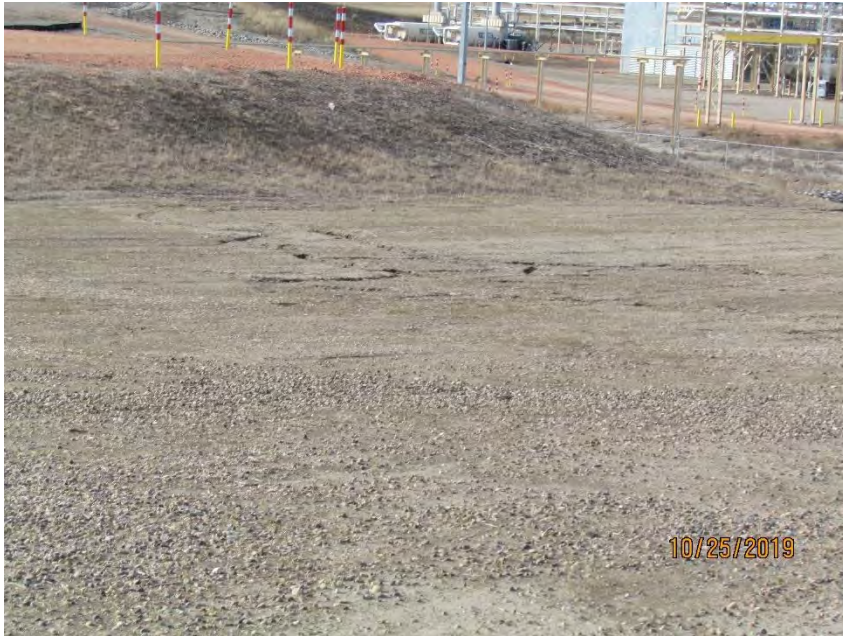
Photo 13:
View of surface water
drainage gully formation

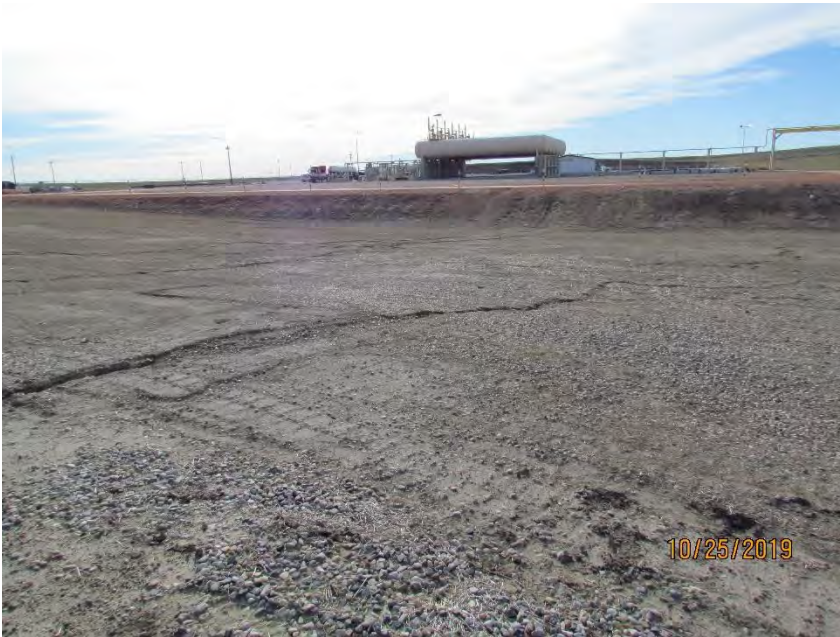
Photo 14:
View of surface water
drainage gully formation

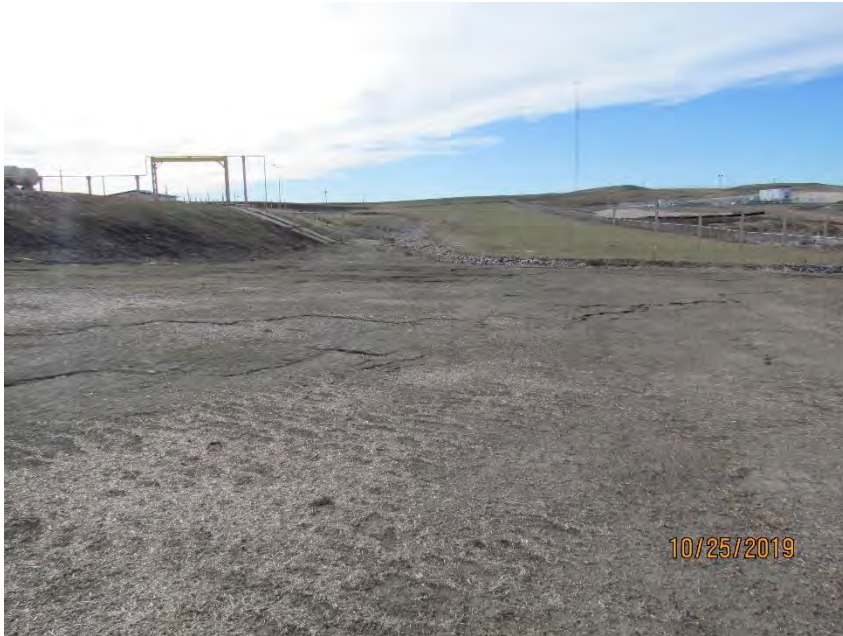
Photo 15:
View of surface water
drainage gully formation

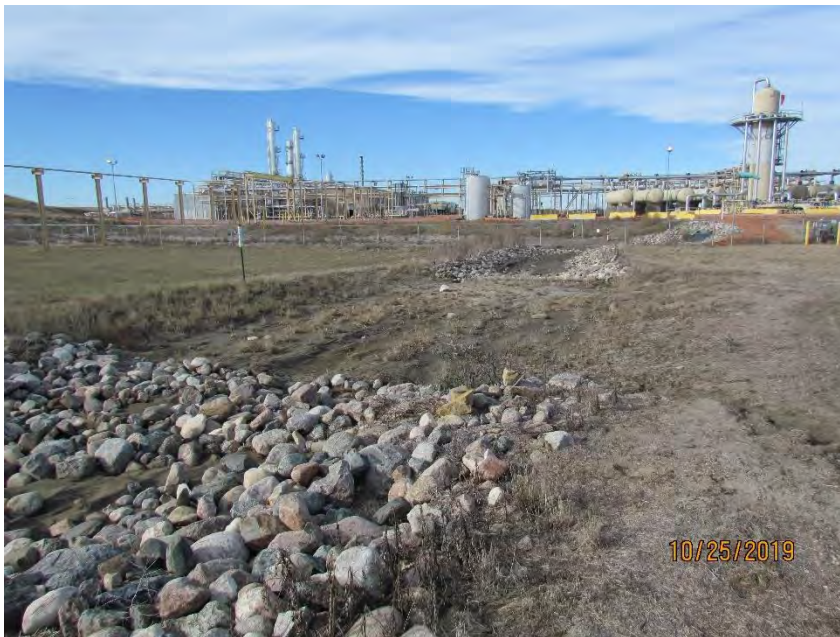
Photo 16:
Stormwater drainage within
the eastern extents of the
facility

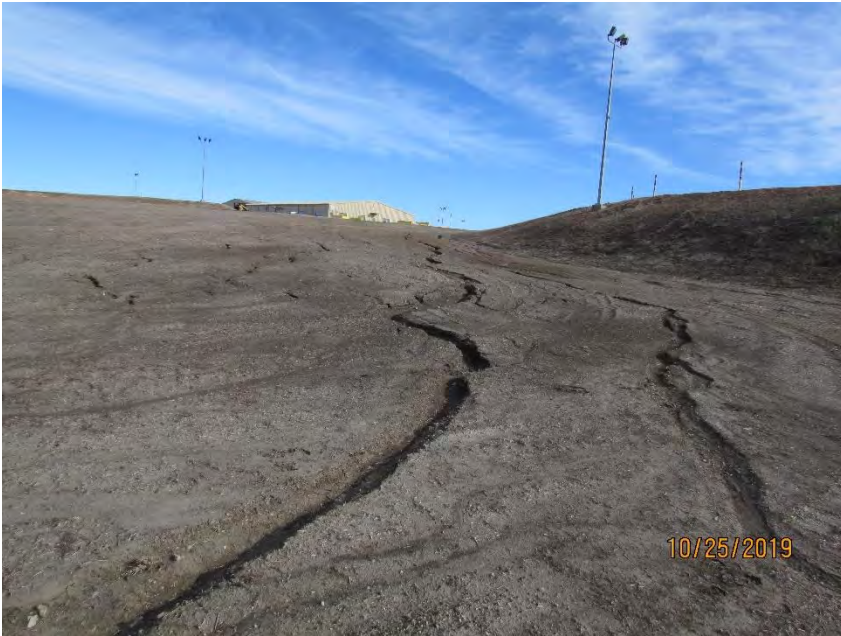
Photo 17:
Stormwater flow path and
gully formation along eastern
portion of facility site

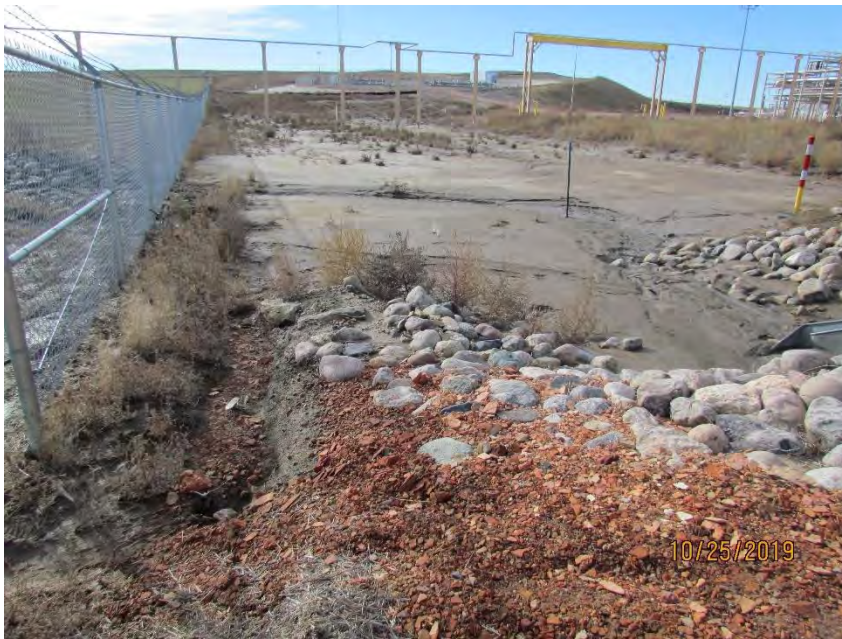
Photo 18:
Facing south, view of the
facility.

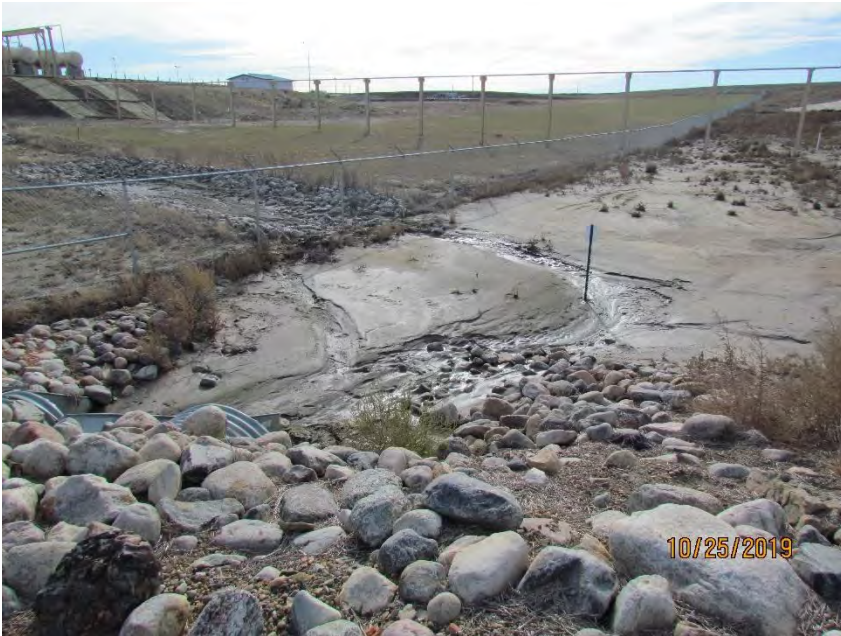
Photo 19:
Stormwater flow paths and
Sediment draining to culvert
within eastern portion of
facility site
10-25-2019

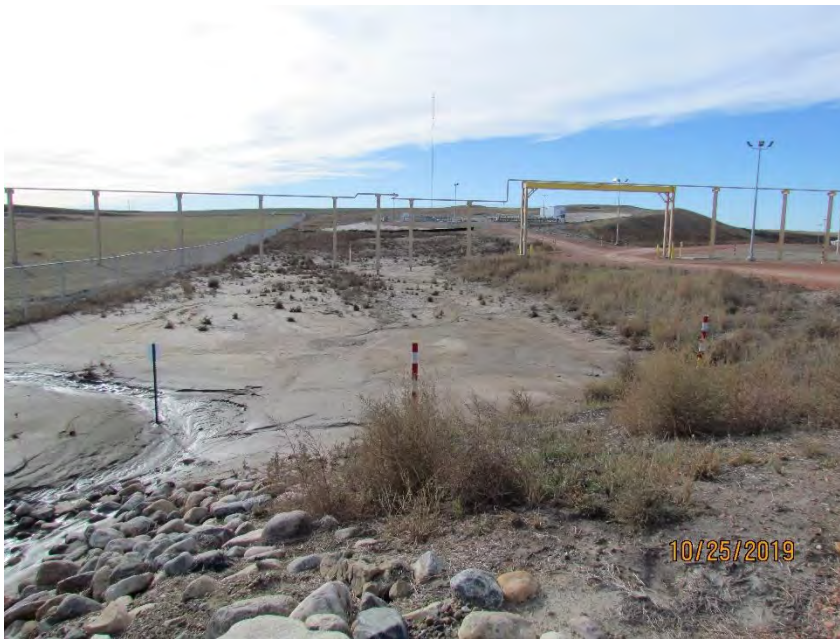
Photo 20:
Facing south, view of the
facility.
10-25-2019

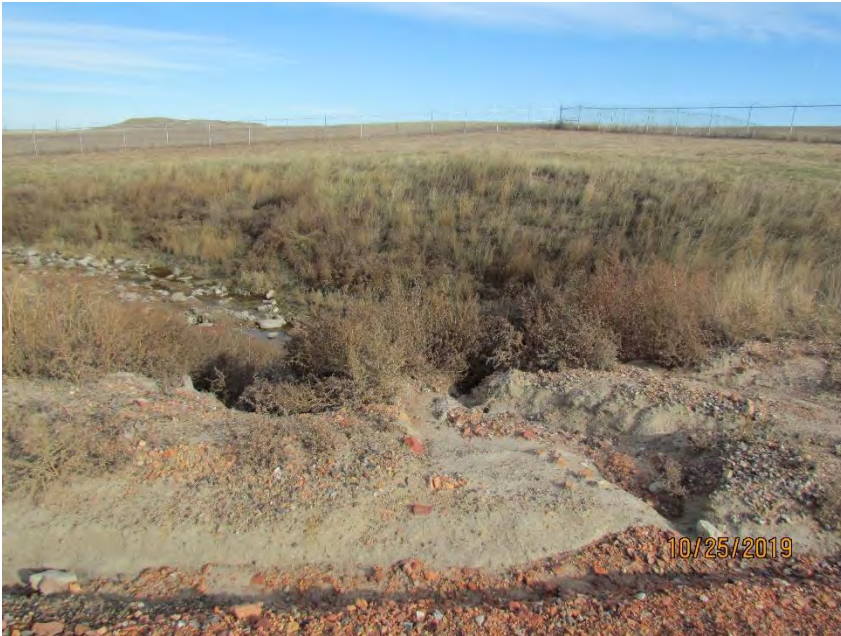
Photo 21:
Gully erosion in northern
extents of the facility

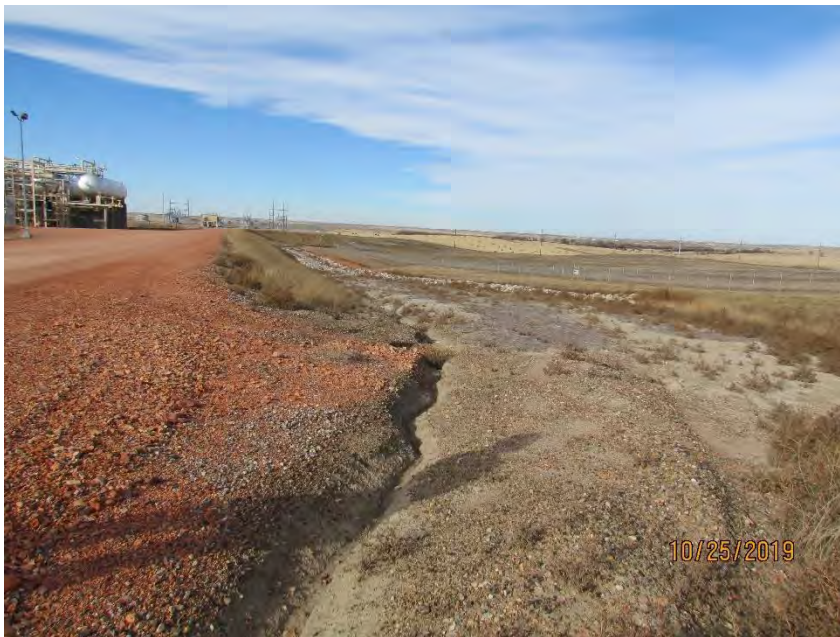
Photo 22:
Gully erosion in northern
extents of the facility

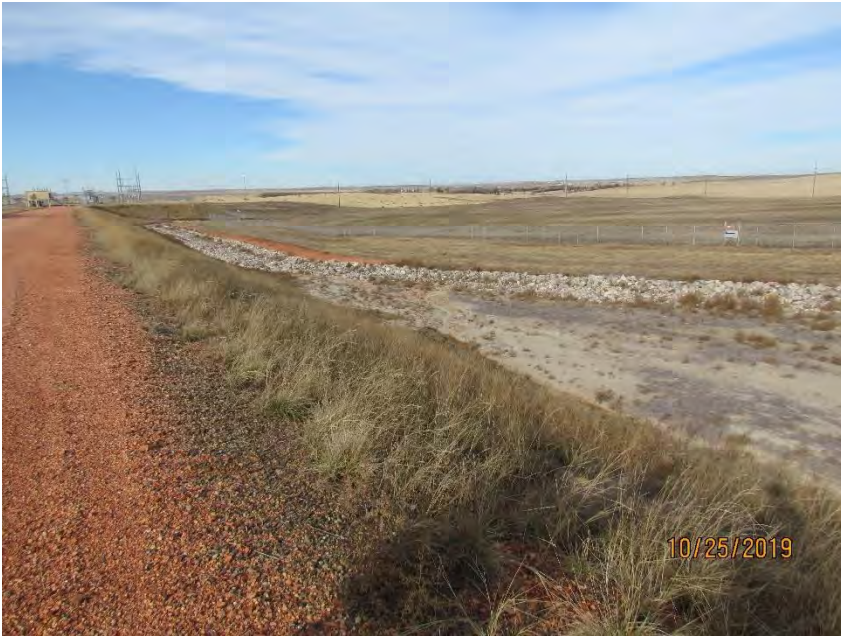
Photo 23:

Unvegetated areas directly on northern extents of facility site

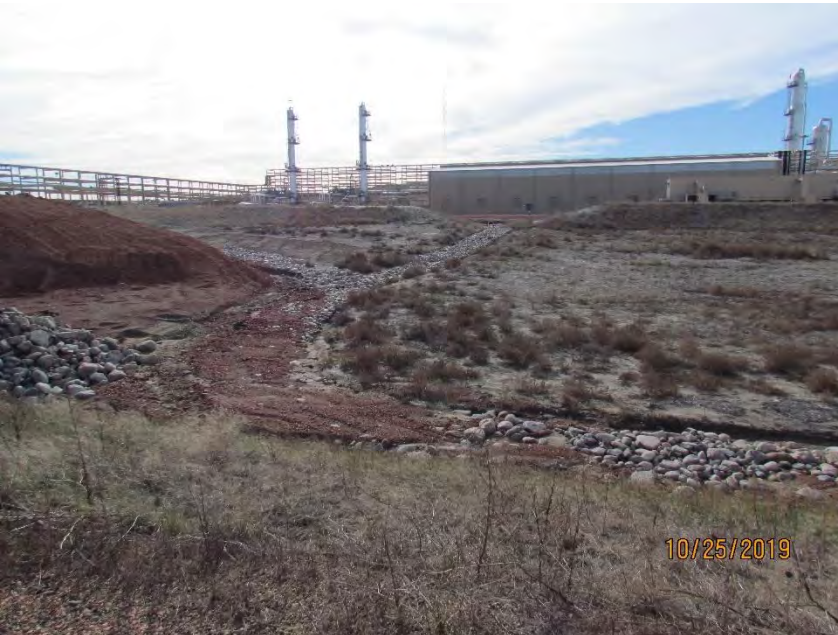
Photo 24:

Sparsely vegetated areas, flow paths and sedimentation from the northern portion of the facility site

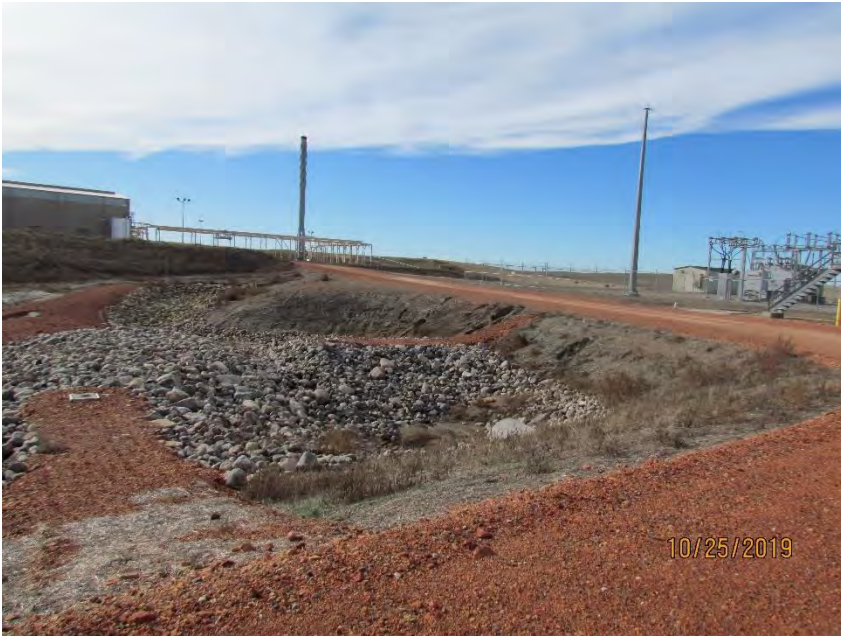
Photo 25:
Facility road along northern
extents of site

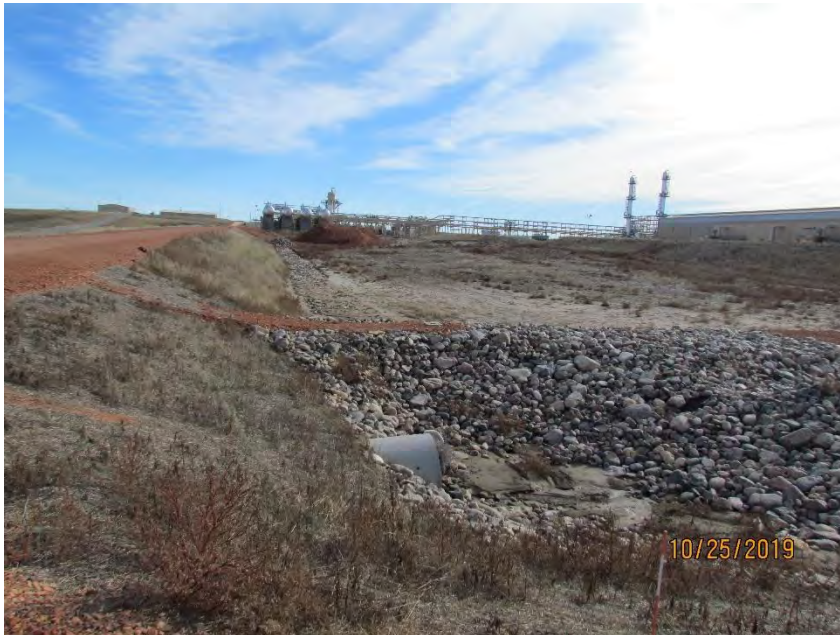
Photo 26:
Facility road along northern
extents of site, view of
stormwater culvert

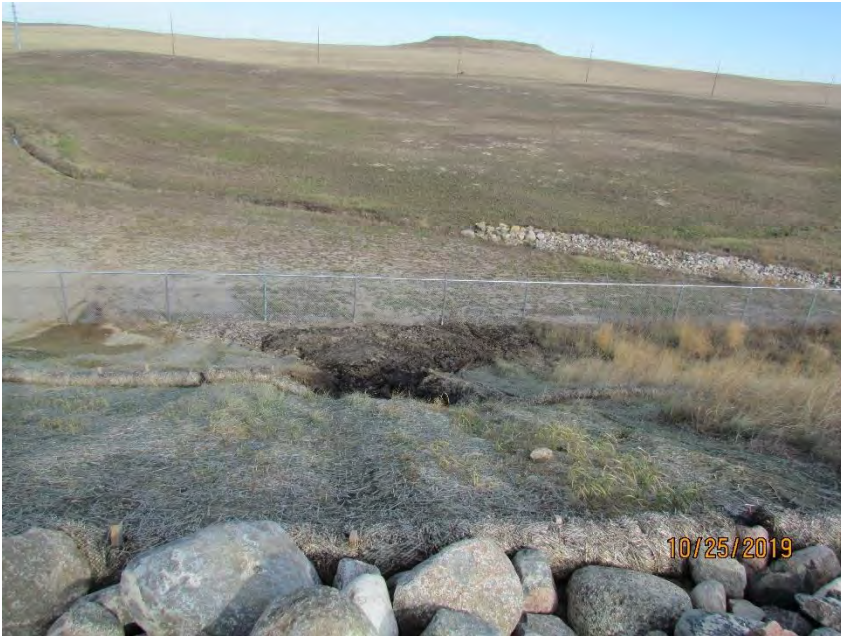
Photo 27:
Slope failure. Top of hill view
of photos 1-3

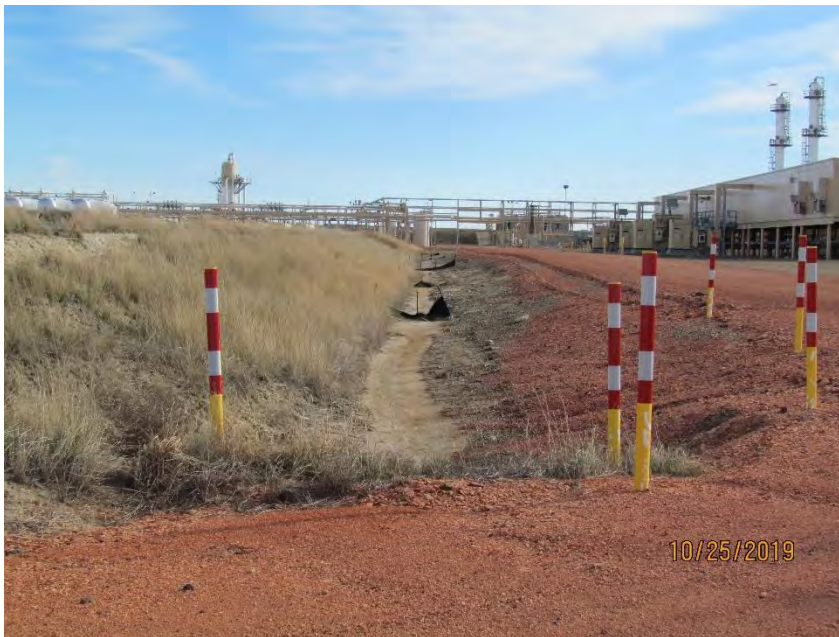
Photo 28:
Along facility gravel road
looking east

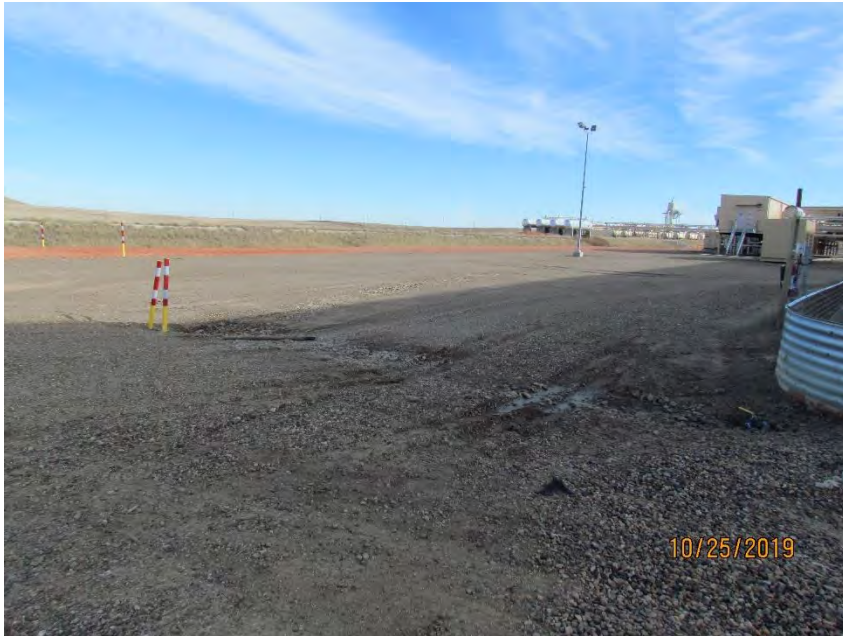
Photo 29:
Along facility gravel road,
looking northeast

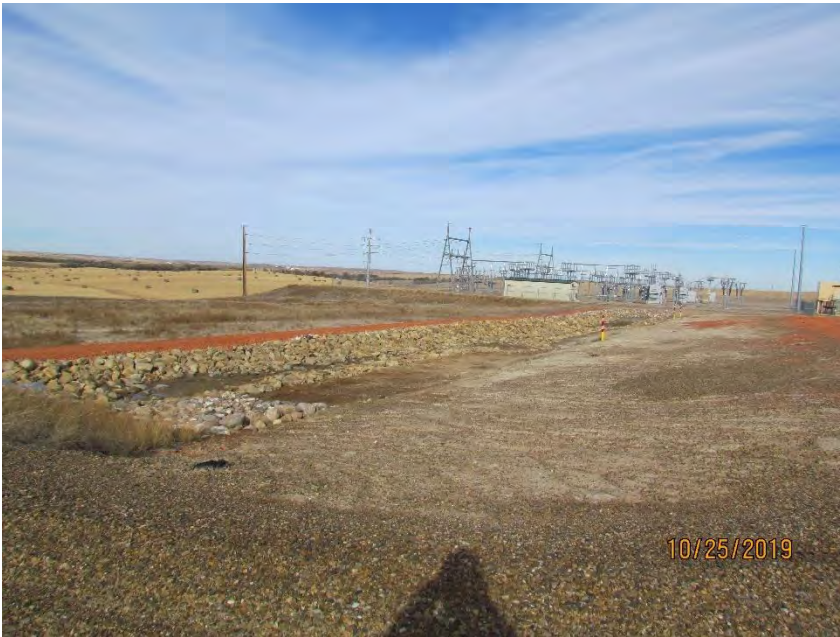
Photo 30:
Southcentral portion of facility
site.

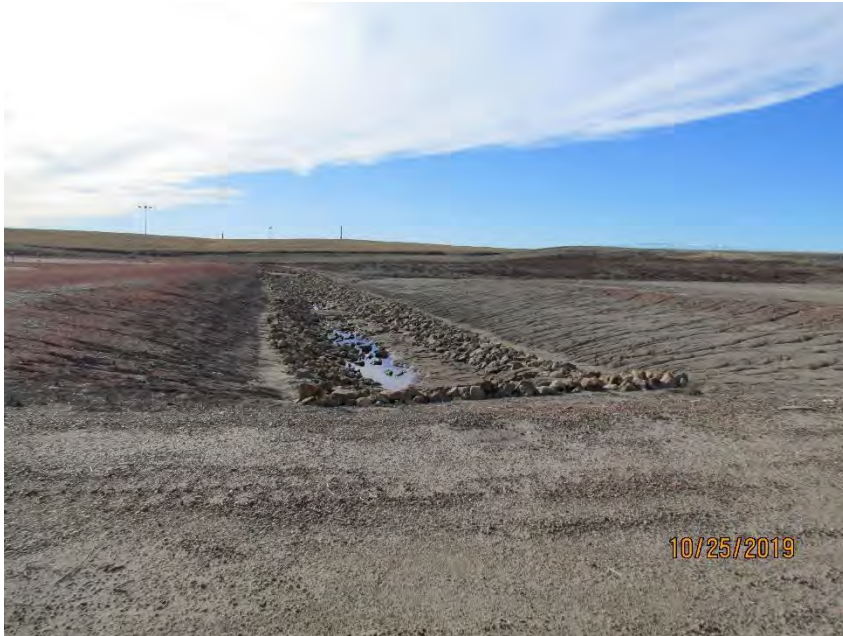
Photo 31:
Stormwater conveyance ditch
along southcentral portion of
facility site
10-25-2019

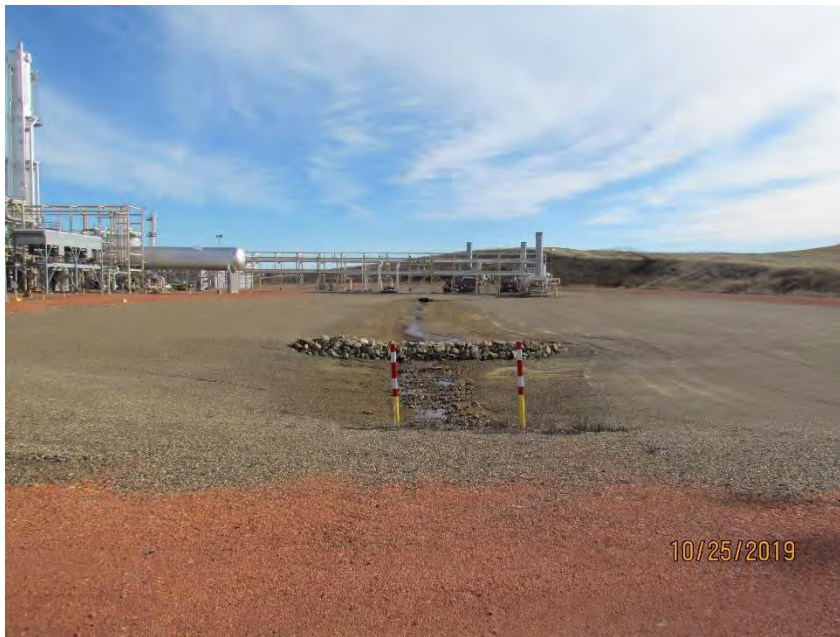
Photo 32:
Southern extents of facility
site, looking east at
stormwater conveyance ditch
10-25-2019

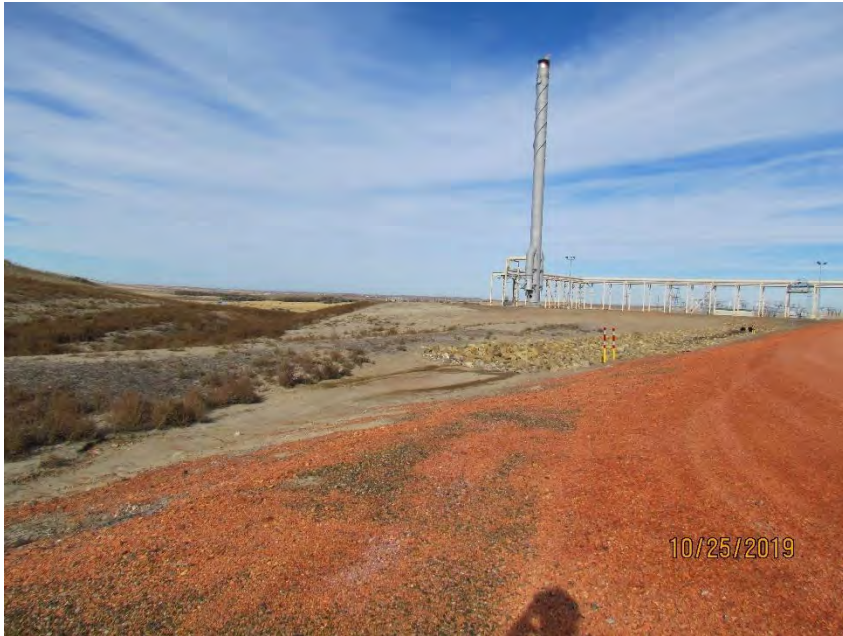
Photo 33:
Southcentral side of the
facility site looking northwest

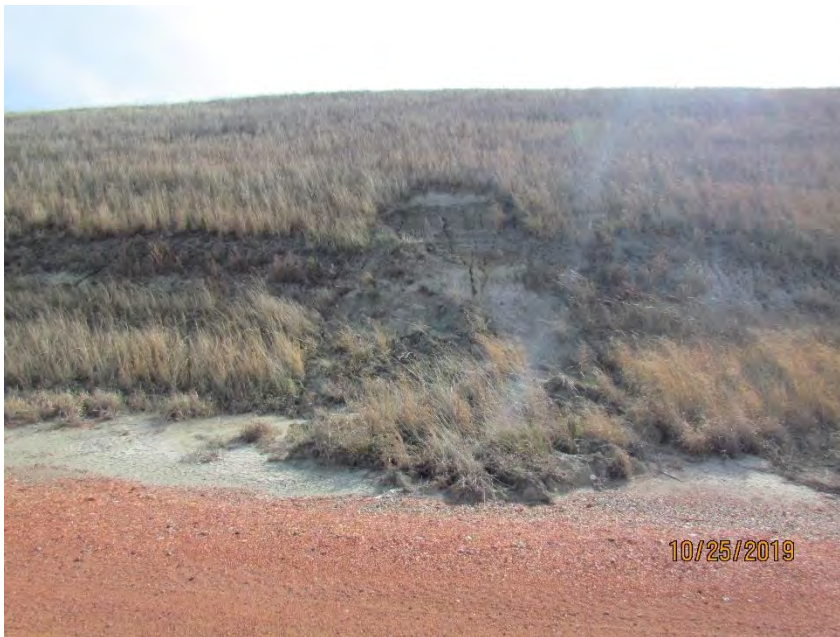
Photo 34:
Slope failure along the
southcentral extents of the
facility boundary

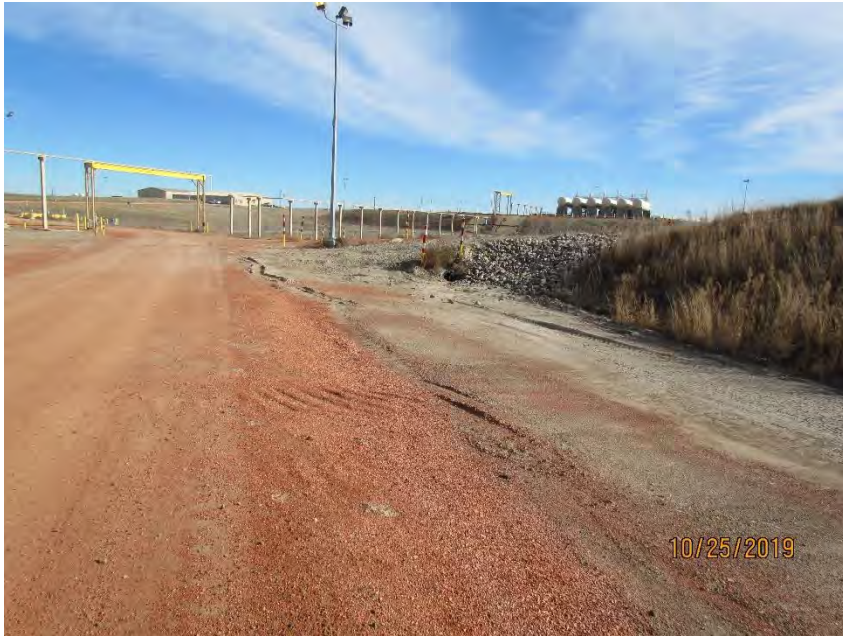
Photo 35:
Facility road along
southcentral portion of site
10-25-2019

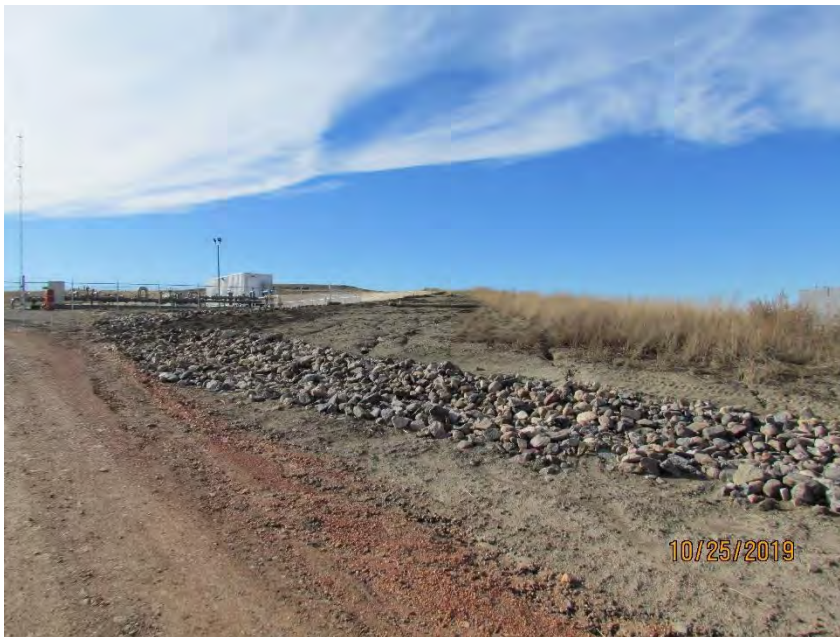
Photo 36:
Facility road and ditch along
southcentral portion of site
10-25-2019

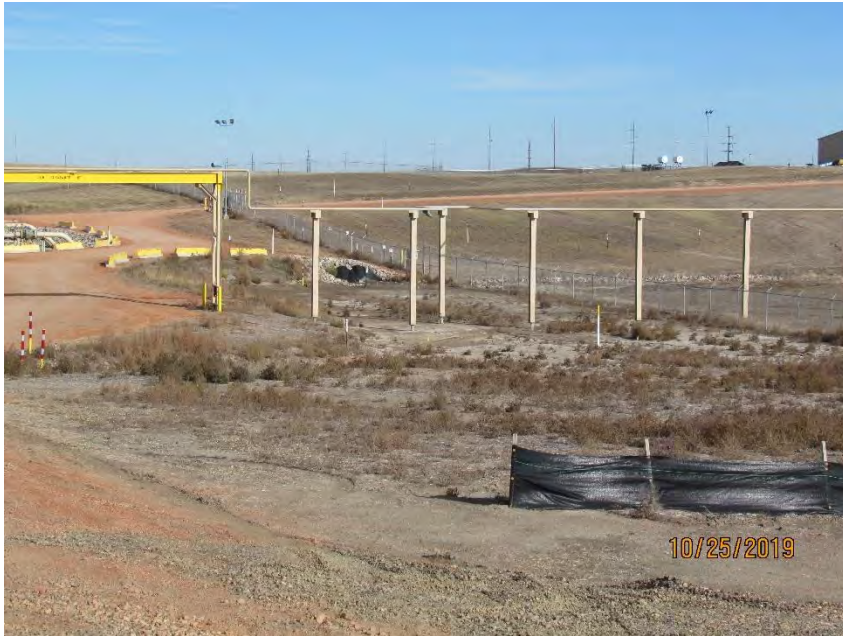
Photo 37:
Silt fence and sparse
vegetation at southeast
portion of facility site
10-25-2019

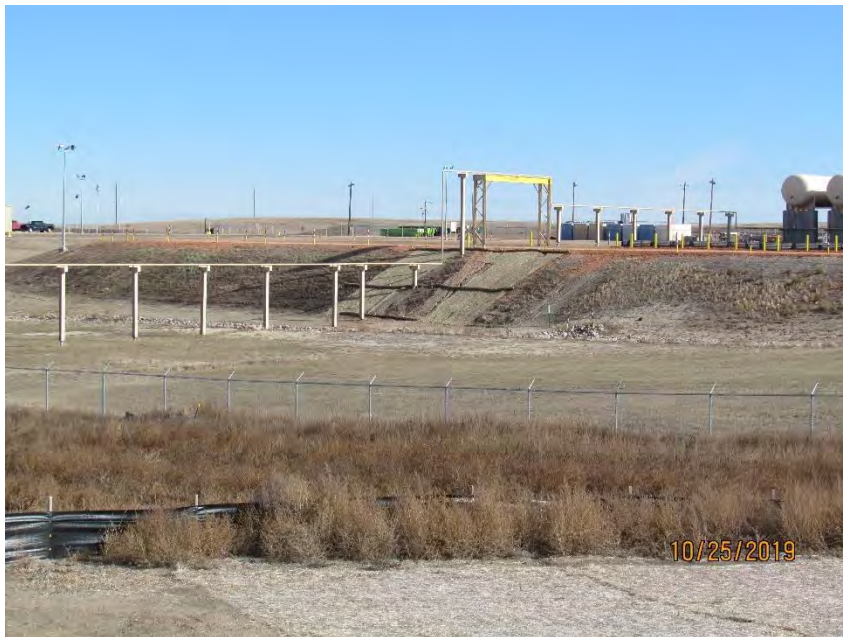
Photo 38:
Facing south, view of the
facility.
10-25-2019

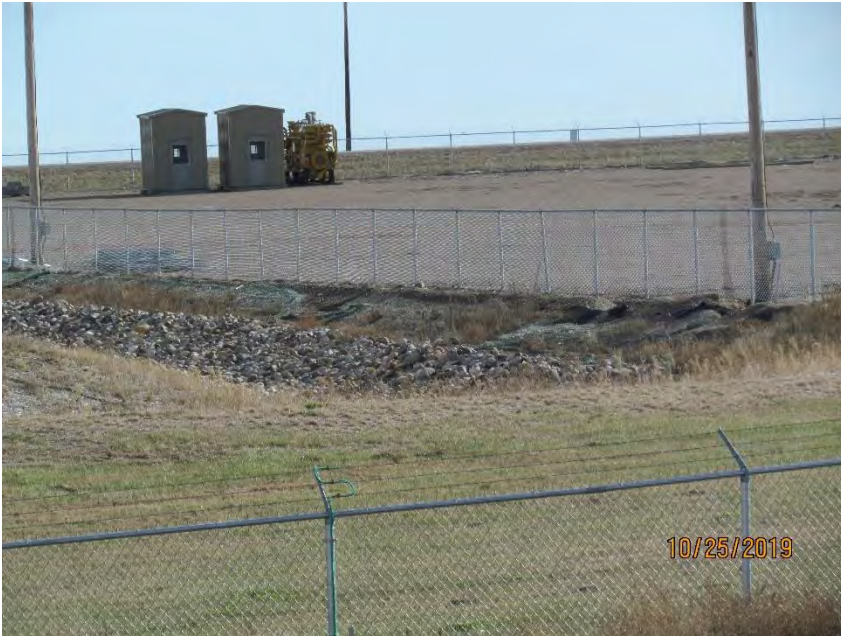
Photo 39:

Southern extents of facility site showing site fence and ditch

A comparison of the existing conditions and the previous 2016 site visit was conducted. Based on the compliance inspection, it is concluded that erosion and sedimentation issues still exist on the site, and the site has not been restored to *as near as is practicable to the condition as it existed prior to the beginning of construction* (Certification Relating to Order provisions, paragraph 25). **Photographs 1-3 and 27** show slope failure along the northwestern corner of the facility. This area has not been fully restored and considerable erosion issues were evident. Another location of slope failure is on the southcentral extents of the site as shown in **Photograph 34**. Stormwater flow from the site shows rill formation off the northwestern portion of the facility (**Photograph 6**). The entrance of the facility appeared to be well kept and no reclamation evident (**Photograph 7**), However, along the entrance is an area needing revegetation to prevent further erosion and sedimentation (**Photograph 9-10**,). **Photograph 24** shows how stormwater has been directed on site. Rill erosion is evident throughout the site, within the facility campus (**Photographs 13-15, 17, 36**) and gully/rill erosion on the border extents of the facility (**Photographs 5-6, 21-22, 42**). Significant sedimentation and need for vegetative cover was evident (**Photographs 18-20**). The silt fence observed in disrepair during the 2016 inspection still remains and revegetation in this area is encouraged (**Photographs 37-38**). It is recommended that the facility slopes and fencelines be checked for erosion and sedimentation control (**Photographs 39-45**).

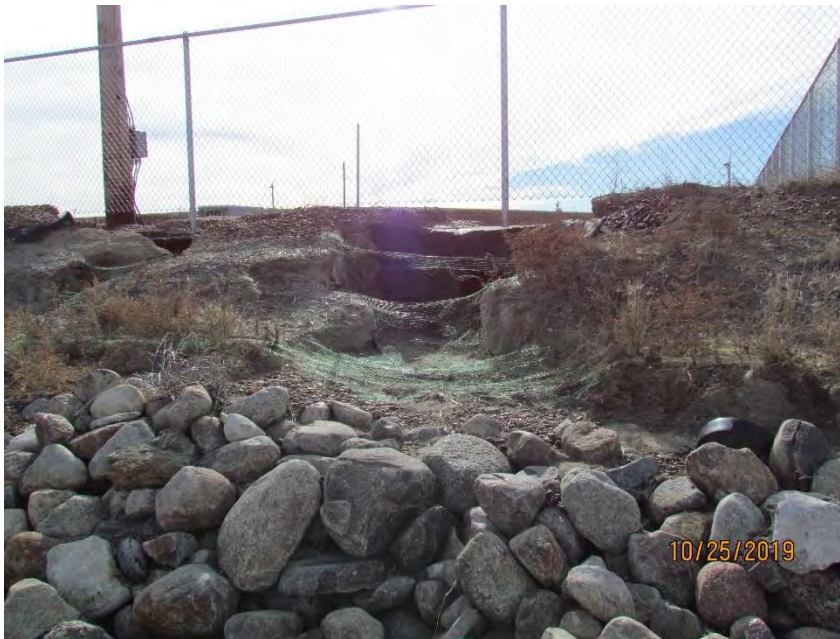
Photo 40:

Stormwater conveyance path off southeastern fence line
