LONESOME CREEK GAS PLANT PROJECT (PU-14-218)

Permit Compliance - Addendum to the Final Inspection Report

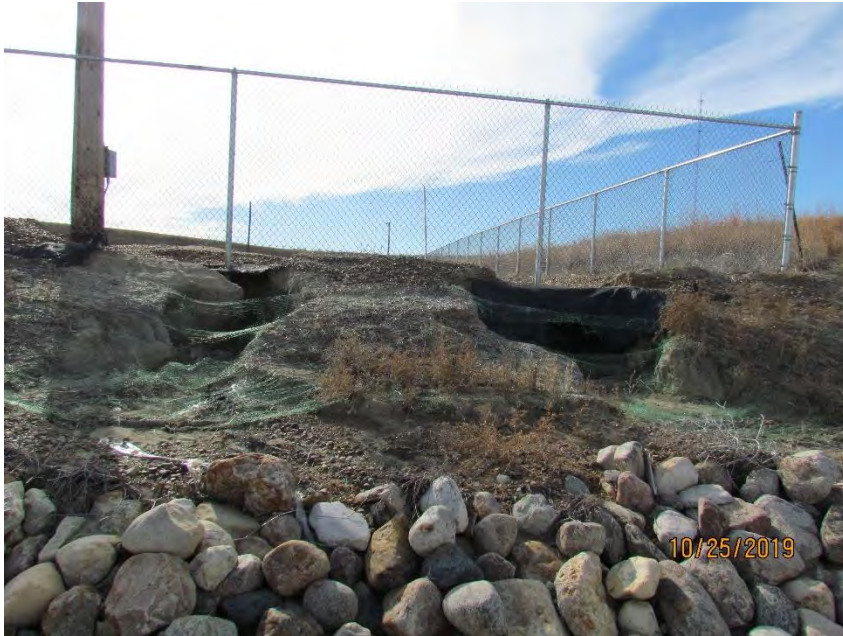
Photo 40:
Stormwater conveyance path
off southeastern fence line

A comparison of the existing conditions and the previous 2016 site visit was conducted. Based on the compliance inspection, it is concluded that erosion and sedimentation issues still exist on the site, and the site has not been restored to *as near as is practicable to the condition as it existed prior to the beginning of construction* (Certification Relating to Order provisions, paragraph 25). **Photographs 1-3 and 27** show slope failure along the northwestern corner of the facility. This area has not been fully restored and considerable erosion issues were evident. Another location of slope failure is on the southcentral extents of the site as shown in **Photograph 34**. Stormwater flow from the site shows rill formation off the northwestern portion of the facility (**Photograph 6**). The entrance of the facility appeared to be well kept and no reclamation evident (**Photograph 7**), However, along the entrance is an area needing revegetation to prevent further erosion and sedimentation (**Photograph 9-10**,). **Photograph 24** shows how stormwater has been directed on site. Rill erosion is evident throughout the site, within the facility campus (**Photographs 13-15, 17, 36**) and gully/rill erosion on the border extents of the facility (**Photographs 5-6, 21-22, 42**). Significant sedimentation and need for vegetative cover was evident (**Photographs 18-20**). The silt fence observed in disrepair during the 2016 inspection still remains and revegetation in this area is encouraged (**Photographs 37-38**). It is recommended that the facility slopes and fencelines be checked for erosion and sedimentation control (**Photographs 39-45**).

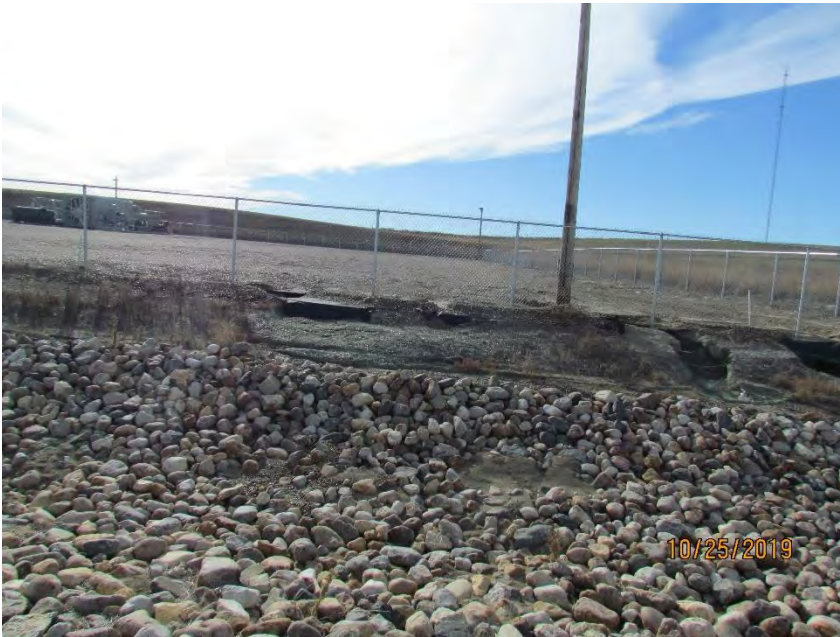
Photo 42:
Stormwater conveyance path
off southeastern fence line

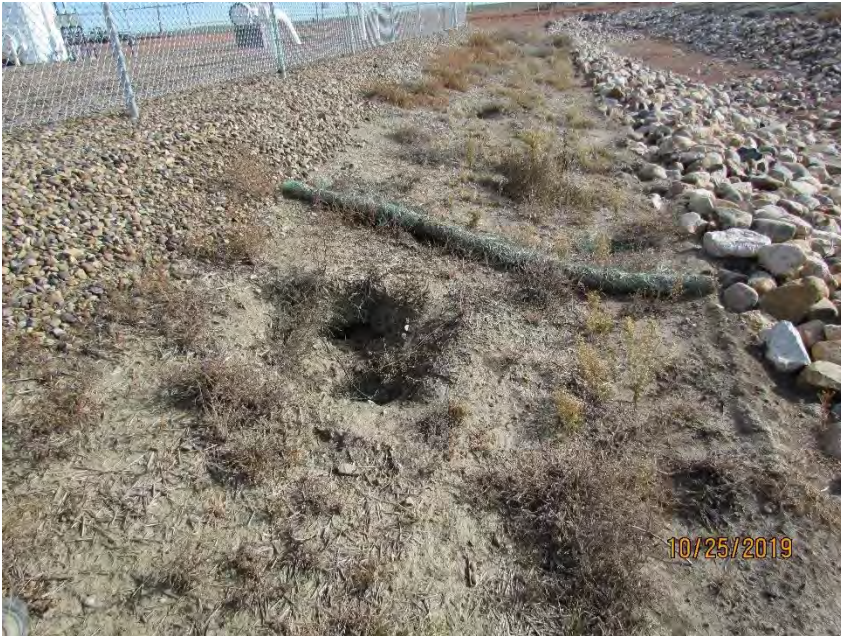
Photo 43:
Sparse vegetation along
southeastern extents of
facility fence line

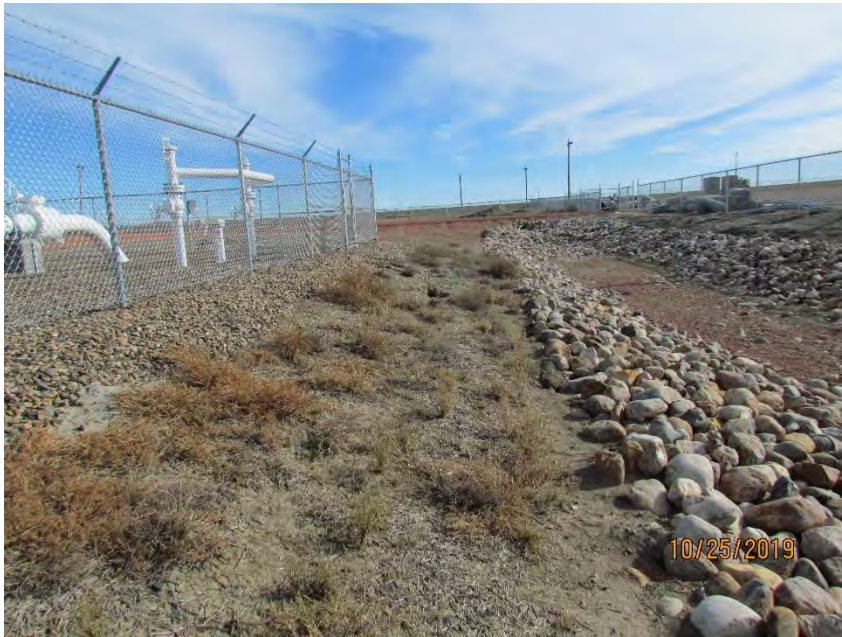
Photo 44:
Southeastern extents of
facility fence line

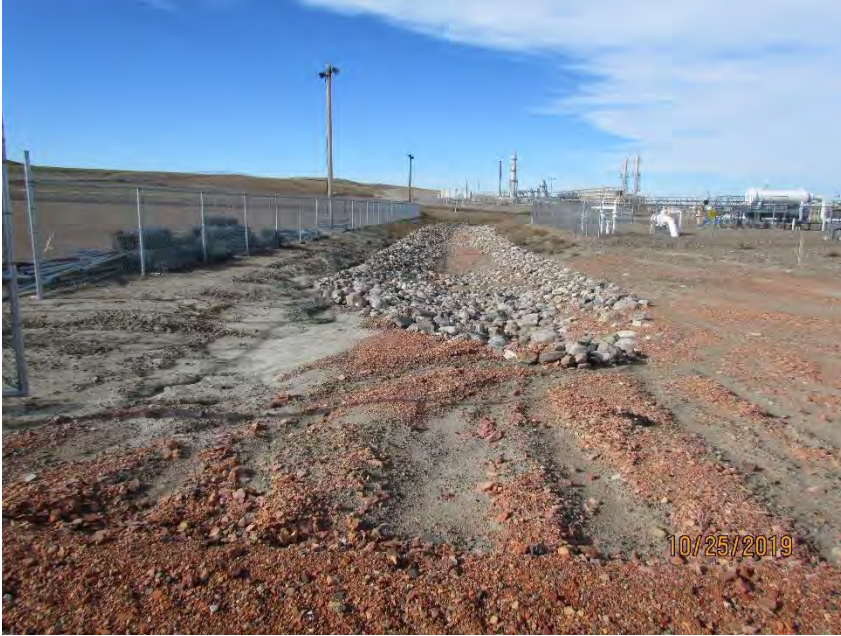
Photo 45:
Stormwater impacts near the
facility's eastern fence line
