ND ONE-CALL COMPLAINT

To allege a violation of the One-Call Excavation Notice System Law: North Dakota Century Code Chapter 49-23

Pictures of May 6, 2014 Damage in Ross, North Dakota.

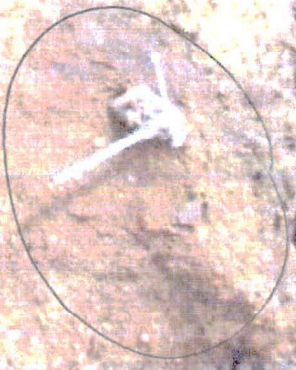
Location of Violation: 309' East of 2nd Street East on Central Avenue
Date and Time of Violation: On or about 8:57 a.m. on 6 May 2014
Description (summarize the observations on which you rely to allege the violation) <i>If more space is required, please provide the description on a separate page.</i> On or about the above time and date, Jody Mitteleider operator for the above named company was digging on Central Avenue in Ross, ND under locate ticket 14038256. During the excavation he struck a 1" natural gas distribution main causing the interruption of service to two commercial customers for a period of around 2 hours. Ross Public Works Director, Bobby Seibel, indicated he told them a line was present and located, but they dug through it regardless of the warning. See attached photos, and description of photos.

1. Photo from ELM (Contract Locating Company) of extent of work with arrow noting a locating whisker, and the white house as a landmark.
2. Replication of photo 1, at time of damage with white house as landmark.
3. Photo of locate mark by damage spoil pile.
4. Another locate mark
5. Wider view of construction area, including cones shown in picture 3.
6. Photo of damage
