Public Service Commission  
State of North Dakota

**NOTICE OF VIOLATION**  
**NORTH DAKOTA PUBLIC SERVICE COMMISSION**  
 SFN 18099 (10-91)

### INSPECTION REPORT

PERMITTEE - MINE: Dakota Westmoreland - Beulah Mine

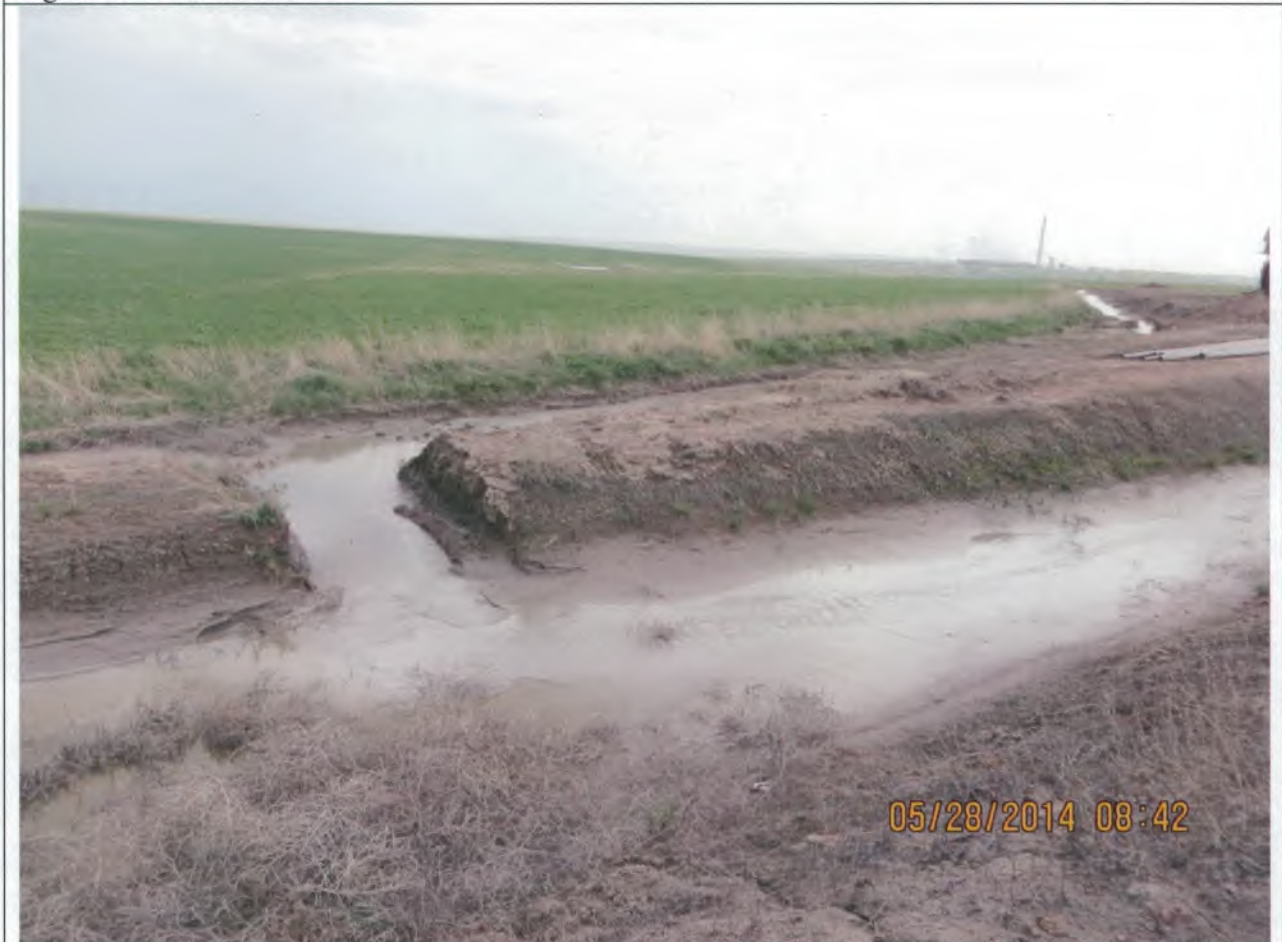
Figure 2: Washed out berm

At another location, a berm installed for water management purposes failed and this resulted in sediment laden water being pumped from the pit to flow across a reclaimed area. Sediment was deposited on a reclaimed tract that had been respread with topsoil and seeded.

The straw bale dike located adjacent the sump that is located northeast of the 480 dragline was noted as having been blown out by a runoff event. Water carrying a very heavy load of silt was passing through the sump and over reclaimed land located in the SE1/4 of Section 16, Permit KRSB-8603. The source of much of this water was found to be pit water that was being pumped at a rate of about 100 gallons per minute. The pumped discharge pipe was located in the NE1/4 of the NE1/4 of Section 21 and this water was passing down a gully that had formed on graded spoil to the haul road where it passed through a culvert and then through a washed out spot in a berm to a drainage way that leads to the sump located northeast of the 480 dragline. This pump was shut down and DWC was informed that the straw bale dike needs to be repaired as soon as possible. The day after this inspection DWC informed the Reclamation Division that a berm located north of the north haulroad ditch had failed which is why the pumped discharge was traveling over reclaimed land. The discharge was apparently supposed to go to the sump located in the SW1/4 of Section 15. The photograph in Figure 2 below shows that this sump failed during a recent rain event.

Remedial Action Required (including interim steps, if any)
Install a culvert in the reconstructed county road located between the SE1/4 of Section 18 and NE1/4 of Section 19 to ensure runoff from disturbed land will pass to sedimentation pond 95, place a ditch block on the west side of the inlet to the culvert and install a properly constructed silt fence and small sump in the reconstructed road ditch at the disturbance boundary. Reconstruct the temporary diversion located in SE1/4 of Section 16 in accordance with NDAC 69-05.2-16-06 (1) so that runoff passes to the red pit sump located in SW1/4 of Section 15. Clean out the sump located north of the 480 dragline site and install a silt fence along the north side of sump. Respread additional topsoil on the reclaimed drainage below 480 dragline sump, stabilize respread soil with fabric and seed site to appropriate seed mixture.

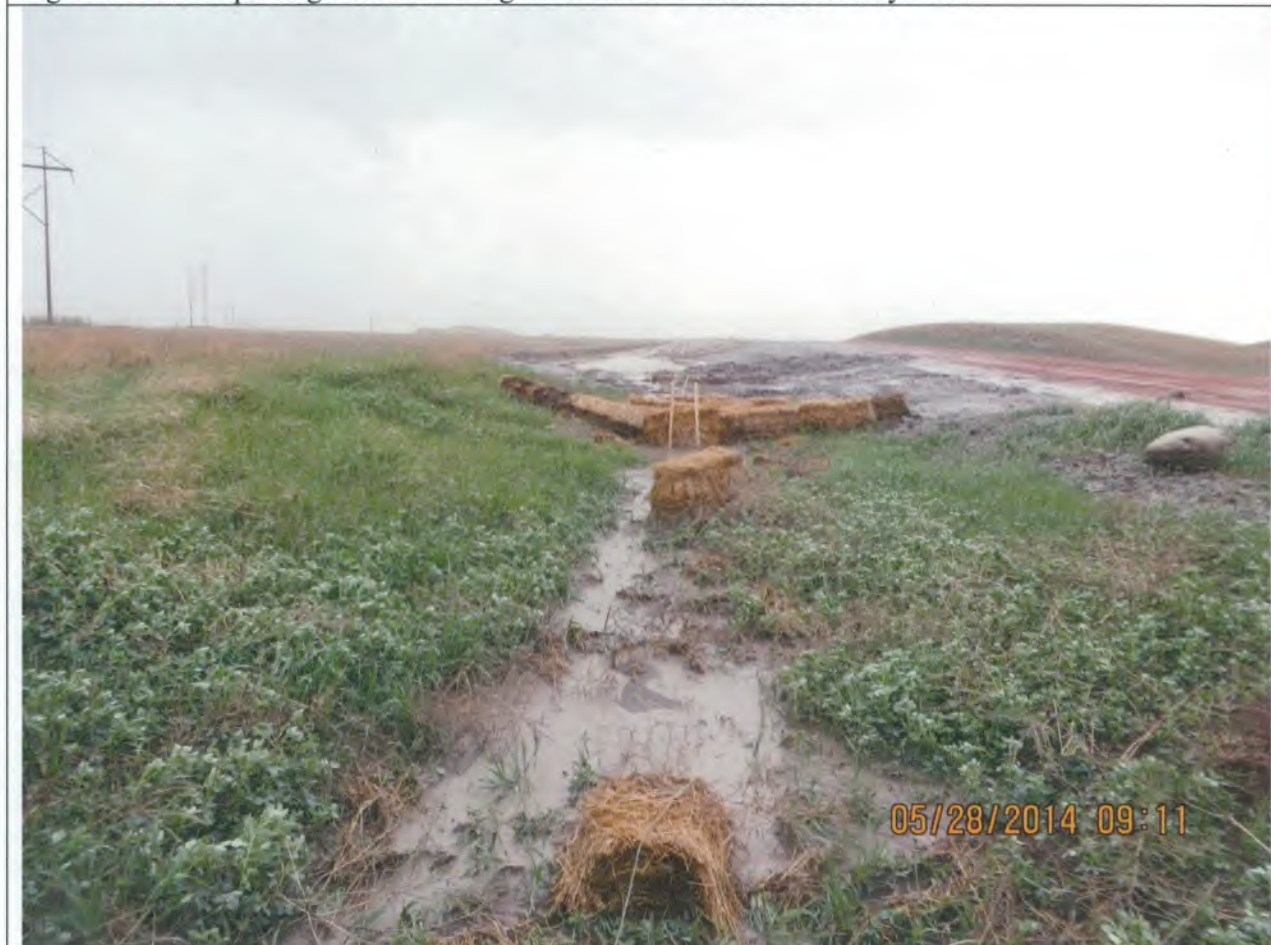
Figure 2: Runoff passing westward along north side of undisturbed county road.

The mine operator failed to properly implement and maintain water management plans at the Beulah Mine. The operator failed to install a culvert in a re-constructed road and this resulted in runoff from about 9 acres of disturbed land to go off the permit area without being passed through a sedimentation pond. Some sediment was deposited on undisturbed land as a result of this failure. (continued P. 4)

About one half inch of rain fell during the inspection and surface runoff was passing from portions of Silver 1 and 2 grade approvals southward to the rebuilt county road. This runoff moves westward along the north ditch of the road to the disturbance boundary where it passes under some straw bales to the undisturbed ditch and continues westward off the permit to a secondary drainage of the Knife River. The straw bales were not dug in the ground and are not functioning as the desired best management practice. The Silver 1 grade approval and the water management plan in Permit KRSB-8603 indicate that runoff from this reclaimed land is to be contained by Sediment Ponds 94 and 95. In this case the runoff should be directed to pond 95 by installing a culvert in the county road that was rebuilt by DWC. The road ditch where this runoff water passes off permit is not designated as a NDPDES discharge point. Figure 2 shows how runoff during a rain event is diverted by the reconstructed county road.
