# Public Service Commission

### INSPECTION REPORT

DATE OF INSPECTION: September 3, 2014

PERMITTEE - MINE: BNI Coal Ltd. - Center Mine

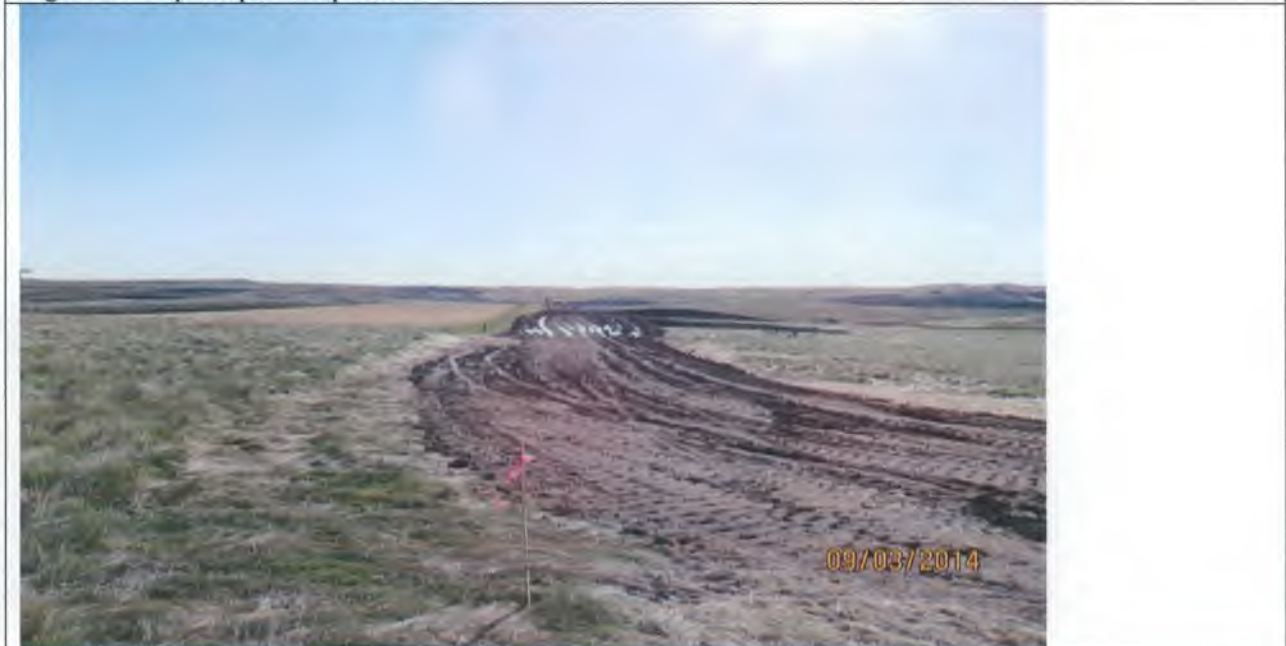
A new topsoil pile was observed along the north side of the NE1/4 of Section 7 of BNCR-1101 that appeared to be very close to the permit boundary. An inspection of the site revealed that a few feet of this pile was located north of the permit boundary in Section 6 of T141N, R83W (off-permit). Wooden stakes, that appeared to have been recently put in place, were noticed on the permit boundary and they indicated that a small portion of this pile was in Section 6. A backhoe was in the process of pulling this topsoil pile to the south to keep it in the Permit BNCR-1101. Photographs of this pile in relation to the wooden stakes identifying the permit boundary were taken and are on file with the Reclamation Division. BNI representatives were notified what was observed regarding this pile and they were informed that a Notice of Violation (NOV) will be written for operating outside of the approved permit area and for not installing permit boundary markers at this location. NOV 1402 was subsequently issued to BNI Coal on September 10. Figure 1 shows the pile in relation to the permit boundary. Areas to the left of the stake in the photo are off-permit.

Figure 1: Topsoil pile off permit

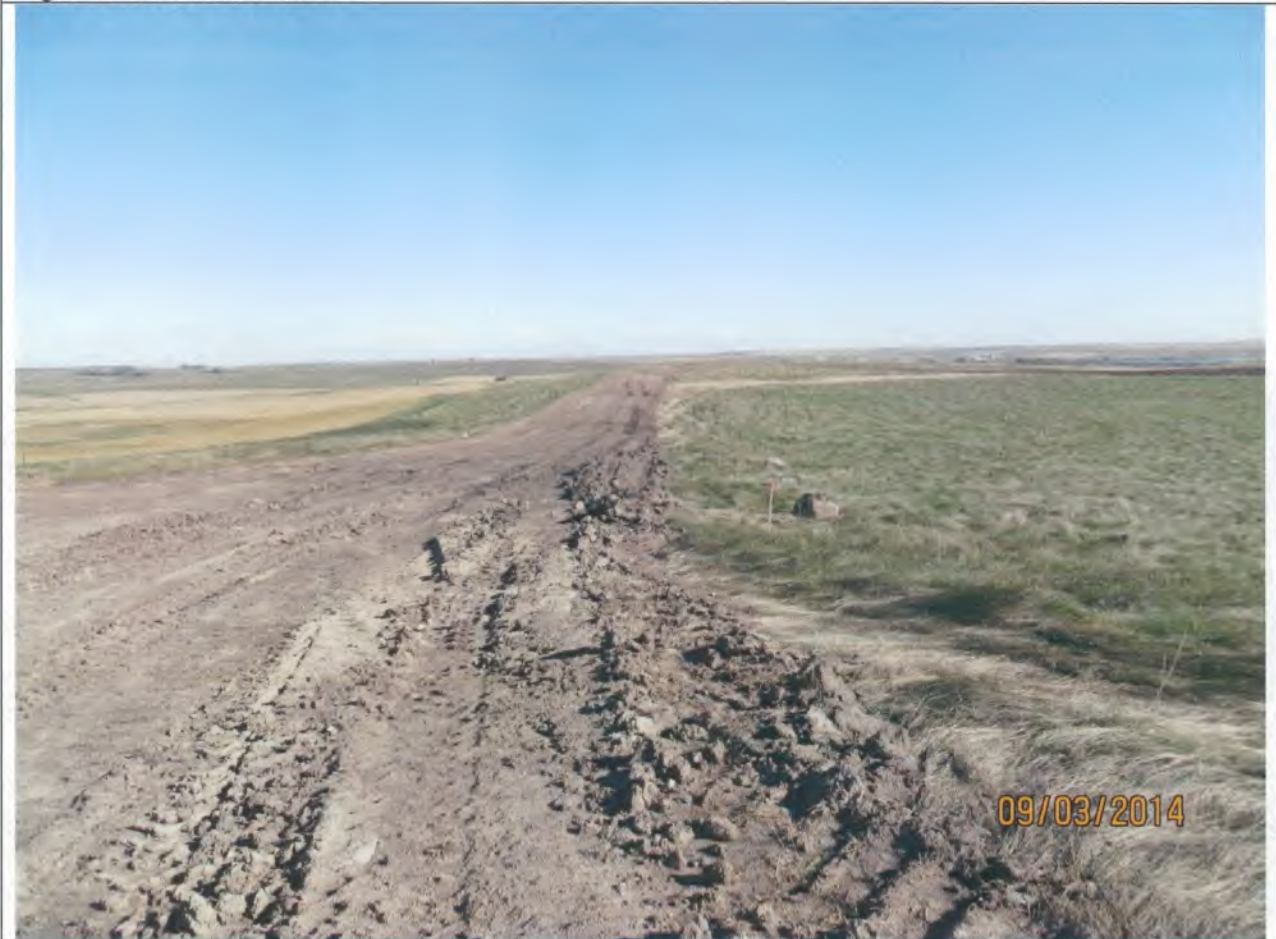
Figure 2: NE1/4 of Section 7

A scraper access trail was noted in the NE1/4 of Section 7 of Permit BNCR-1101 where it appeared scrapers had been traveling over an area prior to removing all available topsoil. No topsoil stripping edge could be seen in this area and BNI was reminded that topsoil needs to be stripped from these access trails prior to use to ensure topsoil is not lost or contaminated. Figure 2 shows the trail where topsoil was not salvaged.

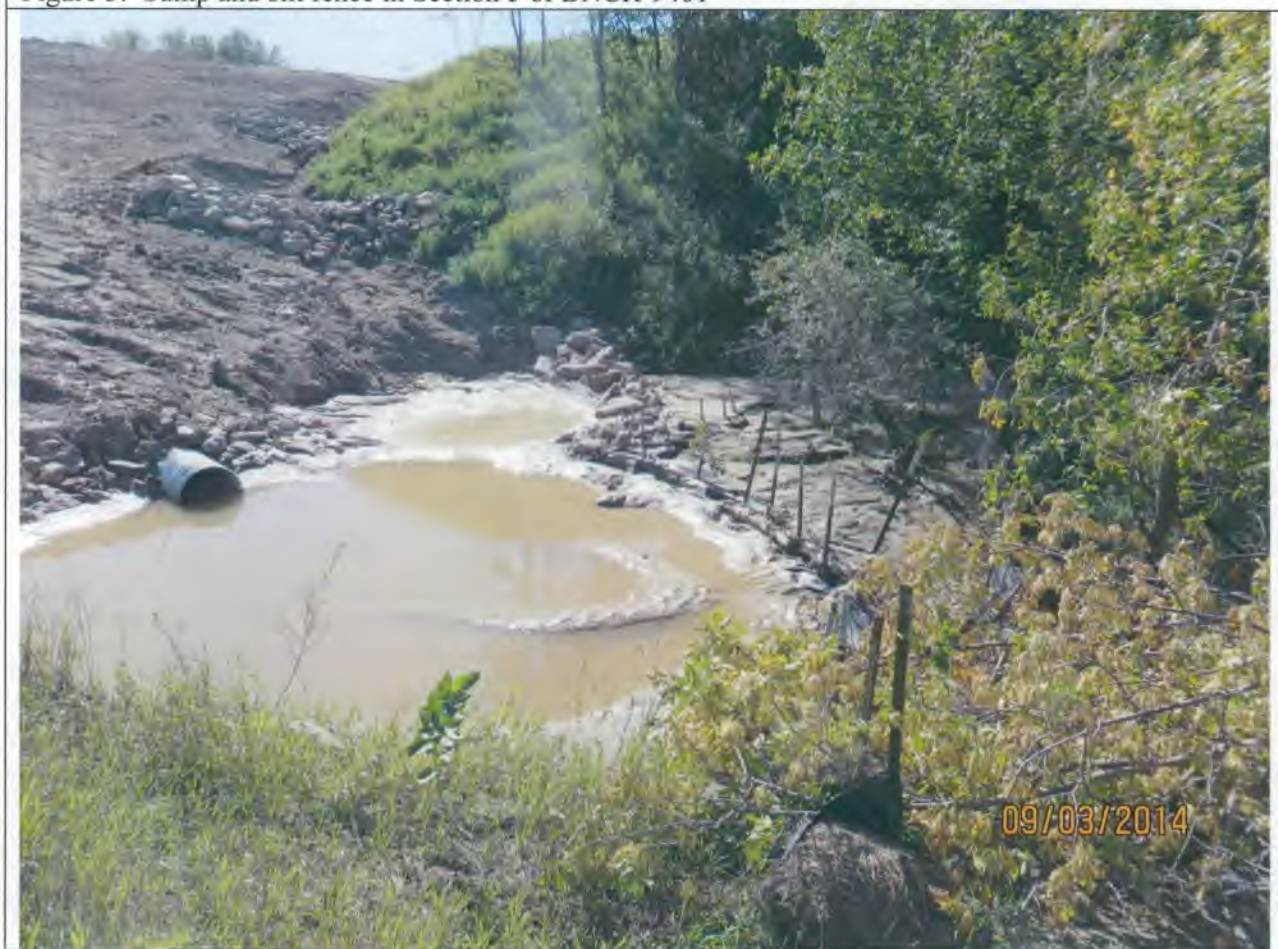
Silt fences and sumps were noted in place along the haul road being constructed in BNCR-1101. The silt fence along the haul road in the major drainage in the NW1/4NE1/4 of Section 5, BNCR-9401, needs to be cleaned out and the associated silt fence is in need of repair. There is a considerable amount of sediment deposition in the undisturbed drainage way below this silt fence. This issue was discussed with BNI and it was recommended that a larger sump be constructed at this location. It is not clear why the side slopes of the haul road have not yet been seeded as establishing vegetative cover on the side slopes and ditches of this road is the most basic “best management practice” to control erosion. Figure 3 shows the sump and drainage below this haul road.

Figure 3: Sump and silt fence in Section 5 of BNCR-9401

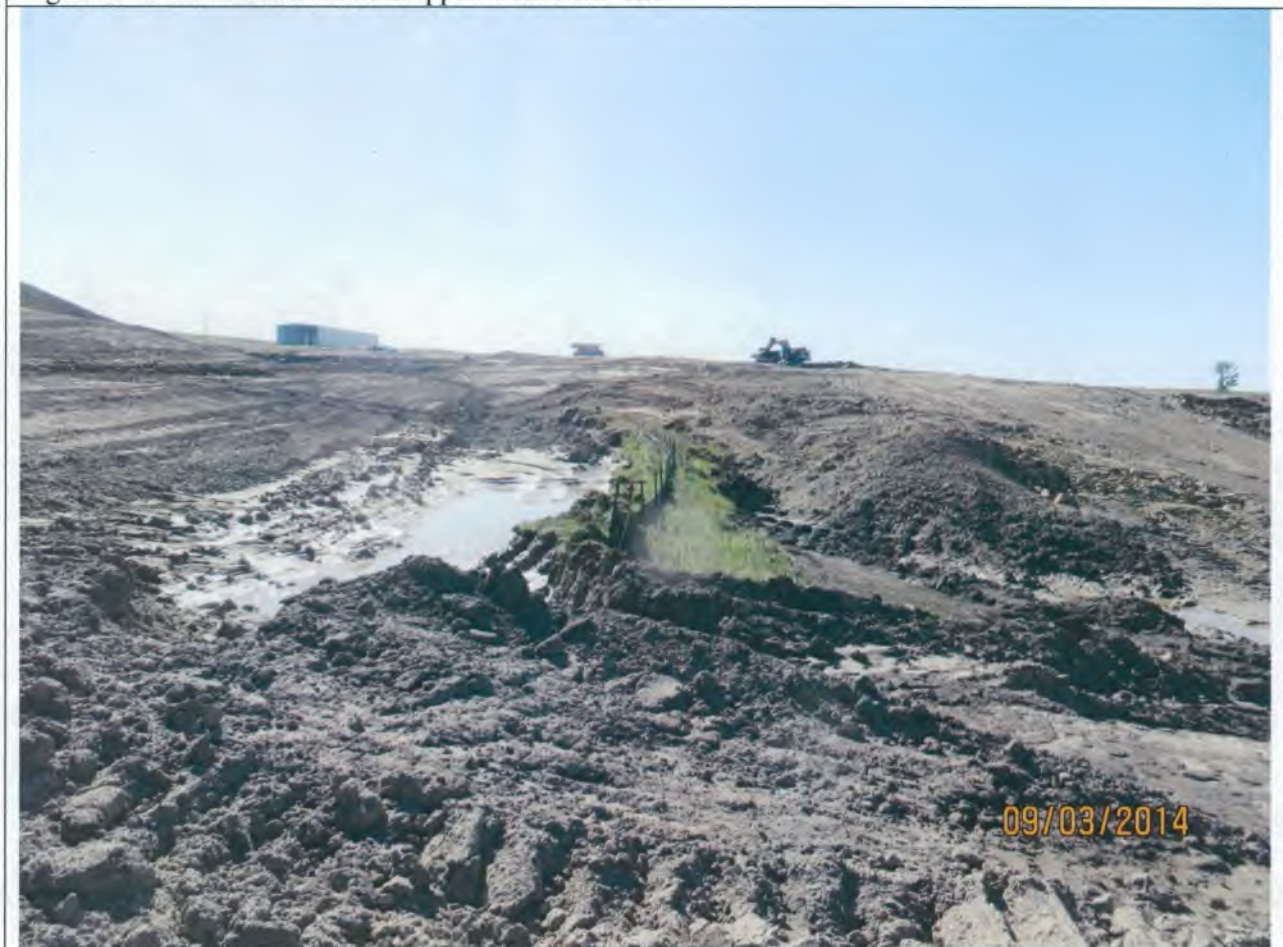
The pre-mine stockponds in the SW1/4 of Section 8 of BNCR-1101 will be functioning as sumps and the drainage way below these features is stripped. Silt fences were noticed in place above the culverts that allow runoff to pass from Section 5 of BNCR-1101 off-permit to Section 6. SPGM was being stripped from the adjacent area in Section 5 and the silt fences appeared to be functioning as intended. In a few instances, “small islands” of in-situ SPGM remains intact with a silt fence in place. BNI is reminded that the SPGM from these small islands must also be salvaged. Figure 4 shows one of these BMP’s.

Figure 4: Soil that needs to be stripped from BMP site

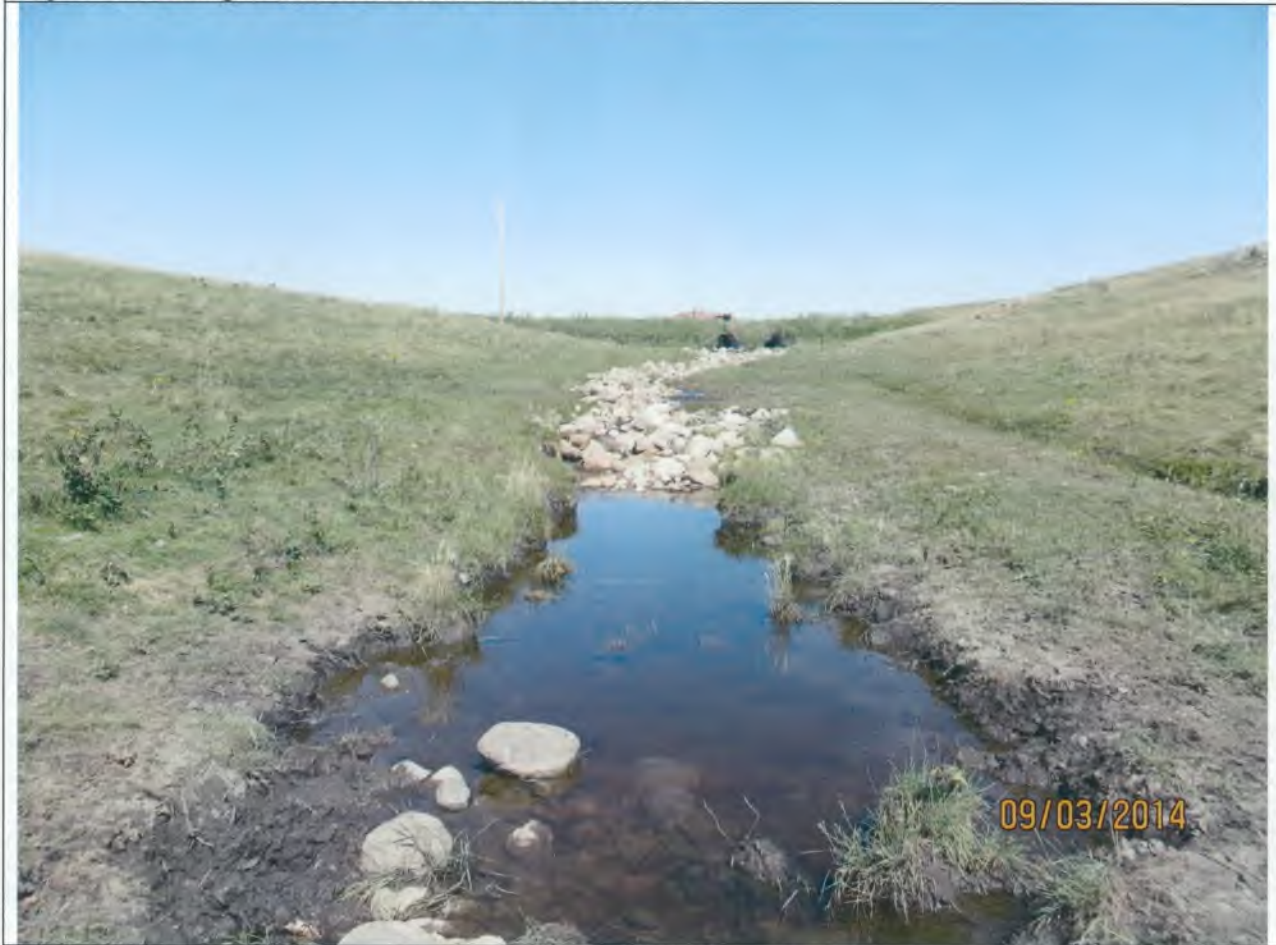
Likewise, additional rock is needed in the drainage way in Section 7 of Permit BNCR-9702 where runoff is diverted around the reclaimed wetland in Section 5 via a diversion channel in Section 6. This natural drainage way has eroded significantly since the diversion in Section 6 has been installed. A head cut feature that is holding water about 4 feet deep exists in this drainage and a gully has formed in a portion of the channel. Runoff was flowing through this drainage way at the time of the inspection and it was evident that large volumes of water had flowed through this drainage with the recent heavy rainfall events. Figure 5 shows this drainage way.

Figure 5: Drainage in Section 7 where runoff is diverted
