LITTLE MUDDY CREEK PIPELINE (PU-14-769) Reclamation and Final Report

1 EXECUTIVE SUMMARY

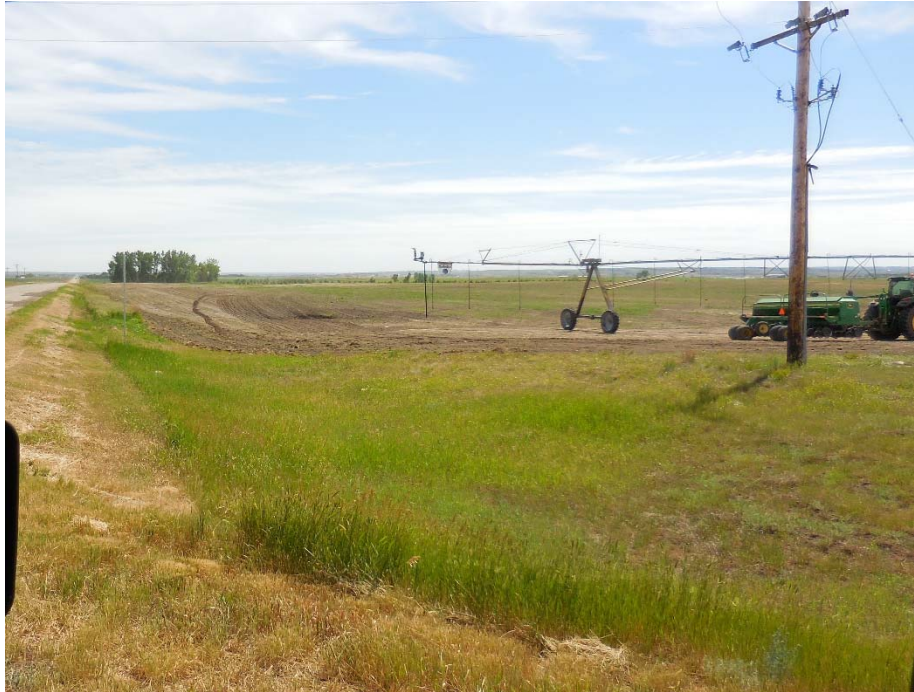
Photo 1: Pipeline corridor, west side of County Highway 9, near the Little Muddy Creek Station, facing south.

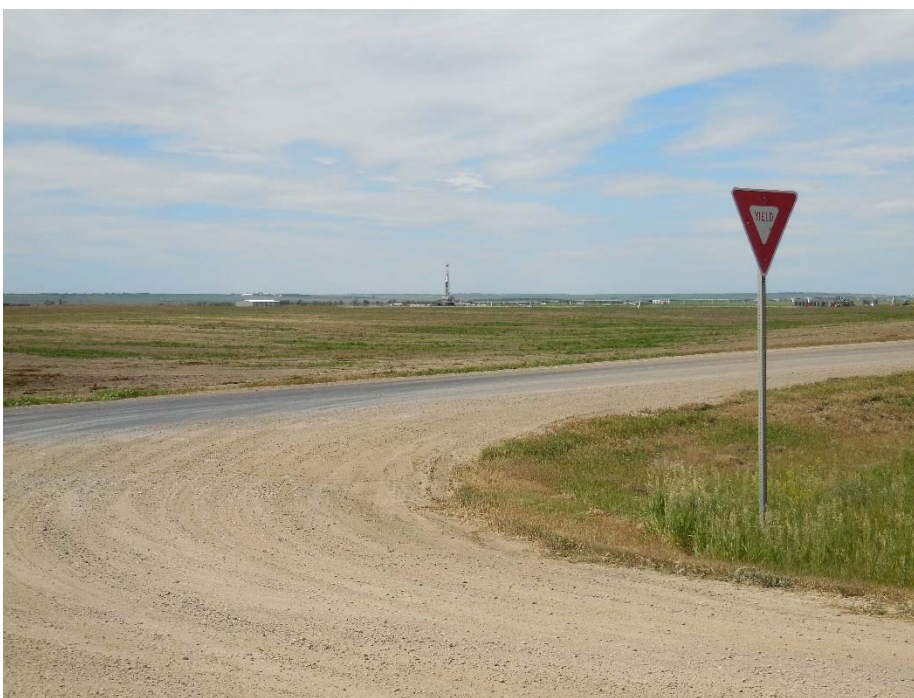
Photo 2: Pipeline corridor, near the intersection of County Highway 9 and County Highway 8b, facing northwest.

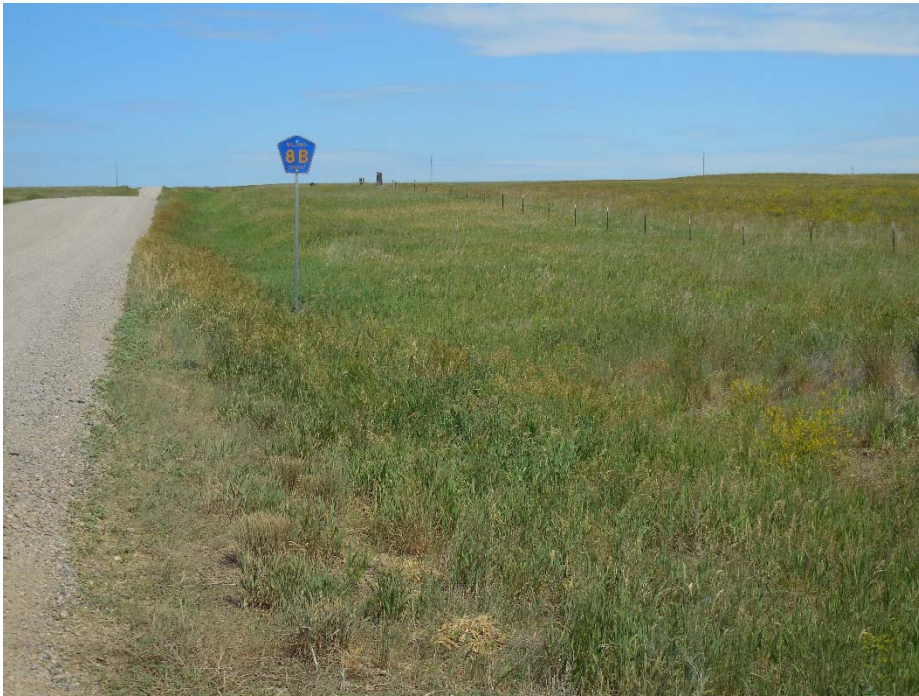
Photo 3: Pipeline corridor parallel to County Highway 8b, facing east near Little Muddy Creek Station.

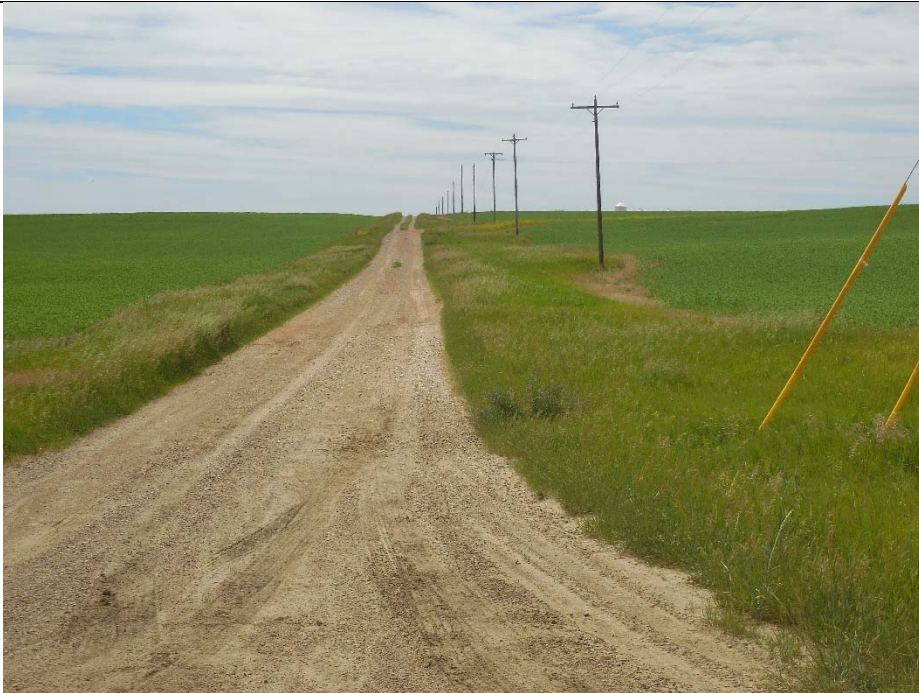
Photo 4: Pipeline corridor at 62nd Street NW, facing west. Corridor is on north (right) side of road.

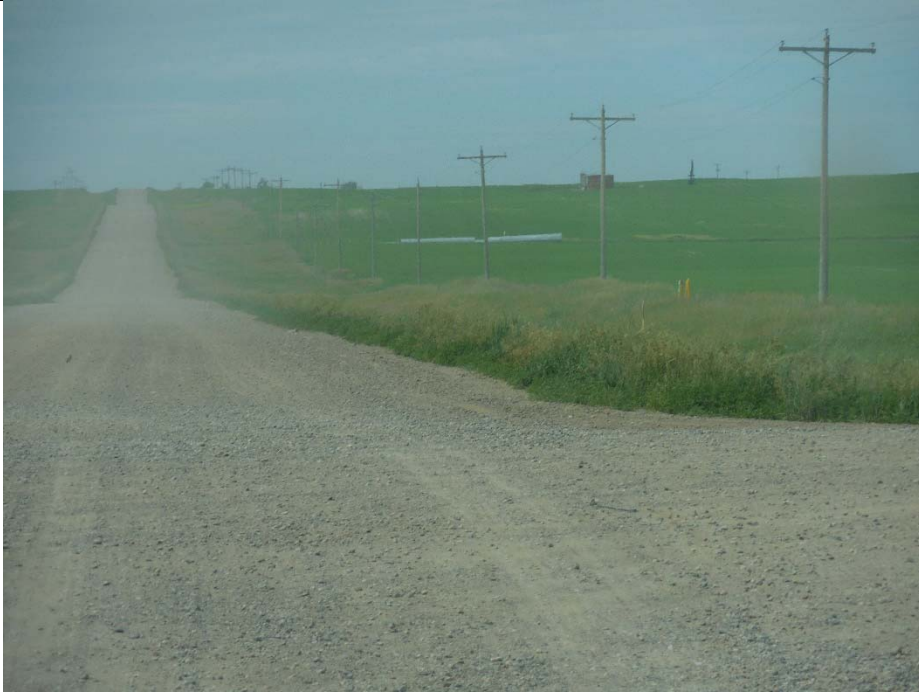
Photo 8: Pipeline corridor at intersection of County Highway 11 and Co and County Road 8, facing west. Corridor is on the north (right) side of the road.

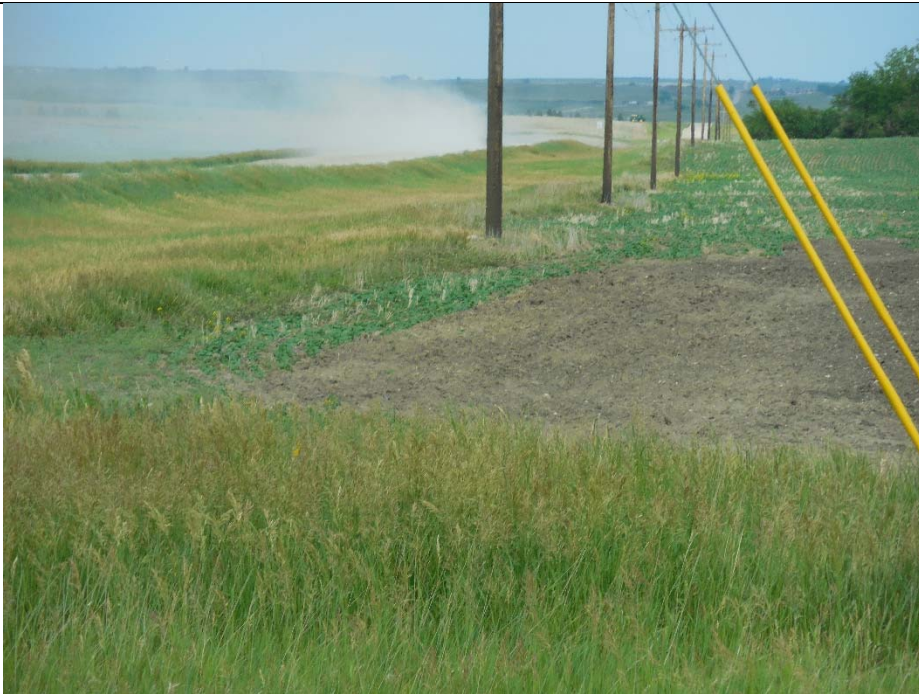
Photo 9: Pipeline corridor at intersection of County Highway 11 and Co and County Road 8, facing north. Corridor is on the east (right) side of the road.
