Project Name: North Killdeer Loop Phase I 34 kV **Date:** 7/8/2016
PSC Case Number: PU 14-813 **Time:** 1100
Inspector: Jon Knudsen, E3 Environmental, LLC **Weather:** Sunny, dry

ND PSC Inspection Report

Docket No.: PU 14-813	Permittee: Basin Electric Power Cooperative	Project Name: N Killdeer Loop Phase I 345 kV
Inspection Date: 7/8/2016	Type of Inspection: Field inspection/interview	
Inspector Name: Jon Knudsen	Contact: Cris Miller

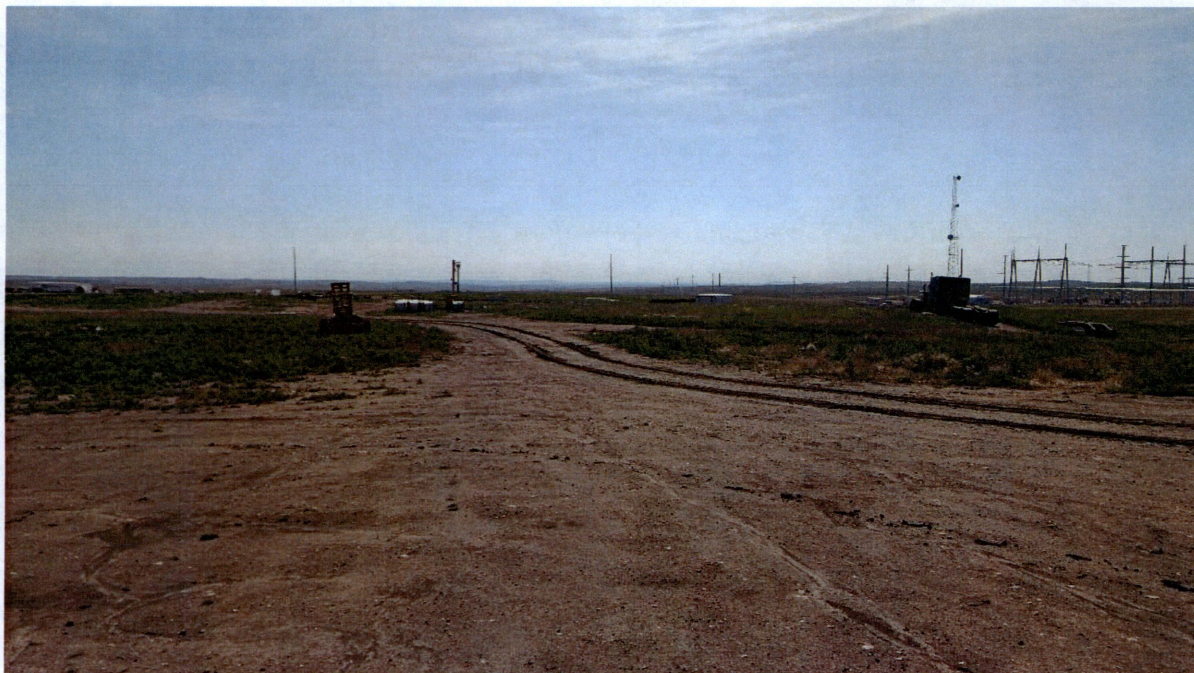
Photo 1. Substation on west end of Project, with stored equipment in the background.

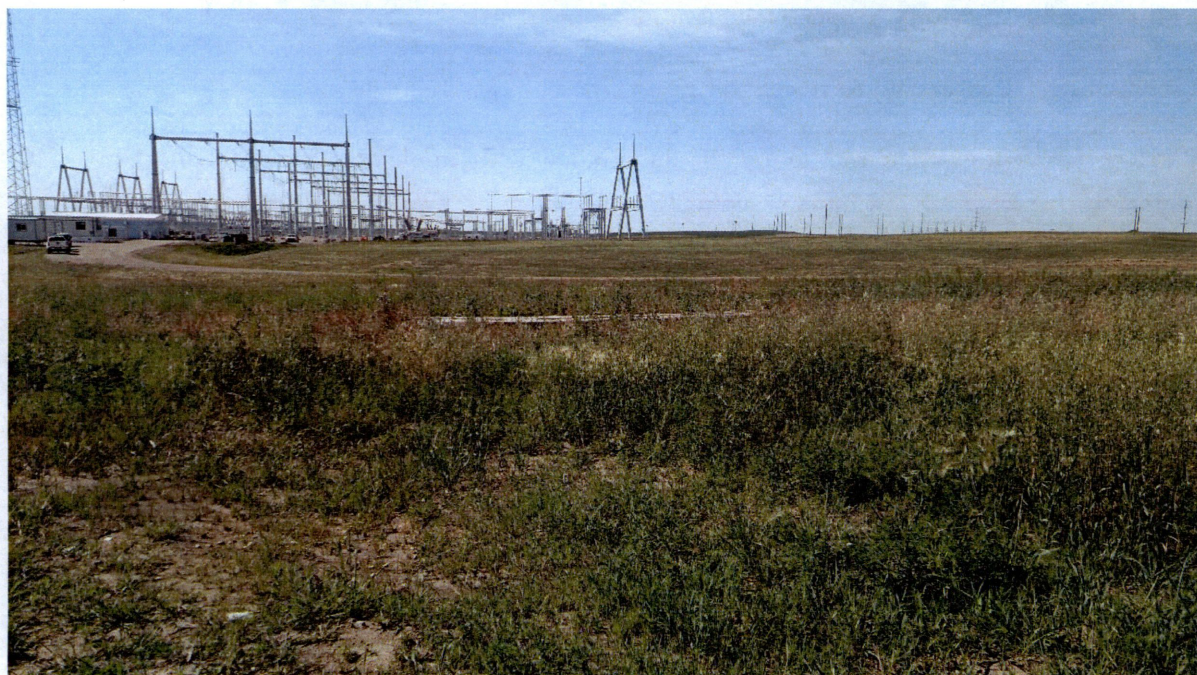
Photo 2. Natural vegetation growth along silt fence/waddles protecting wetland at substation on west end of Project.

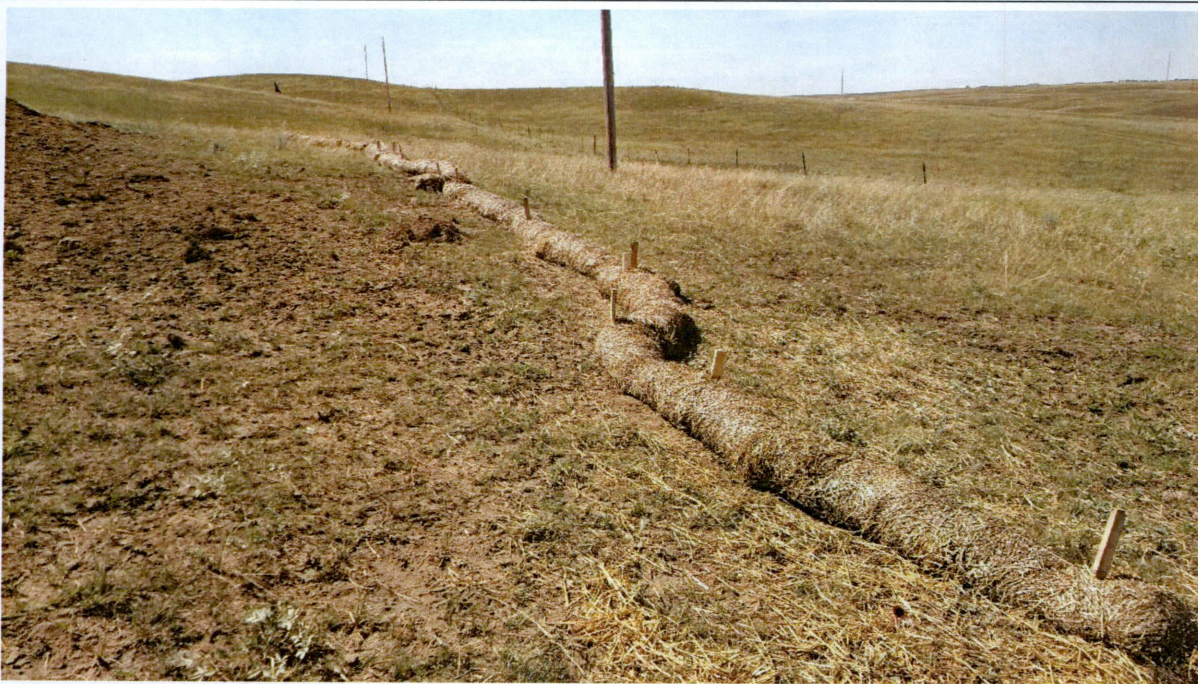
Photo 3. Properly-installed waddle on downhill slope of crane pad.

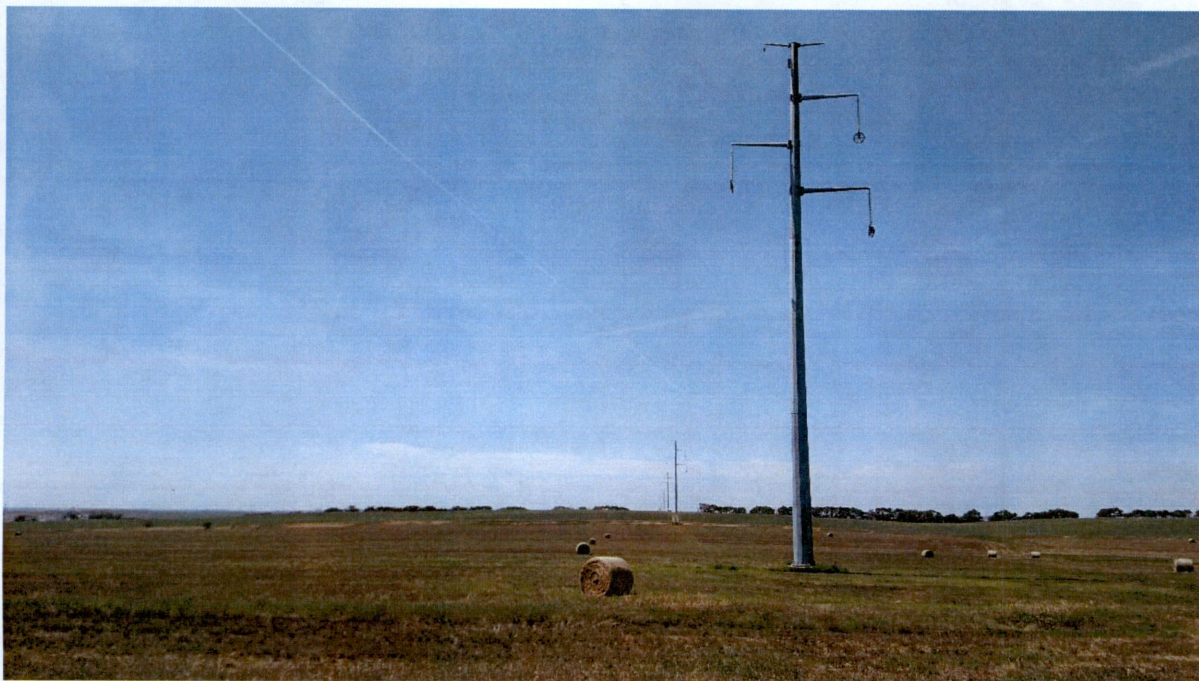
Photo 4. General landscape and ROW along Project.

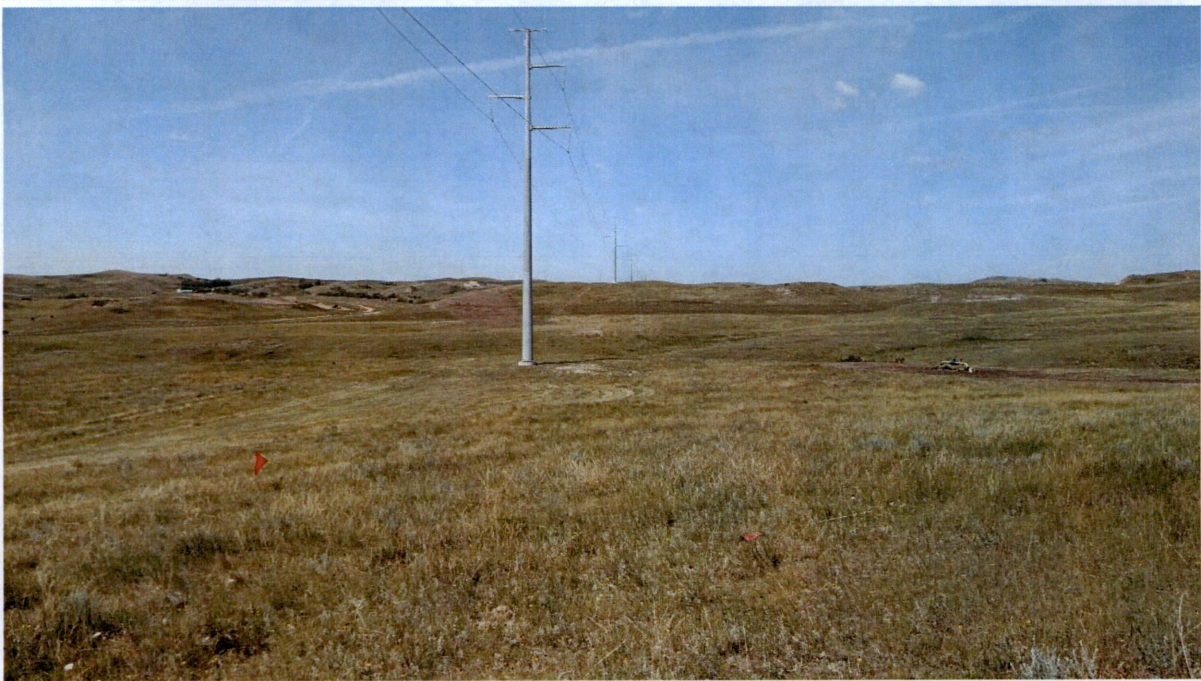
Photo 5. Strung towers spanning recent pipeline project.

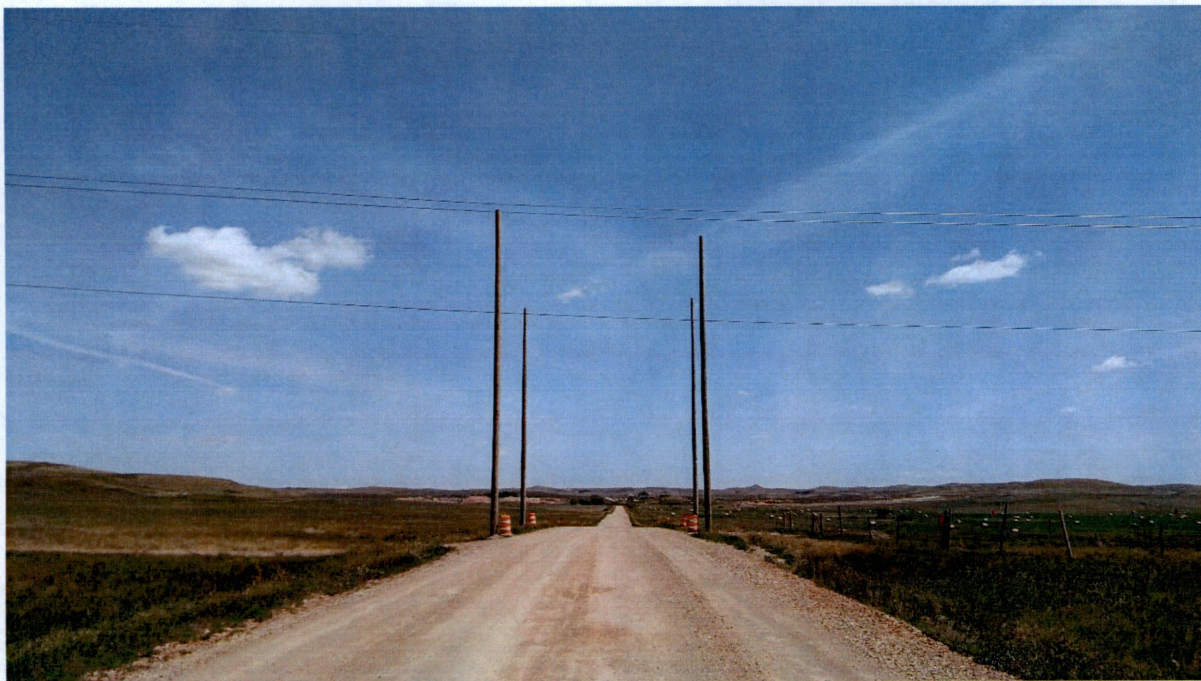
Photo 6. Supports for spanning wire across road.
