Post-Construction Inspection Report

10-inch Crude Oil Pipeline – Divide & Burke Cnty
Meadowlark Midstream Company, LLC

ND PSC Case No. PU-14-823

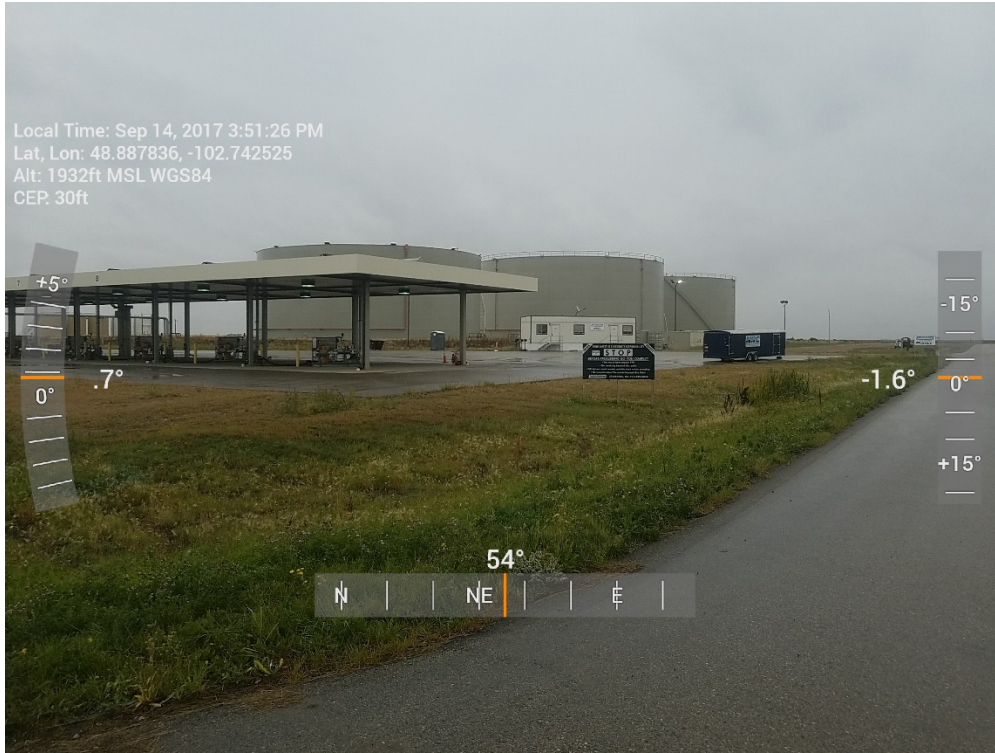
Report Photo #1: Basin Transload and Global Partners' Basin Transload Rail Facility.

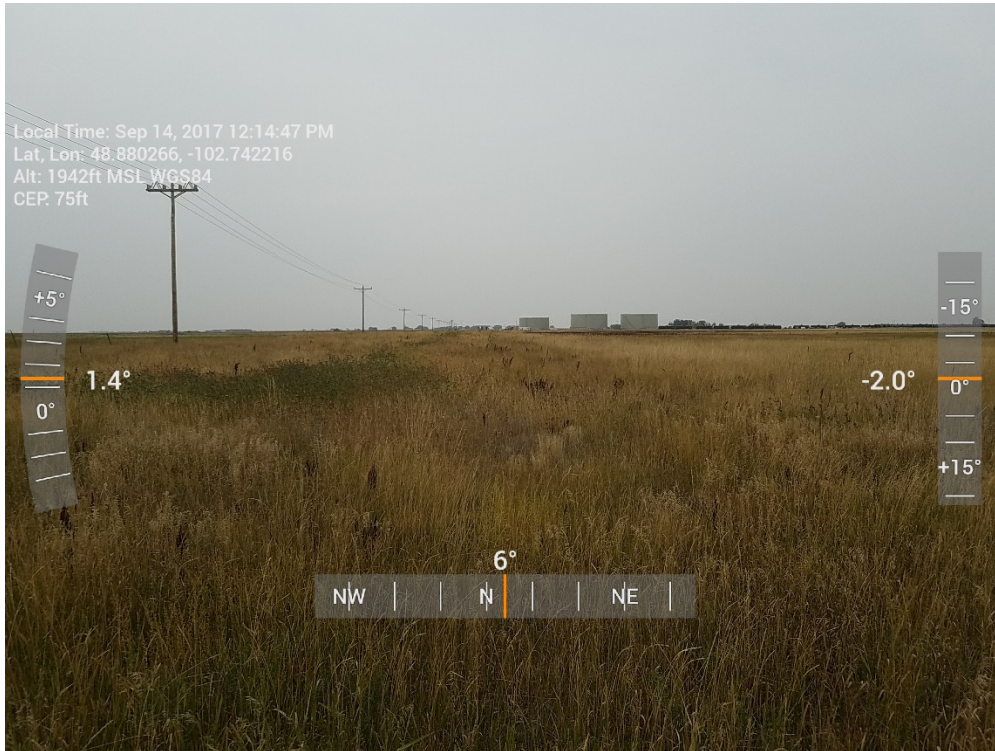
Report Photo #2: Revegetated ROW Looking Towards Terminal.

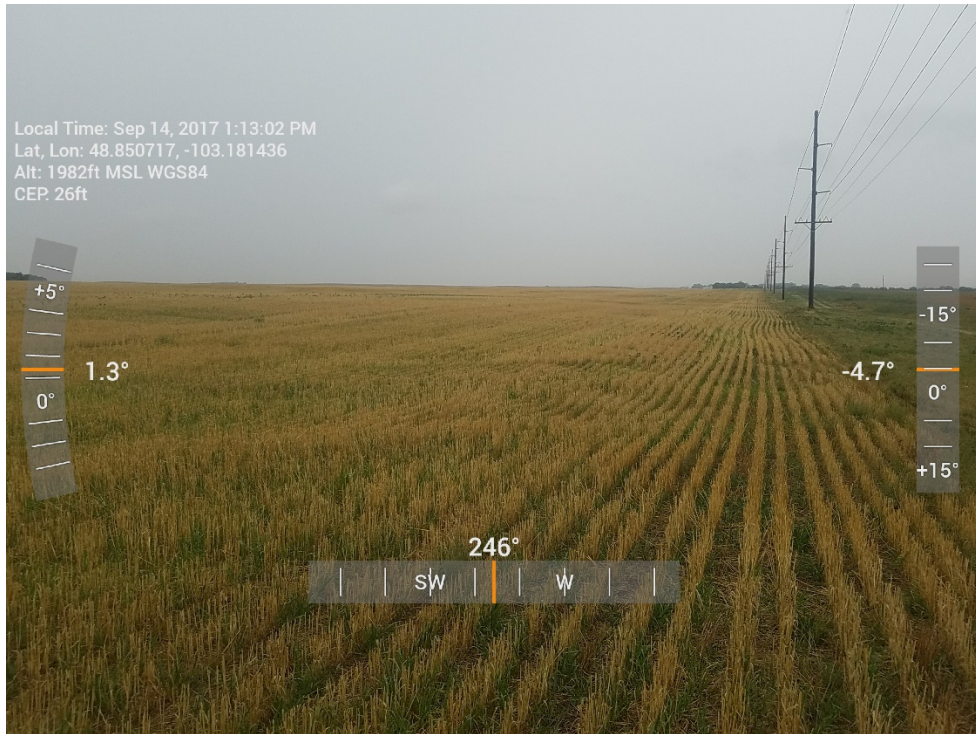
Cropland in the Project area appeared to have no lasting effects from construction. Crops appeared to be similar in density to areas outside of the Project area. Occurrence of noxious weeds and other undesirable plants did not appear to be any greater than areas outside of the pipeline ROW.

Report Photo #3: Typical ROW Condition in Croplands.

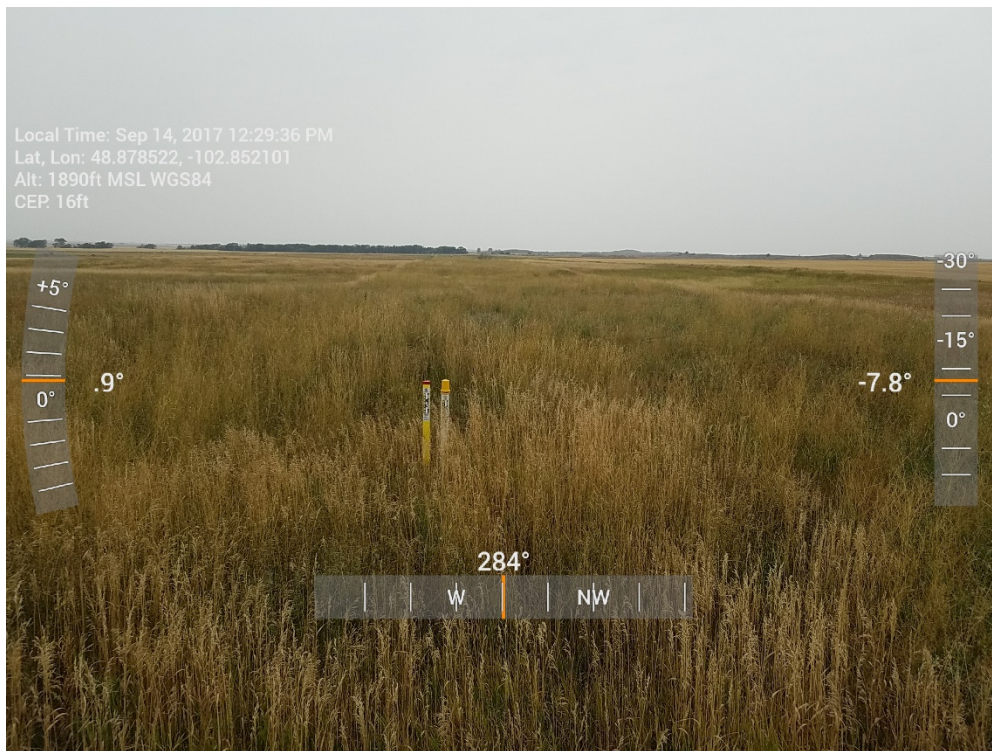
Construction was completed at the time of the visit. The terminal facilities were clear of vegetation and gravel covered. In grassland areas on the pipeline right-of-way (ROW), there was nearly 100% vegetative cover at the time of the field inspection. The only noxious weed found in the Project area was Canada thistle (*Cirsium arvense*). The number and density of this species did not appear to be any greater than areas outside of the Project area.

Report Photo #4: Typical ROW Conditions in Grasslands.

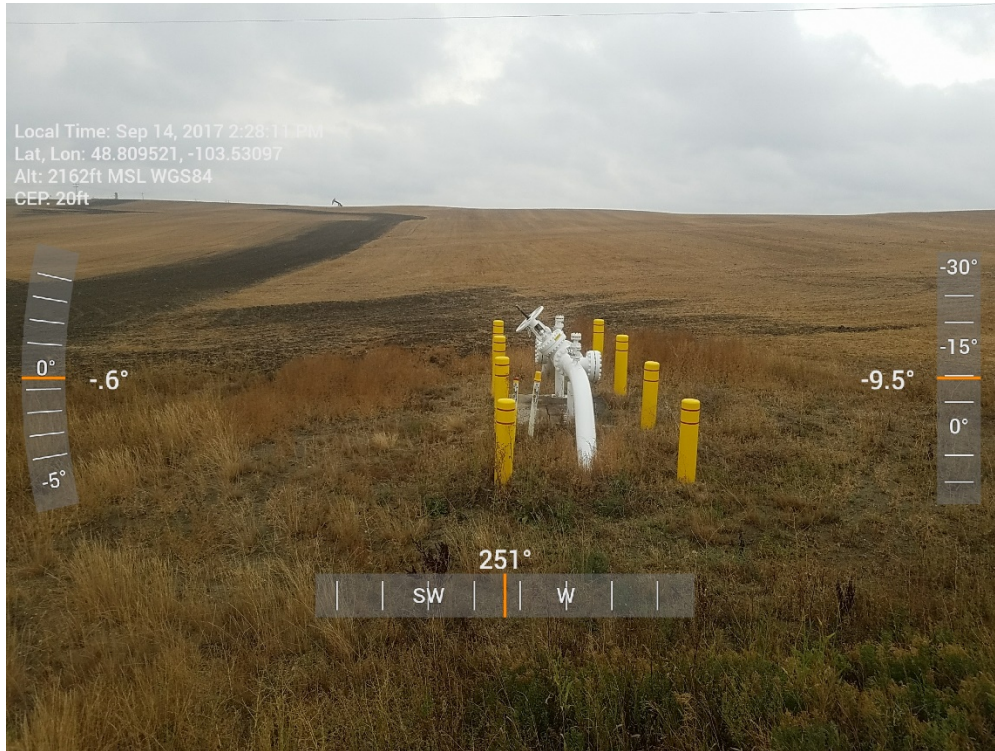
Report Photo #5: Valve Location. Note – Disturbed soil is a different project’s ROW.

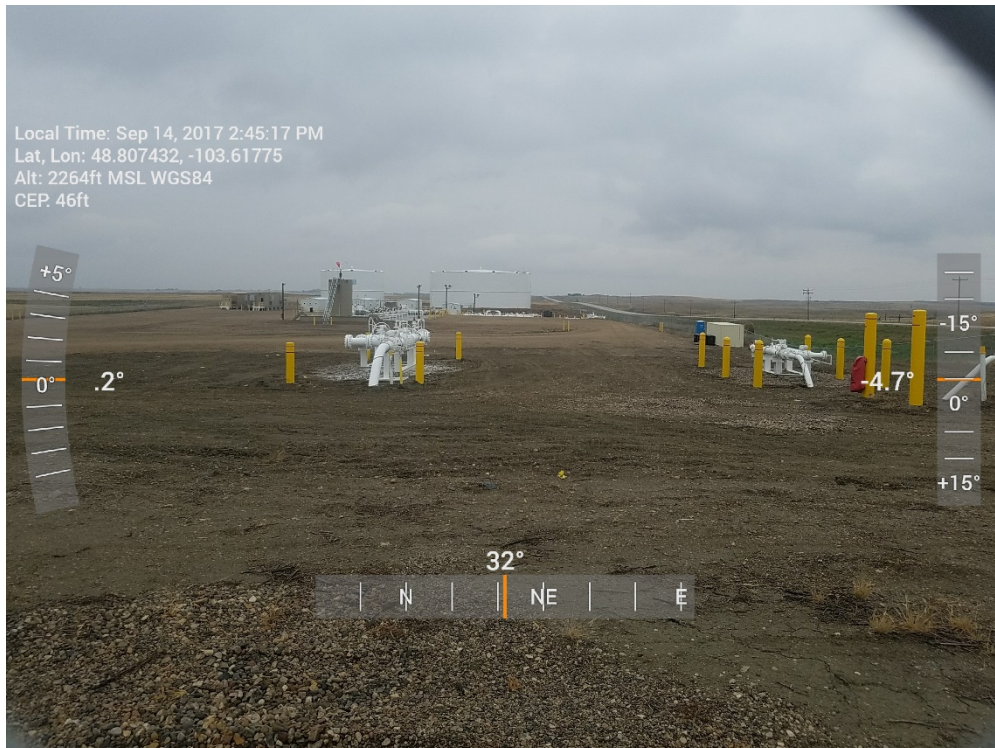
Report Photo #6: Divide Pump Station at West End of Project.
