**BASIN ELECTRIC- PIONEER GENERATION
STATION PHASE III**

INTERIM CONSTRUCTION INSPECTION REPORT

Inspector Name: Dave Hennen, ProSource Technologies	Inspection Date: 1-05-16	Report Number: PU-14-829
Weather: Sunny, 12 degrees F	Precipitation: 0.00

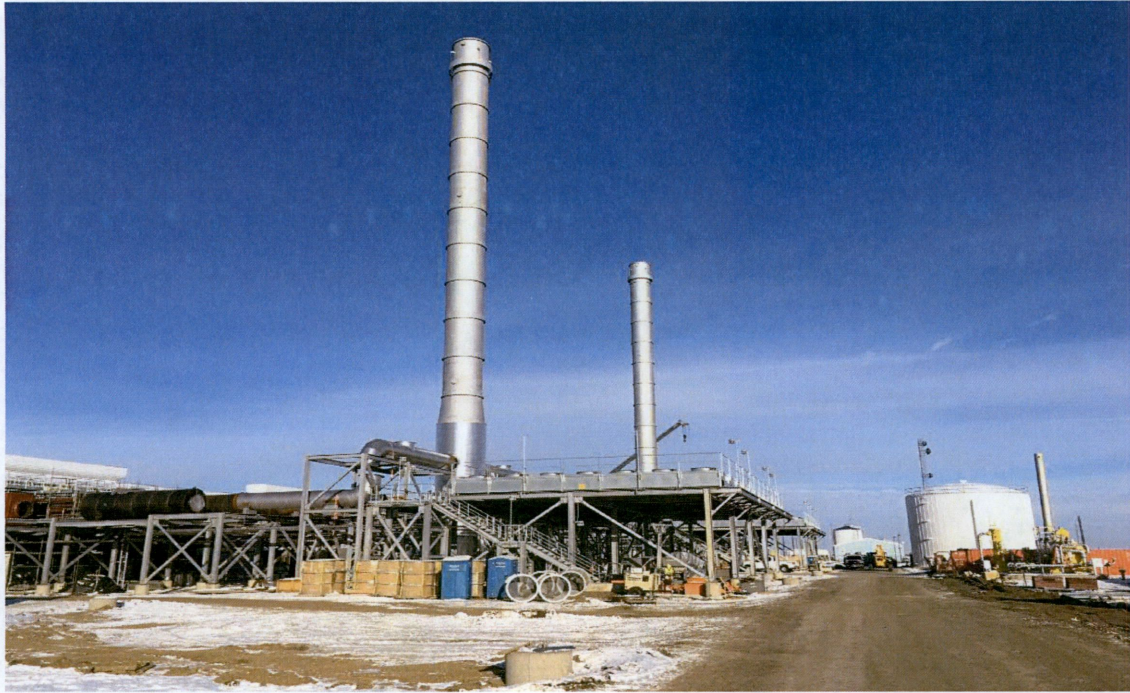
Photo 1 – View of Pioneer Generation Station Phase III facilities

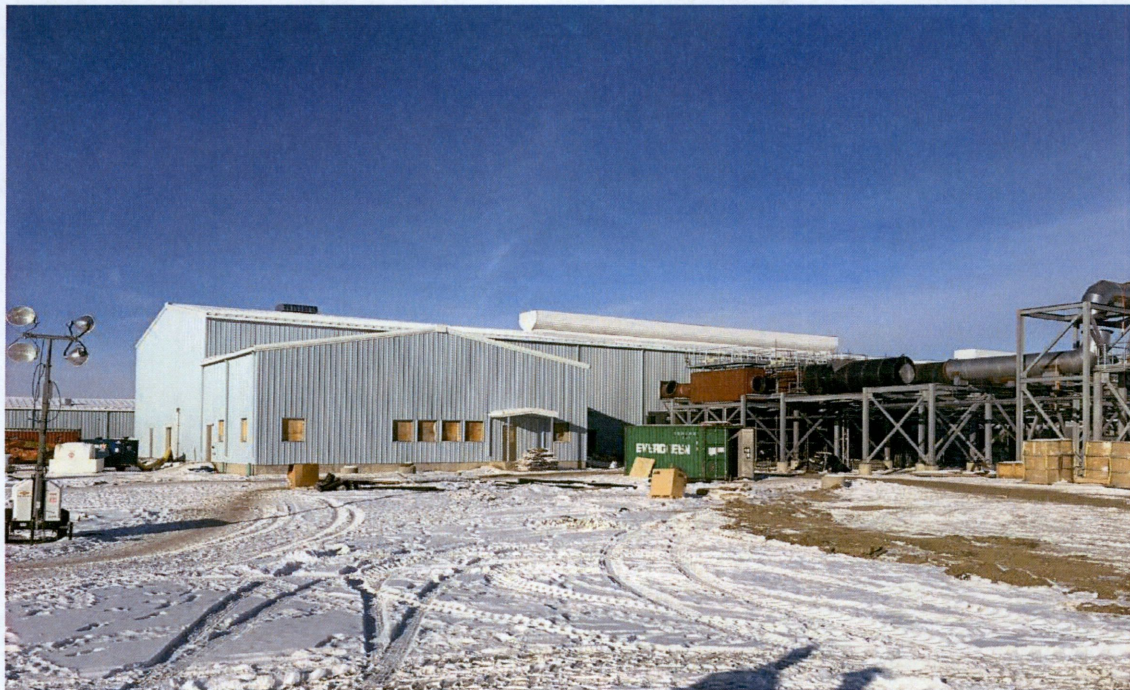
Photo 2 – View of Pioneer Generation Station Phase III facilities

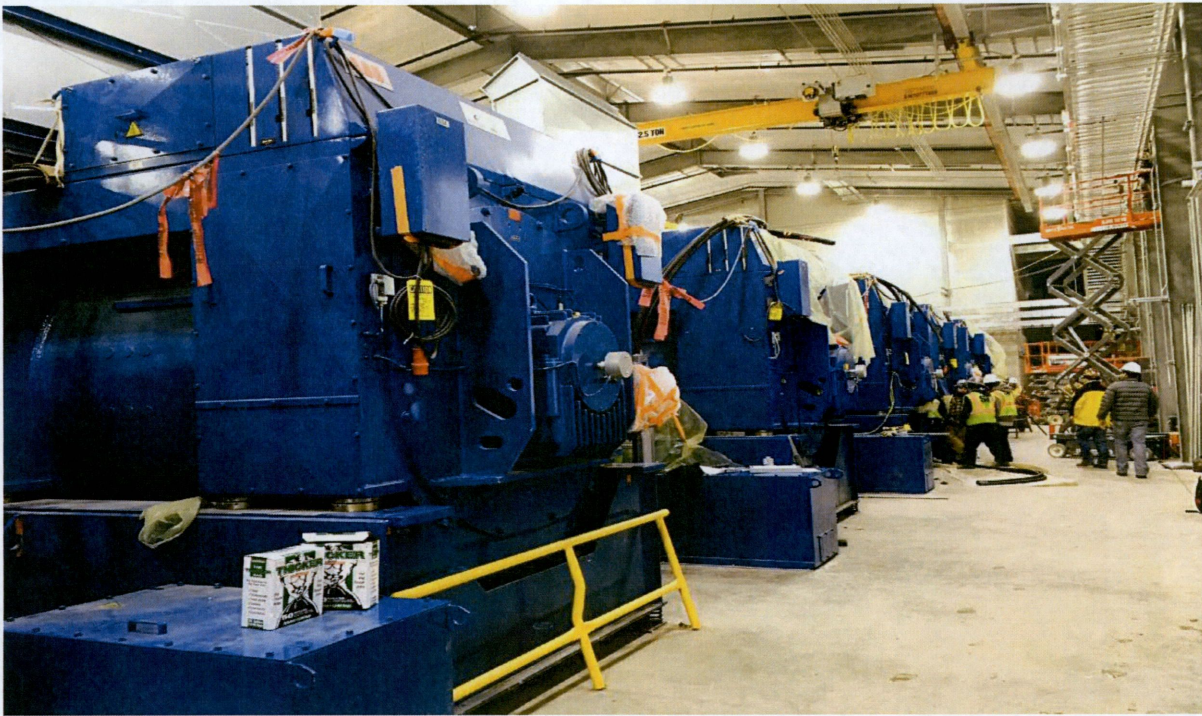
Photo 3 – View of engines in the North Engine Building

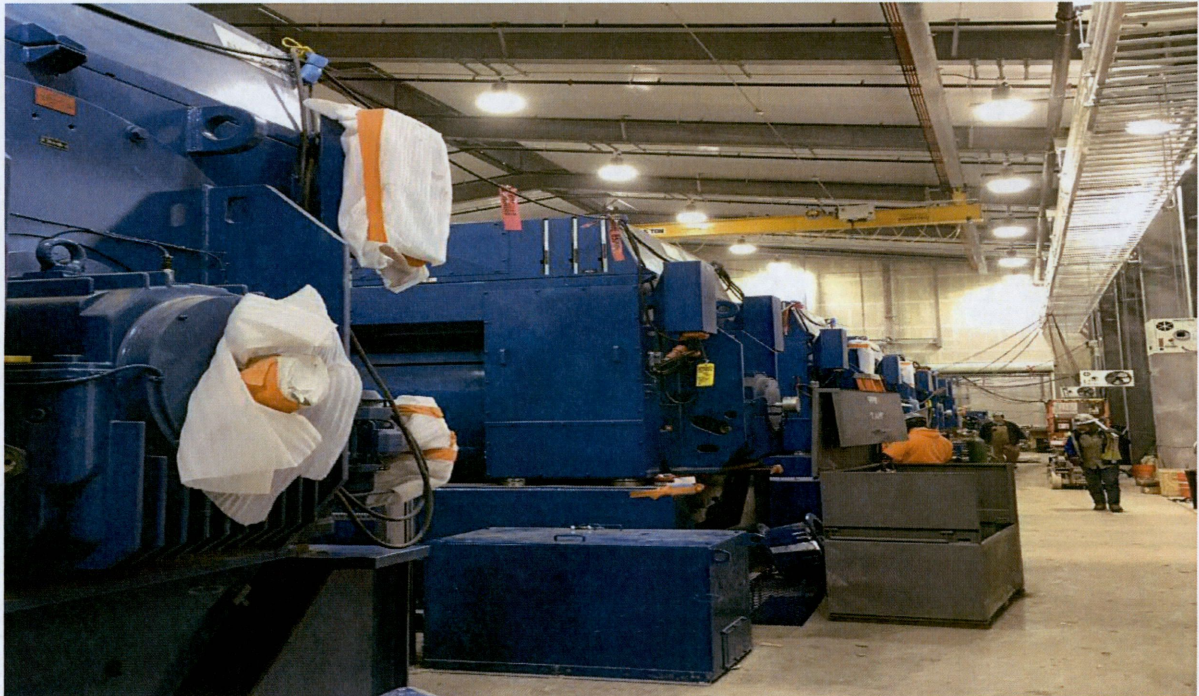
Photo 4 – View of engines in the South Engine Building

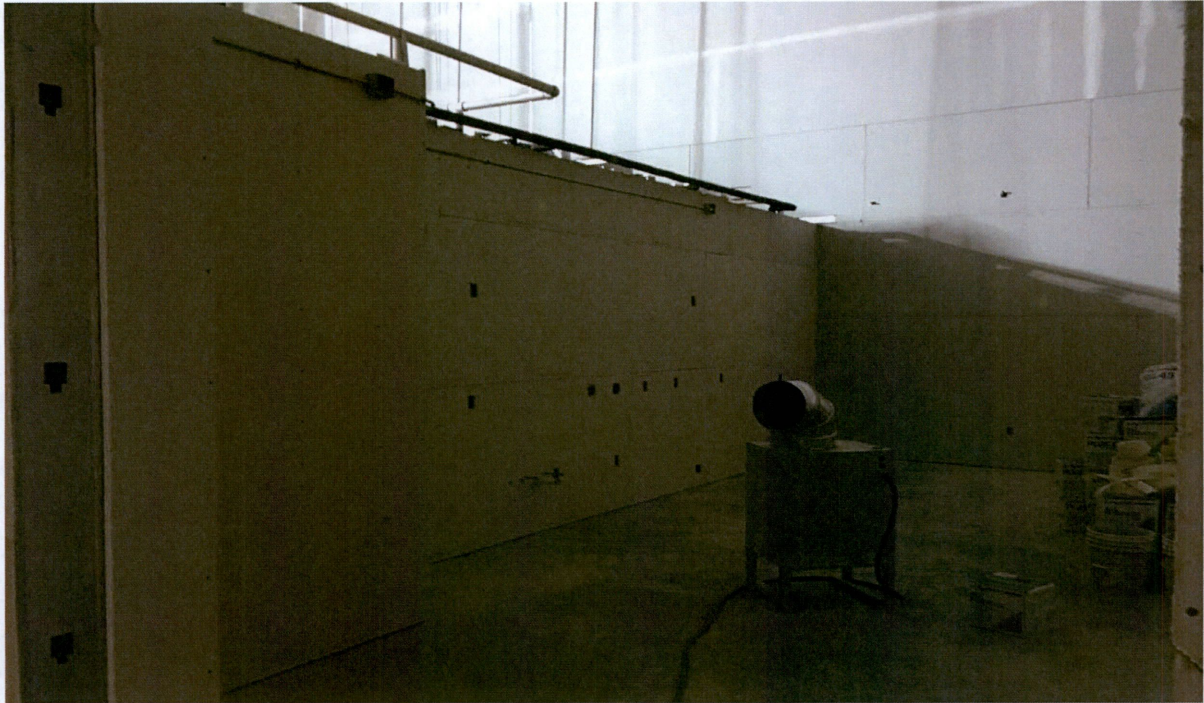
Photo 5 – View of Administration areas under construction

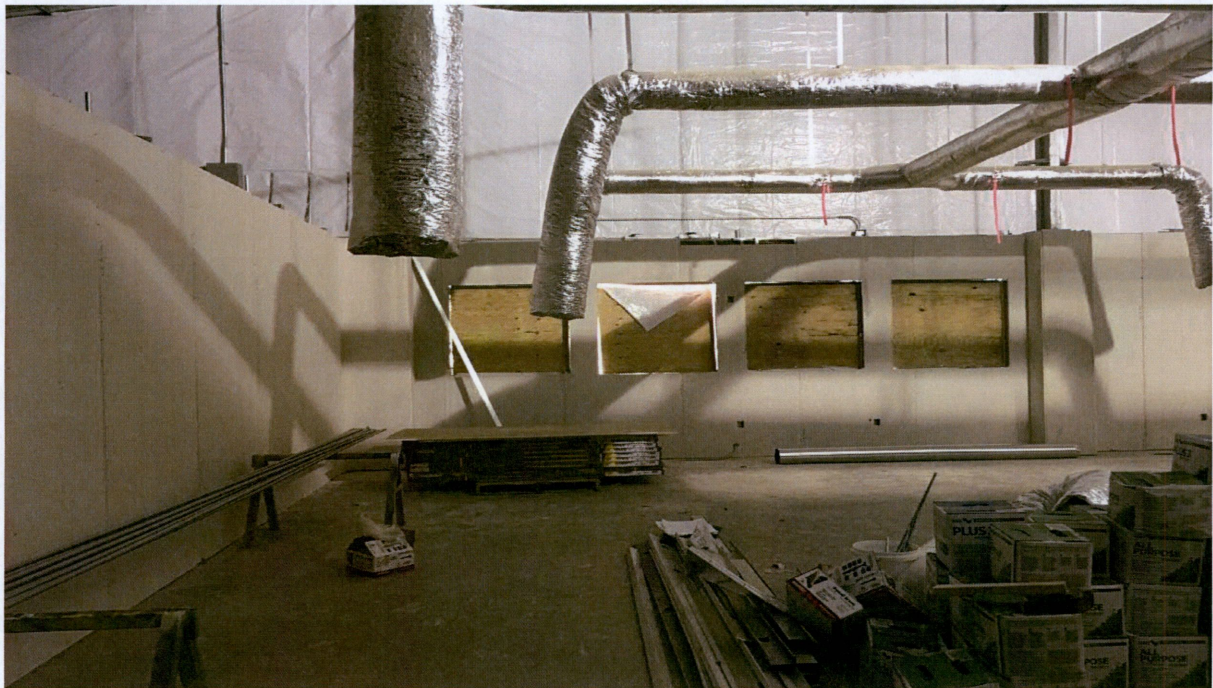
Photo 6 – View of Control Room under construction

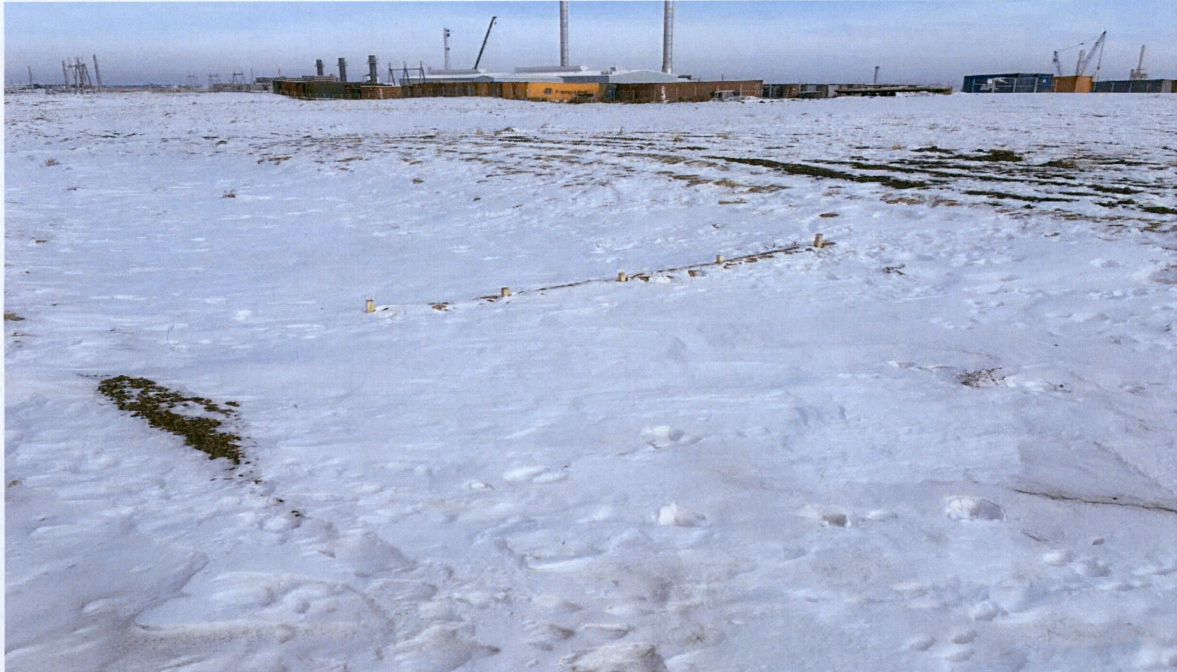
Photo 7 – View of BMP (straw wattle) in ditch adjacent to road

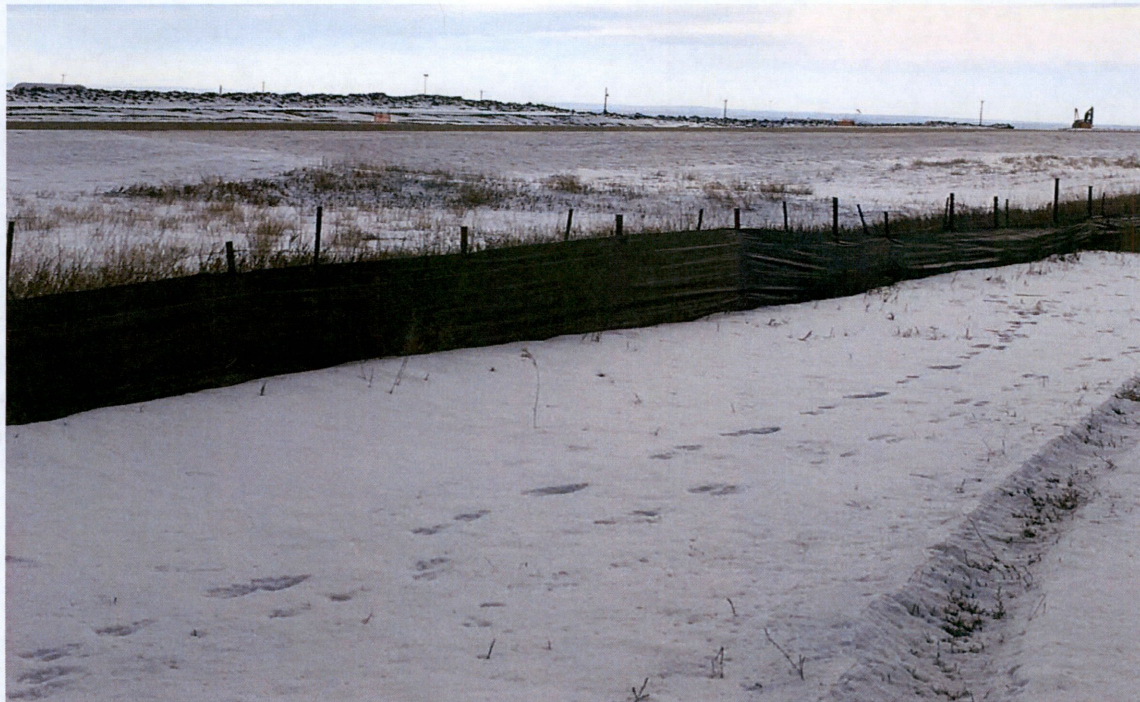
Photo 8 – View of silt fence along the perimeter of the site

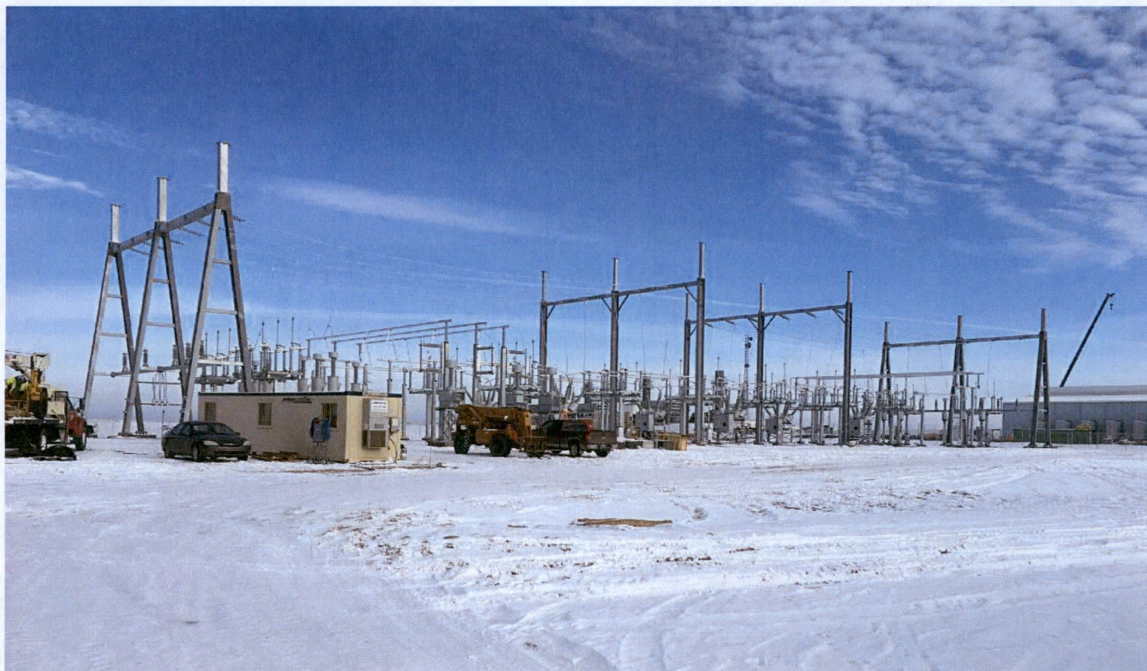
At the time of the Interim Construction Inspection, the switchyard was approximately 90% complete (Photo 10) and the stormwater pond and drains were installed (Photo 11). The water line and natural gas pipeline were installed, backfilled and restored prior to the inspection (Photo 12). The electric transmission line route was staked and the construction process had commenced (Photo 13). The parking and staging areas were well maintained (Photo 14).

Photo 10 – View of switchyard

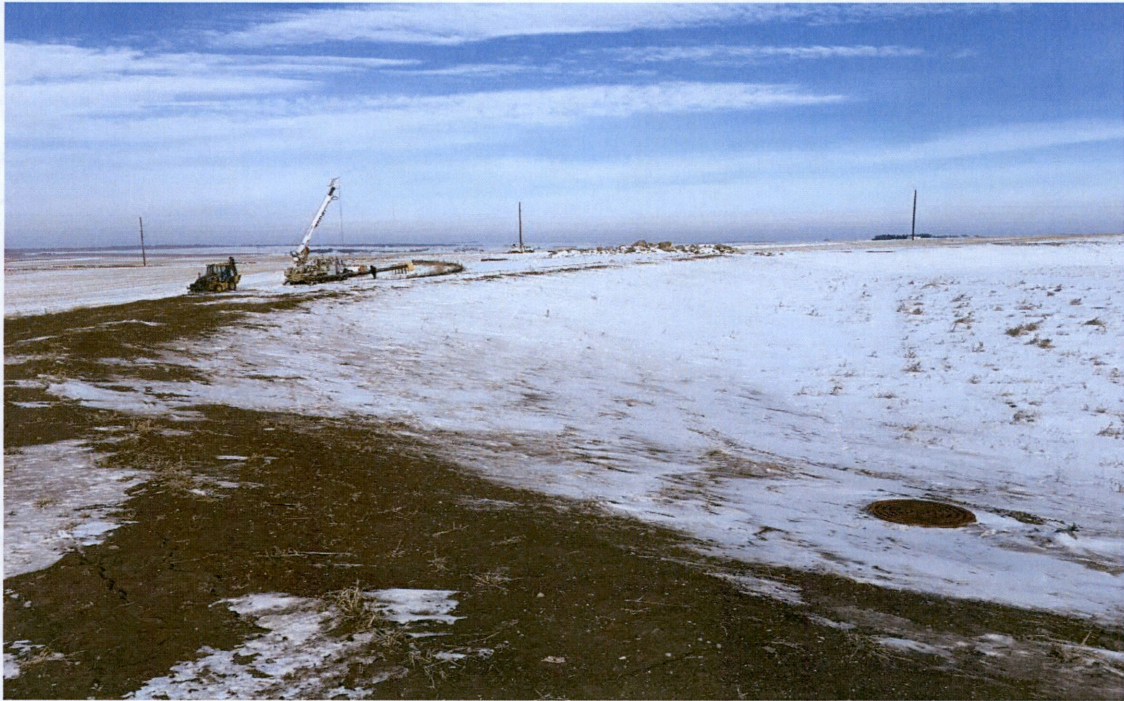
Photo 11 –View of stormwater pond

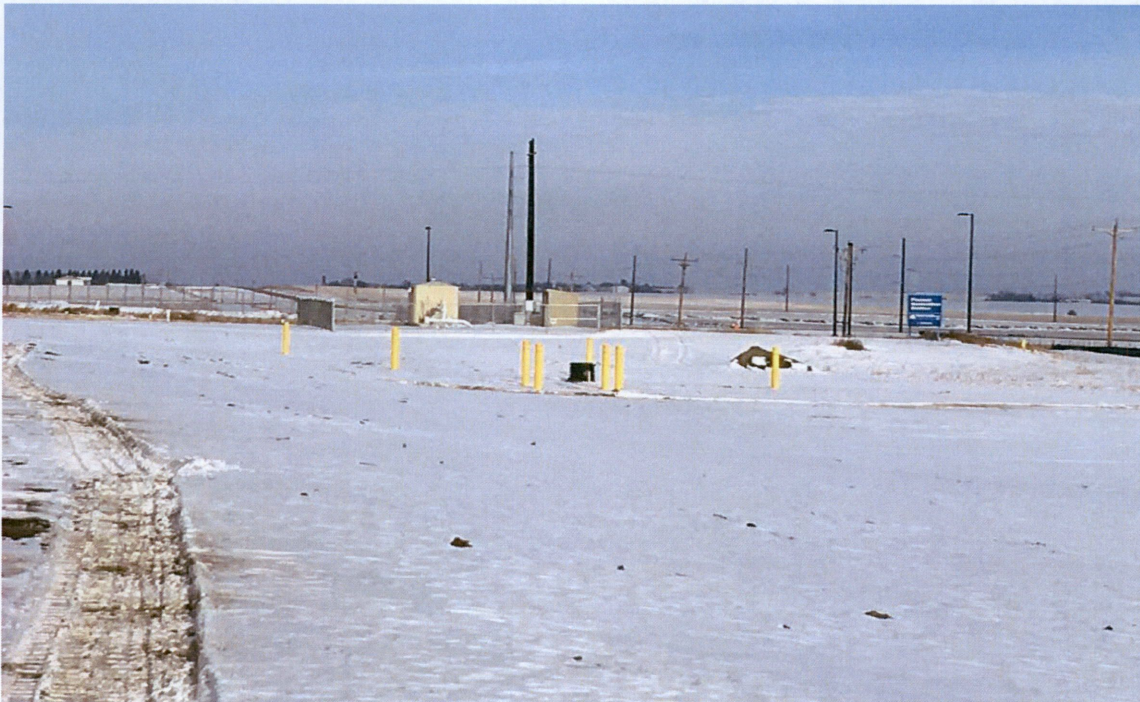
Photo 12 – View of natural gas line route

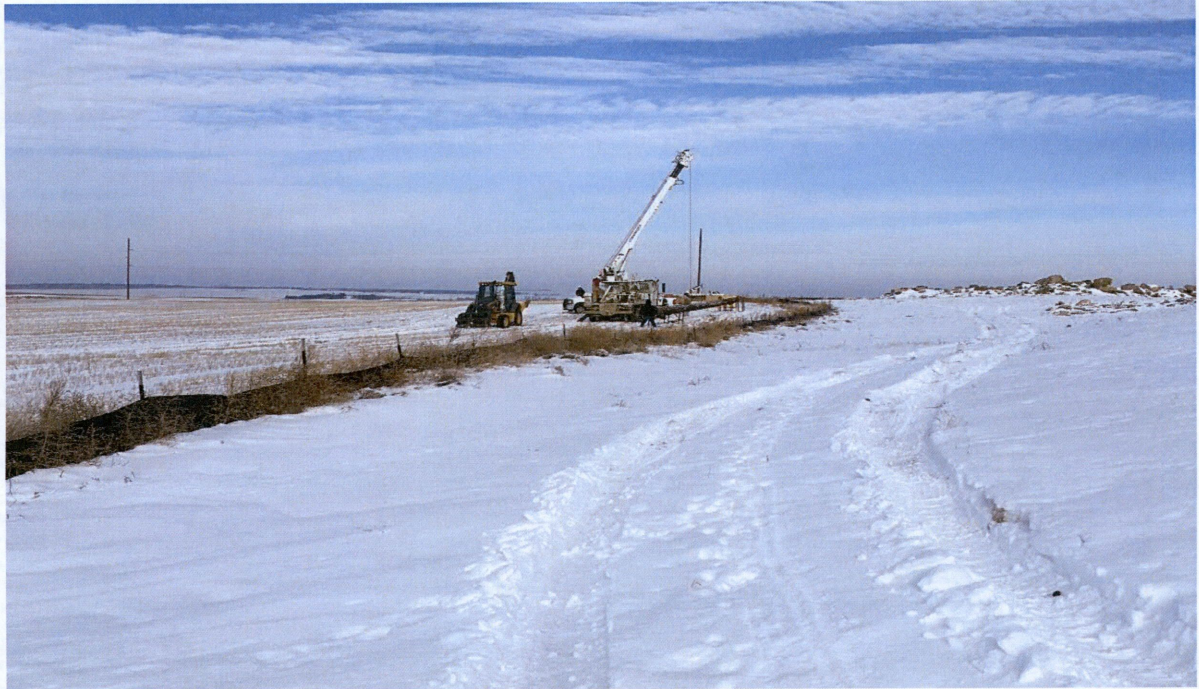
Photo 13 – View of electric transmission line construction

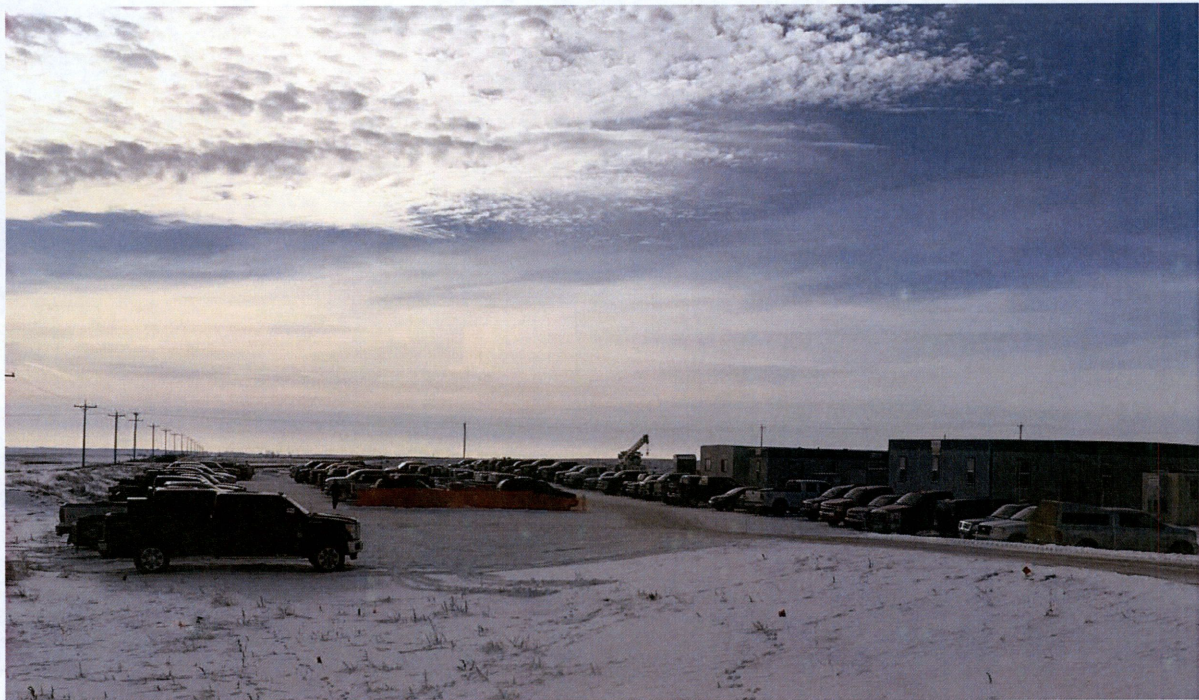
Photo 14 – View of parking and staging area
