# Dore Crude Oil Loop Pipeline Project Post-Construction Inspection Report PU-14-840

*Prepared for:*  
**North Dakota Public Service  
Commission**

**WENCK Associates, Inc.**  
301 1<sup>st</sup> Street NE, Suite 202  
Mandan, ND 58554  
Phone: 701-751-3370  
Fax: 763-479-4242

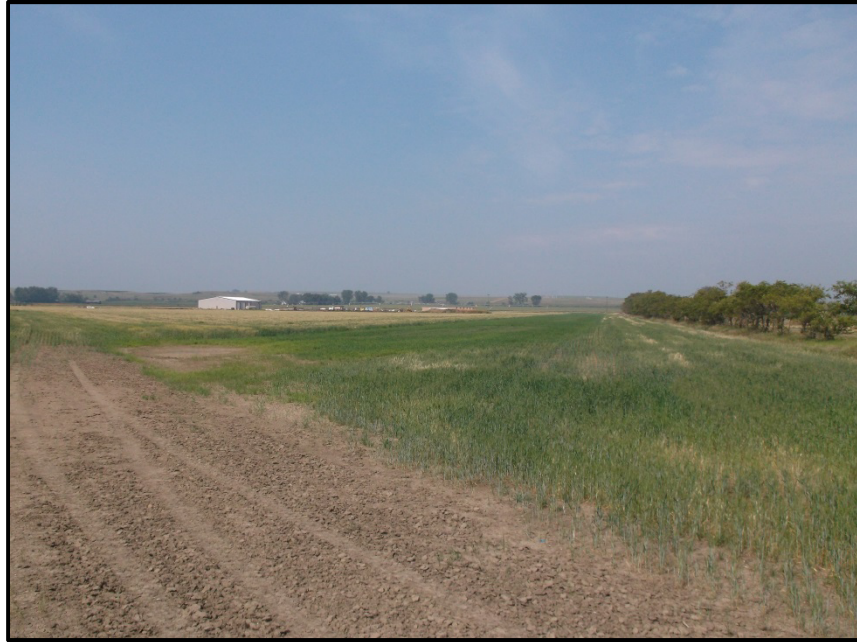
**Photo 1.** Direction: Southeast. The inspection started at the Dore County Terminal, the pipeline heads north along Hwy 58 and then bends and heads to the west. Depicted here is the pipeline section that runs to the west.

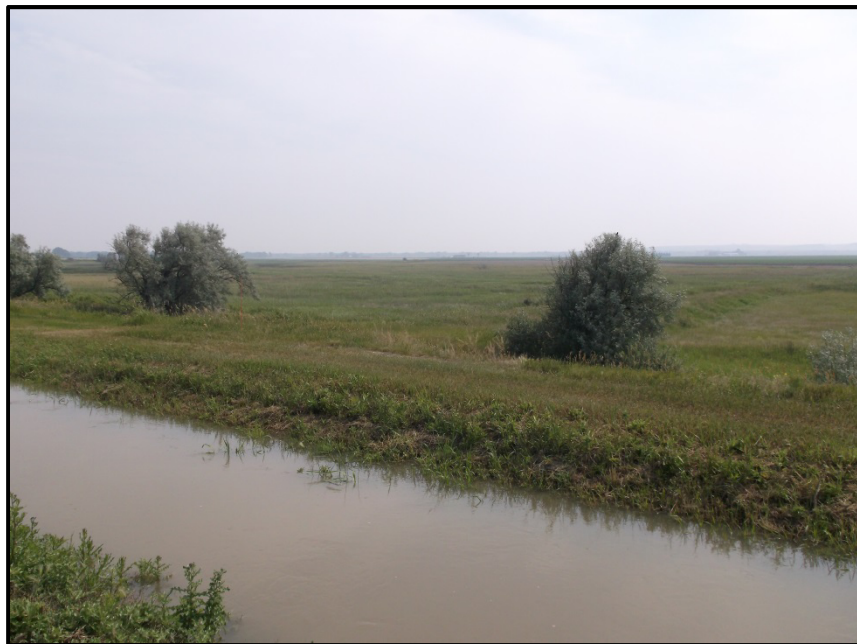
**Photo 2.** Direction: Northeast. Wetland and canal were bored under to limit impacts. Wenck observed during the inspections that the wetland had not suffered any impacts. The pipeline continues to run to the northeast.

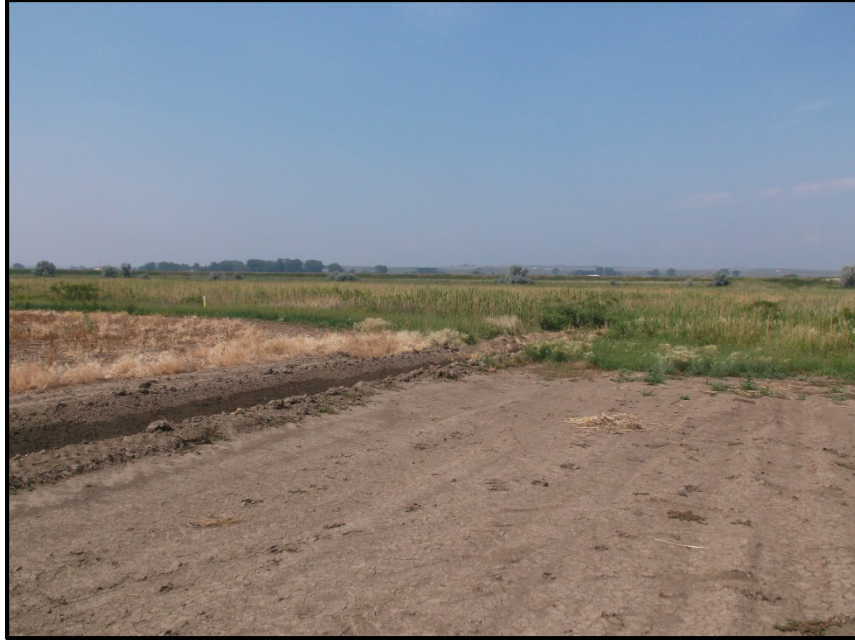
**Photo 3.** Direction: Northeast. Pipeline continues to run to the northeast through a second wetland. No impacts to the wetland were observed during the inspection.

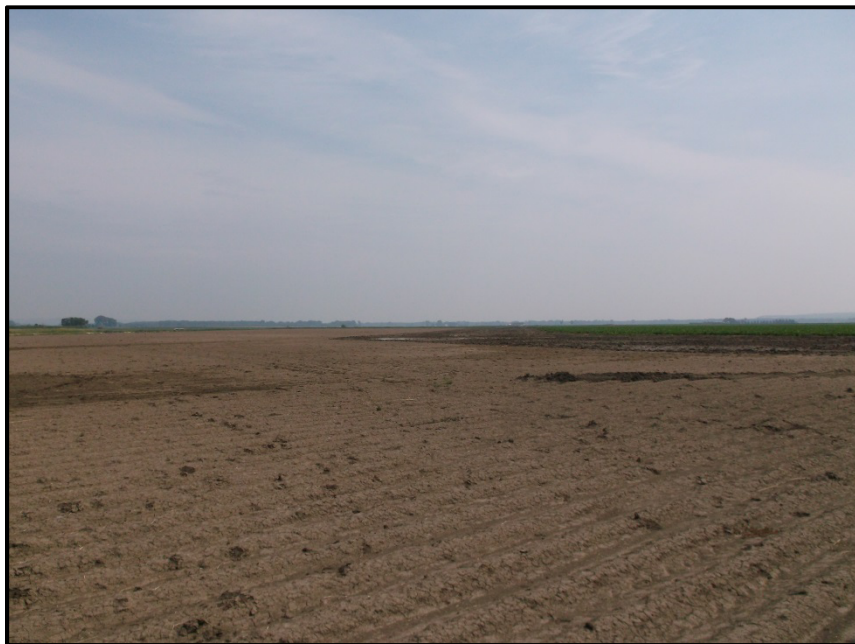
**Photo 4.** Direction: Northeast. The pipeline continues to run to the northeast through an agricultural area. Impacts were limited to the route corridor. The impacted areas were restored to preconstruction conditions.

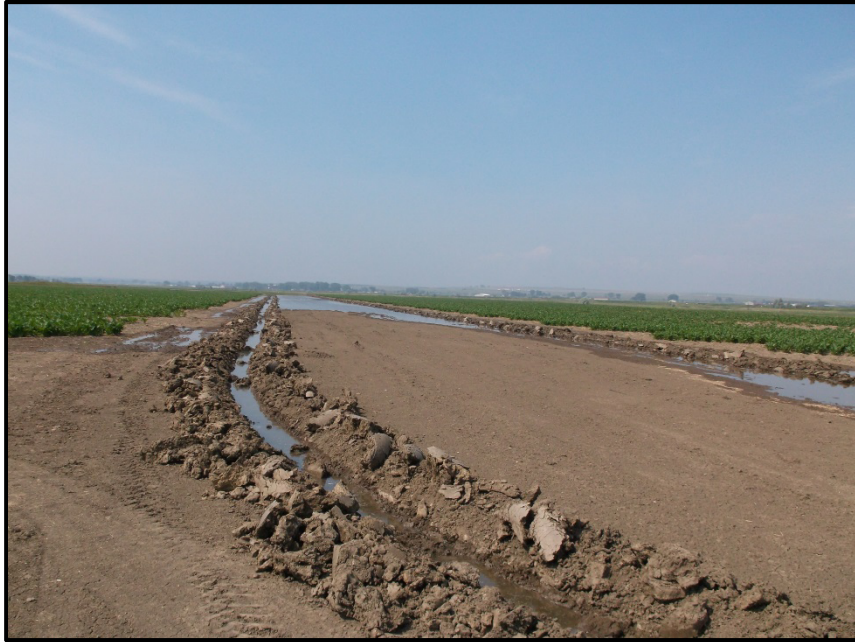
**Photo 5.** Direction: Northeast. Northeast side of bore of wetland, there were no impacts to the wetland and none were apparent during inspection. This area will be restored to preconstruction conditions. Standing water will also be remedied by the time construction is completed. Standing water is a result of farmland irrigation channels.

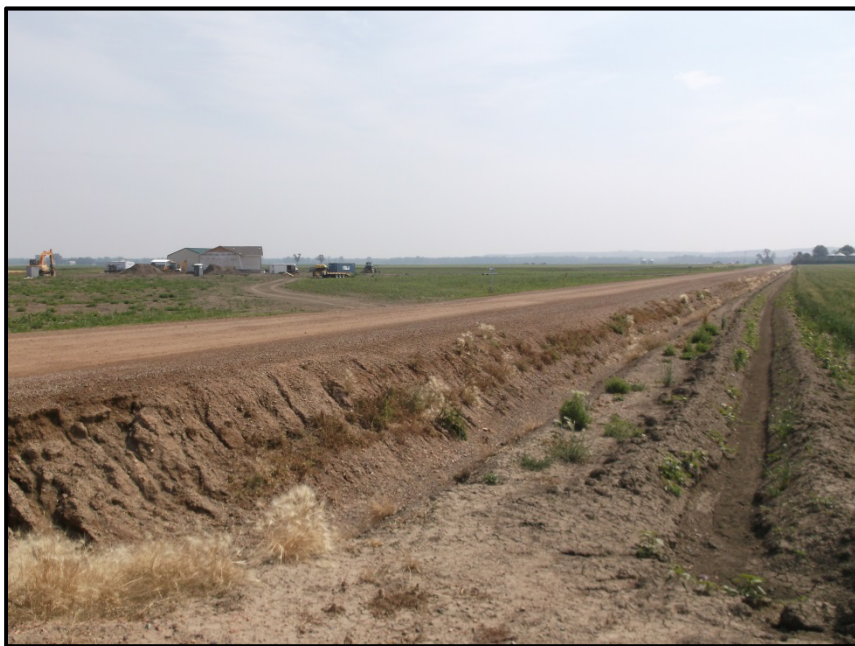
**Photo 6.** Direction: Northeast. The pipeline crosses the road via a bore underneath it. The pipeline then bends to the east after crossing the road and runs parallel to it in the ROW. After this point there are no more major road crossings or wetlands, several irrigation channels are bored under during the run alongside this road.

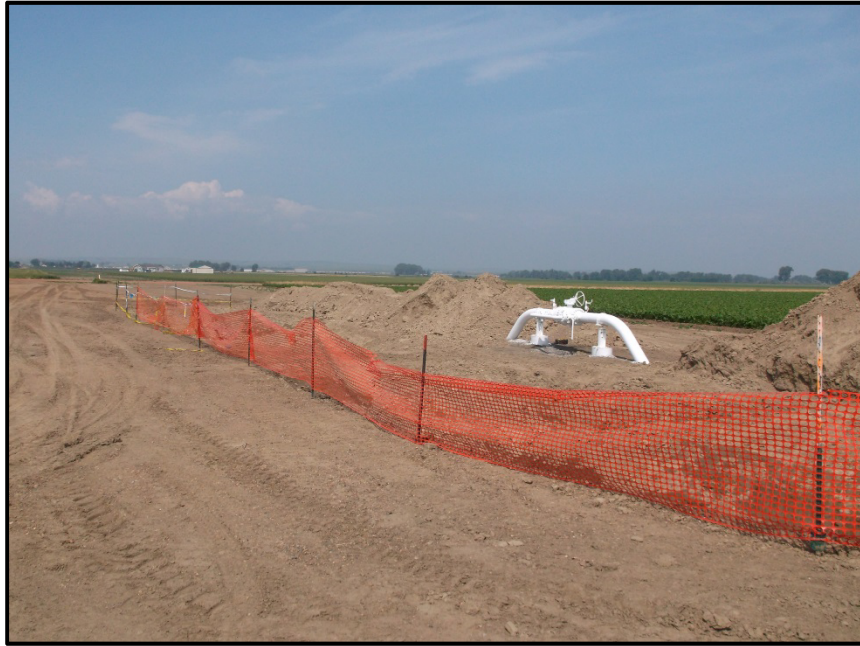
**Photo 7.** Direction: Northwest. One of several currently active construction sites that will be completed in the near future. Pipeline continues to run east along the ROW.

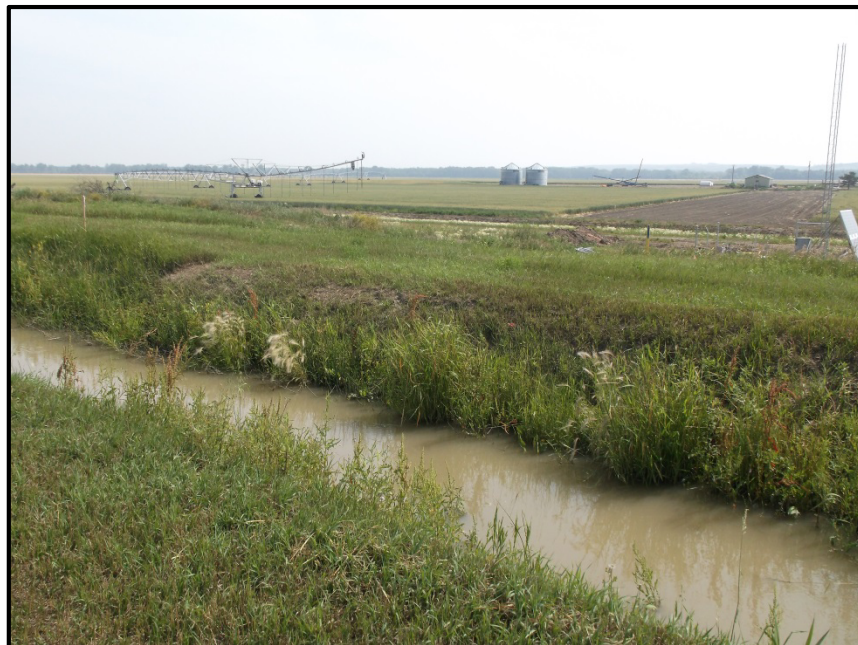
**Photo 8.** Direction: Northeast. Pictured above is one of the irrigation canals that were bored under. No impacts were apparent during the inspection.

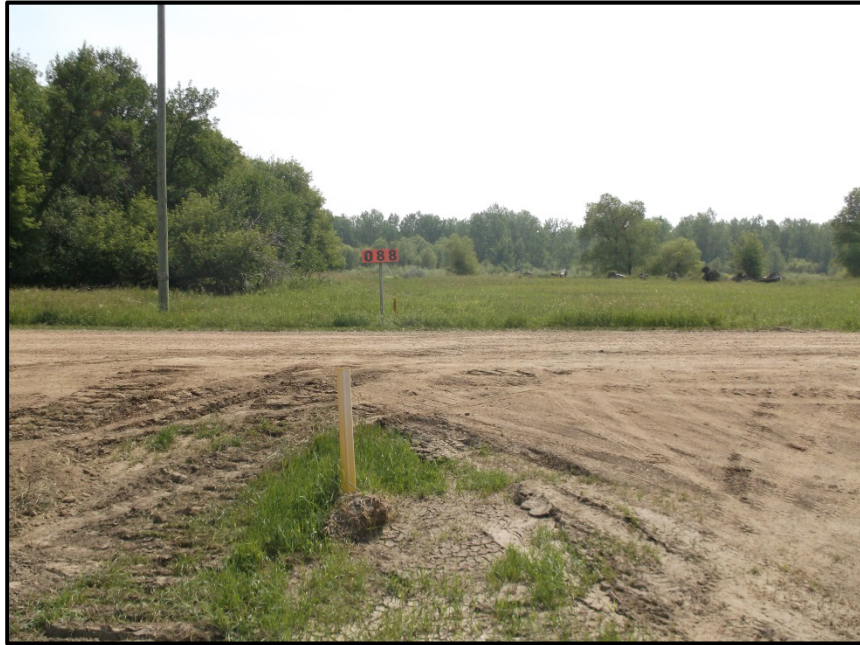
**Photo 9.** Direction: East. This is the entry point for the bore underneath the Yellowstone River.

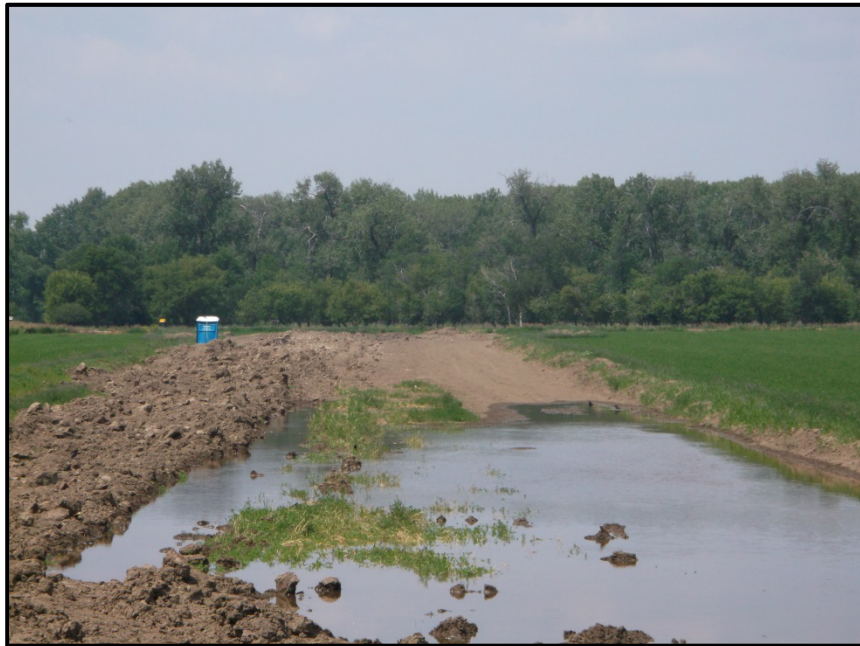
**Photo 10.** Direction: West. This is the exit point for the bore underneath the Yellowstone River. At the time of the inspection the topsoil was being put back in place. Standing water is a result of irrigation from surrounding farmlands. Area will be completely mitigated by the end of construction.

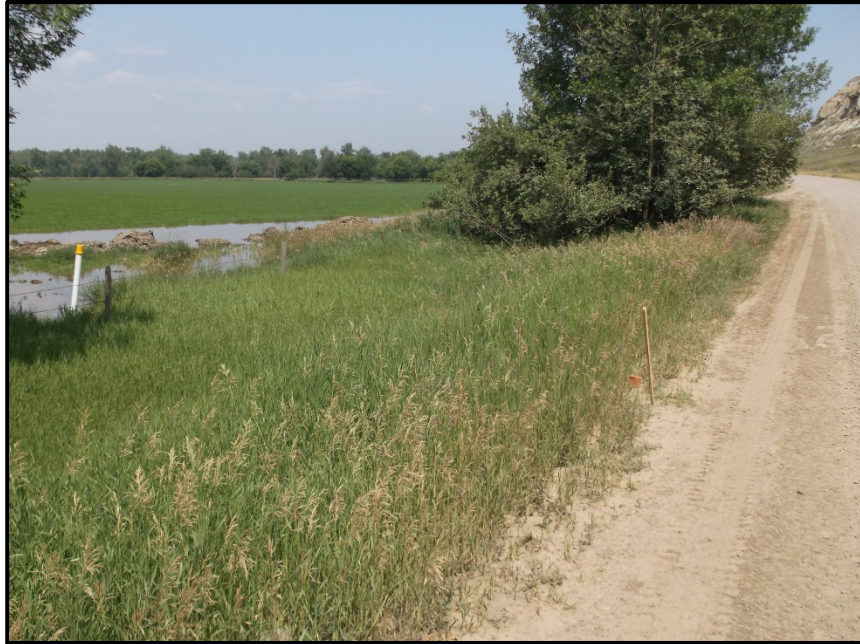
**Photo 11.** Direction: North. After the bore underneath the river the pipeline continues to the east.

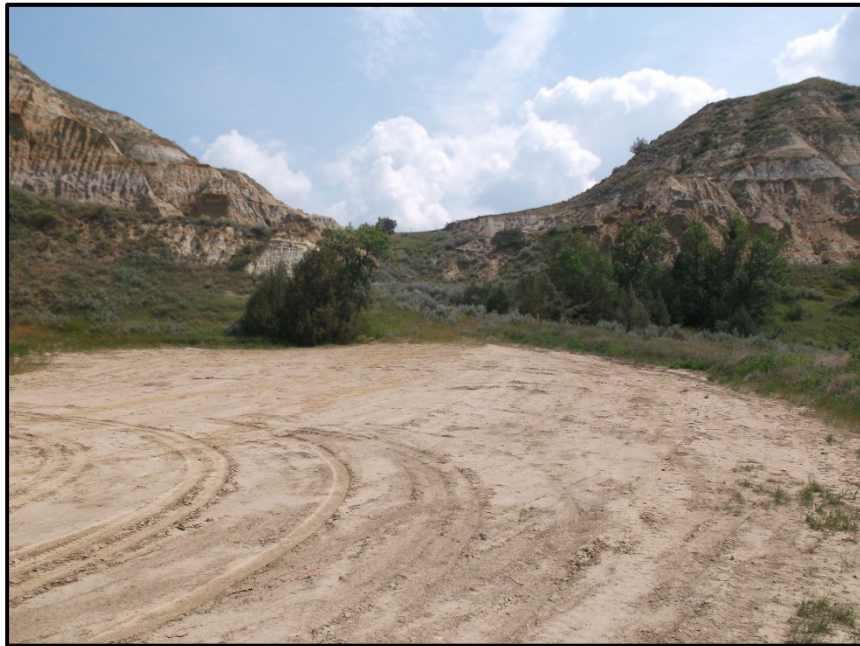
**Photo 12.** Direction: East. The pipeline continues to the east and a bore was completed through the hill pictured above.

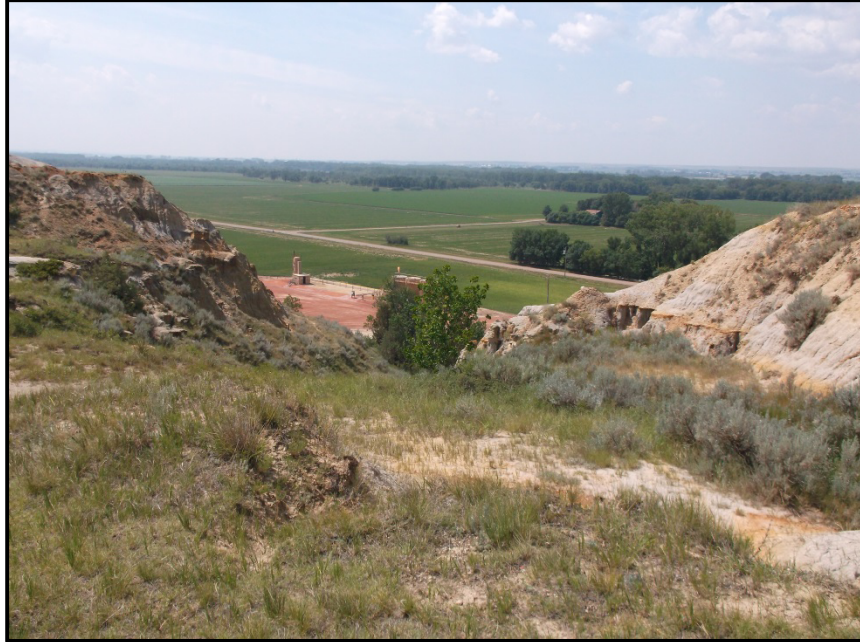
**Photo 13.** Direction: West. This is the approximate exit point of the bore through the hill. The pipeline then continues to the east following the existing ground contours.

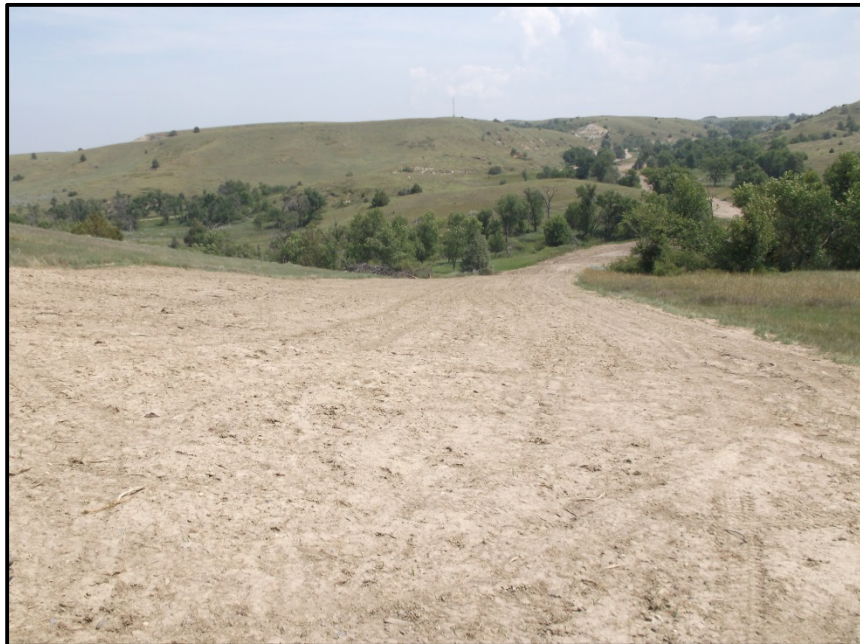
**Photo 14.** Direction: East. Depicted above is the pipeline corridor done the side of the hill previously mentioned. The corridor still needs to be seeded to fully complete remediation.

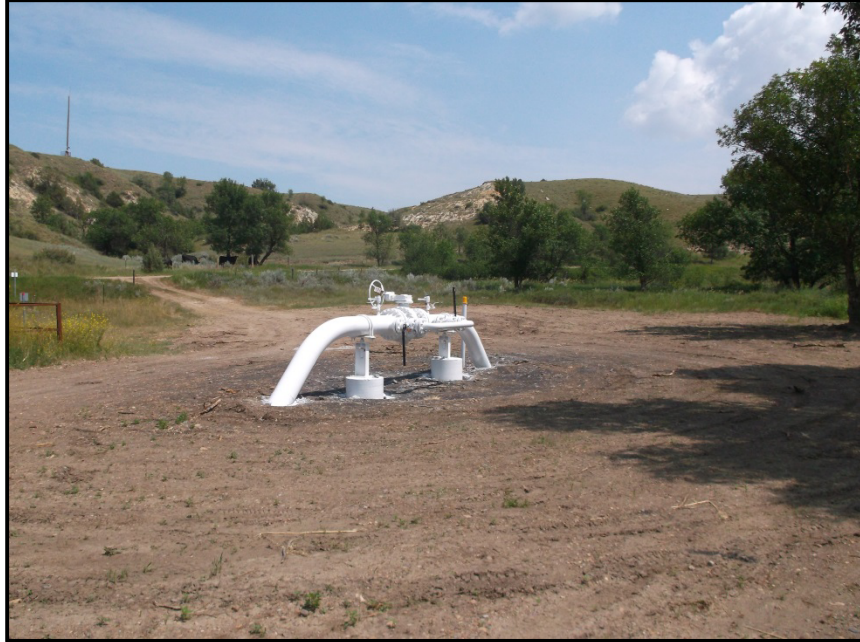
**Photo 15.** Direction: Northeast. Pictured above is one of several block valves, at this point the pipeline bends to the north. This area also still needs to be seeded.

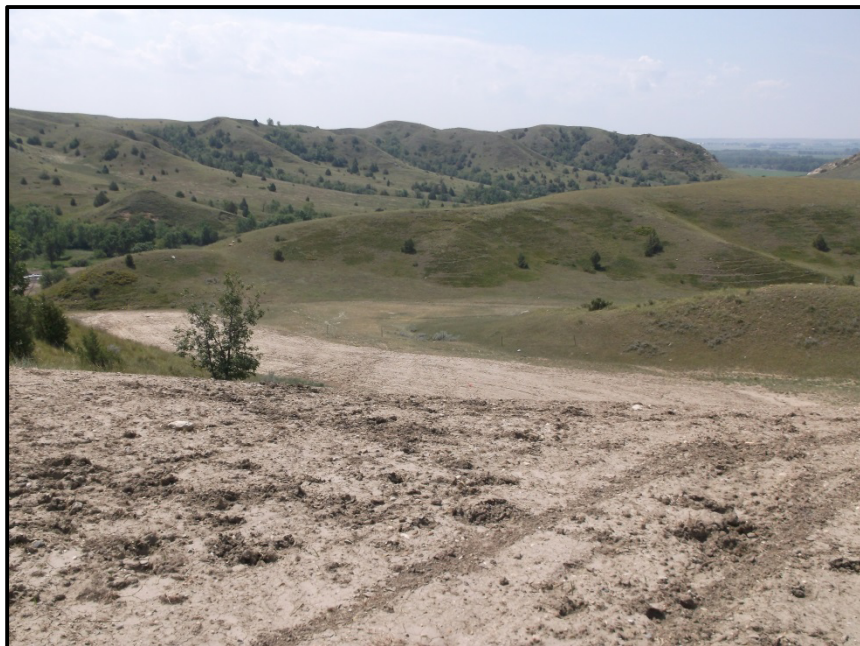
**Photo 16.** Direction: Southwest. After its short run to the north the pipeline bends continues running to the east. It was apparent that the route corridor widths described in the application were used throughout the project as depicted in the picture above.

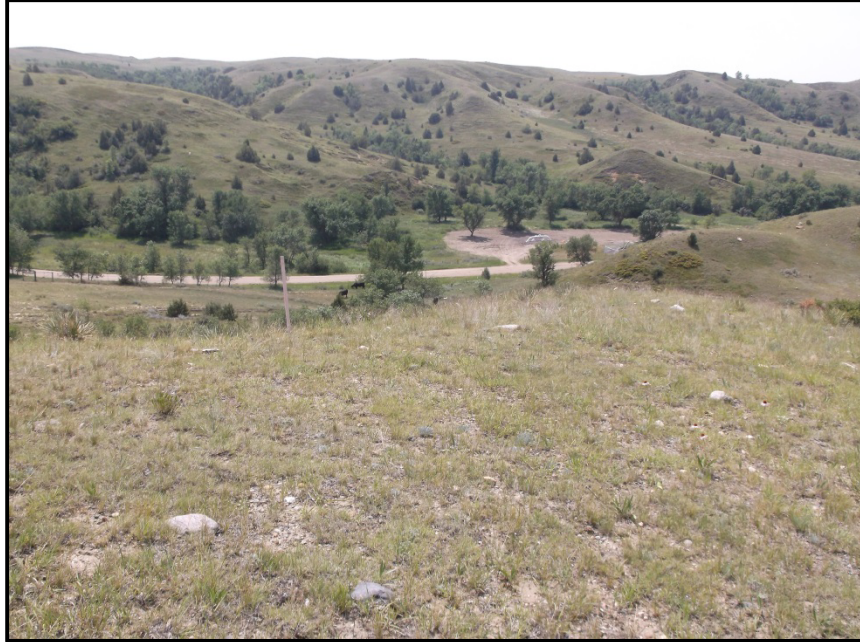
**Photo 17.** Direction: Southeast. Shown above is the one cultural resource site located near the project. The site was not affected in any adverse way during construction and this was observed to be the case during the inspection.

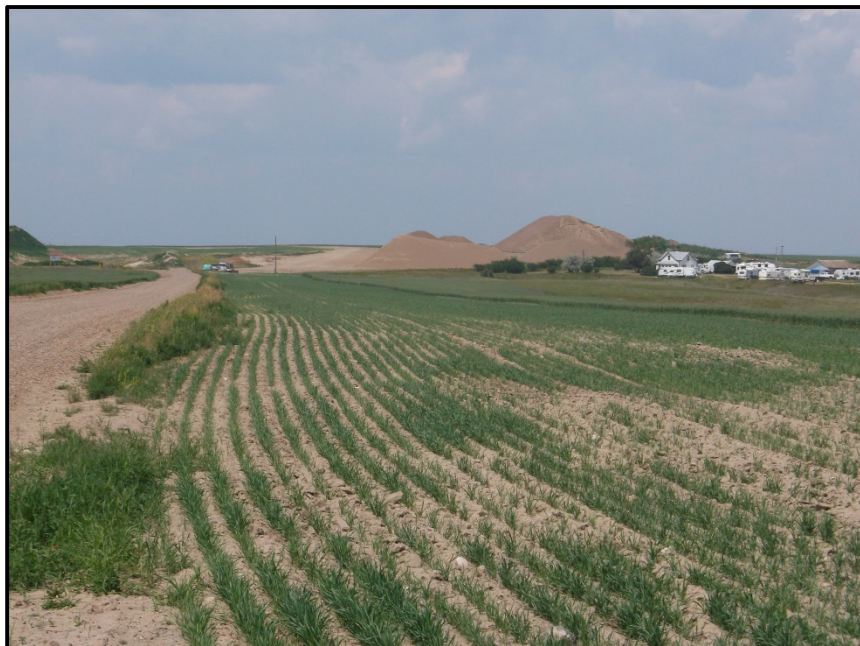
At the time of the site inspection, the pipeline trench had been backfilled, soils had been recontoured, and part of the reseeded had been completed in grassland areas (**Appendix A**, Photos 18-19) The majority of the project had just been seeded (**Appendix A**, Photos 23-32). There were still three areas of active construction at time of inspection (**Appendix A**, Photos 7, 22, 25). Wenck recommends the PSC request documentation from Hiland once vegetation has fully established in all reseeded areas of the project.

**Photo 18.** Direction: East. This section of the pipeline ROW runs east and west and has recently been seed as depicted above. A follow up by the PSC with Kinder Morgan is needed to ensure full reclamation.

When the post construction inspection of the project was conducted reseeding of the project had just been completed. Wenck recommends the PSC request monitoring and documentation to ensure the vegetation is established throughout the project.

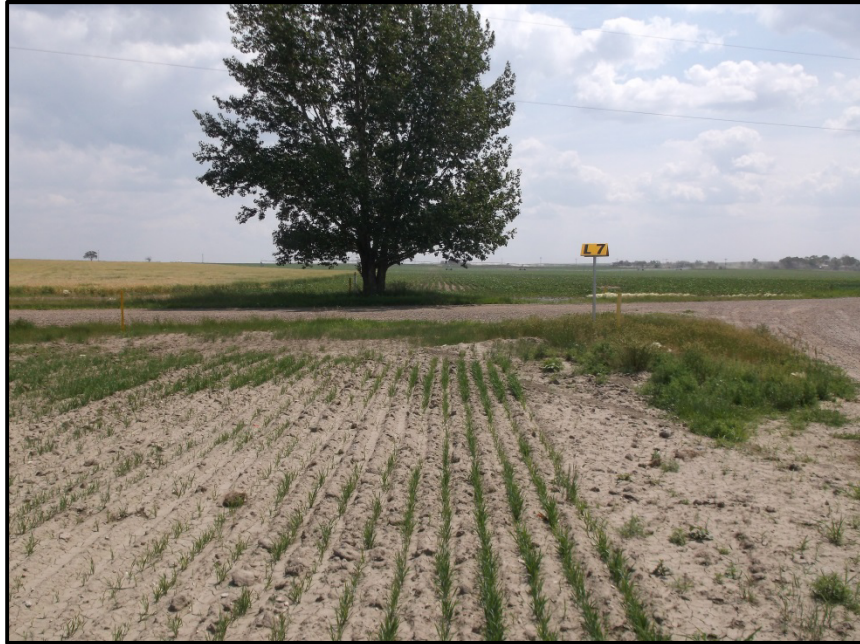
**Photo 19.** Direction: East. This section of the pipeline ROW runs east and west before bending to the southeast and has recently been seeded as depicted above. A follow up by the PSC with Kinder Morgan is needed to ensure full reclamation.

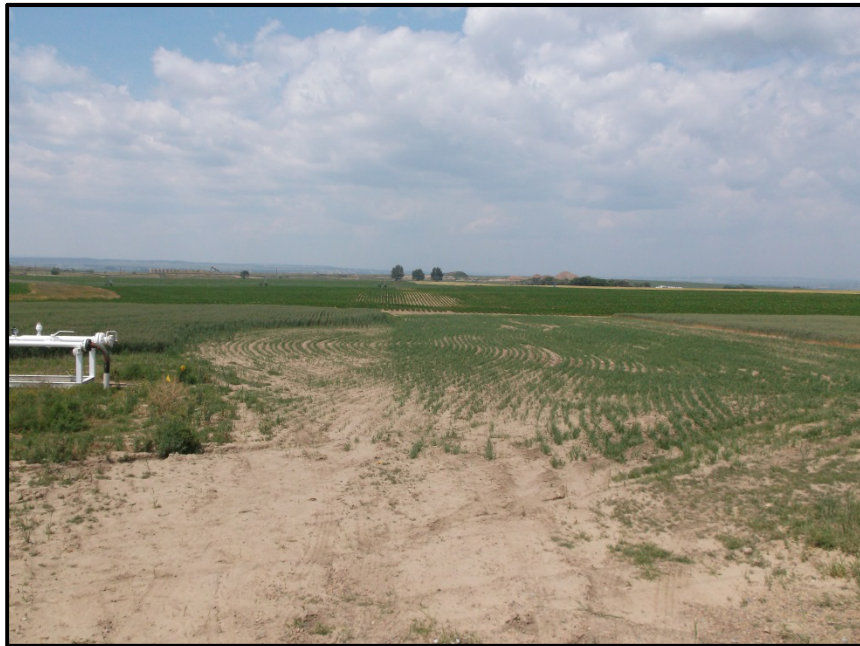
**Photo 20.** Direction: Southeast. The pipeline corridor continues to run to the southeast towards 36 St NW. This is another area that had been recently seeded.

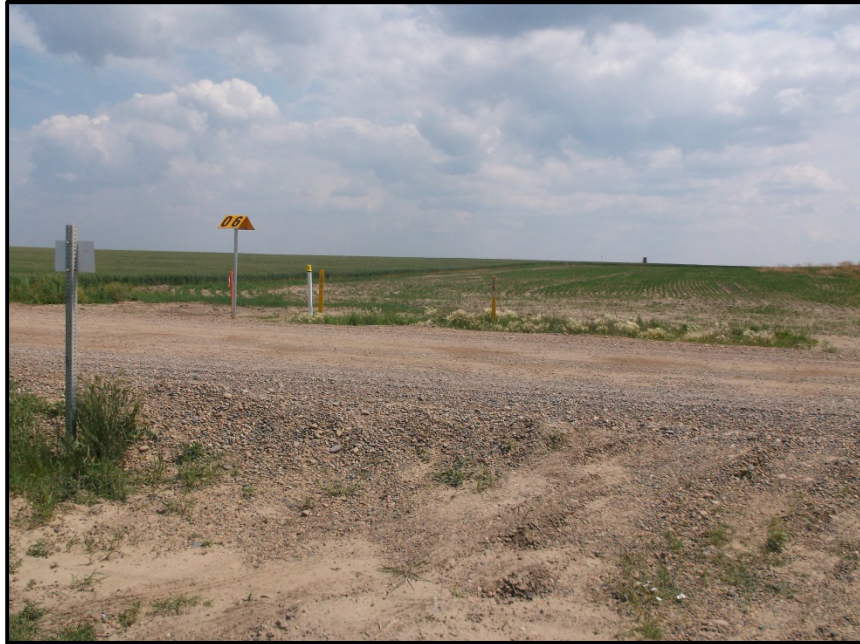
**Photo 21.** Direction: South. This is the bore location underneath 36<sup>th</sup> St NW. No permanent impacts to the road were observed during the inspection. Above ground pipeline markers are also depicted in this photo.

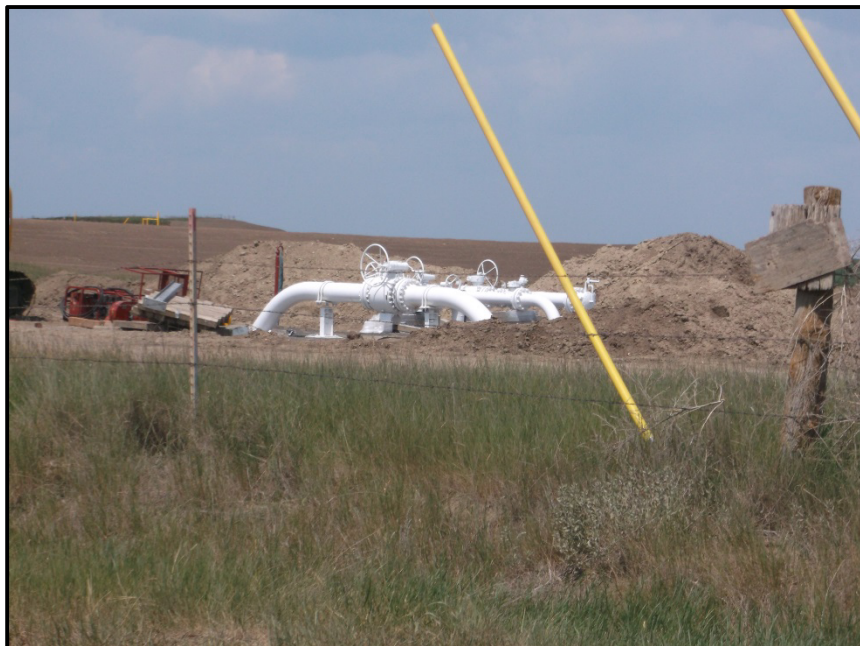
**Photo 22.** Direction: Southwest. After crossing 36<sup>th</sup> St NW the pipeline bends back to the east and runs parallel to the road on the south side. Pictured above is another active construction site at a block valve at the time of the inspection.

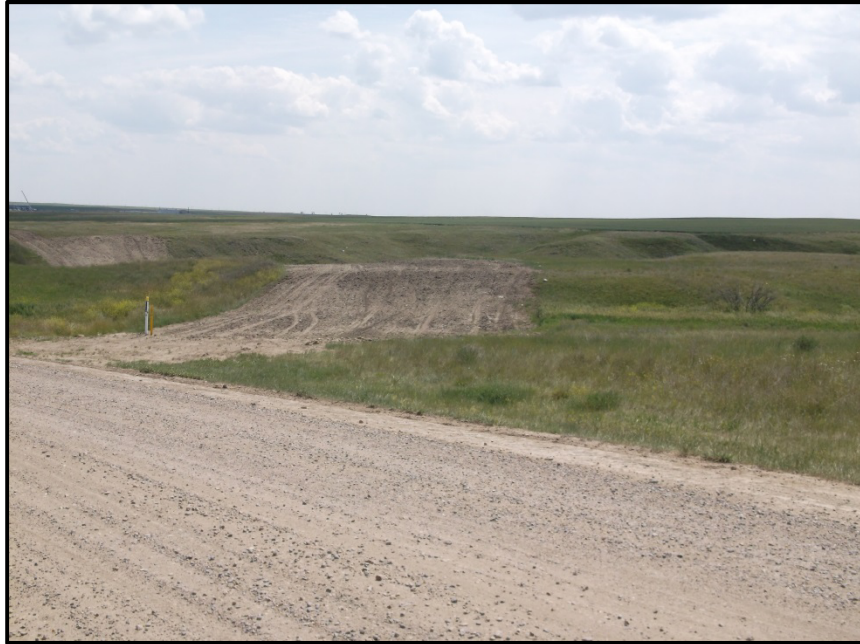
**Photo 23.** Direction: Southeast. The pipeline crosses 36<sup>th</sup> St NW and runs north of the road for a short while before crossing again and continuing parallel and south of the road. This portion of the corridor still needs to be seeded and monitored until fully reclaimed.

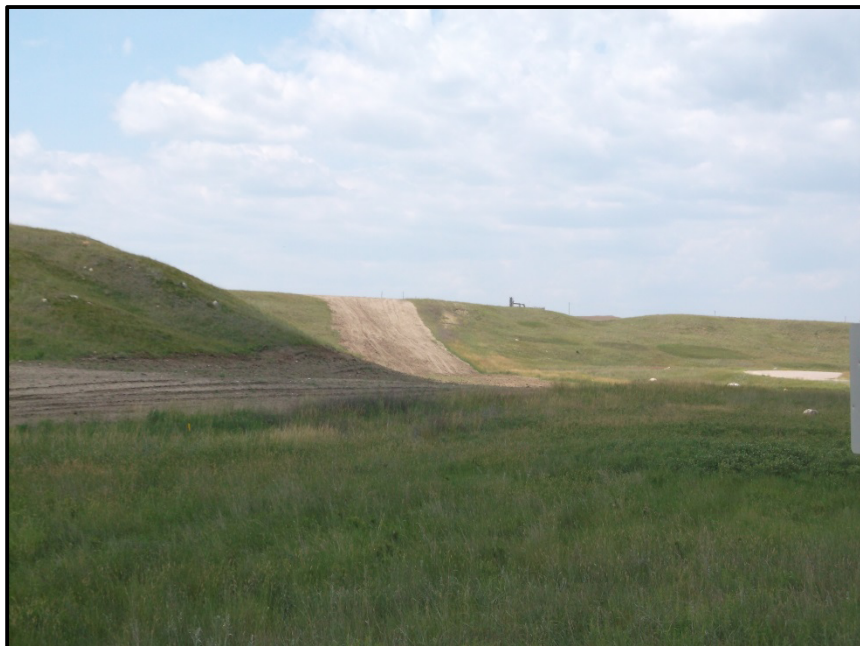
**Photo 24.** Direction: East. This portion of the corridor still needs to be seeded and monitored until fully reclaimed. It was apparent that the route corridor widths described in the application were used throughout the project as depicted in the picture above.

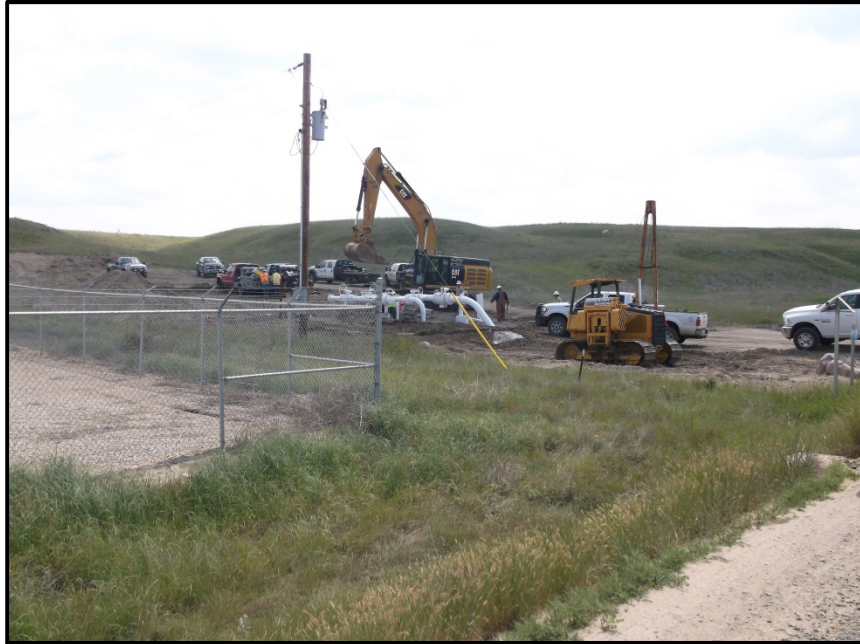
**Photo 25.** Direction: South. This is a third active construction site at the time of the inspection. It is likely that construction has been completed since the inspection and it is recommended that the PSC follow up with Kinder Morgan.

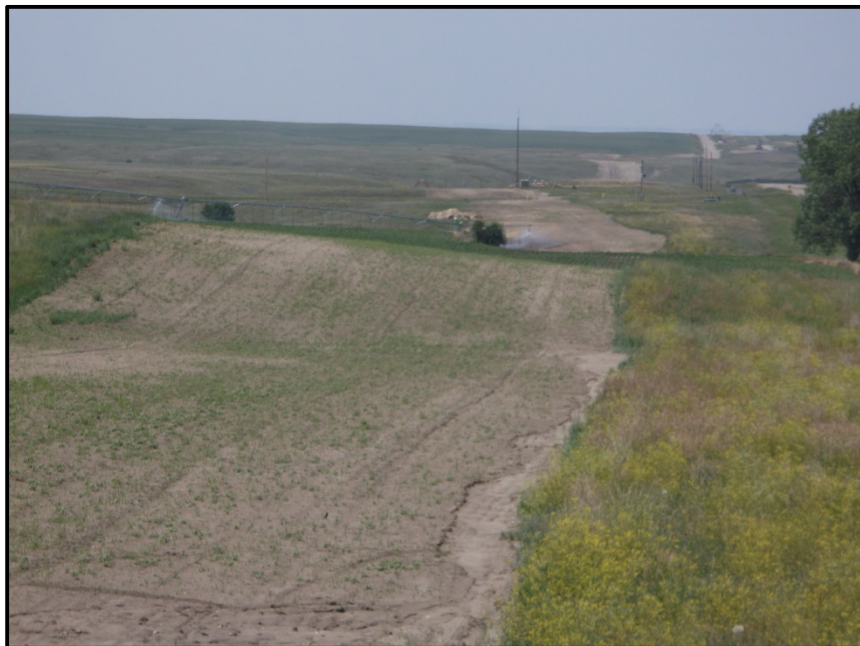
**Photo 26.** Direction: East. This portion of the corridor was recently seeded and needs to be monitored until fully reclaimed. It was apparent that the route corridor widths described in the application were used throughout the project as depicted in the picture above.

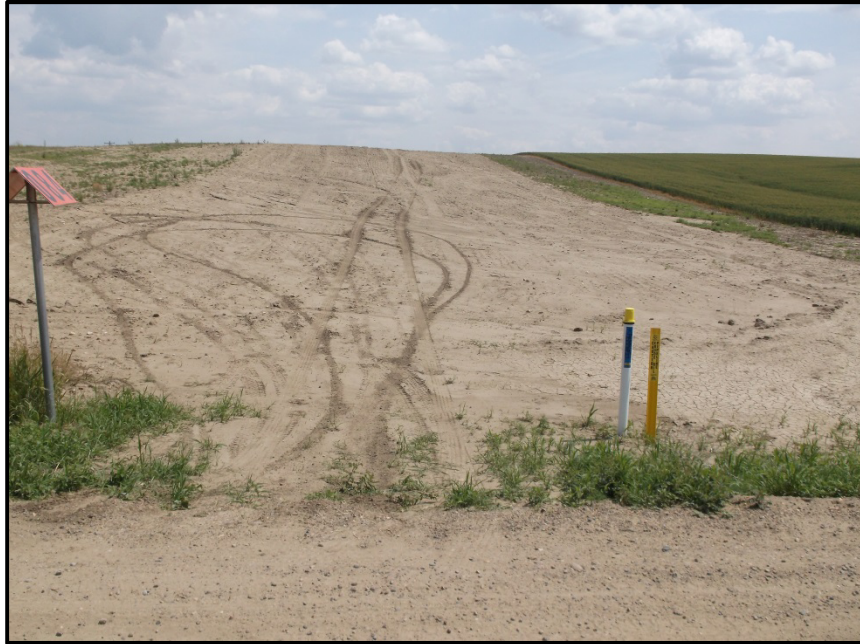
**Photo 27.** Direction: East. This is the section of the pipeline corridor that runs east and west parallel to 36<sup>th</sup> St NW. The ROW along the road has not been completely reclaimed. Shown here is an access road crossing that was completed by boring underneath the road. Also shown is an above ground pipeline marker.

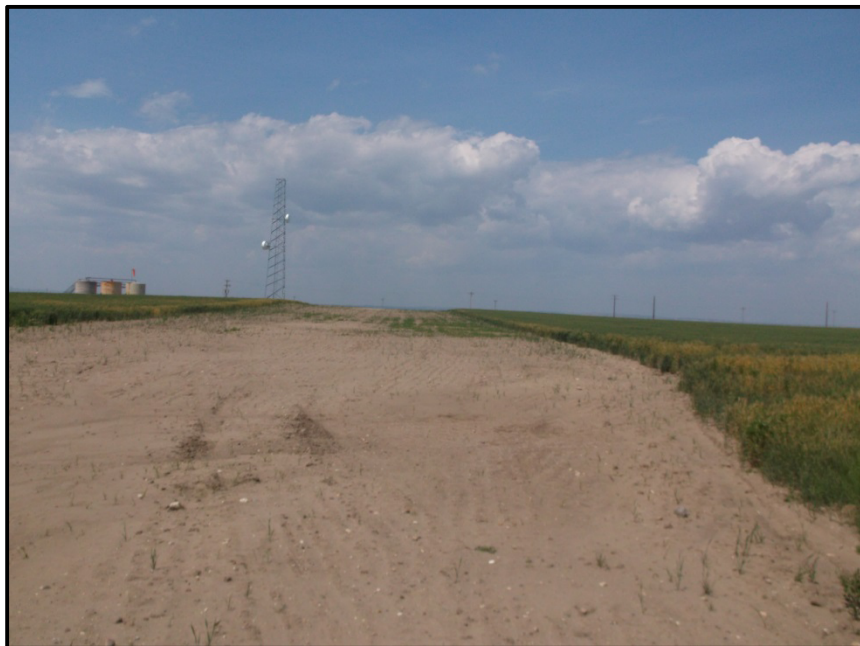
**Photo 28.** Direction: East. This portion of the corridor was recently seeded and needs to be monitored until fully reclaimed. It was apparent that the route corridor widths described in the application were used throughout the project as depicted in the picture above.

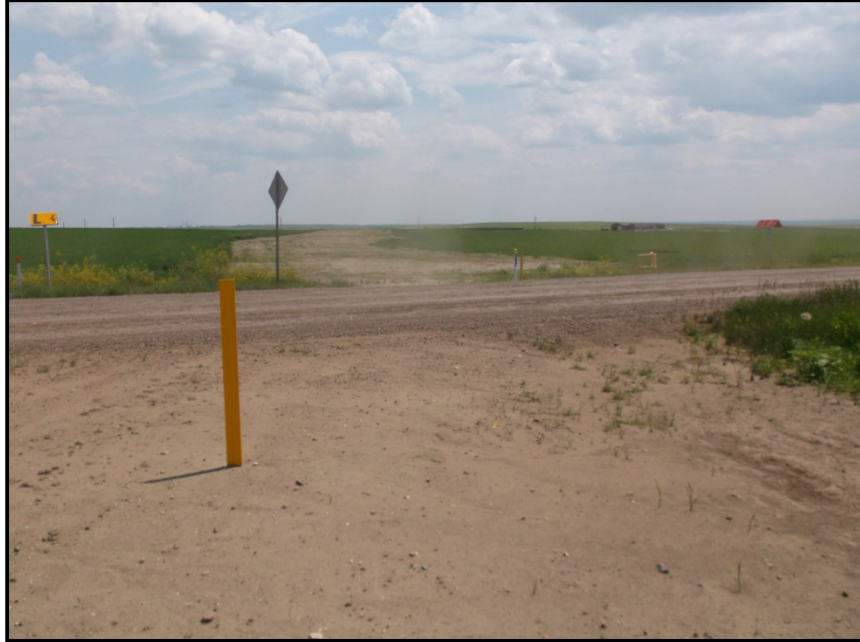
**Photo 29.** Direction: East. This is the section of the pipeline corridor that runs east and west parallel to 36<sup>th</sup> St NW. The ROW along the road has not been completely reclaimed. Shown here is an access road crossing that was completed by boring underneath the road. Also shown is an above ground pipeline marker.

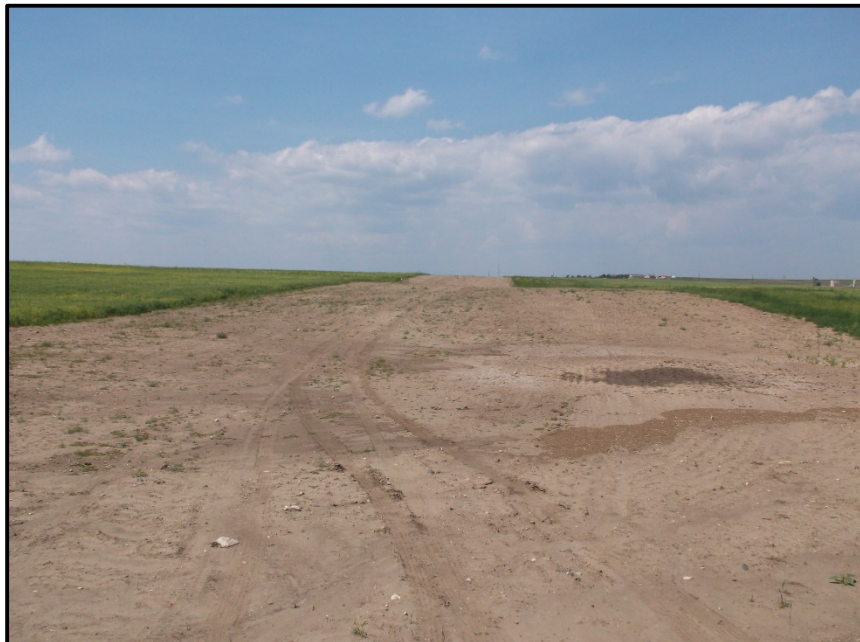
**Photo 30.** Direction: East. This portion of the corridor was recently seeded and needs to be monitored until fully reclaimed. It was apparent that the route corridor widths described in the application were used throughout the project as depicted in the picture above.

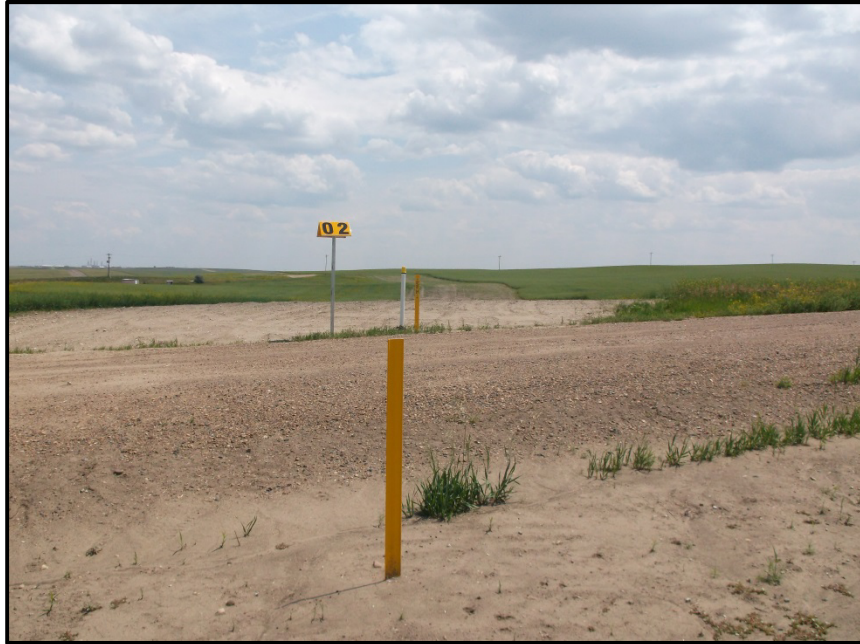
**Photo 31.** Direction: East. This is the section of the pipeline corridor that runs east and west parallel to 36<sup>th</sup> St NW. The ROW along the road has not been completely reclaimed. Shown here is an access road crossing that was completed by boring underneath the road. Also shown are above ground pipeline markers.

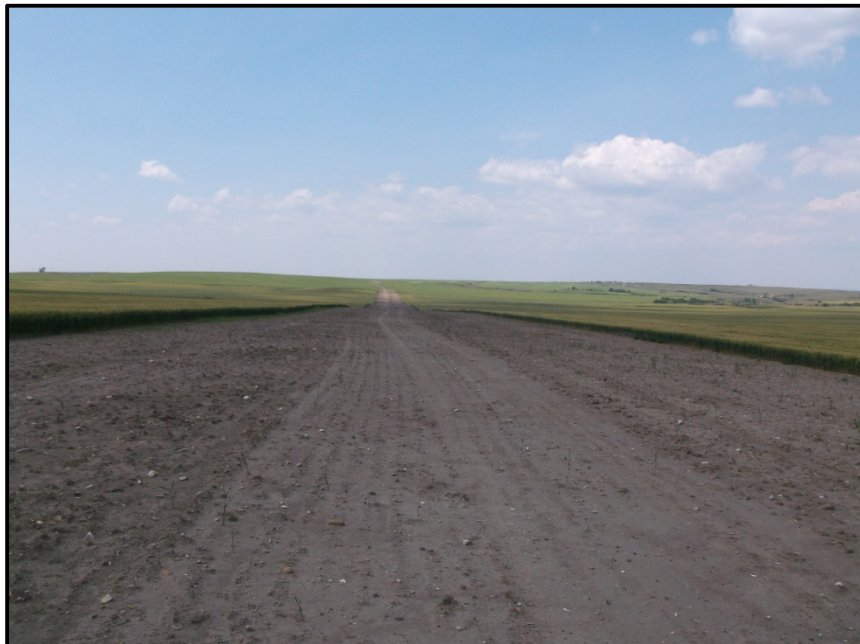
**Photo 32.** Direction: East. This portion of the corridor was recently seeded and needs to be monitored until fully reclaimed. It was apparent that the route corridor widths described in the application were used throughout the project as depicted in the picture above.

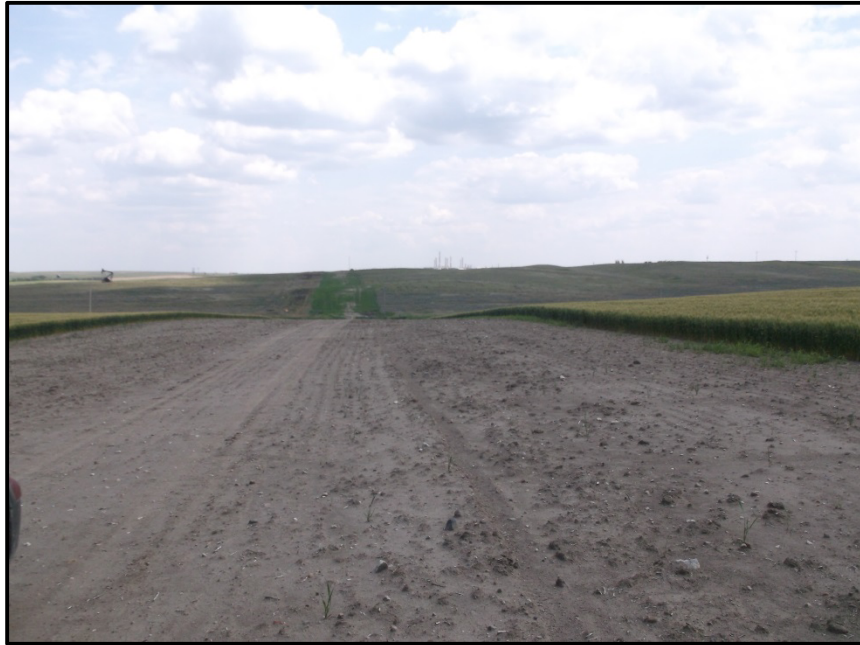
**Photo 33.** Direction: East. Another section of the pipeline corridor running east and west that has been recently seeded and should continue to be monitored until fully reclaimed.

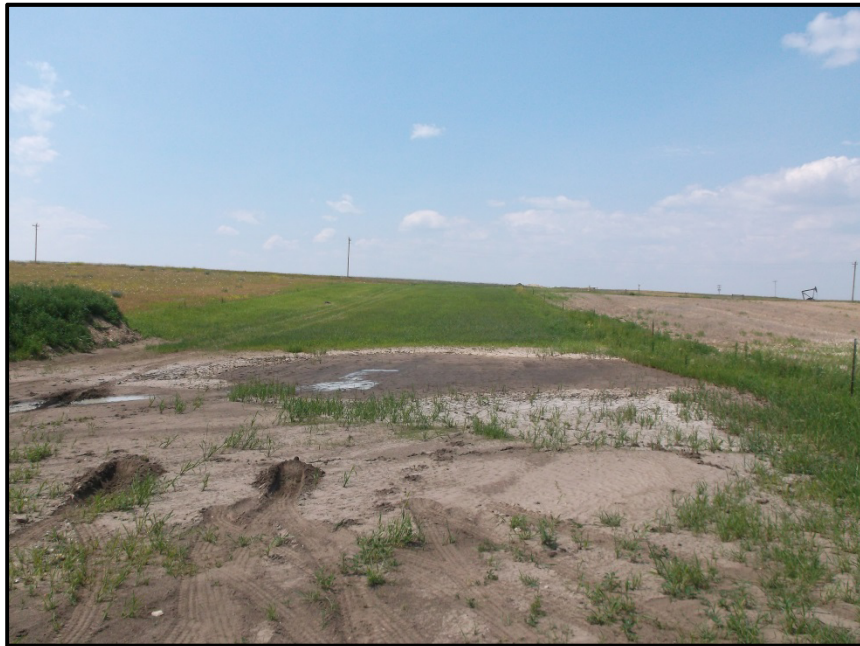
**Photo 34.** Direction: East. The pipeline corridor continues to run east to west through farmlands. The area has been seeded and will be returned to preconstruction conditions.

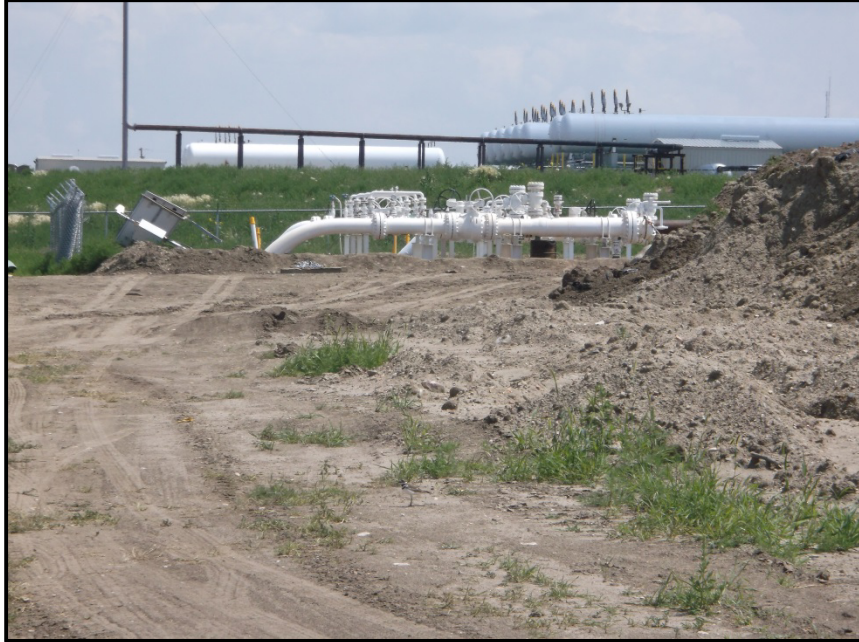
**Photo 35.** Direction: East. Depicted above is the end of the pipeline route which comes to a conclusion at the Dore Junction.
