Subject: PU-14-840 Dore Crude Oil Loop Pipeline Project – Re-vegetation Inspection Report

Re-vegetation Inspection Report

Site Visit: July 27, 2016

Dore Crude Oil Loop Pipeline Project – PSC Case No. PU-14-840

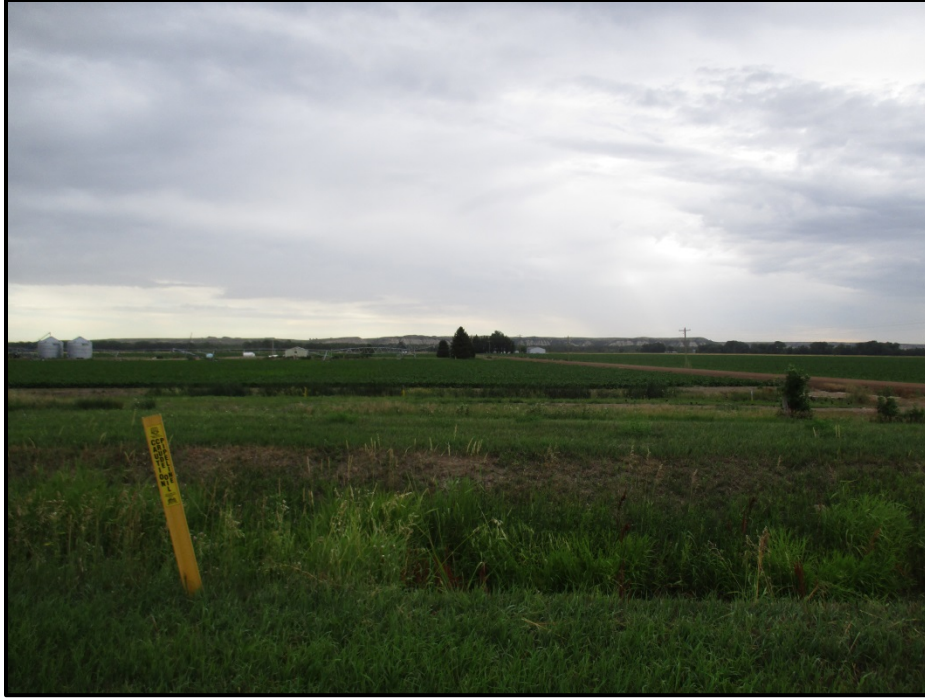
- Pipeline ROW crosses irrigation canal (bored) and then goes through crop field (Photo #1, Point #2);
- Photo taken near road looking at road ditch and wheat field. Weeds (Canada thistle) observed throughout the road ditch (Photo #2, Point #3);
- Wheat field shows small undulation (center of photo) in the wheat where the pipeline ROW is located; did not appear to be any noticeable amount of soil subsidence (Photo #3, Point #3);

Photo 1. (GPS Point #2) – Pipeline ROW crosses irrigation canal (bored) and then goes through crop field. Direction looking east.

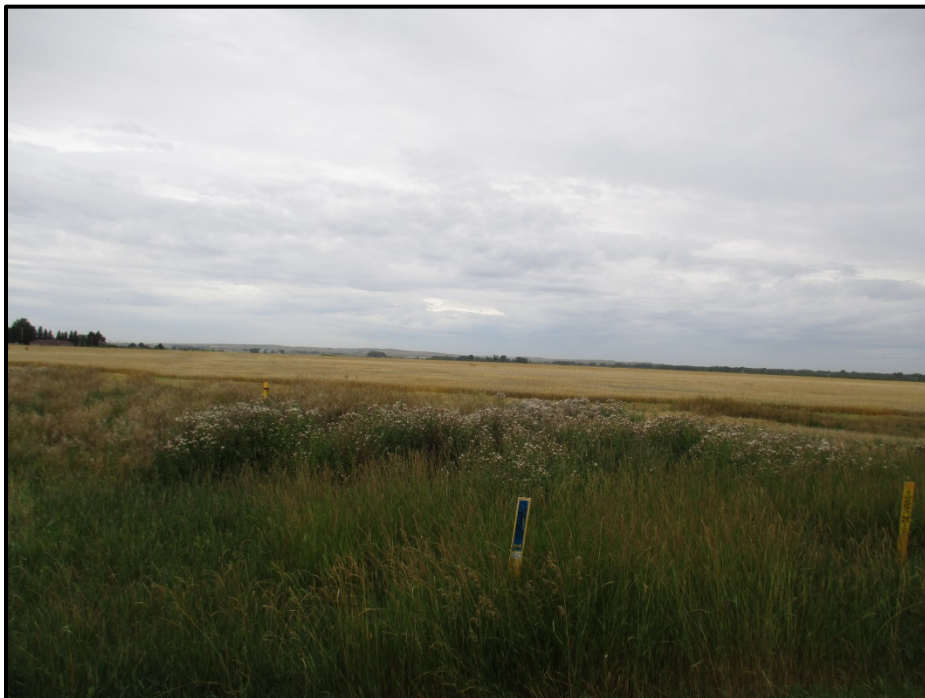
Photo 2. (GPS Point #3) – Photo taken near road looking at road ditch and wheat field. Weeds (Canada thistle) observed throughout the road ditch. Direction looking west.

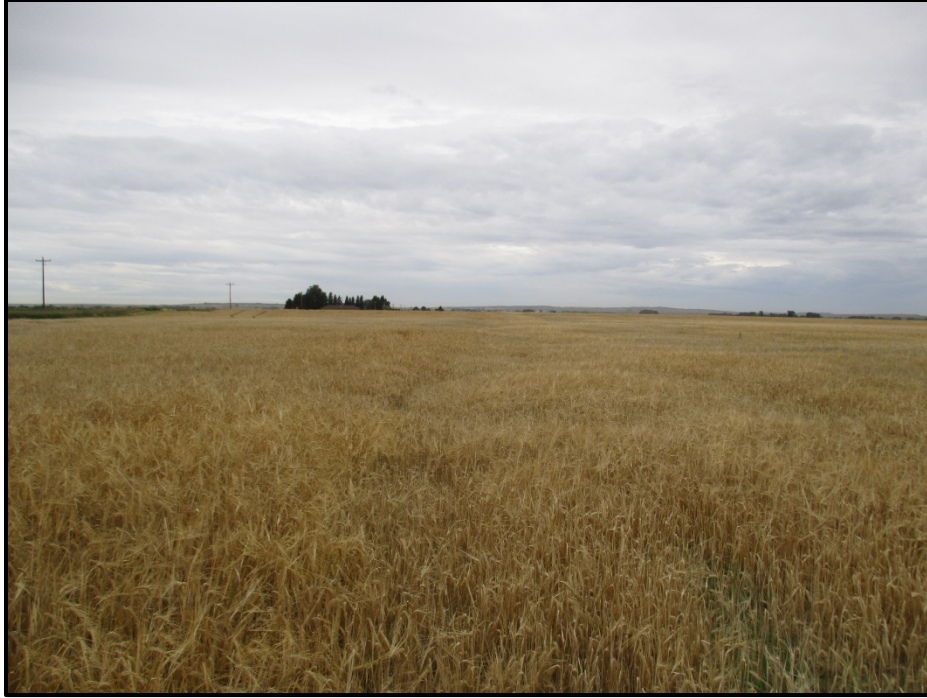
Photo 3. (GPS Point #3) – Wheat field shows small undulation (center of photo) in the wheat where the pipeline ROW is located; did not appear to be any noticeable amount of soil subsidence. Direction looking west.

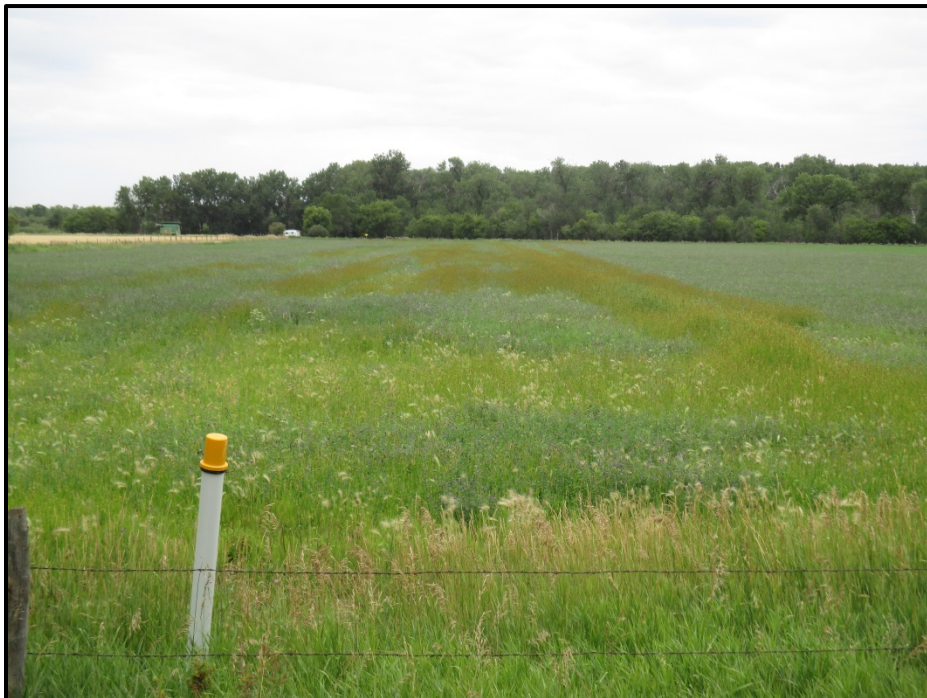
- ROW goes through field. Trees in distance were bored under. There are still some differences in the vegetation in the field as a result of the pipeline disturbance (Photo #4, Point #4);

Photo 4. (GPS Point #4) – ROW goes through field. Trees in distance were bored under. There are still some differences in the vegetation in the field as a result of the pipeline disturbance. Direction looking west.

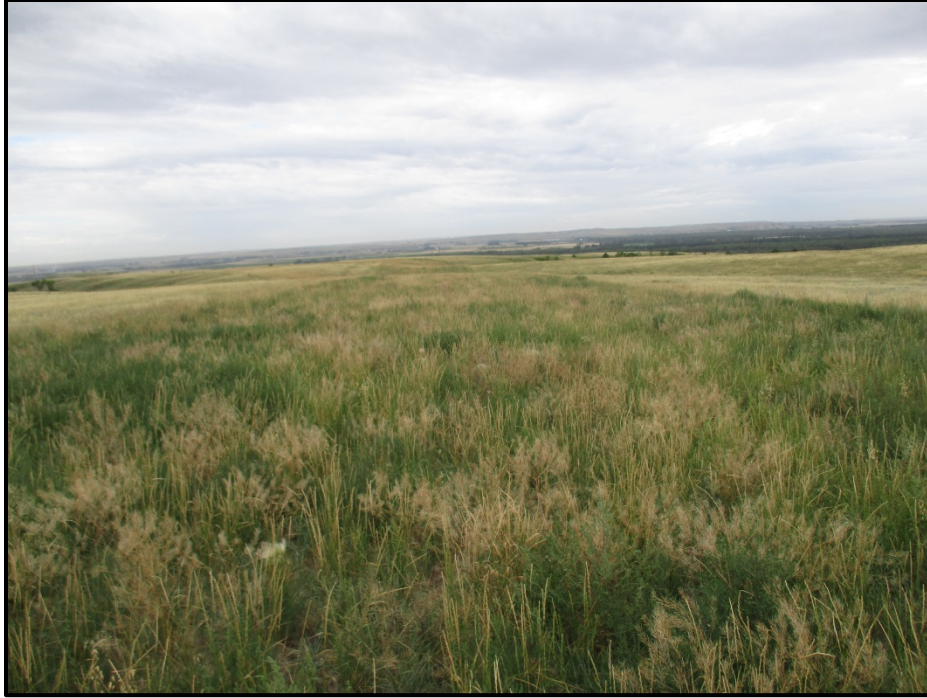
- Pipeline scar is still visible in rangeland. Grasses with some weeds growing throughout the ROW (Photo #5, Point #6);
- ROW crosses through crop field (Photo #6, Point #6);

Photo 5. (GPS Point #6) – Pipeline scar is still visible in rangeland. Grasses with some weeds growing throughout the ROW. Direction looking west.

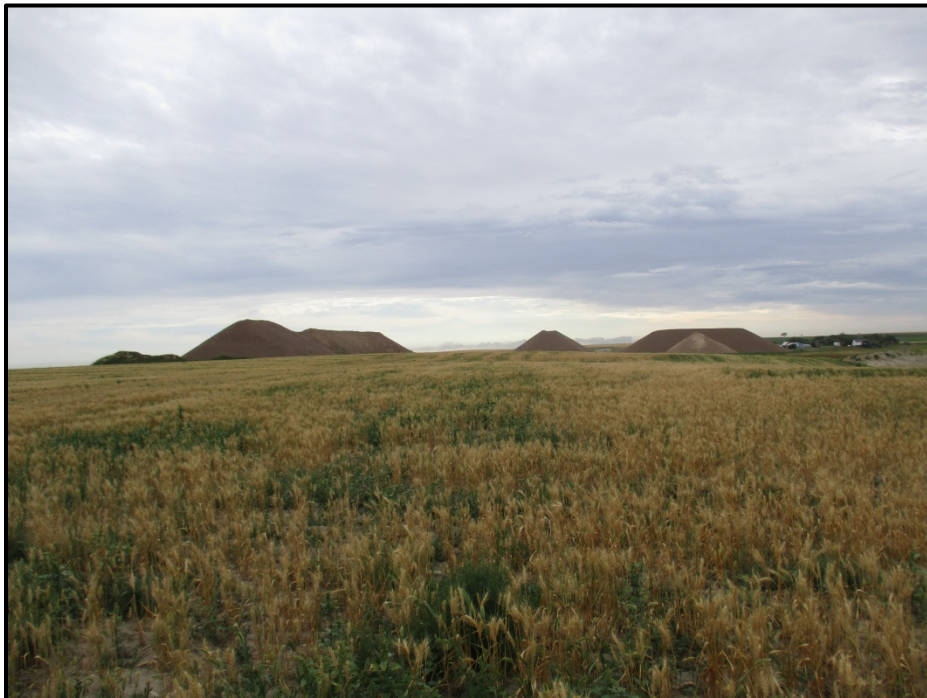
Photo 6. (GPS Point #6) – ROW crosses through crop field. Direction looking east.

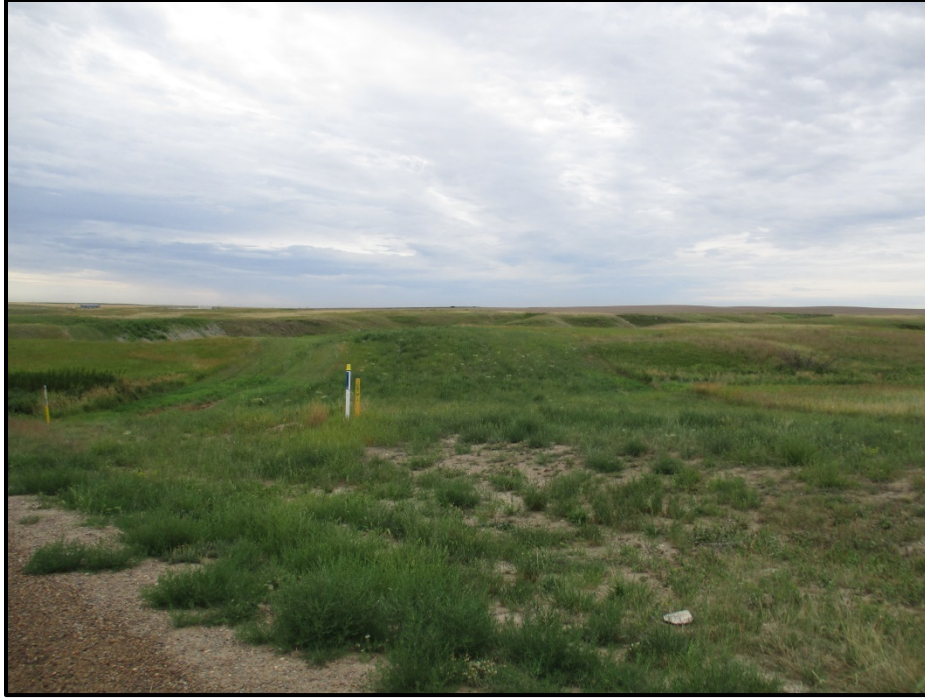
- Pipeline ROW with pipeline markers, showing vegetation along a hilly area. Notice the light colored erosion control blanket on the hill in the background. Area was seeded in the fall of 2015 and the spring of 2016 and mowed in summer 2016 (Photo #7, Point #7);

Photo 7. (GPS Point #7) - Pipeline ROW with pipeline markers, showing vegetation along a hilly area. Notice the light colored erosion control blanket on the hill in the background. Area was seeded in the fall of 2015 and the spring of 2016 and mowed in summer 2016. Direction looking southeast.

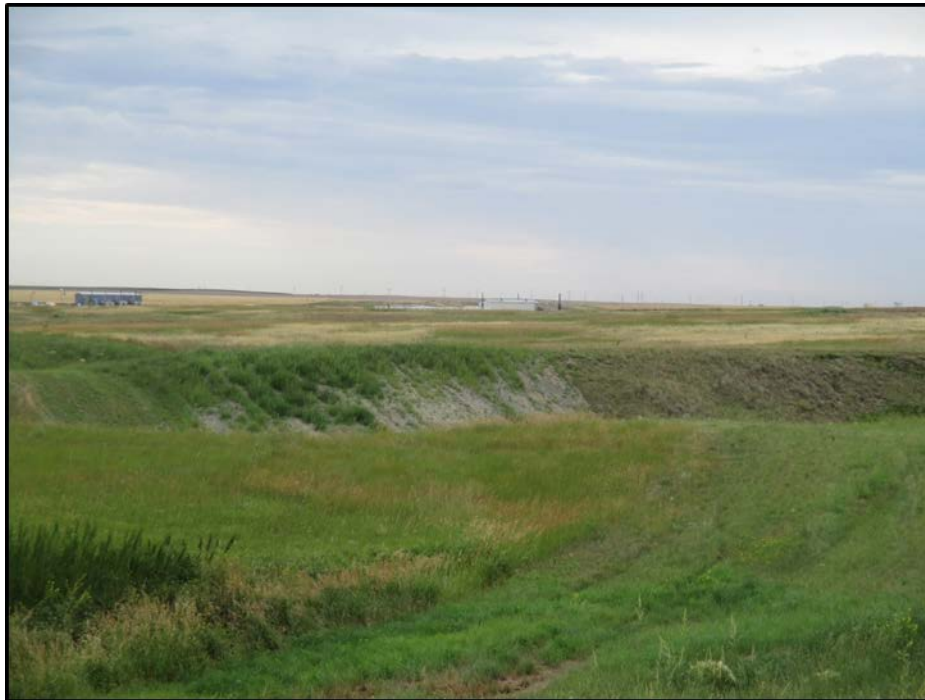
- Zoomed in view from above photo. Light colored area is an erosion control blanket on the hillslopes in the background. Area was seeded in the fall of 2015 and spring of 2016 and mowed in summer of 2016. (Photo #8, Point #7);

Photo 8. (GPS Point #7) - Zoomed in view from above photo. Light colored area is an erosion control blanket on the hillslopes in the background. Area was seeded in the fall of 2015 and spring of 2016 and mowed in summer of 2016.

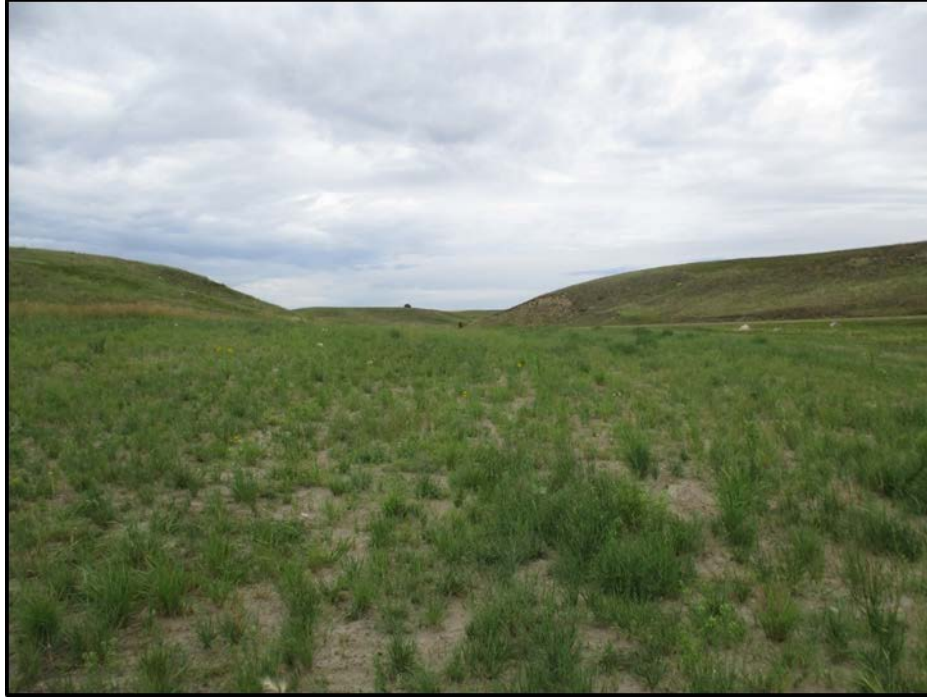
- Grasses and some weeds growing, very few noxious weeds, along with some bare ground visible in pipeline ROW, likely 40-60% vegetation cover in this area. This is a grassland area and is not being grazed. Area was seeded in the fall of 2015 and re-seeded spring of 2016. Area was mowed in summer of 2016. Area has sandy soils (Photo #9, Point #8);

Photo 9. (GPS Point #8) – Grasses and some weeds growing, very few noxious weeds, along with some bare ground visible in pipeline ROW, likely 40-60% vegetation cover in this area. This is a grassland area and is not being grazed. Area was seeded in the fall of 2015 and re-seeded spring of 2016. Area was mowed in summer of 2016. Area has sandy soils. Direction looking west.

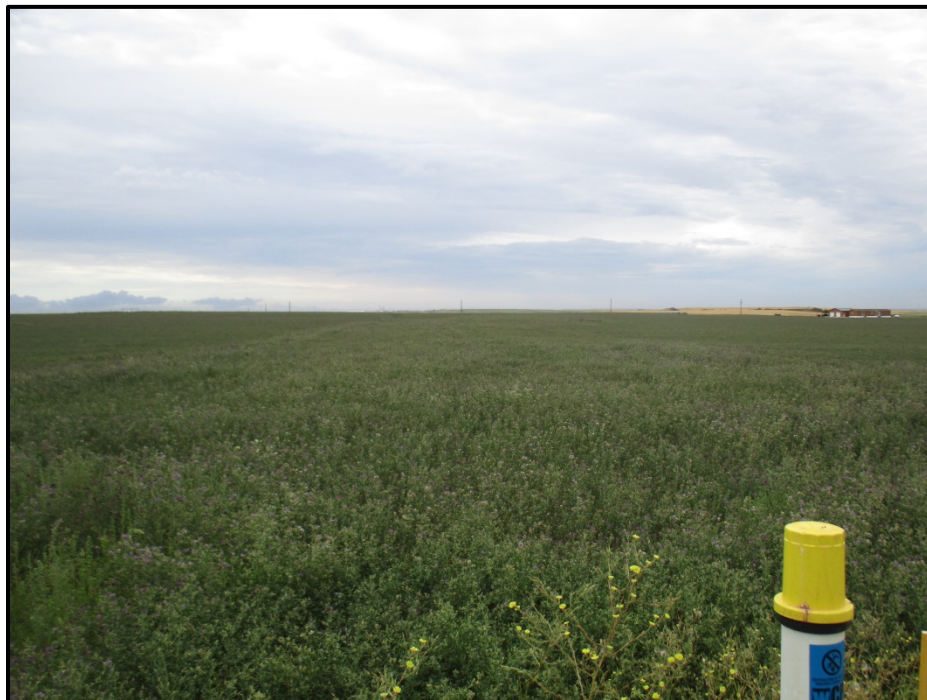
- ROW through alfalfa field. Vegetation looks very good (Photo #10, Point #9).

Photo 10. (GPS Point #9) – ROW through alfalfa field. Pipeline scar is barely visible, vegetation looks very good. Direction looking east.
