Hiland Partners  
Holdings LLC  
a Kinder Morgan company

RE: Hiland Crude, LLC.  
Dore Crude Oil Loop Pipeline- McKenzie County  
Post Construction Inspection Reclamation Report  
Case No. PU-14-840

Attachment A  
PU-14-840 Dore Crude Oil Loop Pipeline  
Reclamation Photos taken May 1, 2017

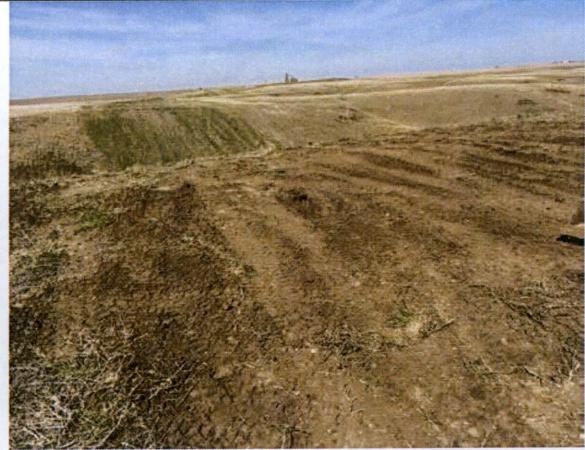
- 7) *.Pipeline ROW with pipeline markers, showing vegetation along hilly area. Notice the light colored erosion control blanket on the hill in the background. Area was seeded in the fall of 2015 and the spring of 2016 and mowed in the summer of 2016 (Photo #7, Point #7).*

Photo 1- Addresses Recommendation 7 (Pre-Reclamation)

**Hiland performed additional post-construction activities on this site. Activities included grading of the site and application of additional seed on both slopes of the identified coulee. Photographic evidence of activities is shown in Photos 1 and 2.**

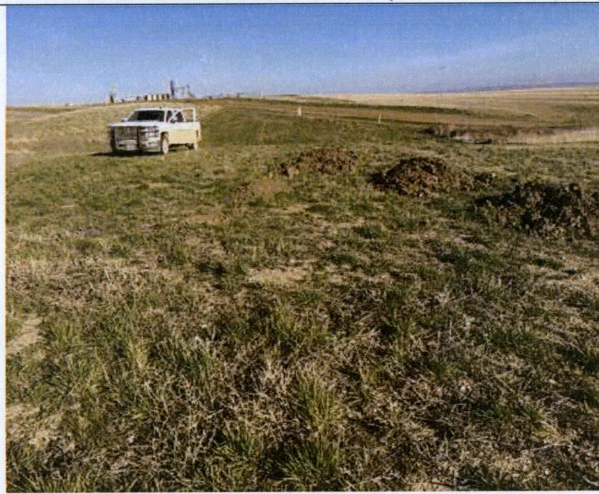
Photo 2- Addresses Recommendation 7 (Post-Reclamation)

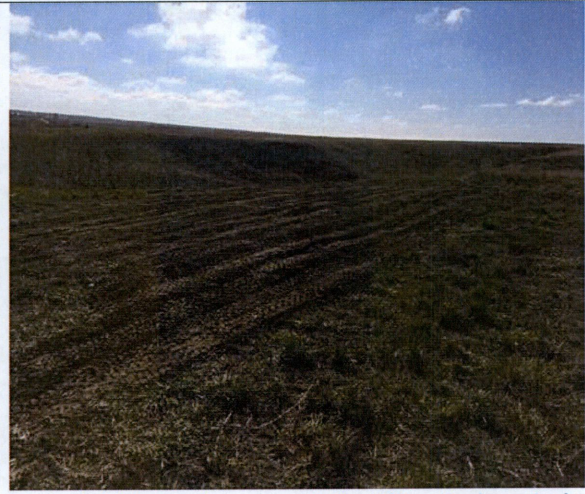
- 9) *Grasses and some weeds growing, very few noxious weeds, along with some bare ground visible in the pipeline ROW, likely 40-60% vegetation cover in this area. This is a grassland area and is not being grazed. Ara was seeded in the fall of 2015 and reseeded spring of 2016. Area was mowed in summer of 2016. Area has sandy soils (Photo #9, Point #8).*

Photo 3- Addresses Recommendation 9 (Pre-Reclamation)

**Hiland performed additional post-construction activities on this site. Hiland performed light disking and reseeding along the pipeline right-of-way for this portion of the pipeline. Photographic evidence of activities is shown in Photos 3, 4 and 5. Approximately 20lbs/ acre of seed was used for reclamation. A seed ticket is attached in Appendix B.**

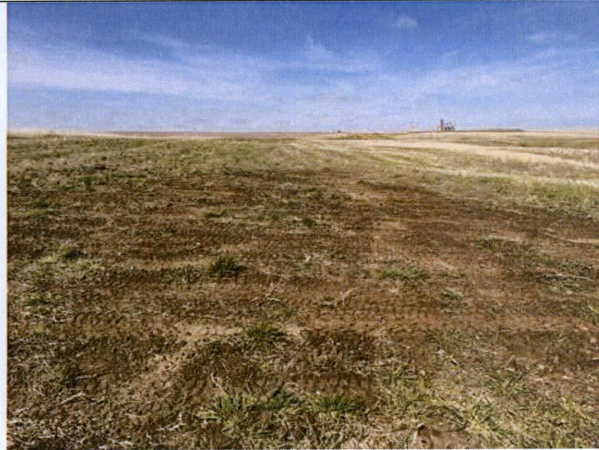
Photo 4- Addresses Recommendation 9 (Post-Reclamation)
