Dakota Access, LLC
Dakota Access Pipeline Project- Pipeline Terminals
McKenzie, Mountrail and Williams Counties, ND
ND PSC Case No. PU-14-842
Keitu Project No. 567-1099

Site/Project Location: Stanley Terminal

Date of Inspection: 25 January 2016

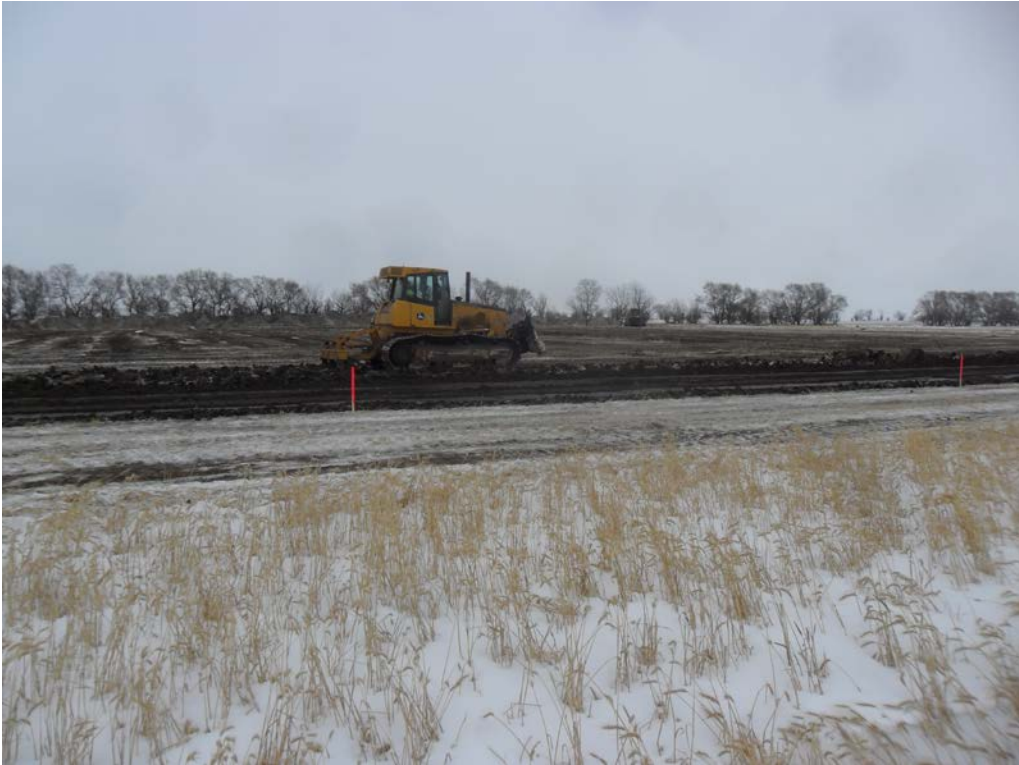
Upon initial visit, Keitu inspector informed Site Chief that it appeared dozers were stripping too deep. Upon consulting with a Matrix representative and Site Chief, two small areas had some subsoil mix with the topsoil due to the frozen ground. After consultation, overall proficient segregation on site was demonstrated. Perimeter storm water sediment control measures were not in place at the time of inspection.

Report Photo #1 "Topsoil Stripping" at GPS Coordinates:

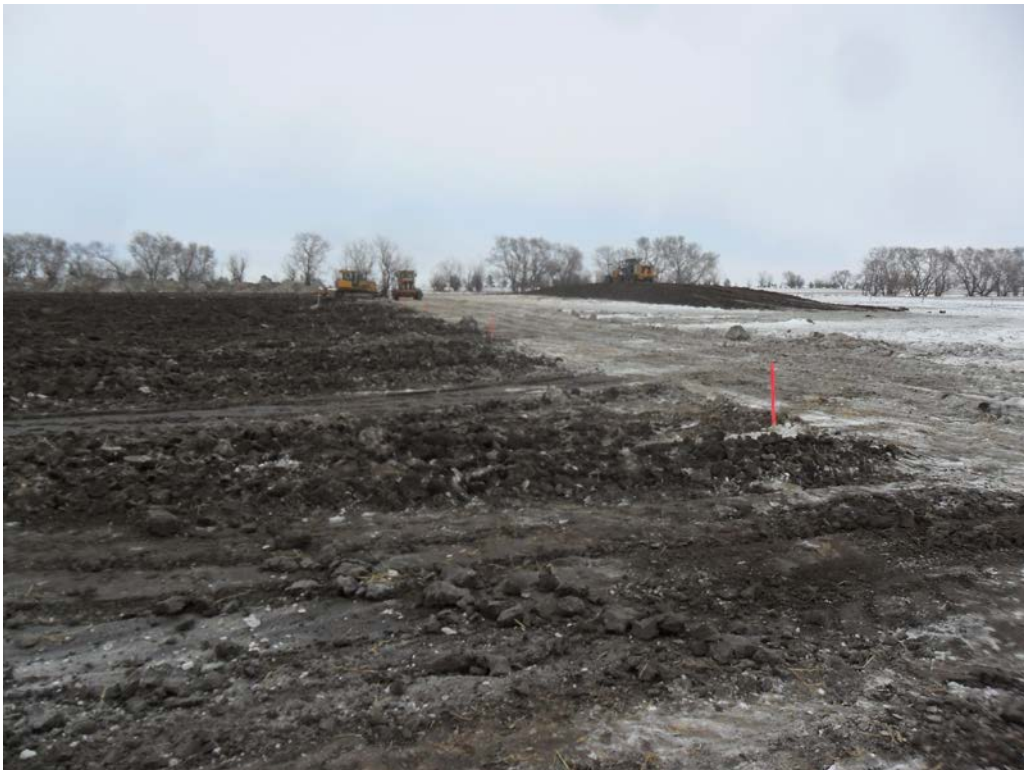
Topsoil is being moved for storage at the southeast corner of the site. Topsoil from subsoil segregation appears adequate.

Report Photo #2 "Topsoil Piling on Southeast Side" at GPS Coordinates:

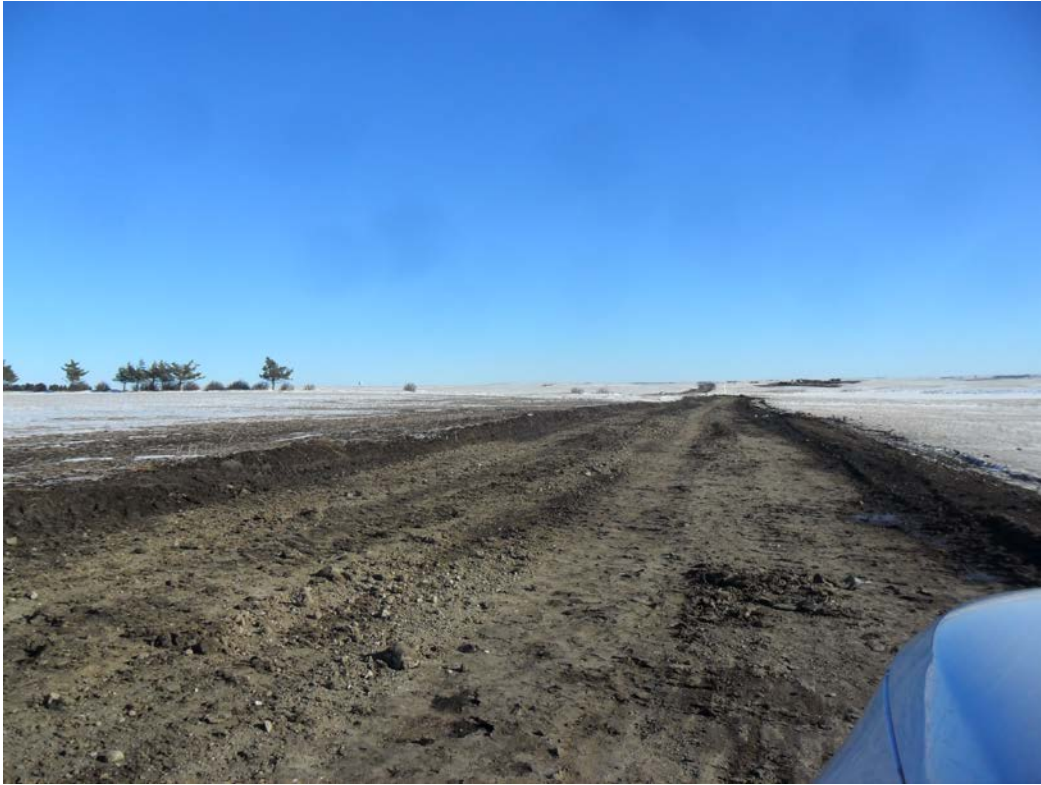
Upon visit, Keitu inspector was informed by Site Chief that subsoils were being piled on an offsite location per landowner request. Temporary road was built for access on site and adjacent landowners property to deliver soils to landowner. Unclear whether a PSC permit was granted/necessary for this work. Subsoil piling was halted in the afternoon due to sediments being tracked offsite due to thawing ground.

Report Photo #1 "Access Road to Offsite Subsoil Piling" at GPS Coordinates: 48.298194°N 102.455°W

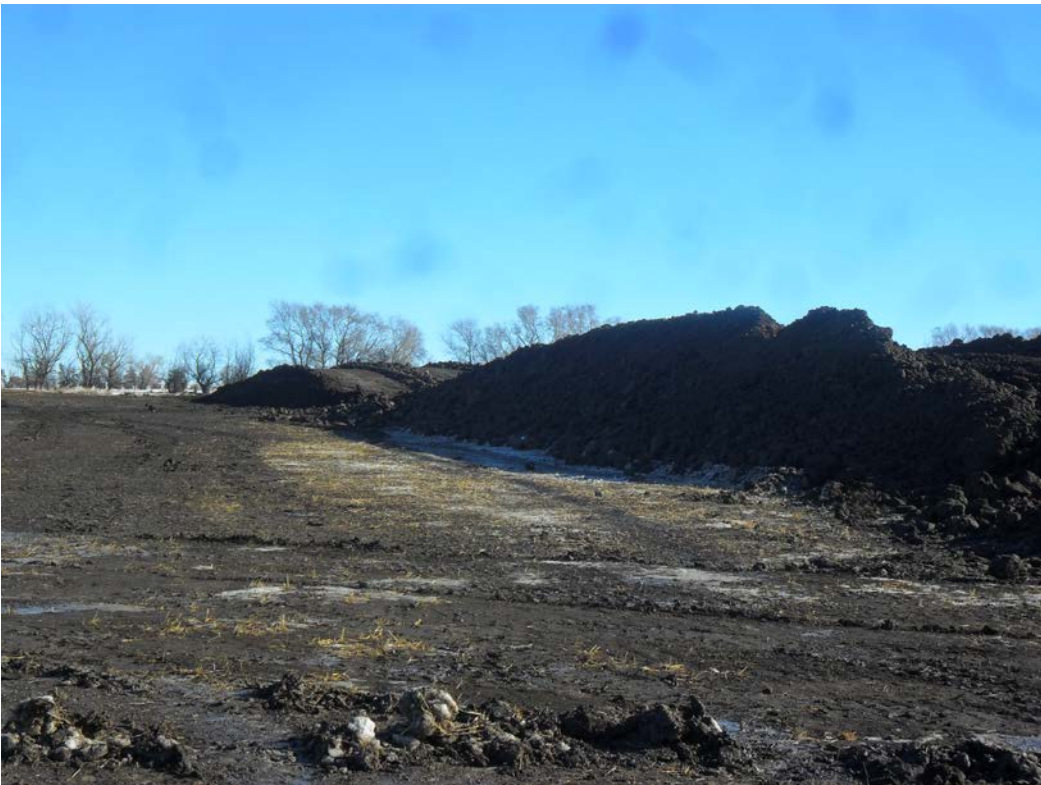
Temporary storage of subsoil had been piled on top of unstripped frozen topsoil per decision made by site construction manager.

Report Photo #2 "Subsoil Piling on South Side" at GPS Coordinates: 48.302222°N 102.460278°W

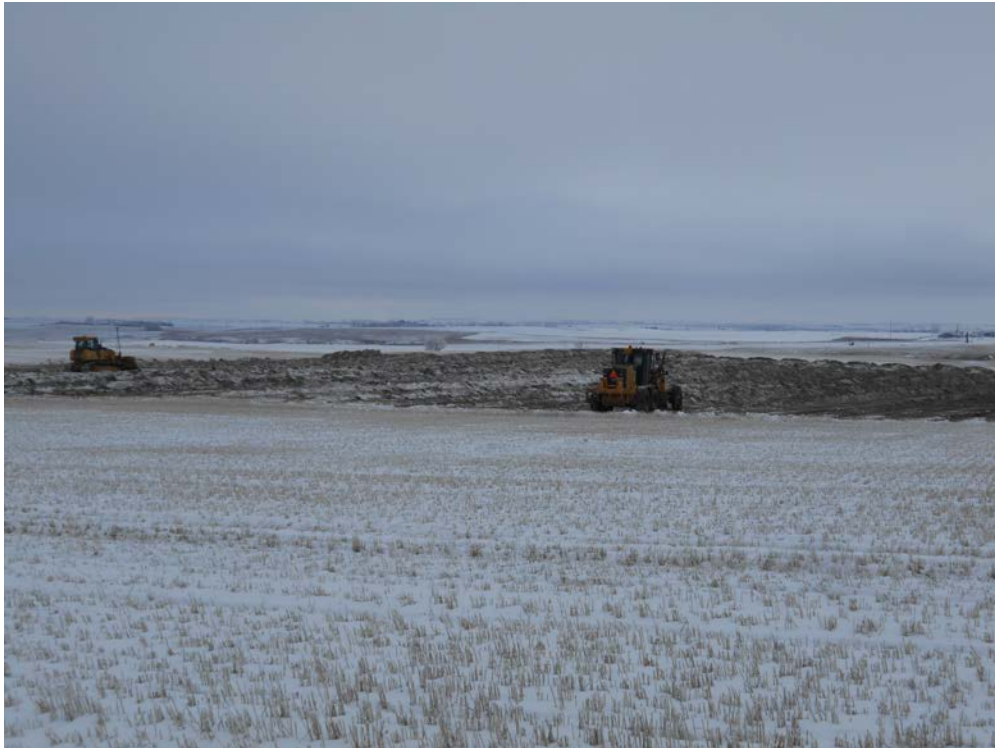
Report Photo #1 “Southern Cut” at GPS Coordinates:

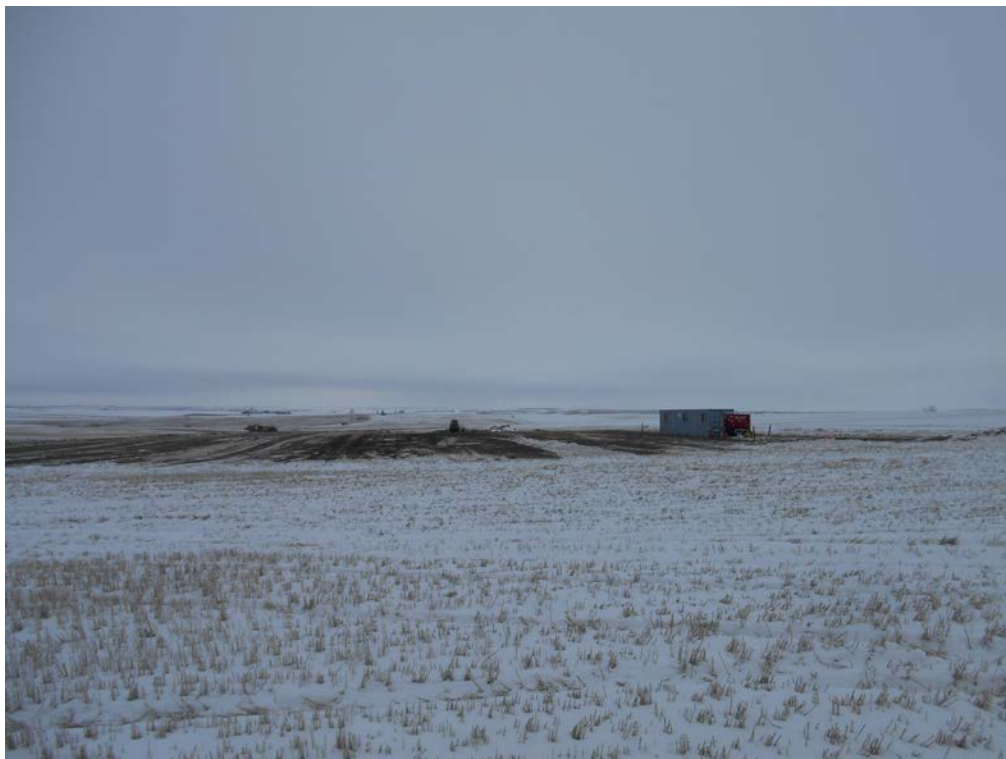
Topsoil is being moved for storage on western edge of northern cut. At the time of inspection sub soil had not been reached yet. Crews were clearing snow and loose top soil so that frost would be accessible to ripping.

Report Photo #2 “Northern Cut” at GPS Coordinates:

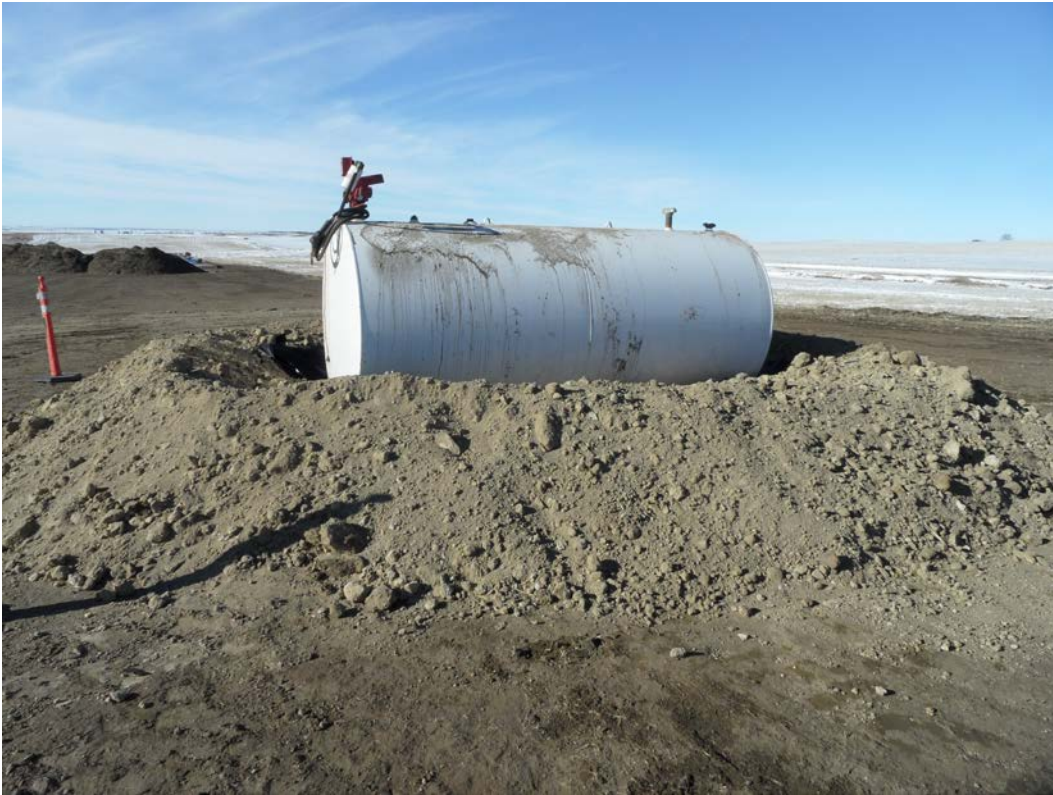
Soil berm had been installed around on-site fuel tank.

Report Photo #1 "Containment Berm" at GPS Coordinates:

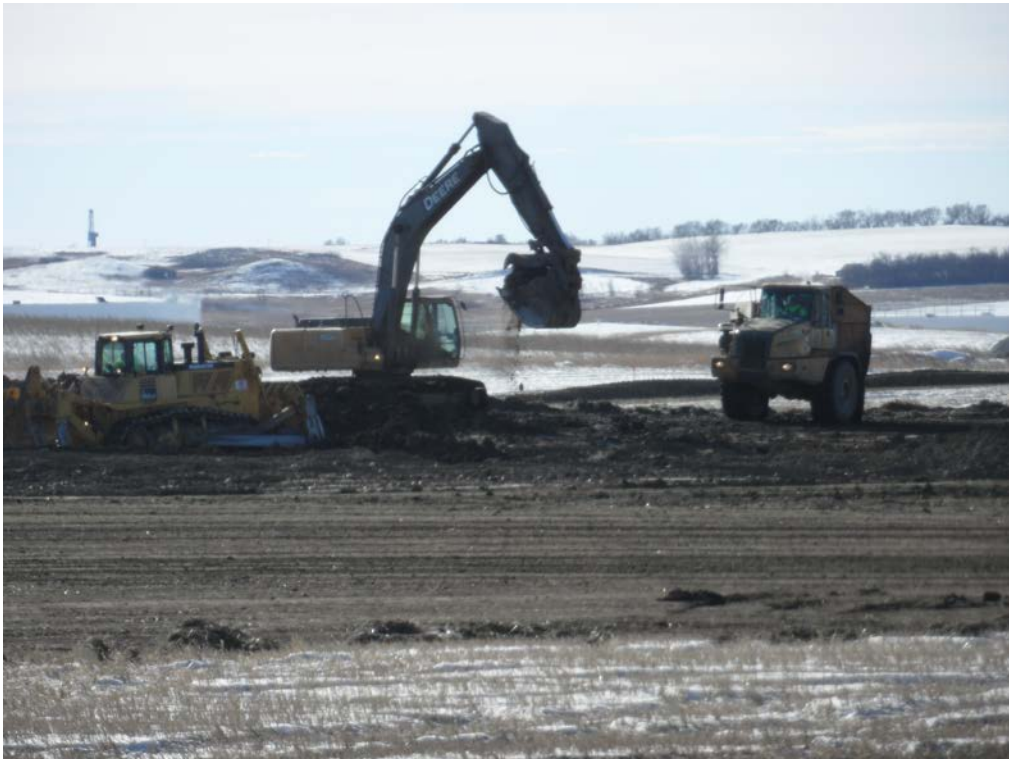
Report Photo #2 "Subsoil Recovery & SW Perimeter Berm" at GPS Coordinates: 48.2939°N 102.9164°W

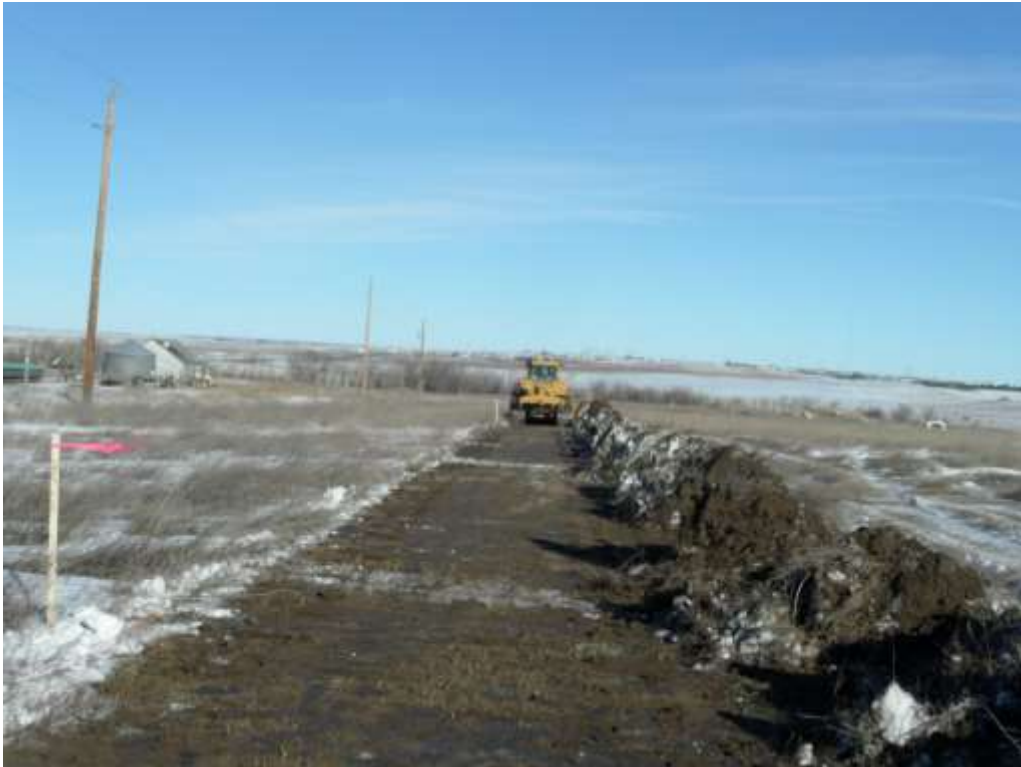
Report Photo #1 "Topsoil removal as west boundary line" at GPS Coordinates: 46.1122°N 103.7696°W

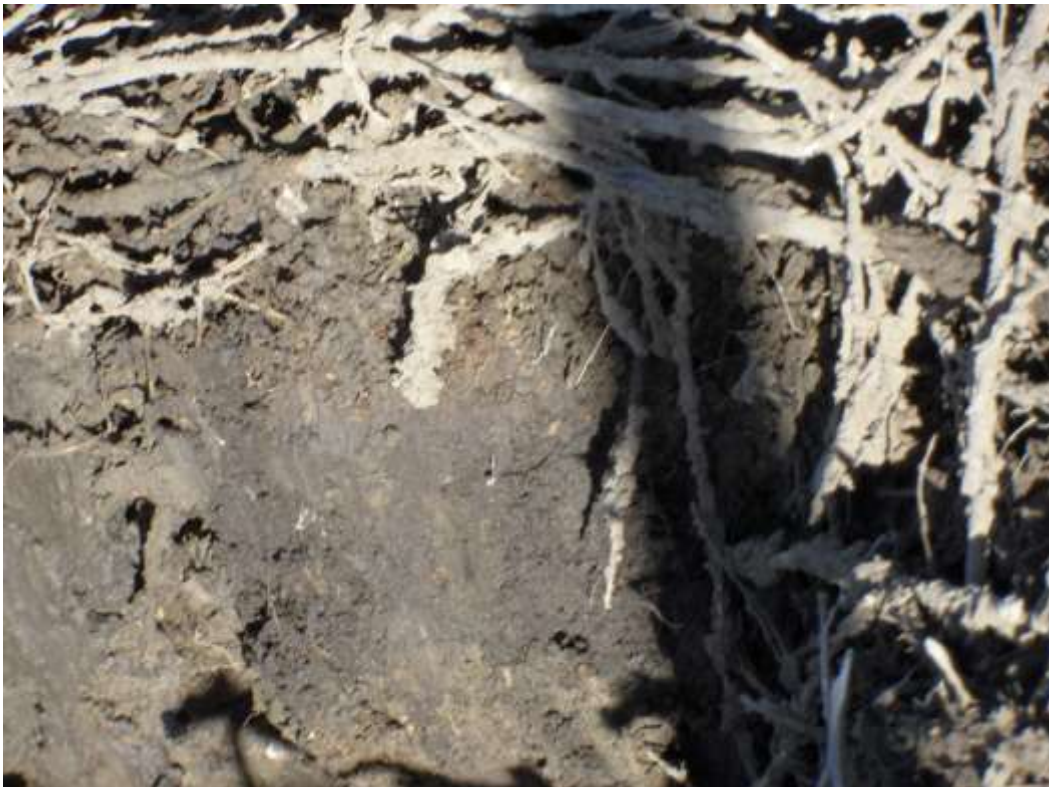
Topsoil from subsoil segregation appears adequate. Site staff expecting 9 inches of topsoil. Approximately 6 inches of topsoil evident in bell holes dug along south portion of site. Stormwater / sediment control were not yet in place although no signs of runoff / snowmelt flow were noted.

Report Photo #2 "Six (6) Inch Topsoil depth" at GPS Coordinates:

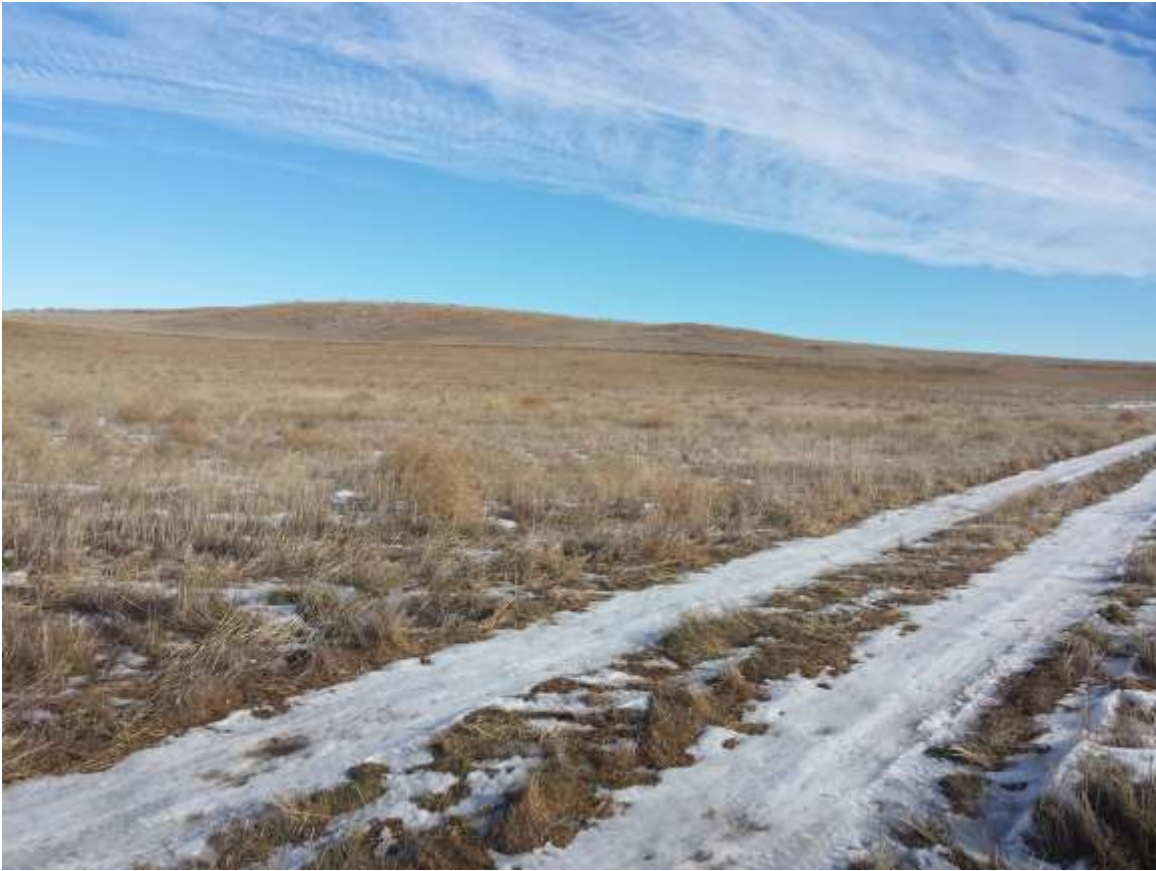
Report Photo #1 "Site Overview" at GPS Coordinates:

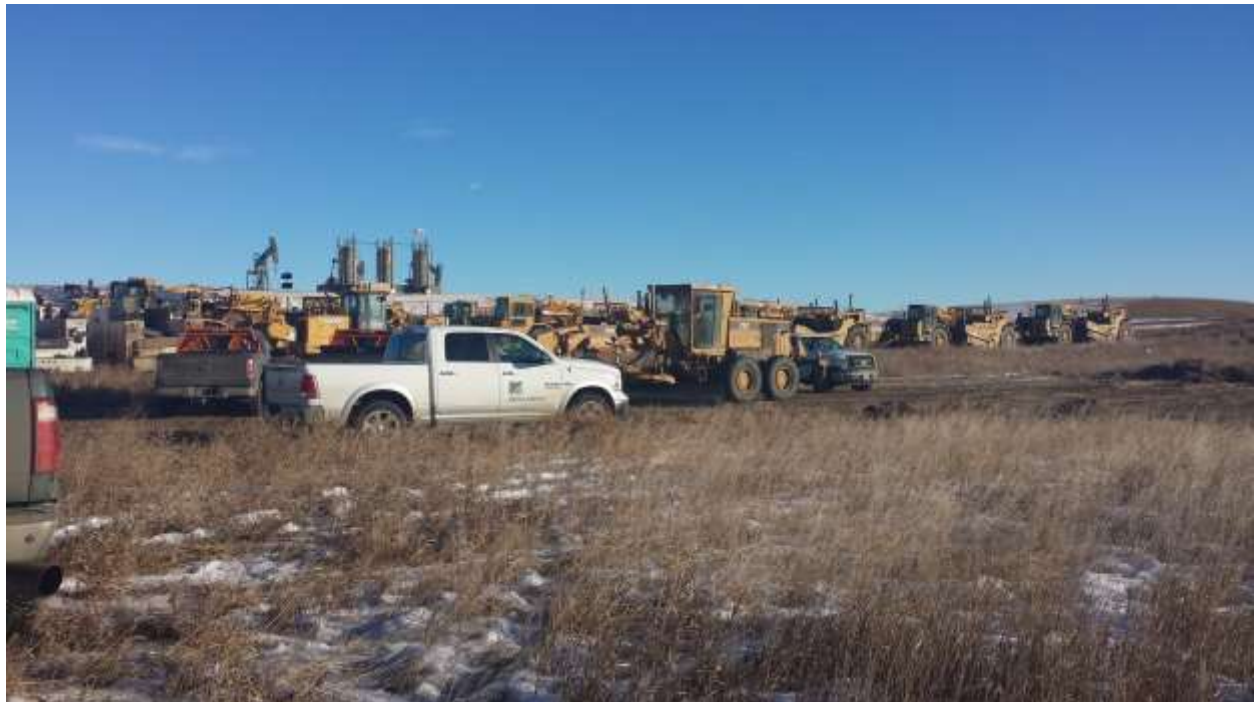
Office trailer and equipment staging occurred on the north side of Dakota Access property adjacent to 24th Street. Vegetation was trimmed in a majority of the staging area.

Report Photo #2 "Equipment Staging Area" at GPS Coordinates:

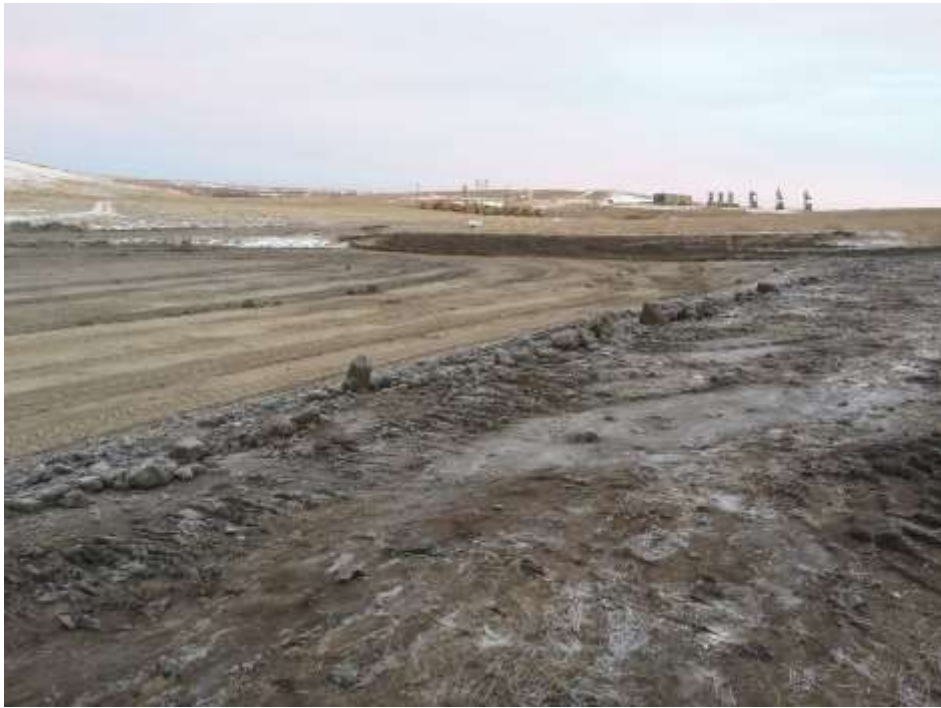
Topsoil was observed being utilized for berms on the southwest area of the site. Topsoil was used for berms on the edge of the sediment pond. Topsoil separation was ongoing during site visit.

Report Photo #1 "Topsoil as Berm" at GPS Coordinates:

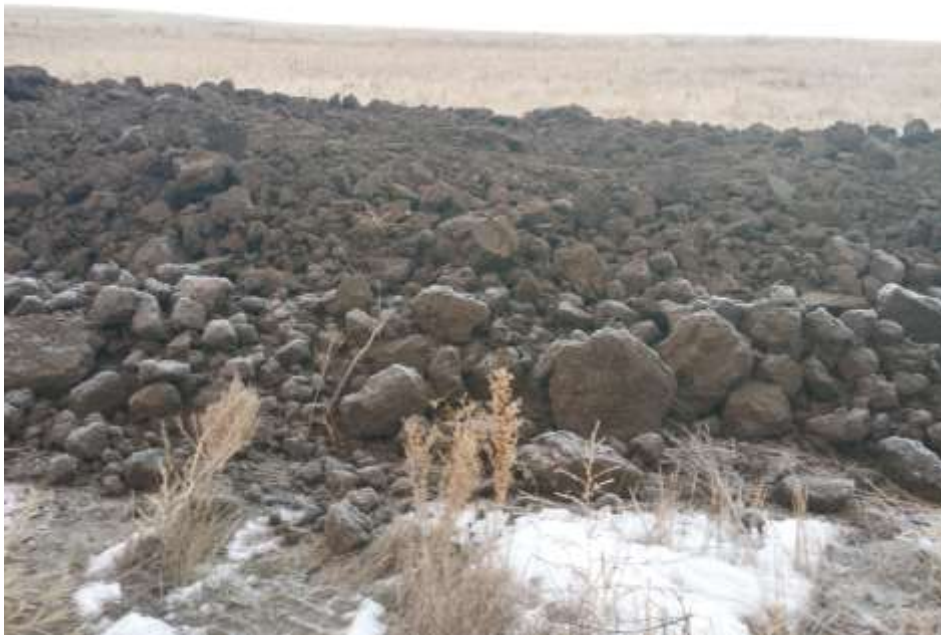
Report Photo #2 "Topsoil Separated" at GPS Coordinates:

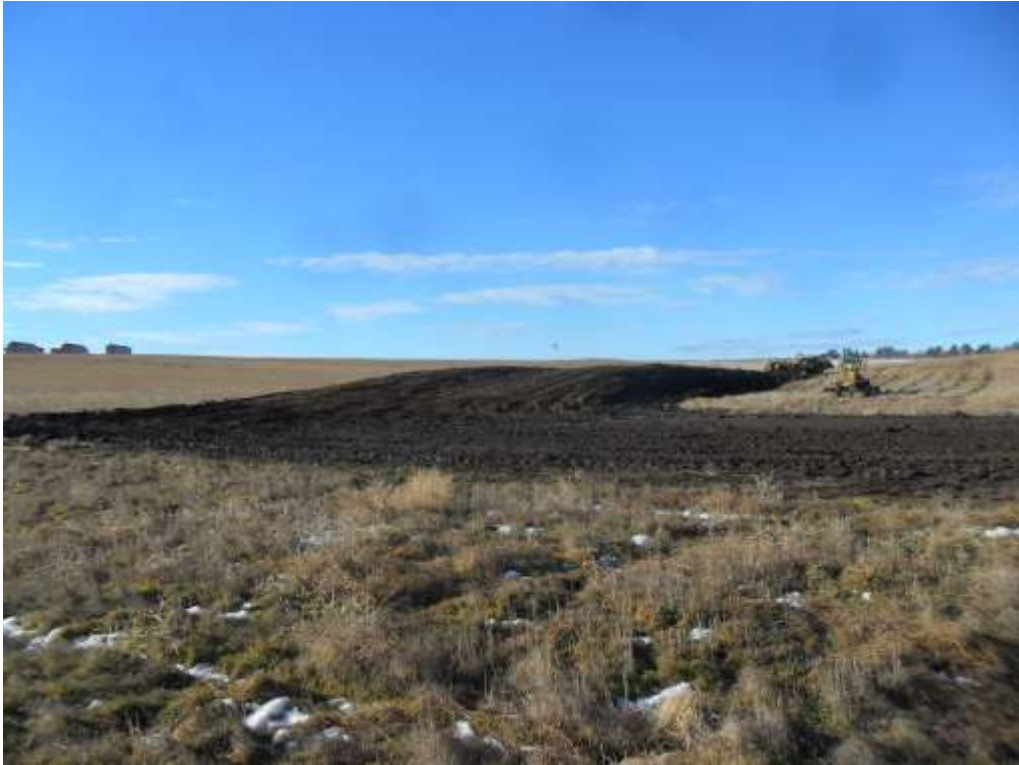
Topsoil was being moved for storage at south area of the site. Depth of topsoil stripped averaged about 1 foot. Topsoil from subsoil segregation appears adequate.

Report Photo #1 "Topsoil Piling on South Side" at GPS Coordinates:

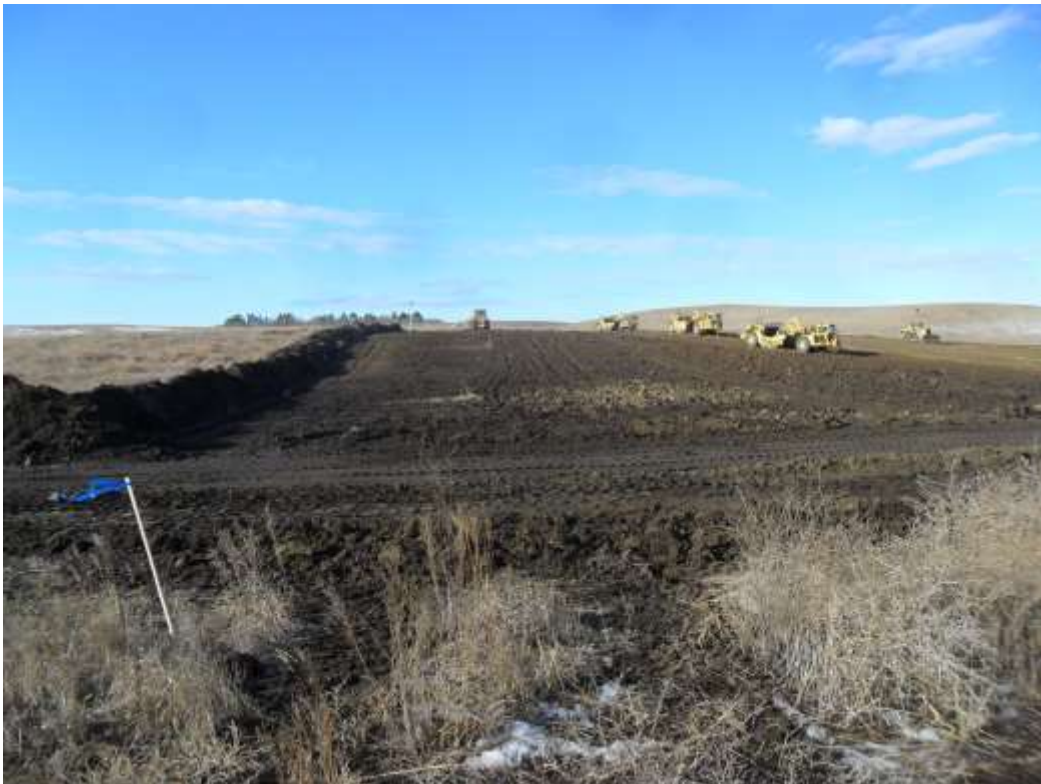
Report Photo #2 "Stripped Ground" at GPS Coordinates:

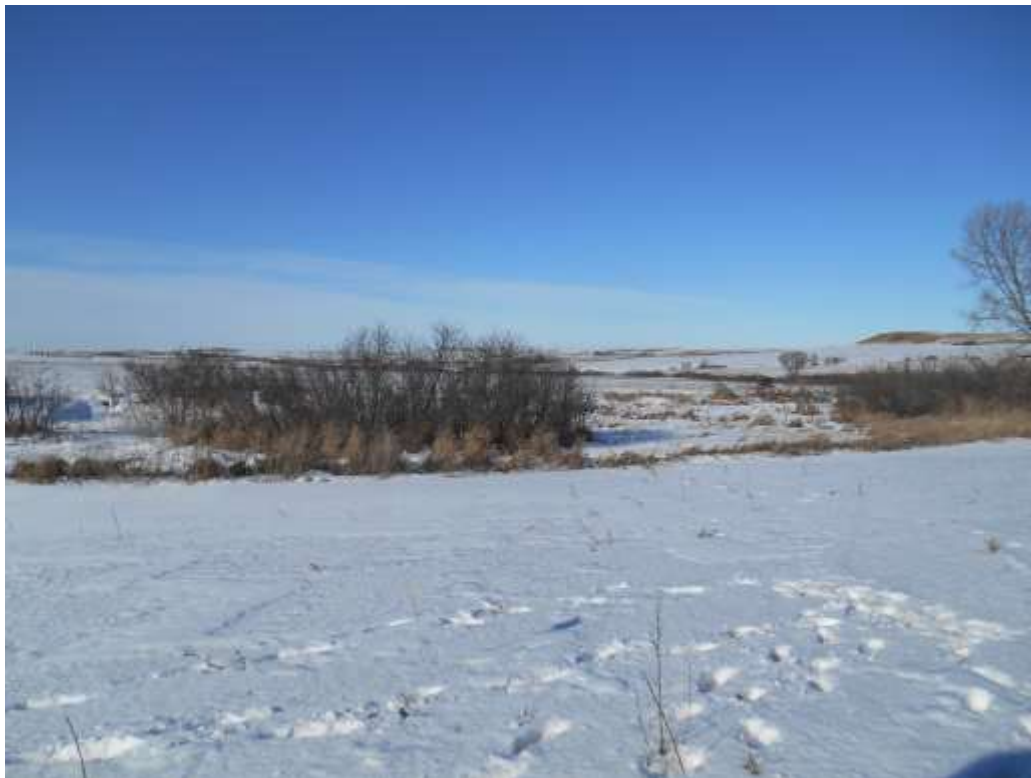
Trees remain in the northwest corner of the site, consistent with historical aerial photo dated August 2013. No evidence of tree or shrub removal noted at this time. Site personnel stated trees and shrubs may need to be removed to build an access road.

Report Photo #1 "Potential Tree and Shrub removal area" at GPS Coordinates: 47.80252°N 102.9272°W

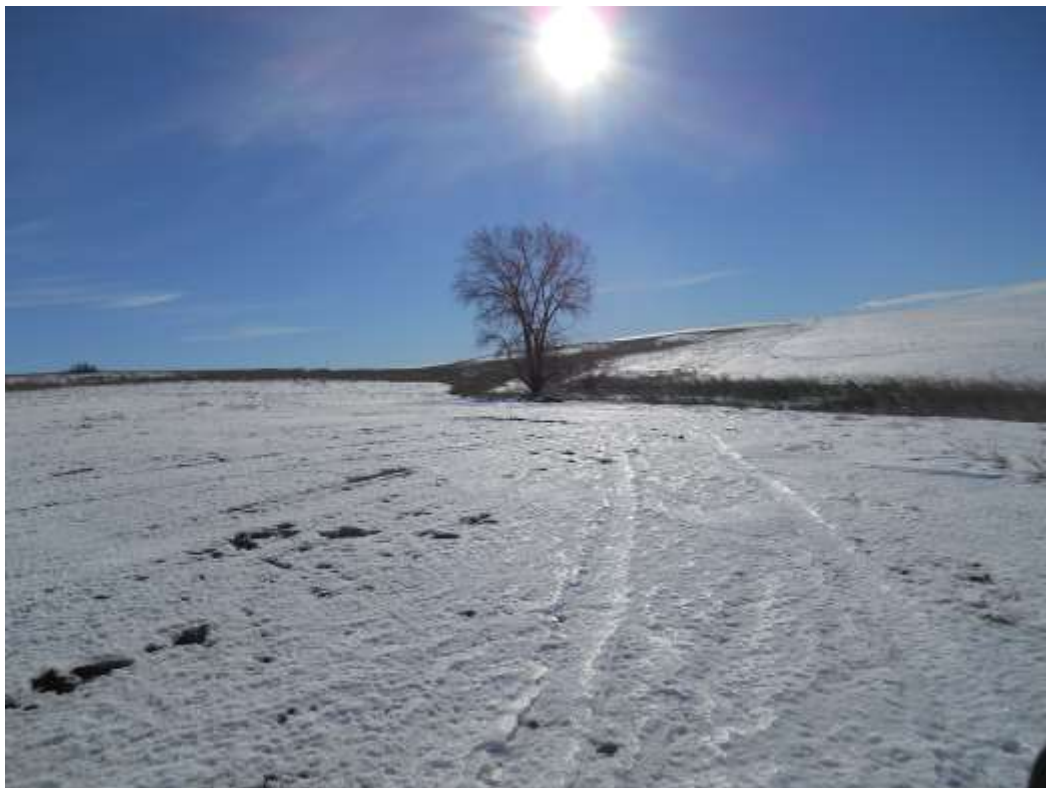
Report Photo #2 "Drainage path running through property" at GPS Coordinates: 47.8012°N 102.9258°W

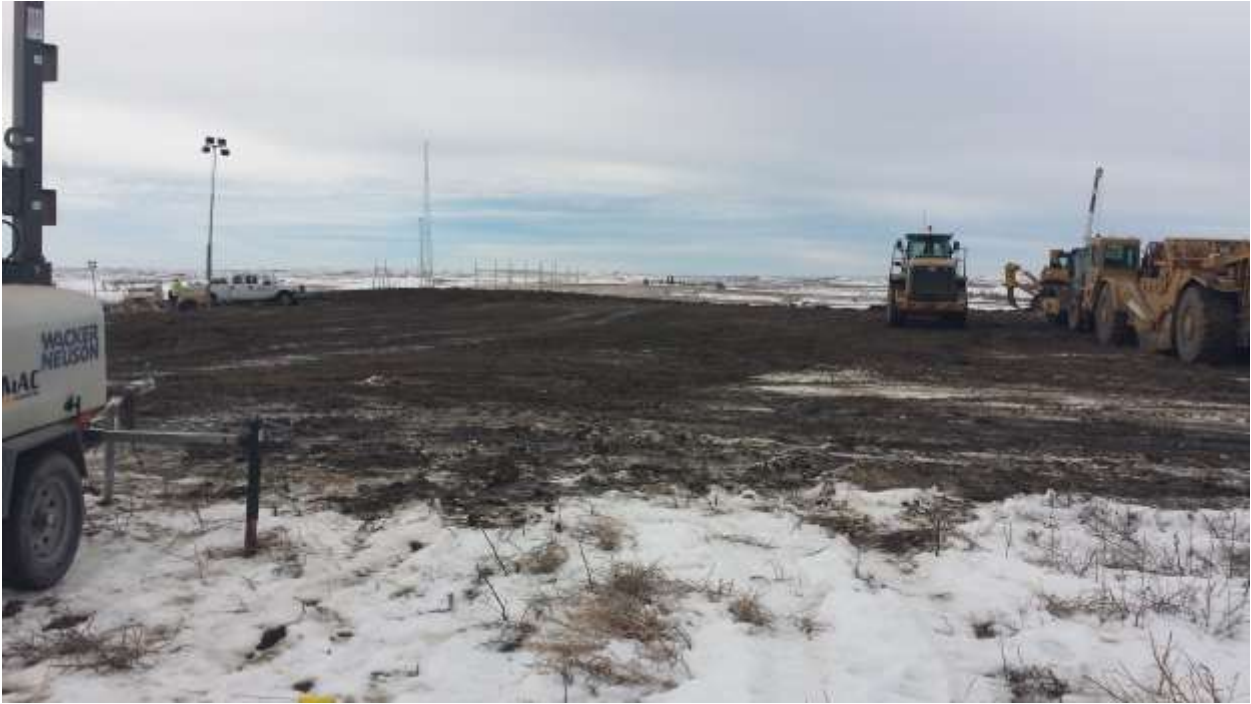
Report Photo #1 “Stripping Vegetation” at GPS Coordinates:

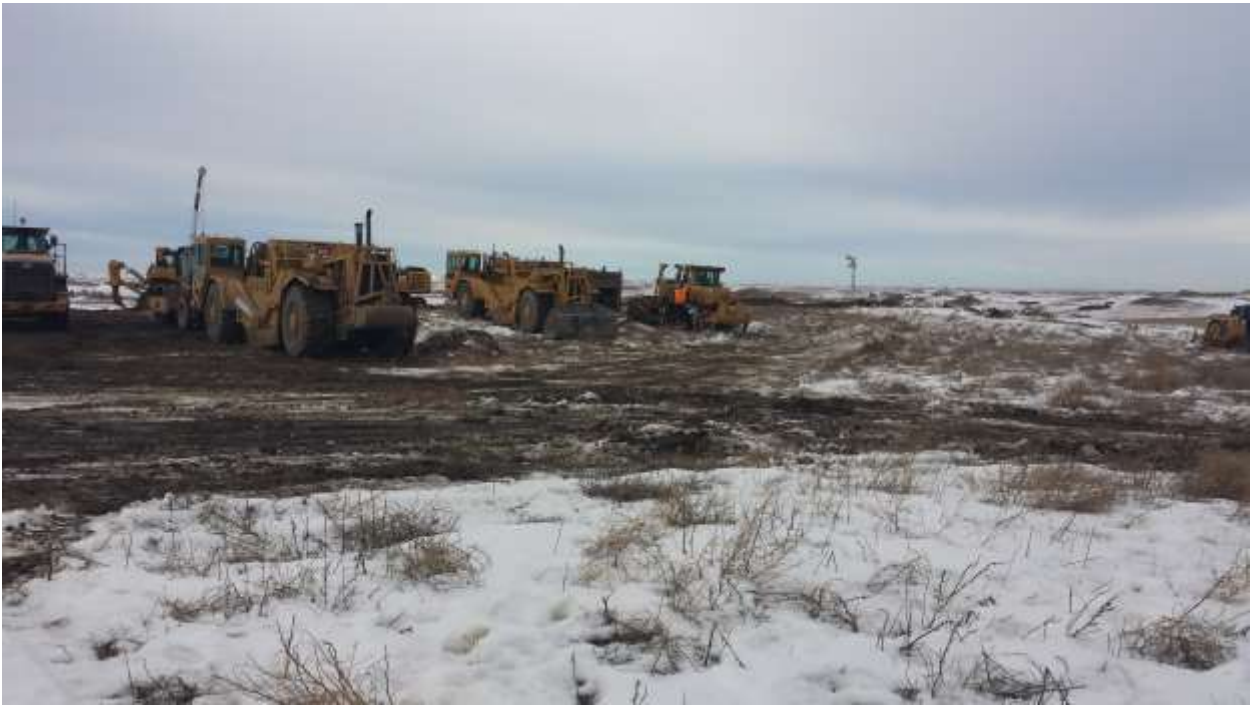
Report Photo #2 “Equipment Staging Area” at GPS Coordinates:

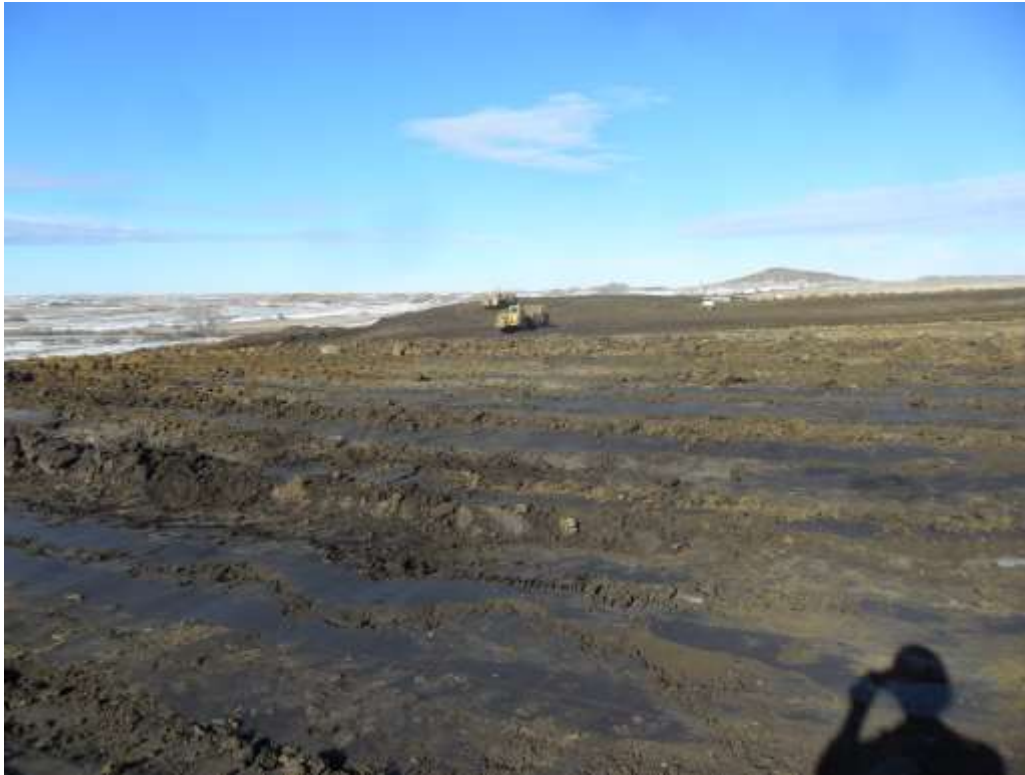
Topsoil segregation from subsoil appeared to be inadequate in a few areas. Subsoil mixing with topsoil seemed unavoidable due to warm weather thawing and softening the bare ground.

Report Photo #1 “Stripped Grounds” at GPS Coordinates:

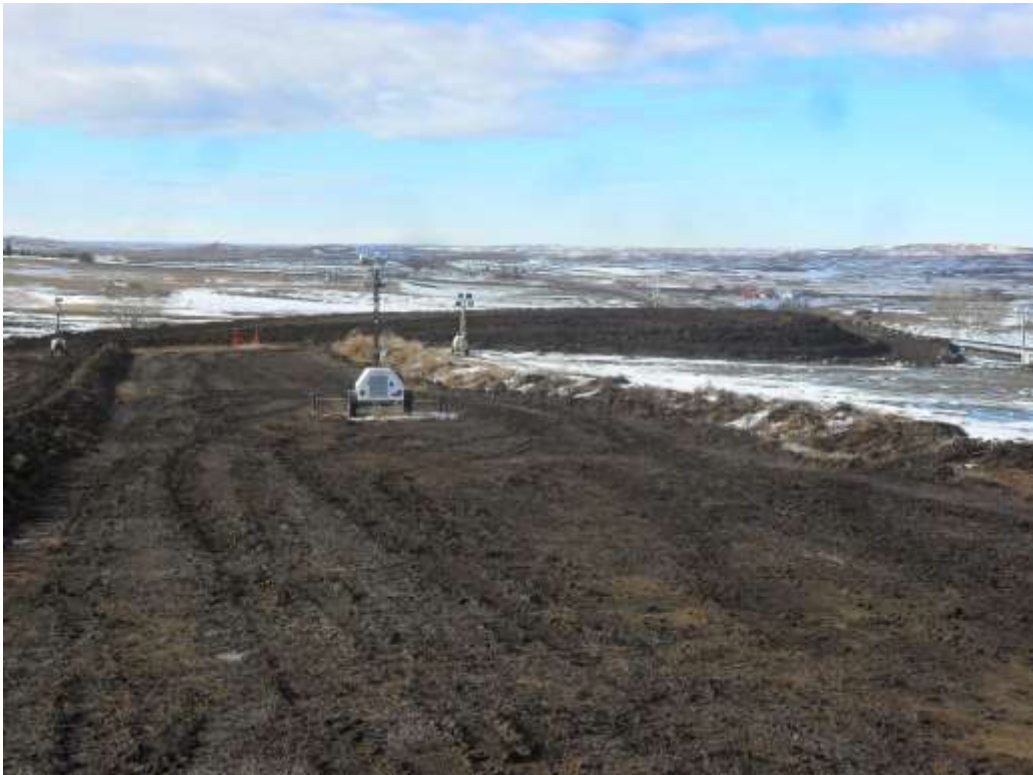
Report Photo #2 “Topsoil Pile” at GPS Coordinates:
