Dakota Access, LLC
Dakota Access Pipeline Project- Pipeline Terminals
McKenzie, Mountrail and Williams Counties, ND
ND PSC Case No. PU-14-842
Keitu Project No. 569-1099

151 PU-14-842 Filed: 2/24/2016 Pages: 7
Update to topsoil segregation report

Site/Project Location: Epping Terminal

Date of Inspection: 4 February 2016

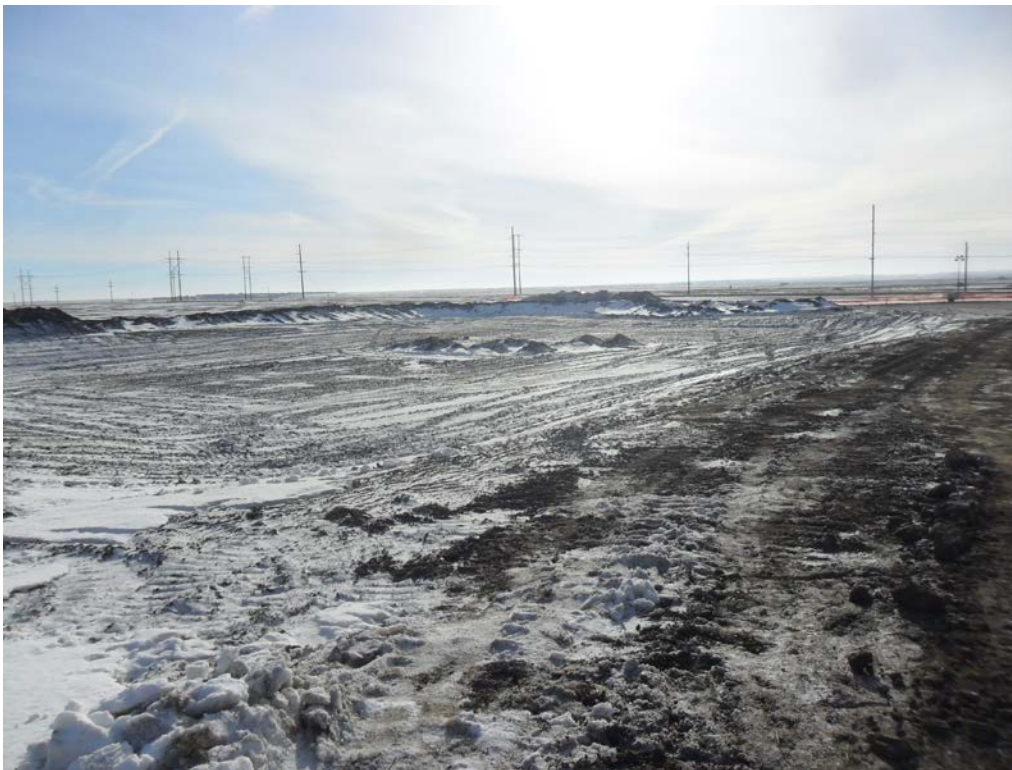
Upon initial visit, previous site owner segregated topsoil from subsoil. Topsoil is piled on east side of site. Previous site owner also dug a 6-10 foot basin in the same area and piled the subsoil on southwest corner of site. Additional inspections will be needed to deem the topsoil was segregated adequately and whether the subsoil pile is on subsoil.

Report Photo #1 “Work from previous site owner” at GPS Coordinates: 48.285833°N 103.321667°W

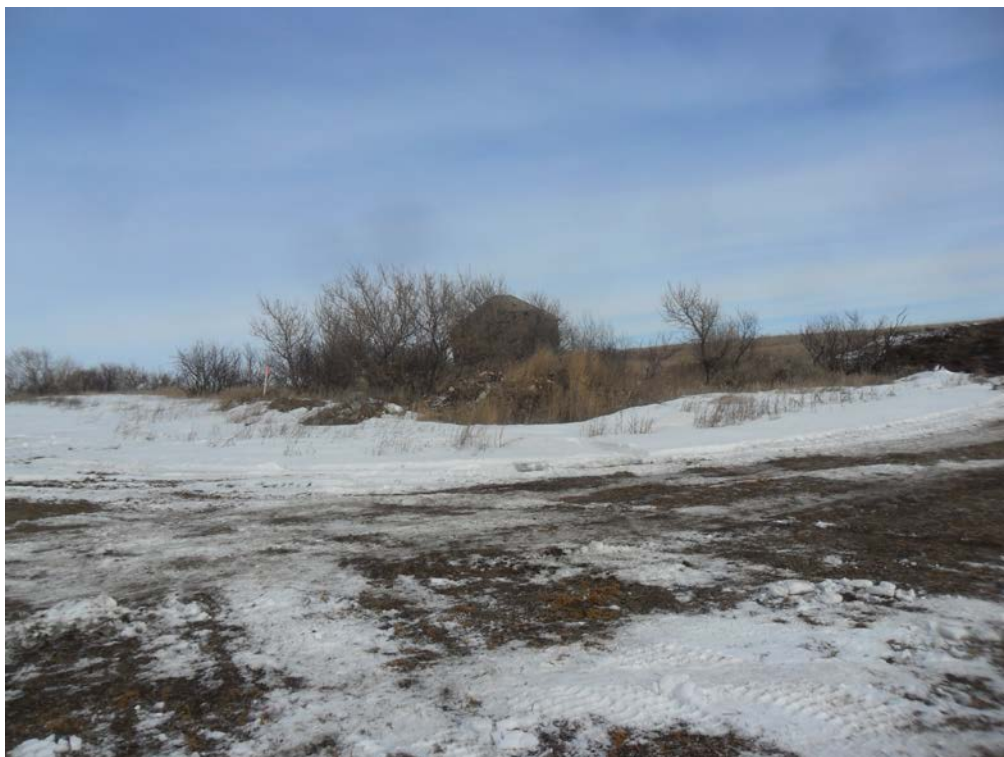
Tree row remains along north side of site, and one tree remains on northeast side of site. These trees have been surveyed and accounted for by as mentioned by Darren LeDouex of Matrix, Inc. No evidence of trees being removed currently.

Report Photo #2 “Tree shrub row on north side” at GPS Coordinates: 48.286667°N 103.322222°W

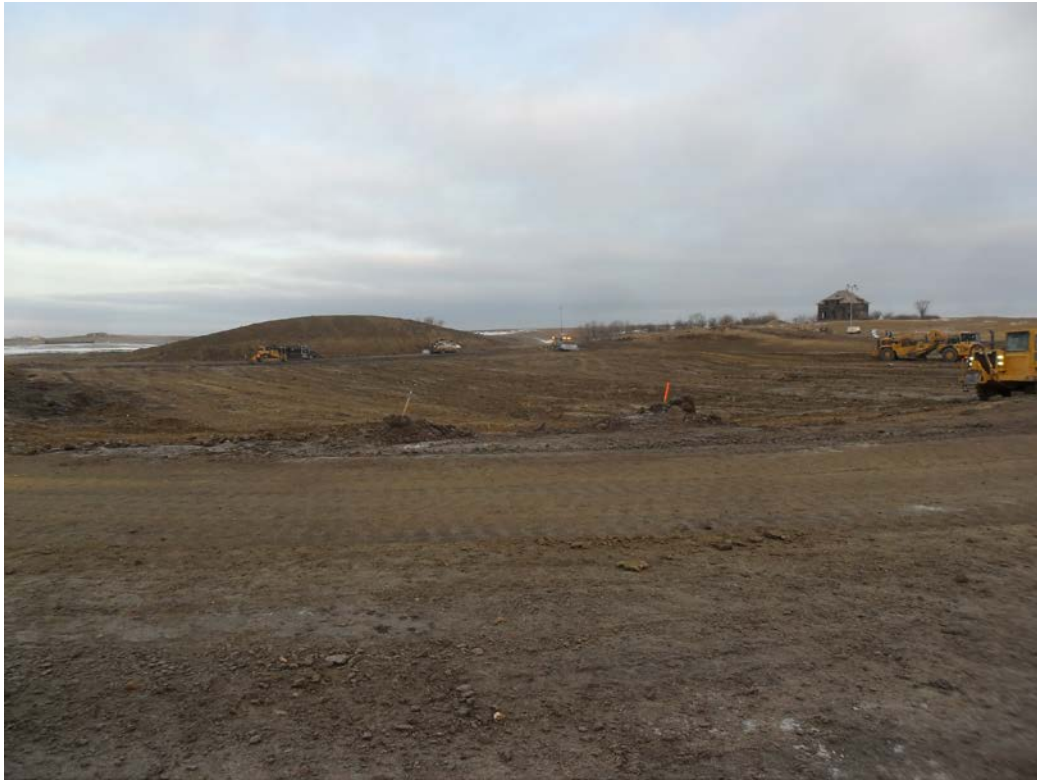
Report Photo #1 “Stripped grounds being landscaped” at GPS Coordinates: 48.285278°N 103.321111°W

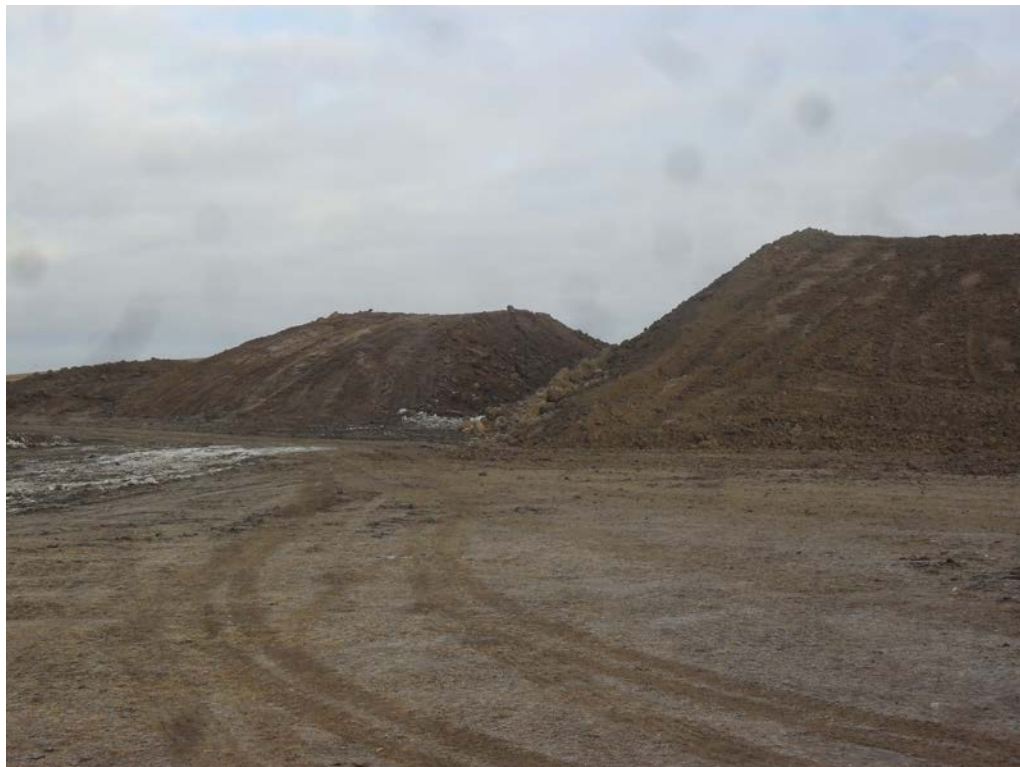
Roughly 1 foot of topsoil was stripped and stockpiled on west part of site during overnight hours. Topsoil from subsoil segregation appears adequate. Storm water sediment control measures are in place along east and south borders of site. Maintenance was being performed on the silt fences during site visit.

During site visit, Keitu inspector received confirmation that topsoil was stock piled on topsoil grounds. Subsoils piles were stockpiled on subsoils. Keitu inspector advised a scraper to be used when soils are hauled off site to prevent soils from being tracked off site.

Report Photo #2 “Topsoil pile left, Subsoil pile right” at GPS Coordinates: 48.285556°N 103.322778°W
