**Re: Dakota Access, LLC
Case No. PU-14-842**

From: Ben Cashman
Craig Erdman
Jon Robison, PE

Date: June 16, 2016

Subject: MP 16.5 Drainage Feature, Vicinity of Little Missouri River Crossing,
Dakota Access Pipeline Project, North Dakota

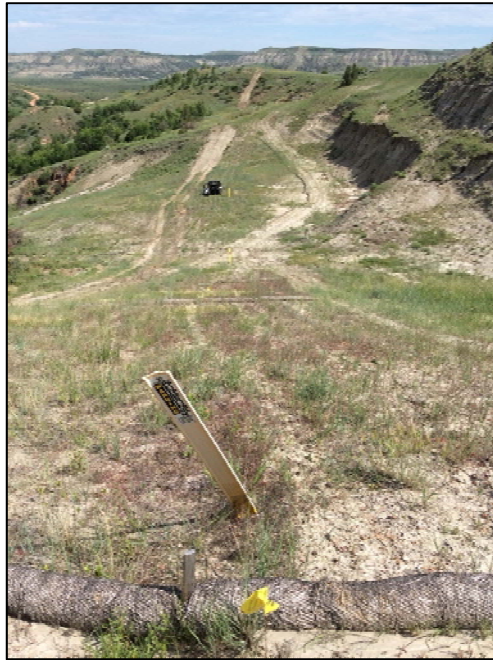
Photograph 1. Vantage of regraded fill area along existing Bridger Four Bears pipeline. View to north.

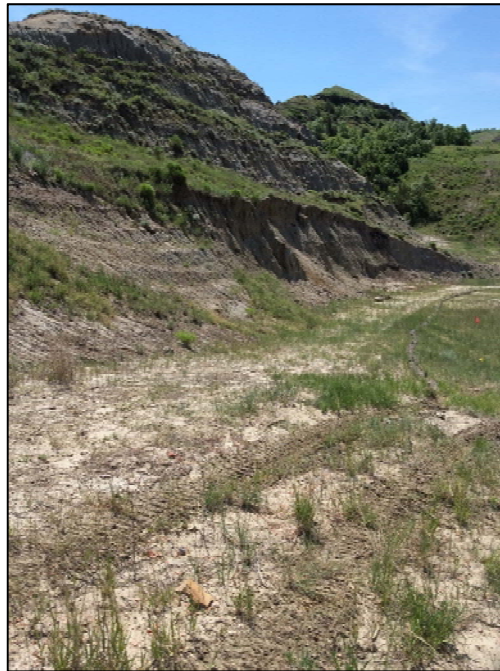
We observed the headscarp of the 2011 slope failure event that exposed the DGC and Bridger pipelines. The scarp is near vertical, approximately 280 feet long and is approximately 25 feet tall above the existing regraded fill surface. The northern portion of the scarp has been regraded to 65 percent.

Photograph 2. Scarp of 2011 "cave-in" event, with bedrock butte on photo left. View to south.

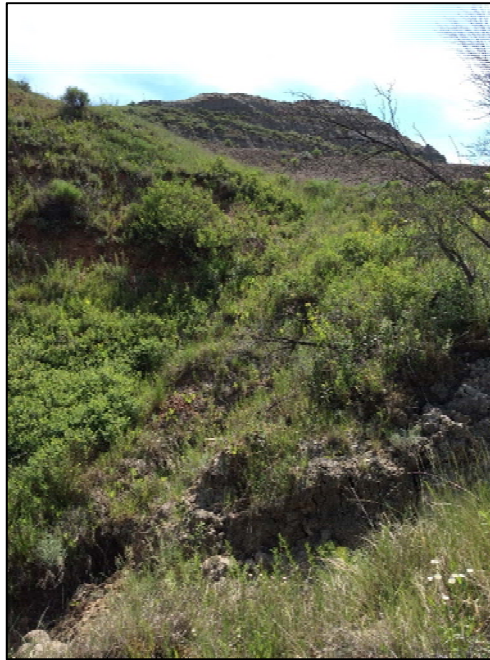
Photograph 3. Vantage from lower stream drainage looking up at natural bedrock buttress (photo left) and bedrock butte (top of photo). View to east.

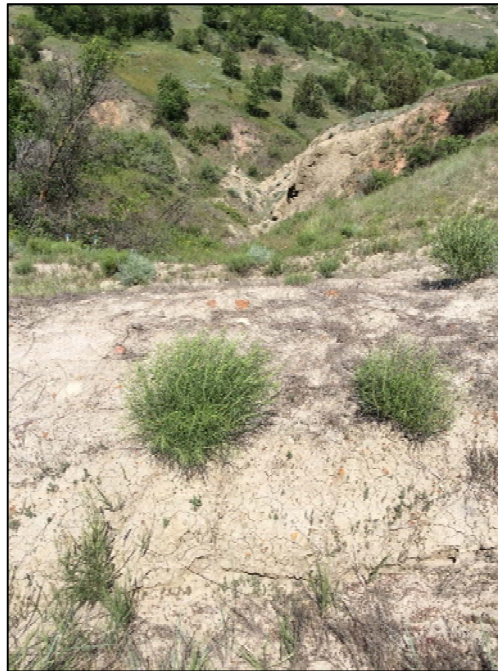
The lower fill berm is approximately 110 feet long and rises about 8 feet above the native underlying topography downstream. The outboard slope of the lower berm is inclined to approximately 50 percent, and the berm crest plunges at approximately 10 percent to the south-southwest. The upper berm is about 205 feet long and rises approximately 10 to 12 feet above the lower berm. The outboard slope of the upper berm is inclined to about 55 percent. The inboard slope of the berm is about 2 feet tall, and the fill slope rises to the southeast (upslope) of the berm and is uniformly inclined to about 20 percent. The material used to construct the fill berms is gray sandy silt that appears to be derived from the local soil and soft bedrock excavated from elsewhere on site. We did not observe evidence that granular drainage layers or other imported materials were used underneath the silty sand fill.

Photograph 4. View from lower buttress berm to lower stream drainage, with natural bedrock buttress on photo right. View to west.

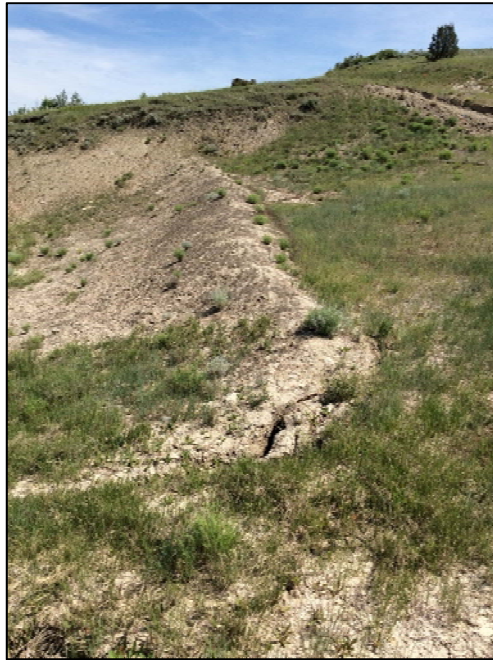
Photograph 5. Upper berm area. View to north

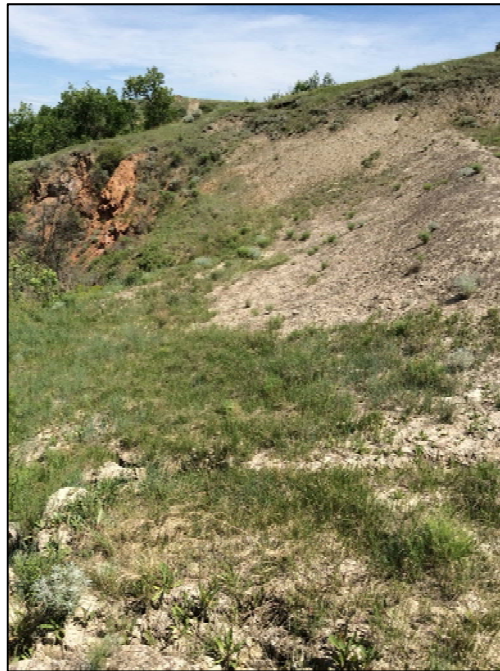
Photograph 6. Upper berm area (photo right) and lower berm (photo left). View to north.

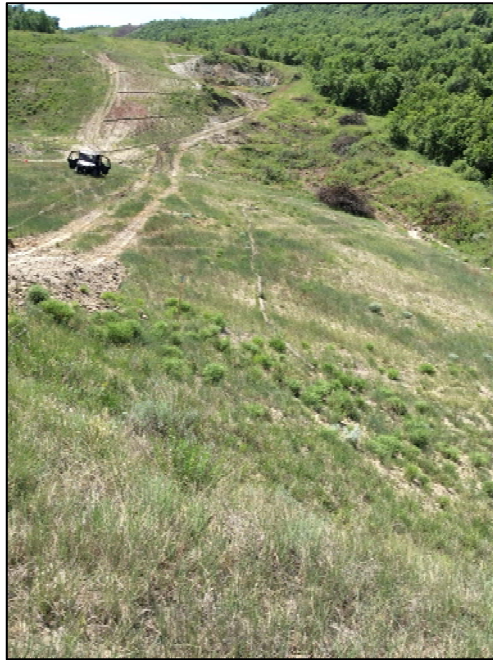
Photograph 7. View across regraded fill area along proposed DAPL centerline (marked by stakes). View to south.

Based on our field observations of the height of the upper buttress berm above the lower natural bedrock buttress downslope to the west (an elevation difference of about 12 to 15 feet), the fill is likely about 15 feet thick above the underlying native slope in this area. Depending on the nature of the underlying topography that was present before the fill was placed (such as possible stream channels or other irregularities in the surface that were buried), it is possible that the fill locally exceeds 20-25 feet in some areas. The potential for the time-independent risk to the Dakota Access pipeline associated with the existing fill may be reduced by installing the pipeline in the native soil/bedrock that underlies the fill.

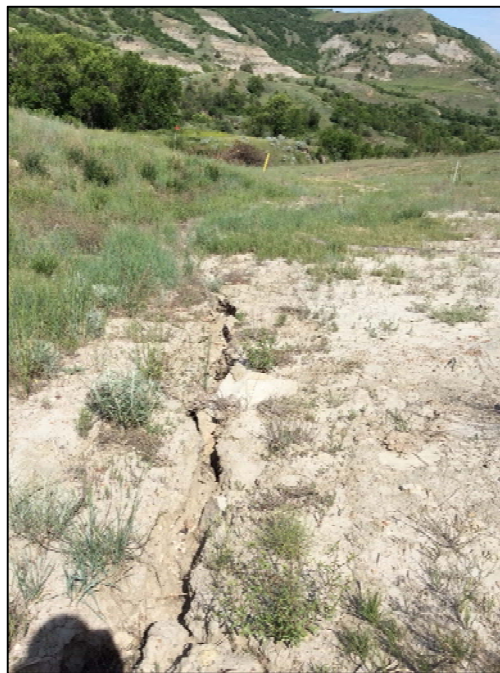
The abundant evidence of actively incising stream channels cutting into the fill along the southern and western margins of the fill is of concern for the existing Bridger Pipeline, as these channels have abrupt nickpoints that appear to be migrating headward towards the Bridger line. If left unaddressed by Bridger, these channels and new channels may create a time-independent risk for the fill in the vicinity of the proposed Dakota Access pipeline.

Photograph 8. Incising stream channel across eastern edge of ROW fill. View to northwest.

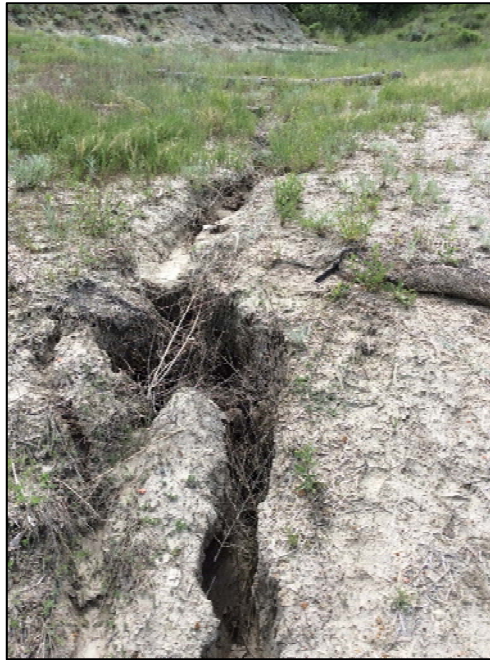
Photograph 9. Headward-migrating nickpoint in incised stream channel on western edge of ROW fill. View to southeast.

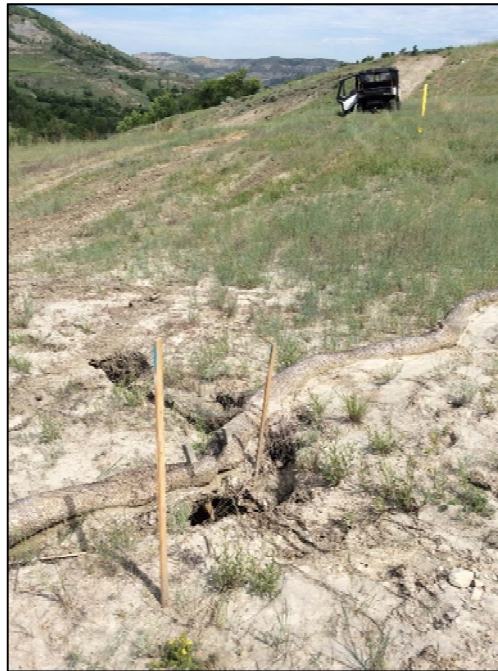
Photograph 10. Incising stream channel in vicinity of Four Bears line. View to northwest.

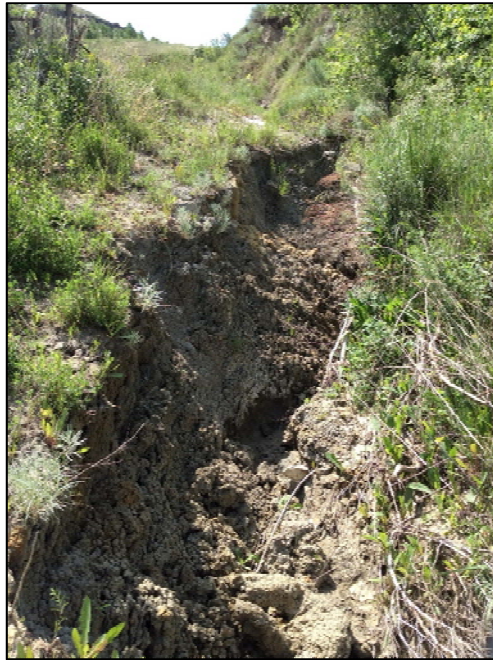
In general, the channel becomes increasingly more incised (up to 5 feet deep) as it continues northwestward along the west boundary of the fill. The channel then makes a sharp bend to the right (northeast) near the northwestern extent of the fill and increases in depth to approximately 7 feet. The channel meanders back to the left (northwest) downgradient of the natural rock buttress. An abrupt nickpoint is migrating headward in the channel from the west side of the ROW towards the Bridger line. We observed two small tributary channels incised into the fill area, one of which originates at the downslope end of the upper fill berm. We observed a 6-inch-diameter corrugated plastic drain pipe daylighting into the main stream channel in this vicinity. The drain pipe was partially filled with sediment and was not producing any flow at the time of our visit. The source or intended function of the drainpipe is unknown. We did not observe any other drainage pipes or structures at the site.

Photograph 11. Incising channel along western margin of fill area. View to southeast.

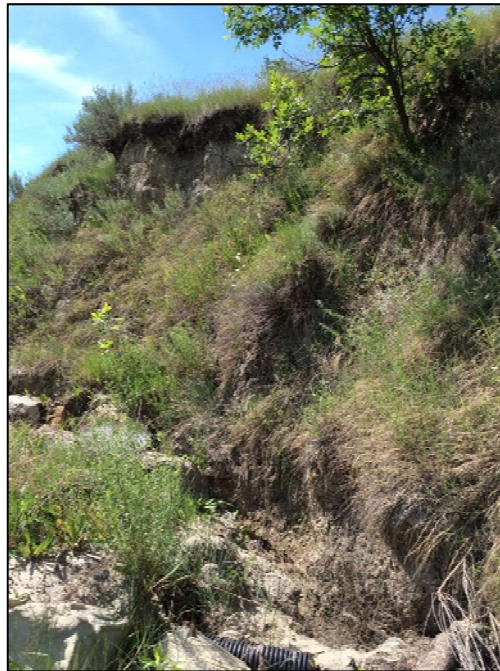
Photograph 12. 12-foot-tall embankment along western margin of fill area. CMP drainpipe at bottom of photo. View to south.
