**Site/Project Location:** West Side HDD Bore Missouri River

**Date of Inspection:** 11 August 2016

**Site/Project Location:** Slip HDD South of Little Missouri River

**Site/Project Location:** MP 13 Pipeline ROW McKenzie County Rd 37      **Date of Inspection:** 20 July 2016

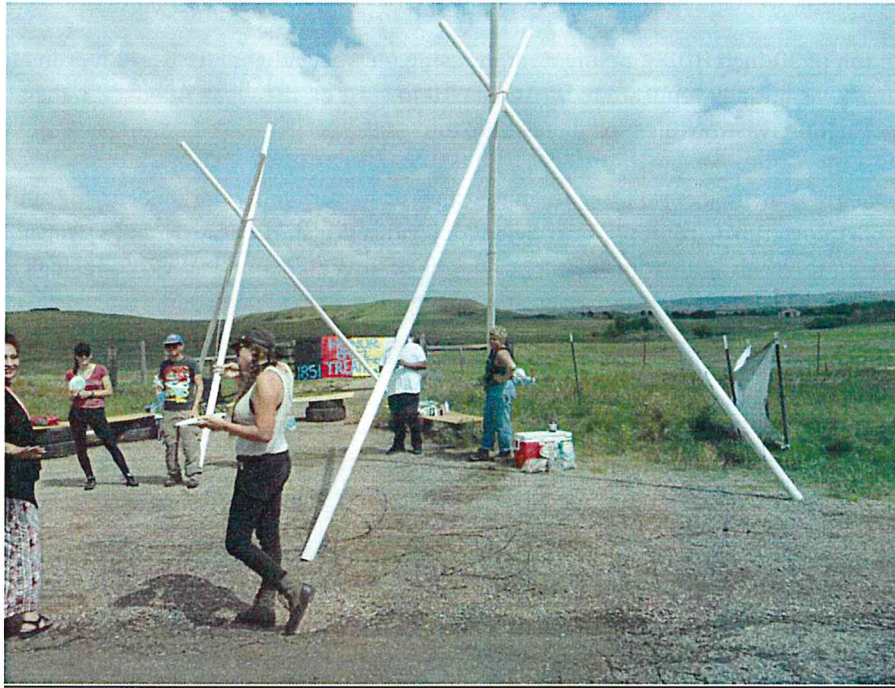
**Report Photo #1 "Protest Area – North Site":**

Protestors at both project access points off ND Highway 1806. Timetable for resolution unknown.

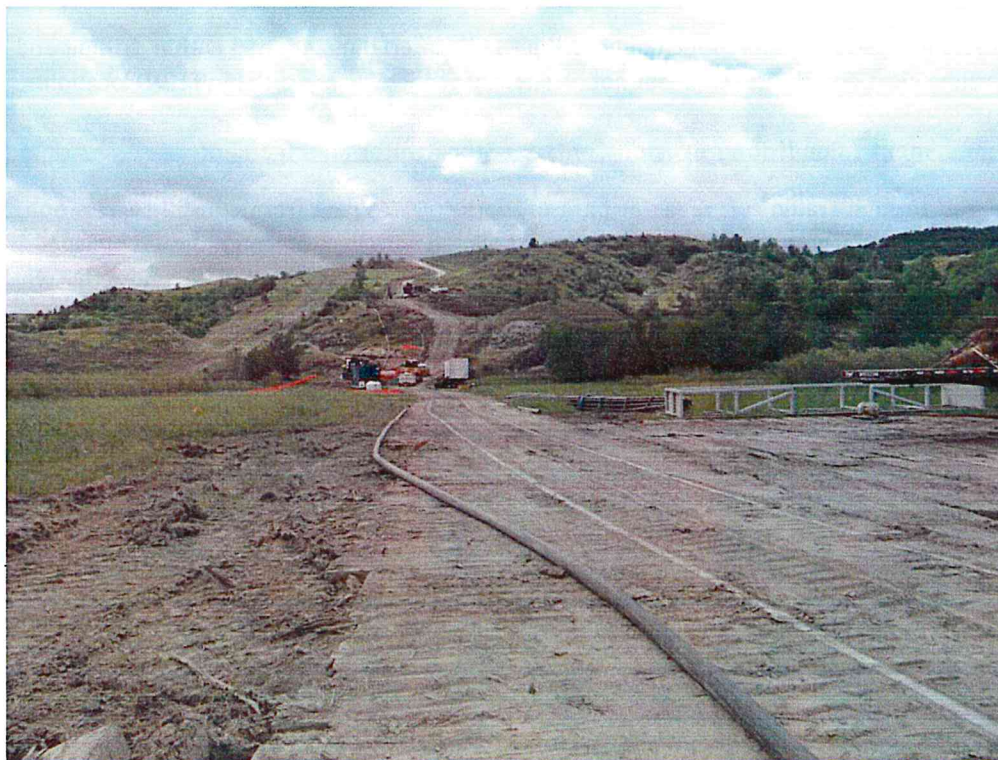
**Report Photo #1 "Overall Site Looking South Toward Backside of Prior Slip":** 47.6069°N 102.8765°W

**NOTE:** Bridger ROW to 50 feet to east (left)

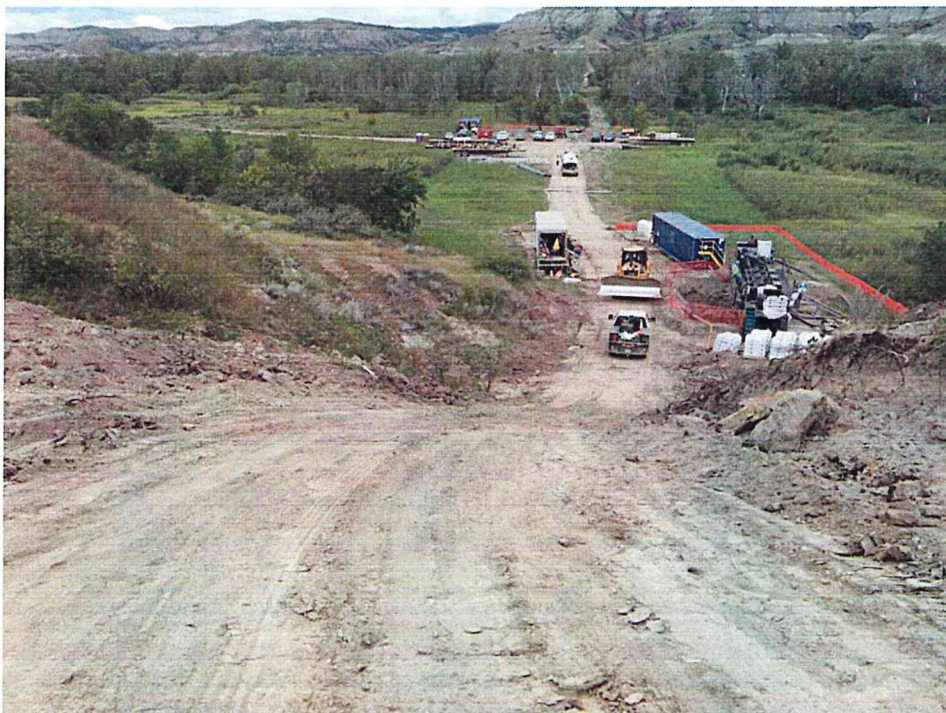
**Report Photo #3 "Overview Site Looking North from Slip Bore Machine Level":** 47.6072°N 102.8764°W

**NOTE:** Mud Mix-Trailer and Overflow Pit on east (right)

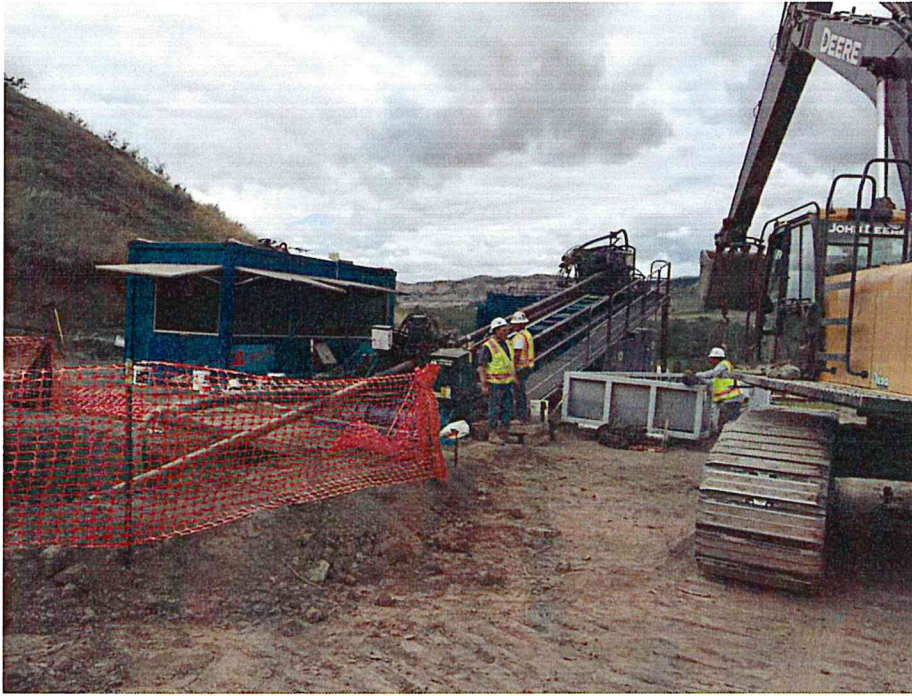
**Report Photo #4 "Bore Machine":**

HDD bore machine location observed including drill pit. All material maintained within drill pit and or mud machine overflow pit. Geotechnical engineer not on site, but reportedly at north bluff HDD location.

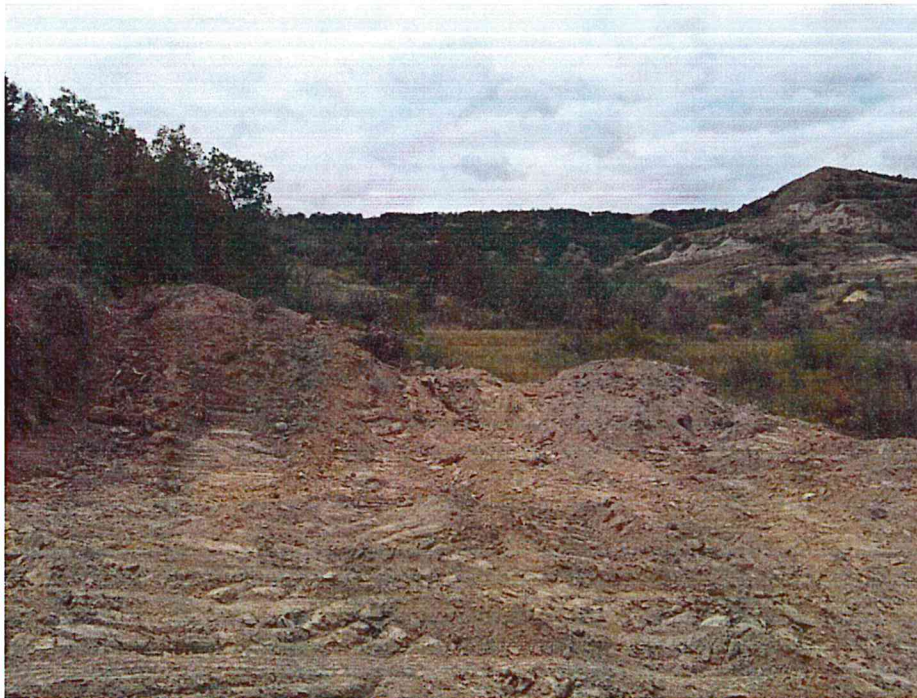
**Report Photo #5 "Marginal Topsoil Segregation":**

Mats/ties placed in high traffic soft areas at base of worksite. Topsoil from subsoil segregation appears adequate although poor segregation in limited areas associated with very steep grades up hillside. Silt fence installed in select areas at base although adequate vegetative cover (50+feet) noted beyond active work areas. Topsoil and subsoil stacks sometimes side-by-side and sometimes on opposite sides of ROW. On steep slope, a couple of small piles of topsoil was being stored on top of subsoil. In other areas, both soil piles had been removed. Where they exist, soil piles are within staked ROW boundaries.

One area of topsoil stacked on top of stripped subsoil.

**NOTE:** Topsoil stacked on subsoil

Moving topsoil pile on subsoil would likely be as much if not more damaging as leaving it at current location. Recommend leaving the soil pile at its current location.

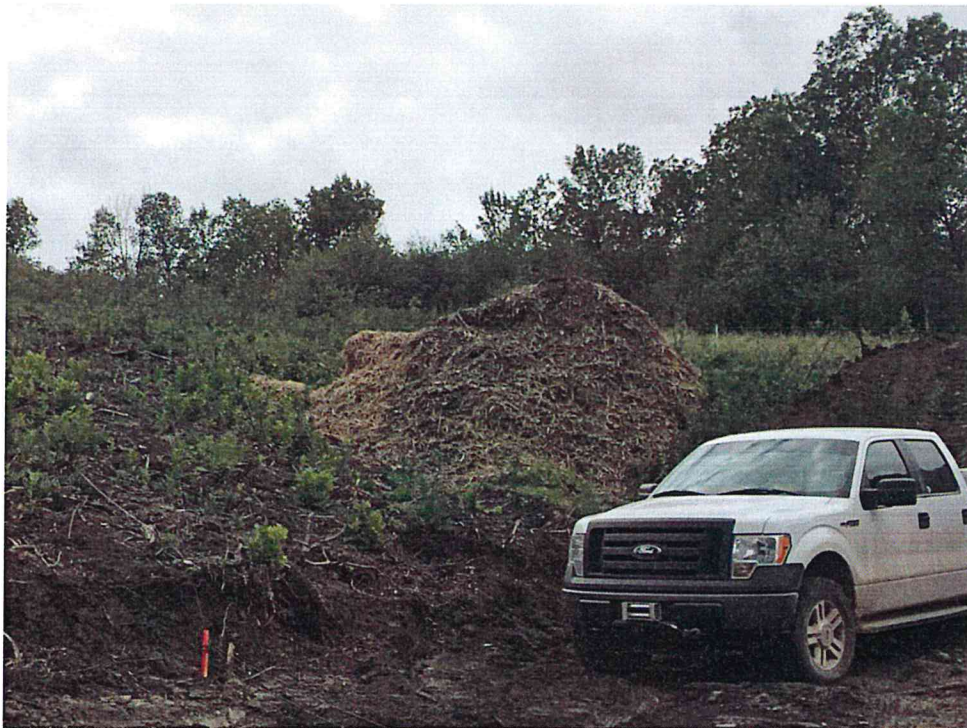
**Report Photo #6 "Chipped Wood Pile on West Side of ROW":**

Tree/shrubs removal in area immediately south of river very narrow, reportedly only 35 feet wide. Full width tree/shrub removal in current work area. Piles of wood chips noted within ROW work areas. Project staff reported they will be removed from ROW and not used during remediation. Asked to see tree count and removal tally. Project staff reported they were still waiting for that information as well from their project's environmental staff.

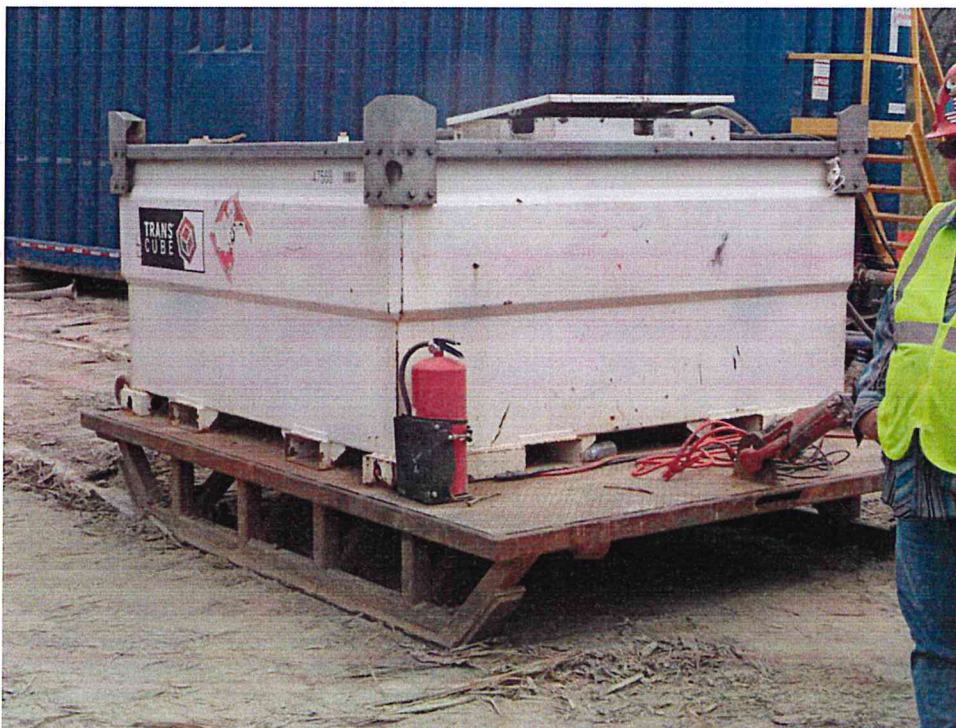
**Report Photo #7 "Transcube Fuel Container":**

Secondary fuel tank located at worksite trailer has been at site for four (4) days protected only by plastic sheeting beneath tank.

Site personnel understood, without prompting, that the secondary containment for the fuel trailer was not adequate. Possible modifications were discussed to correct item. Staff indicated it would be corrected in less than two (2) days.

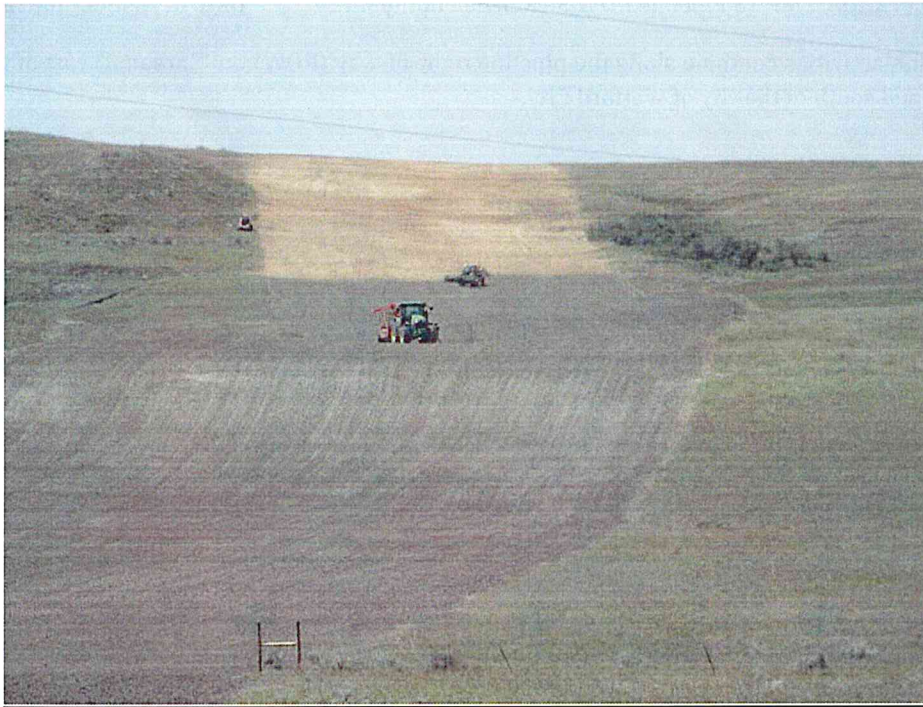
**Report Photo #1 "Pipeline ROW West of County Road 37 (Zoomed)" Looking W: 47.7833°N 103.2192°W**

Stormwater BMPs had been removed from both areas of the ROW. Shredded straw and crimping underway on sloped areas of ROW on west side of McKenzie County Road 37. Topography restored to apparent prior condition and elevation.

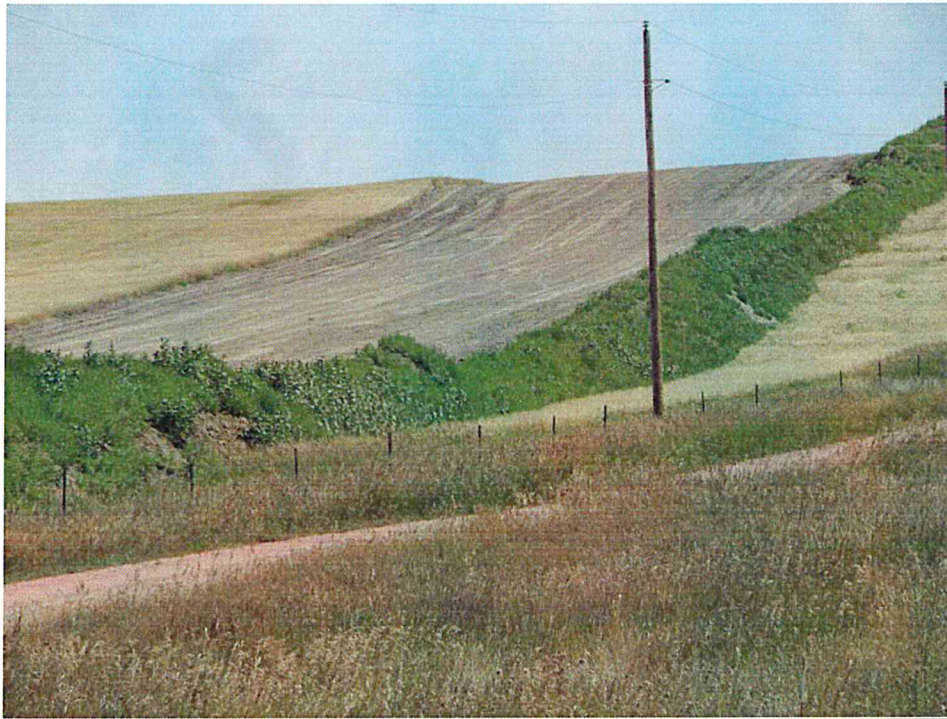
**Report Photo #3 "Pipeline ROW East of County Road 37" Looking ENE:**

On east side of McKenzie County Road 37, topography restored to apparent prior condition and elevation. Subsoil smoothly replaced across entire ROW. Top soil windrows still in place.
