Site/Project Location: MP 1 Spread 7-8 SE Johnsons Corner Terminal **Date of Inspection:** 24 August 2016
Pipeline ROW southeast of DAPL's Johnsons' Corner terminal in McKenzie County.

212 PU-14-842 Filed: 9/2/2016 Pages: 4
Site Inspection Trip Report – August 24, 2016

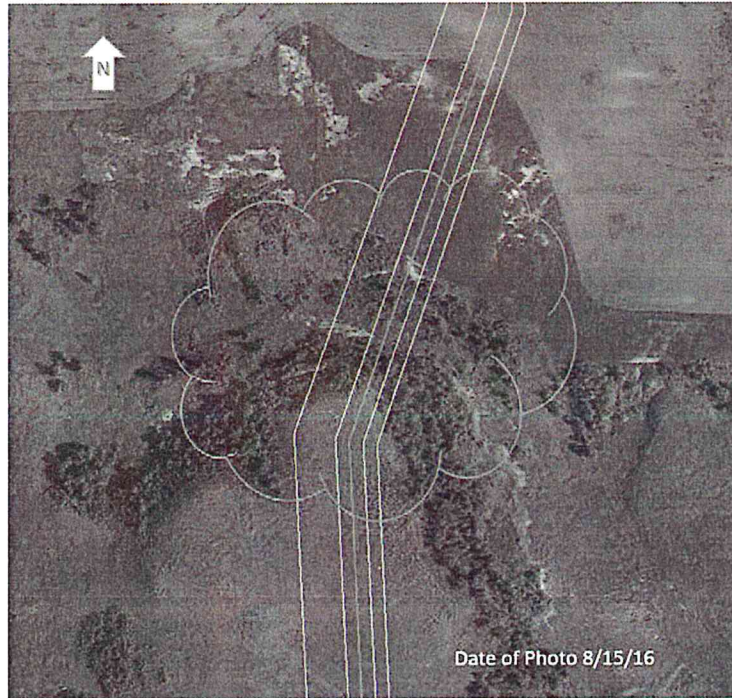
Centroid at 47.7863°N 102.9051°W

Report Photo #1 "Inspection Area Overhead Aerial Photo":

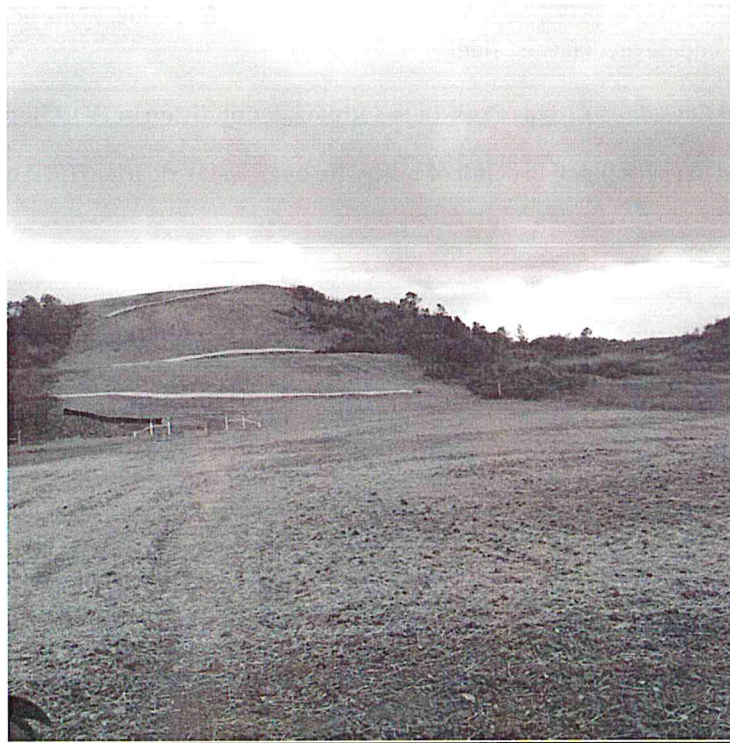
47.7878°N 102.9042°W

Report Photo #2 "Pipeline ROW Southeast of Johnsons Corner Looking SSW":

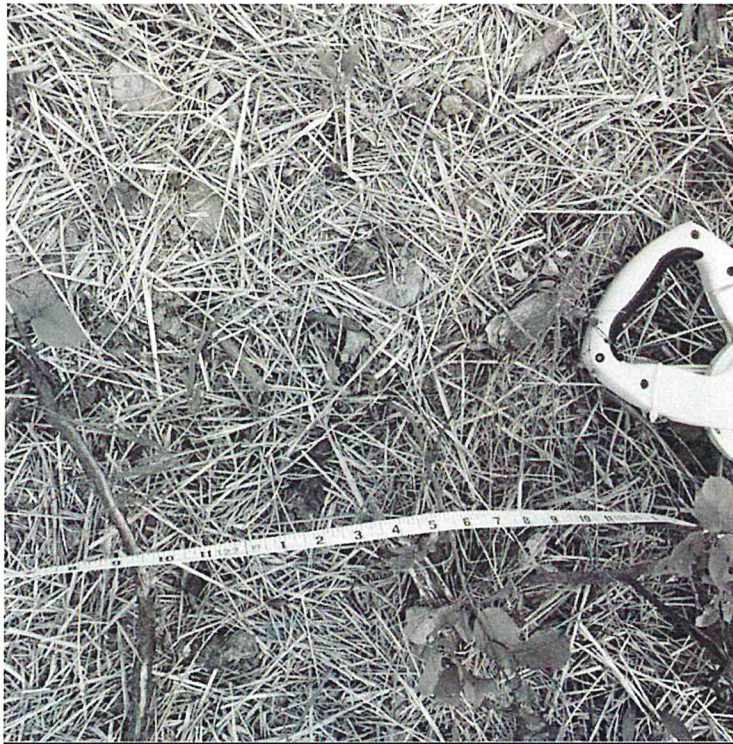
47.7863°N 102.9055°W

Tree removal extended significantly beyond 85 feet approved in revised ND Public Service Commission order. The narrowest area identified was just short of 127 feet wide. Other portions of the trees in the ROW were removed to even a wider width. No indication, however, that stripped area exceeded area of entire easement.

Report Photo #3 "Narrowest Point of Tree Removal 126 feet 9 inches":

Will report to PSC staff for follow-up action. Will perform post remediation inspection at this site.

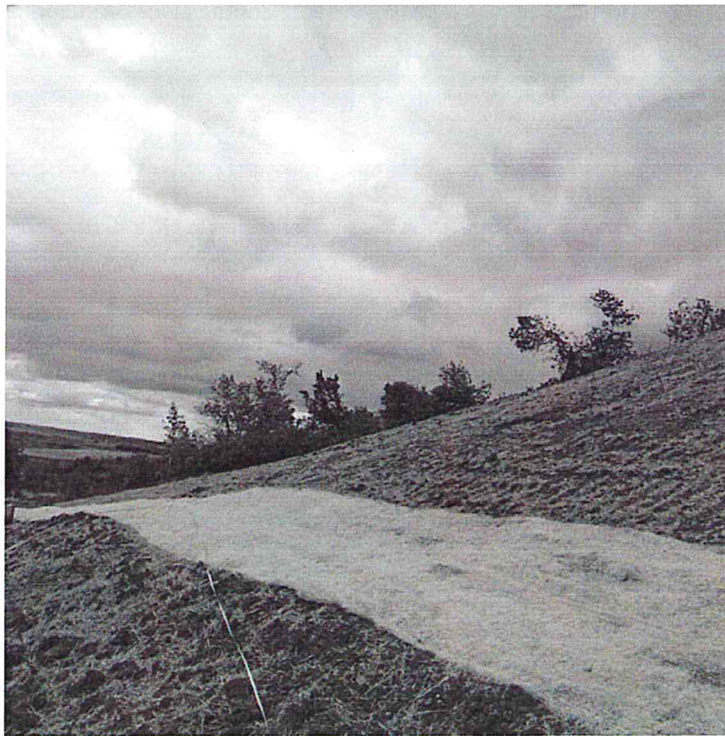
47.7863°N 102.9055°W

Tree removal extended significantly beyond 85 feet approved in revised ND Public Service Commission order. The narrowest area identified was just short of 127 feet wide. Wider removal noted in other portions of ROW.

Report Photo #4 "Narrowest Point of Tree Removal Looking East":

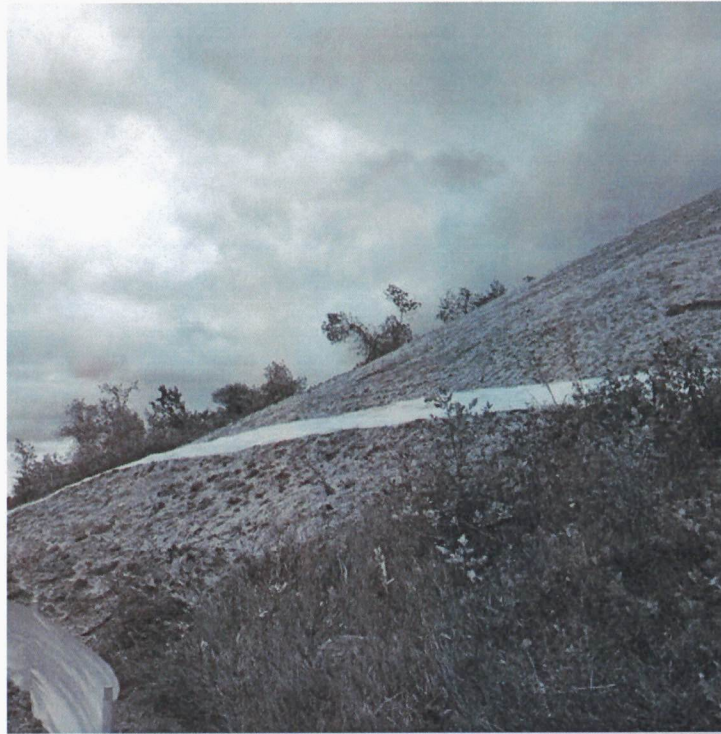
47.7861°N 102.9055°W

Top soil appeared to be spread and "roughened" uniformly across width of ROW. Based on hillside subsidence areas adjacent to the ROW, topsoil depth in area approximately 4-6 inches. Fenceline repaired and painted steel gate installed. Blown cut straw (but not crimped) installed in all areas above 8% slope, but beginning to consolidate in low wind zones and at base of hill. Erosion control blanket installed across ROW in three areas including crest of bluff. Slit fence across ROW in one areas in addition to surrounding drainage area near base of bluff on east side (with limited damage). Reseeding was not apparent.

Blown straw cover was not crimped into topsoil.

Report Photo #5 "High Slope on North Side of Bluff Looking ESE":
