Site/Project Location: MP 61 to 65 Spread 7-8 SE Dodge ND

Date of Inspection: 26 August 2016

Inspected 5 miles of pipeline ROW approximately 2.3 miles SE of Dodge ND including archy site 32DU2255 County Road 7 west of Golden Valley, ND.

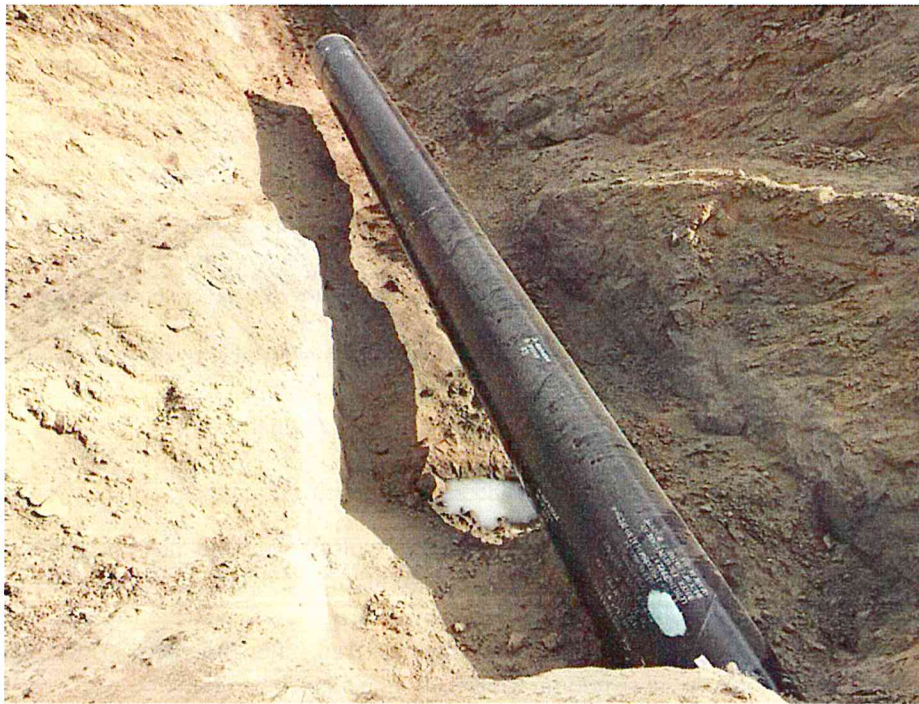
47.2416°N 102.9055°W

Visited between 9:30 am 12:35 pm. Overcast clearing to broken skies. Unrestricted visibility. SW wind at 6-18 mph. No precipitation during visit. Standing water noted only at water crossings and notably a milky white water ground seep with no apparent reason north of HDD bore at County Road 7. Temperature 68-72 °F.

Report Photo #1 "Milky Water Seep Beneath County Road 7 HDD Pipe":

SW Water District to be contacted to inquire if "milky water" seep north Mercer County Road 7 is cause for concern. Location will be targeted for post construction inspection to assure stone features remained intact.

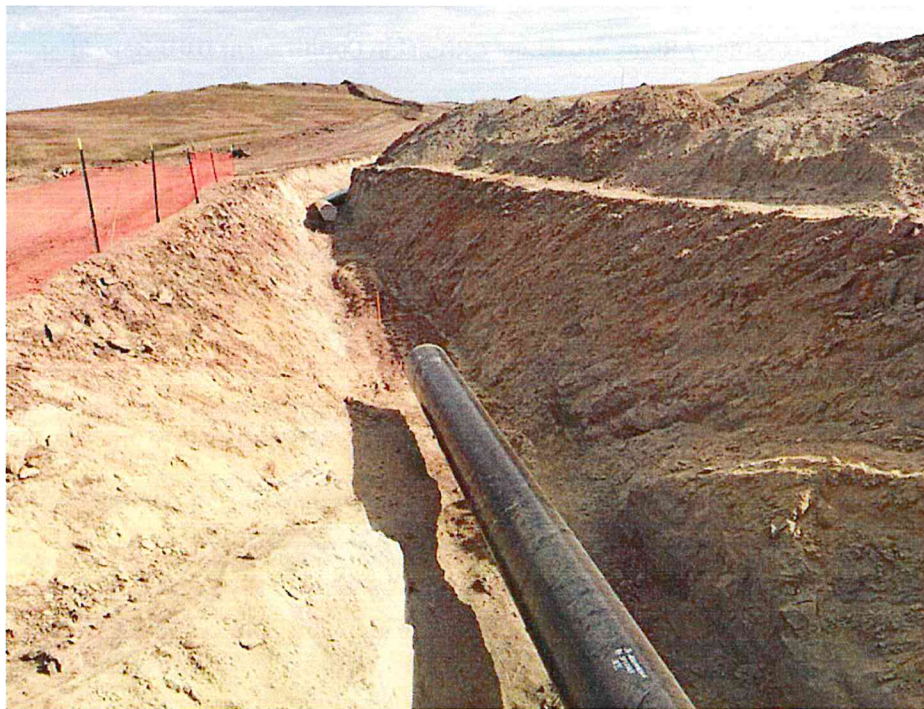
47.2416°N 102.9055°W

Open trench areas (10) observed appeared to be at specified depth or deeper. Two water crossings noted with narrowed work areas with riparian vegetation protected by silt fences. No active HDD operations noted.

Report Photo #2 "Adequate Depth Trench with HDD/Std Pipe Looking NNE":

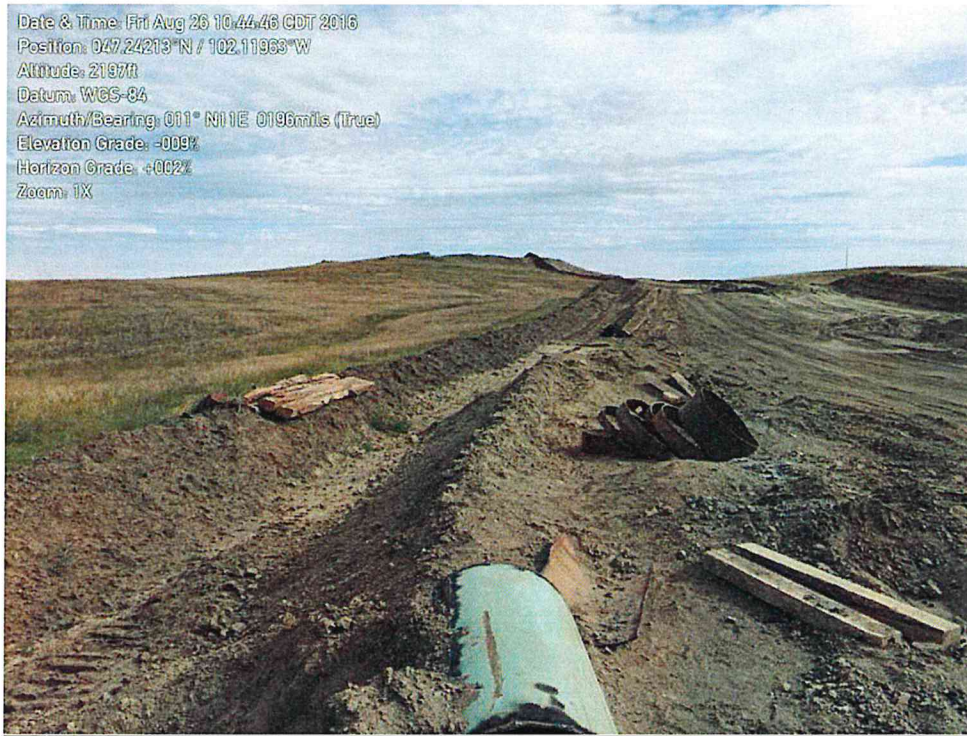
47.2421°N 102.1196°W

Report Photo #3 "Good Topsoil Segregation Looking NNE:"

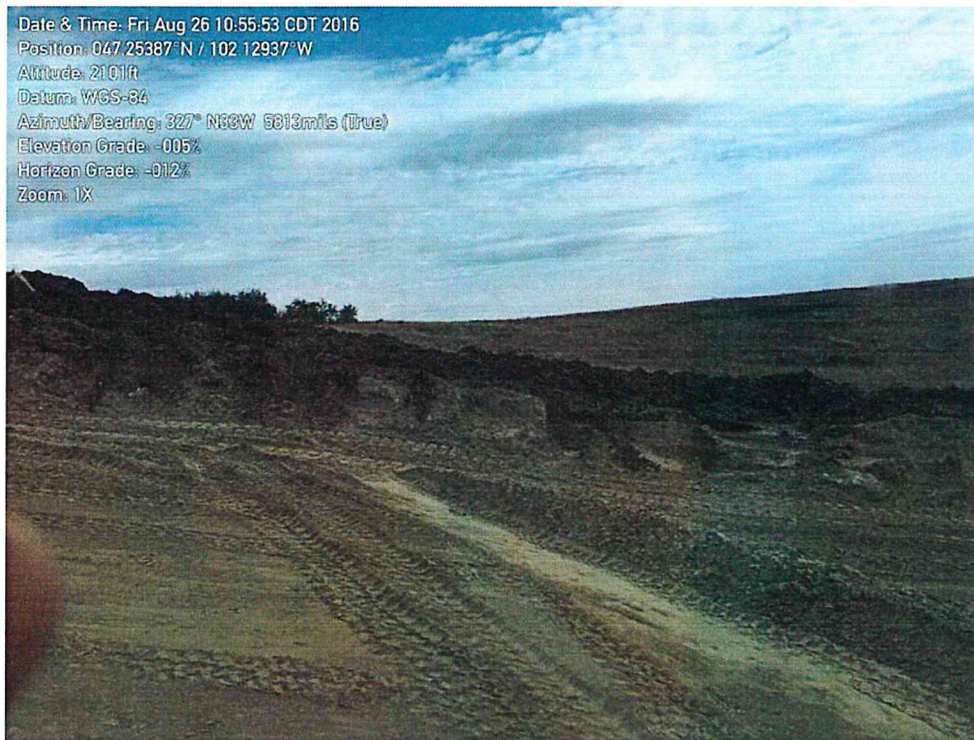
47.2539°N 102.1294°W

A few areas of minor subsoil contact with topsoil and/or surface vegetation. One area appeared specifically associated with late stage install of flow breaker on steep slope of ROW as opposed to initial top soil stripping.

Report Photo #4 "Subsoil Cast on Topsoil Likely During Flow-breaker Install:"

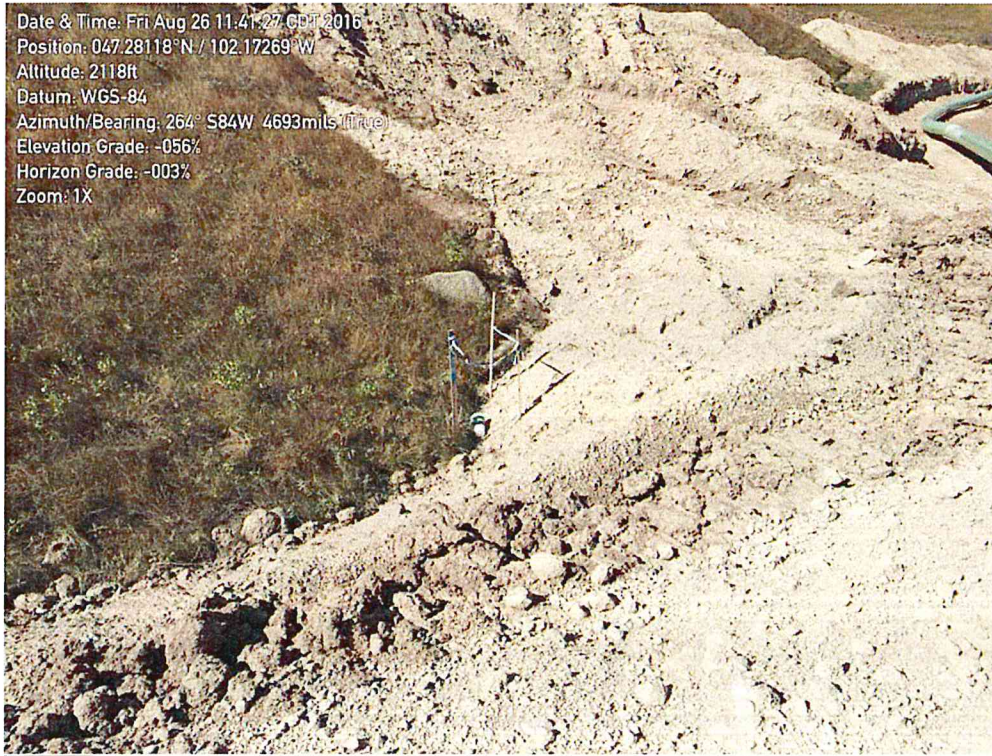
47.2812°N 102.1727°W

Top soil remains segregated. Where exposed, topsoil in region typically only 1-3 inches in depth. Three short areas of subsoil cast on or plowed onto adjacent topsoil noted of limited duration. Stormwater BMPs remain in place and in good repair. Drainage points protected with straw bales or silt fence were cleared of silt. Extreme high sloped areas i.e 12+% grade typically had shallow trench flow breakers. One area of soil piles extending beyond staked boundaries of minor duration (less than 12 inches) noted.

Report Photo #5 "Subsoil Thrown Beyond Stakes/On Top of Vegetation":
