**Site/Project Location:** MP 75 to 92 Spread 7-8

**Date of Inspection:** 13 September 2016

Inspected roughly 13 miles of pipeline ROW approximately 17 miles south of Beulah ND in Mercer County.

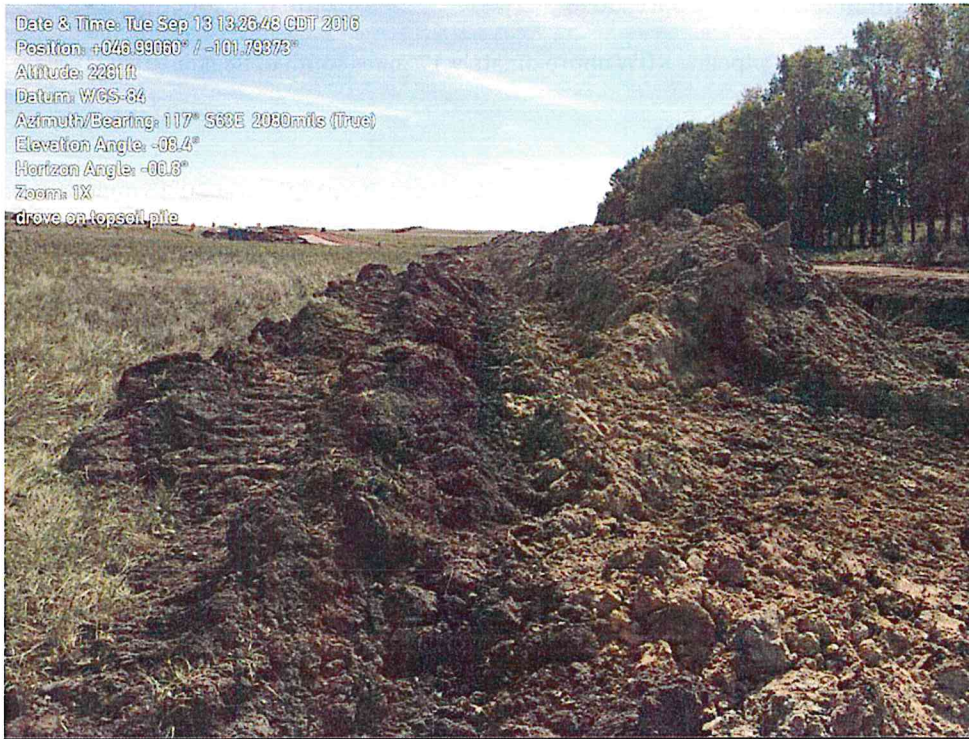
46.99060°N 101.79373°W

Three (3) short areas of topsoil / subsoil missing or subsoil piled on vegetated surfaces. One area had a heavy equipment drive over mixing topsoil and subsoil piles. Some silt fences needing re-stapling.

**Report Photo #1 "Topsoil Driven over, Soils Mixing at M.P. 92":**

Will look for inspection results and prompt repair next time stormwater inspections documents are checked.

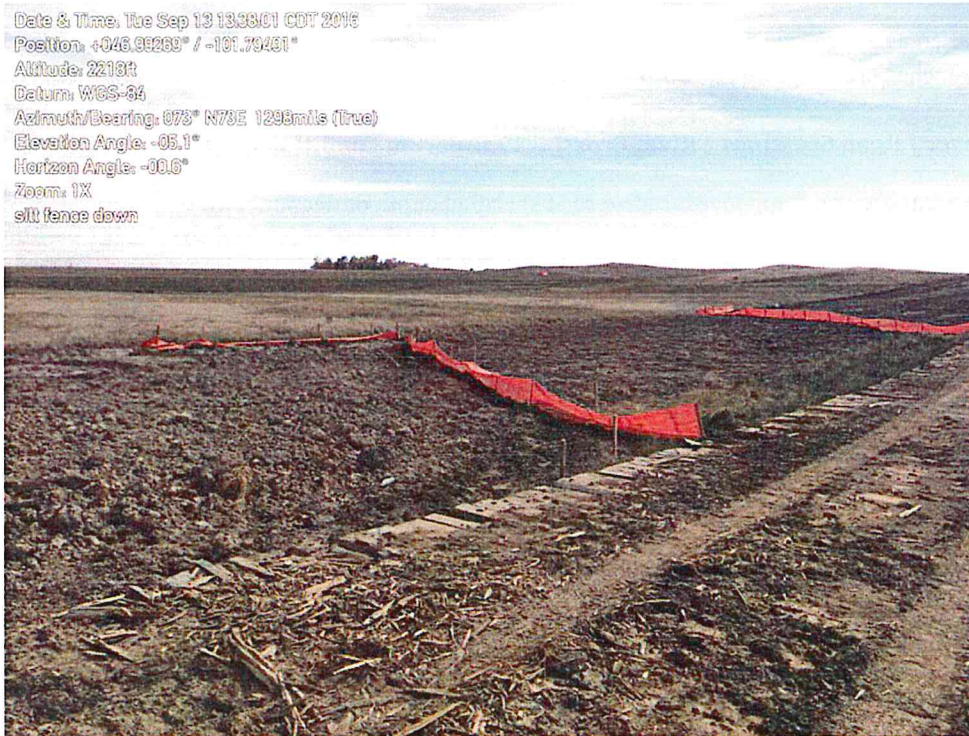
46.99269°N 101.79491°W

**Report Photo #2 "Silt Fences Down":**

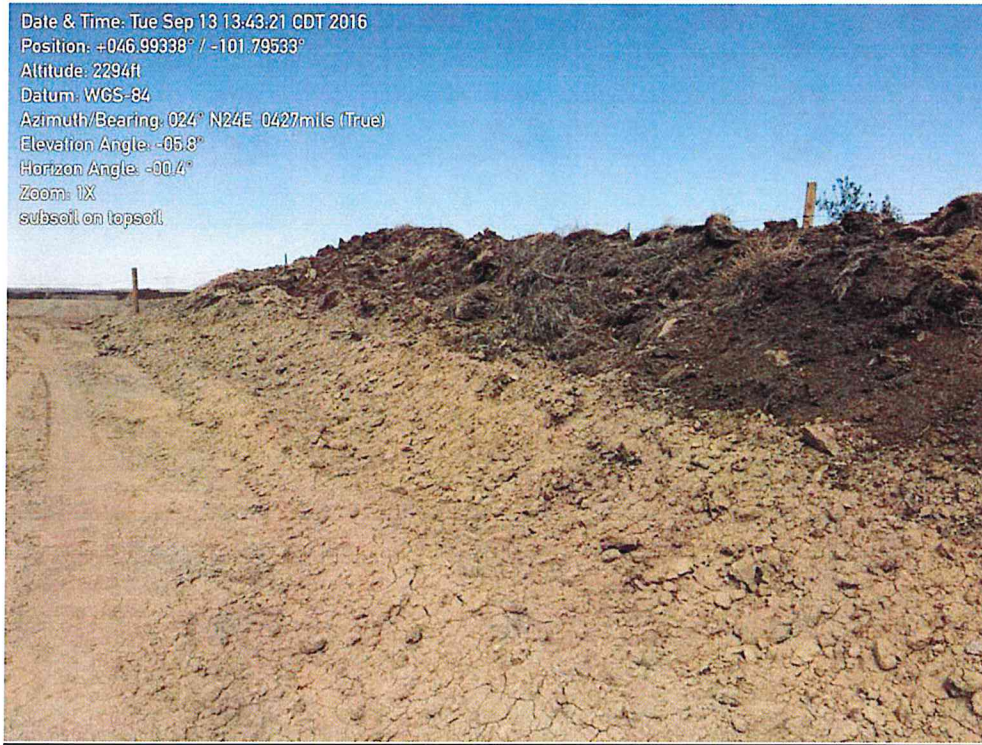
46.99338°N 101.79533°W

**Report Photo #3 "Subsoil Plowed onto Topsoil at M.P.91.25:**

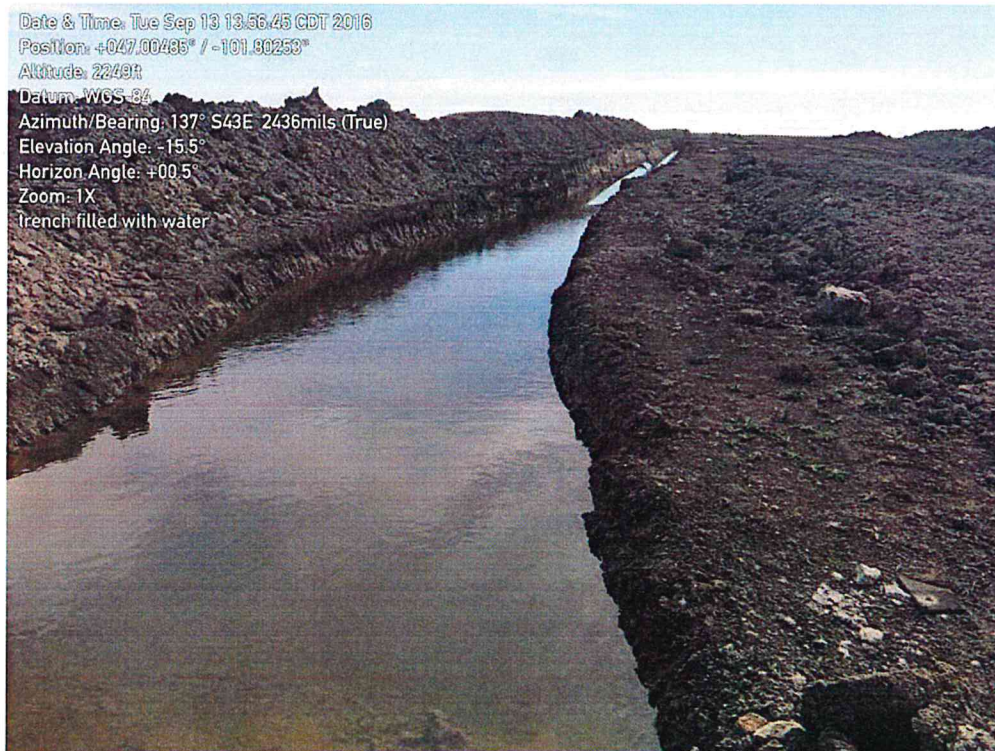
47.00485°N 101.80253°W

Construction activities were shut down during site visit. Pipe was generally in trench with exception at few locations. Trench was backfilled with subsoil back to subgrade on majority of ROW. Multiple open trench areas filled with water. Many areas on ROW where ROW boundary survey stakes were not visible. Exclusion zones were labeled with yellow signs and colored pennant string flags.

**Report Photo #4 "Trench Filled with Standing Water:**

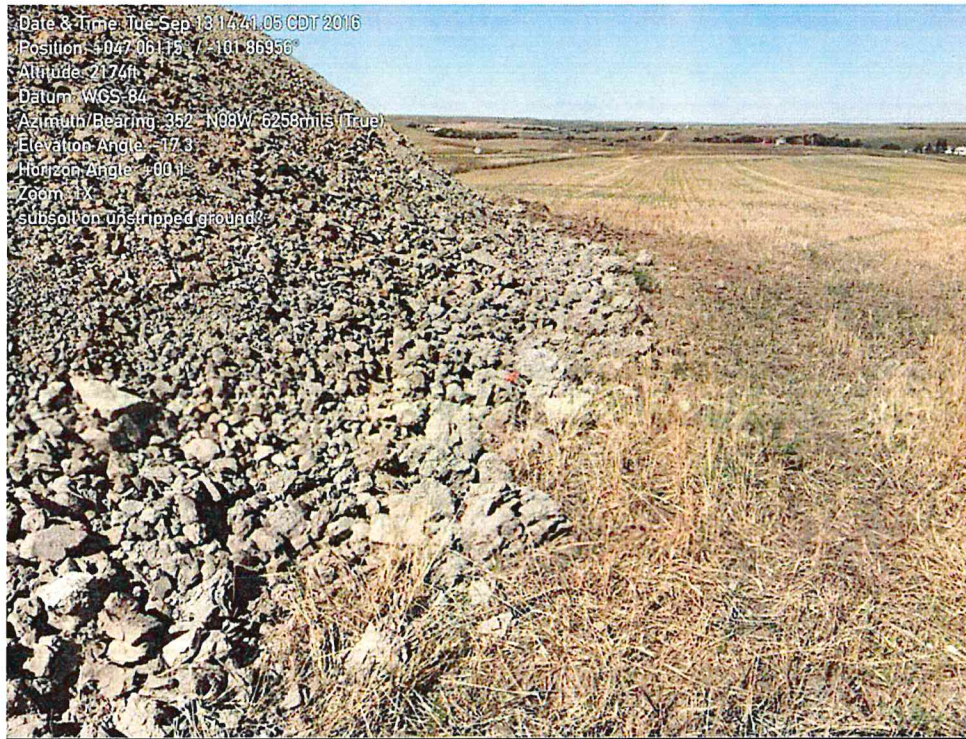
47.06115°N 101.86956°W

**Report Photo #5 "Subsoil On Top of Vegetation, No ROW Stakes":**

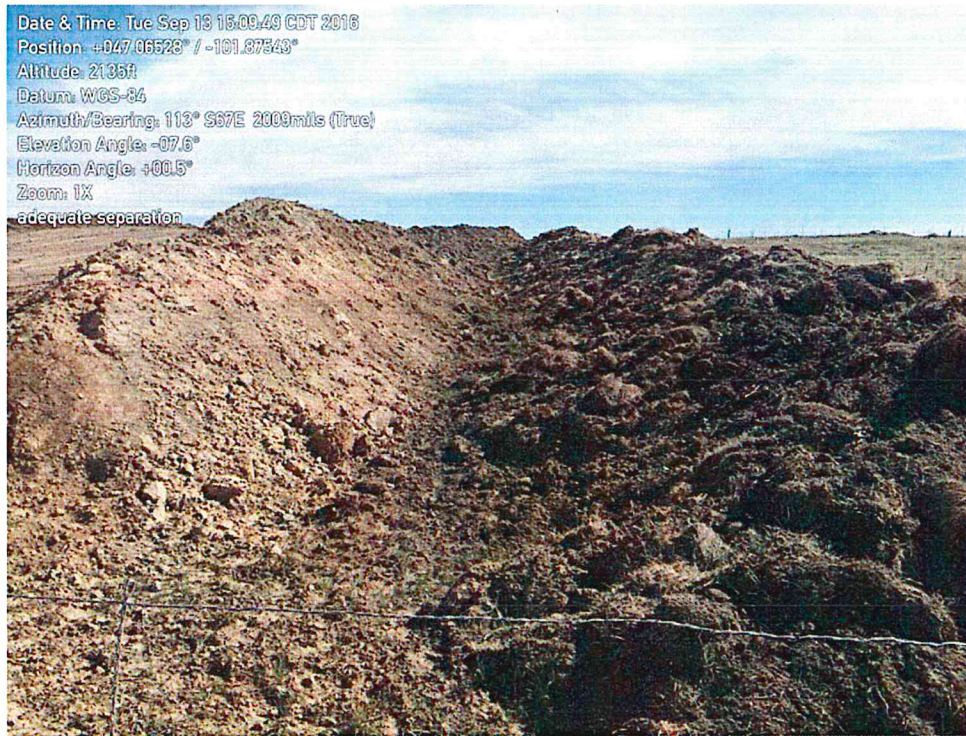
47.06528°N 101.87543°W

**Report Photo #6 "Adequate Topsoil-Subsoil Separation":**

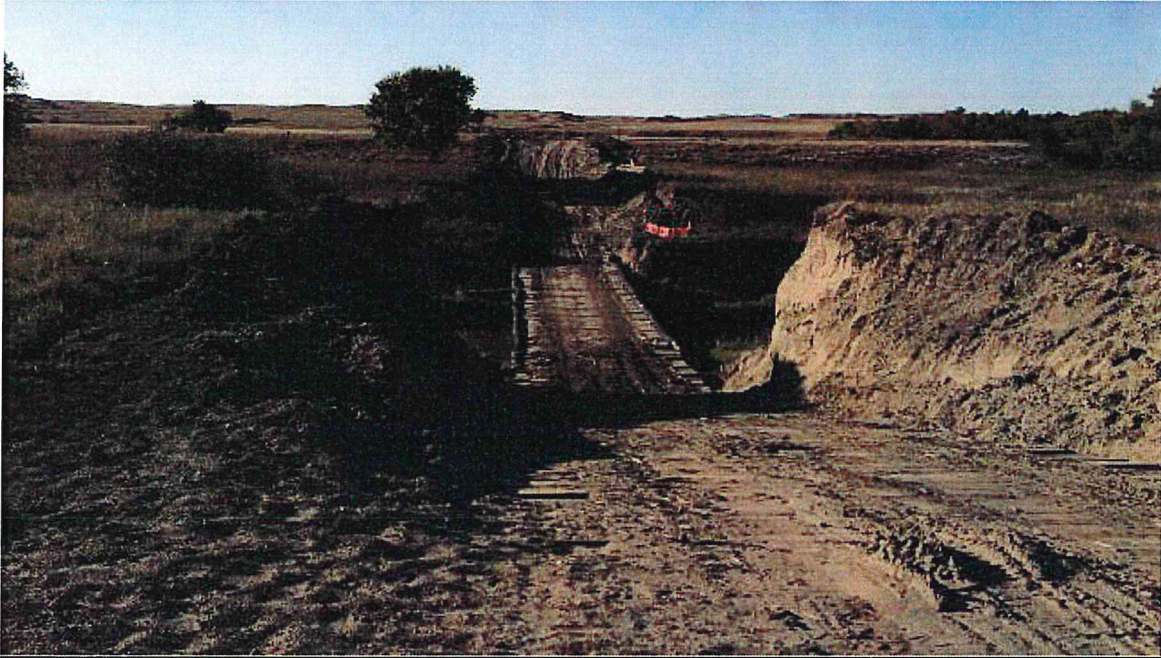
47.171389°N 102.003889°W

Open trench areas observed and measured were at specified depth or deeper. Two water crossings noted with narrowed work areas with riparian vegetation protected by silt fences. No active HDD operations noted. Roughly 30 foot wide access road was created between the Knife River bore pads using matted bridge pads.

**Report Photo #7 "Knife River Crossing":**
