Site/Project Location: MP 118.5 Spread 9, M.P. 1.5 & 42 Spread 8 **Date of Inspection:** 29 September 2016

Pipeline ROW going through tree/shrubs near Arnegard and Dunn Center in McKenzie and Dunn County.

Inspection Report Submitted: 6 October 2016

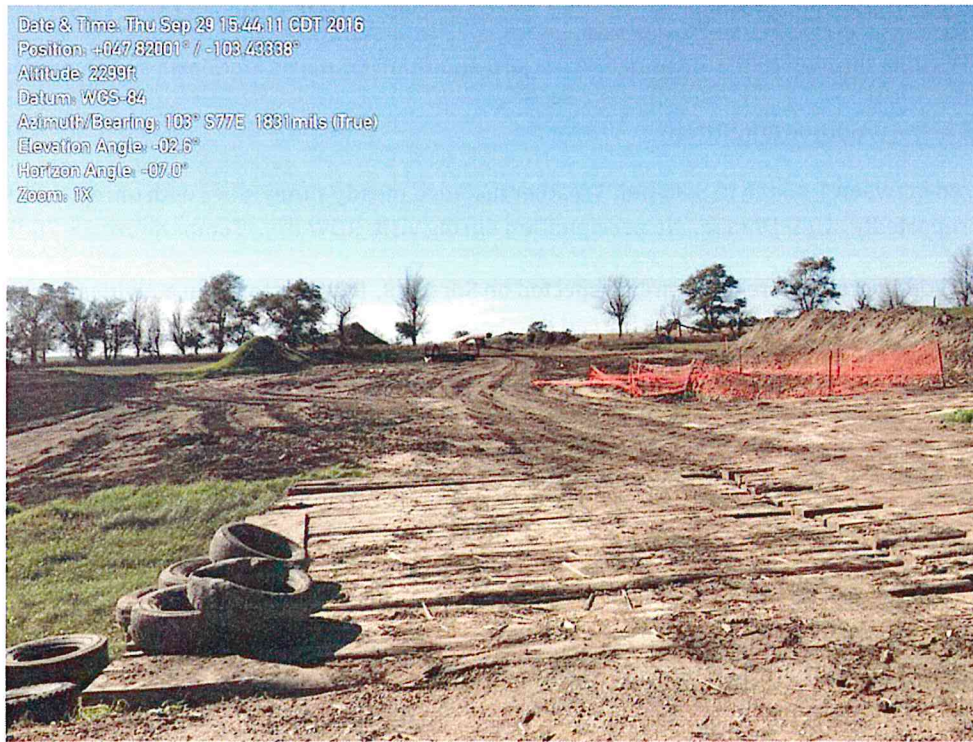
Tree removal was confirmed to be 85 feet or less at M.P. 118.5 Spread 9 and M.P. 42 Spread 8. These areas were proposed to be cleared the full 150' based on shape files received from the ND Public Service Commission. As reported on September 1, 2016, M.P. 1.5 Spread 8 had trees and shrubs were cleared 127 feet at the narrowest visible width. All shrubs removed were completely stripped during topsoil removal and were not cut flush with ground. Shrub species noted and observed were silver buffaloberry and chokecherry.

Report Photo #1 "Tree row at M.P. 118.5 Spread 9":

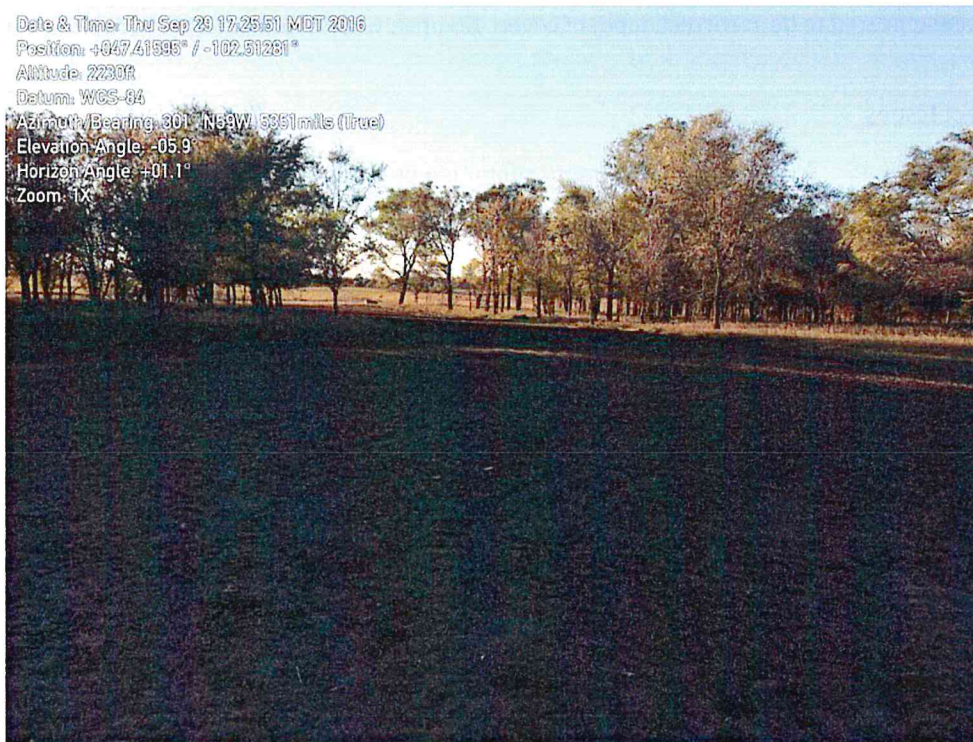
Report Photo #2 "Tree Clearing at M.P. 42 Spread 8":

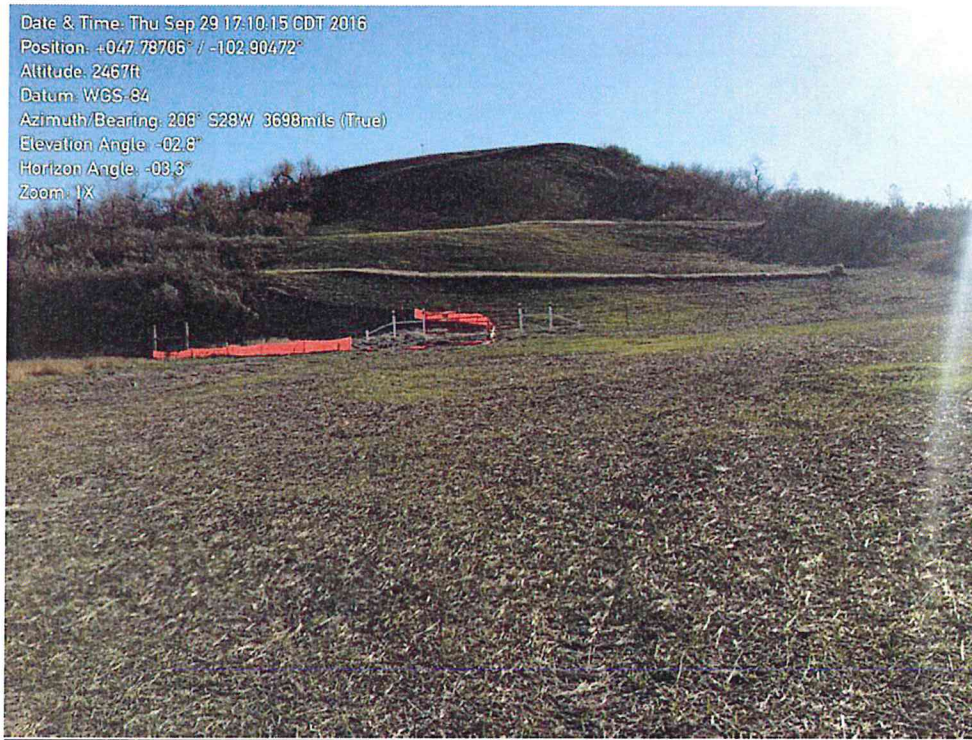
As noted on September 1, 2016, tree/shrub removal extended significantly beyond 85 feet approved at M.P. 1.5 Spread 8. Shrubs were observed and documented on the ROW edges. Further investigating should occur whether these tree/shrubs were surveyed. Shrubs outside the permanent ROW may be mitigated by natural regeneration if: shrubs are cut flush the surface of the ground and if the native topsoil is preserved, but that was not the observed condition i.e. shrubs cleared at M.P. 1.5 on Spread 8 were not cut flush with the ground

Report Photo #3 "Tree Clearing at M.P. 1.5 Spread 8":

Further investigation should occur to see if approved May 2016 reroutes were surveyed for trees/shrubs.

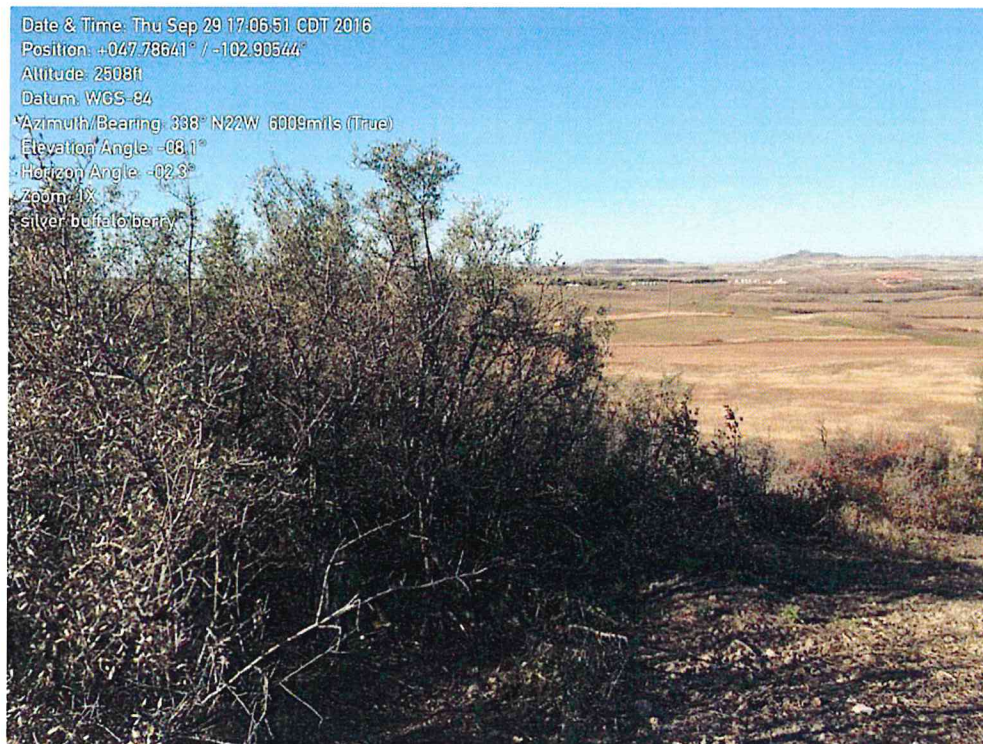
Report Photo #4 "Silver buffaloberry cleared at M.P. 1.5":

According to Docket 45 – Tree and Shrub Inventory submitted by Dakota Access to the PSC, shrubs in native growth and planted areas would be mitigated by natural regeneration outside the permanent ROW. However, the PSC requires that all shrubs cleared must be replaced at 2:1 ratio with stem cuttings.
