**Site/Project Location:** MP 136 to 140 Spread 7-8 NW St. Anthony      **Date of Inspection:** 4 October 2016  
Inspected 4 miles of pipeline ROW approximately 8 miles NW of St. Anthony ND in Morton County.

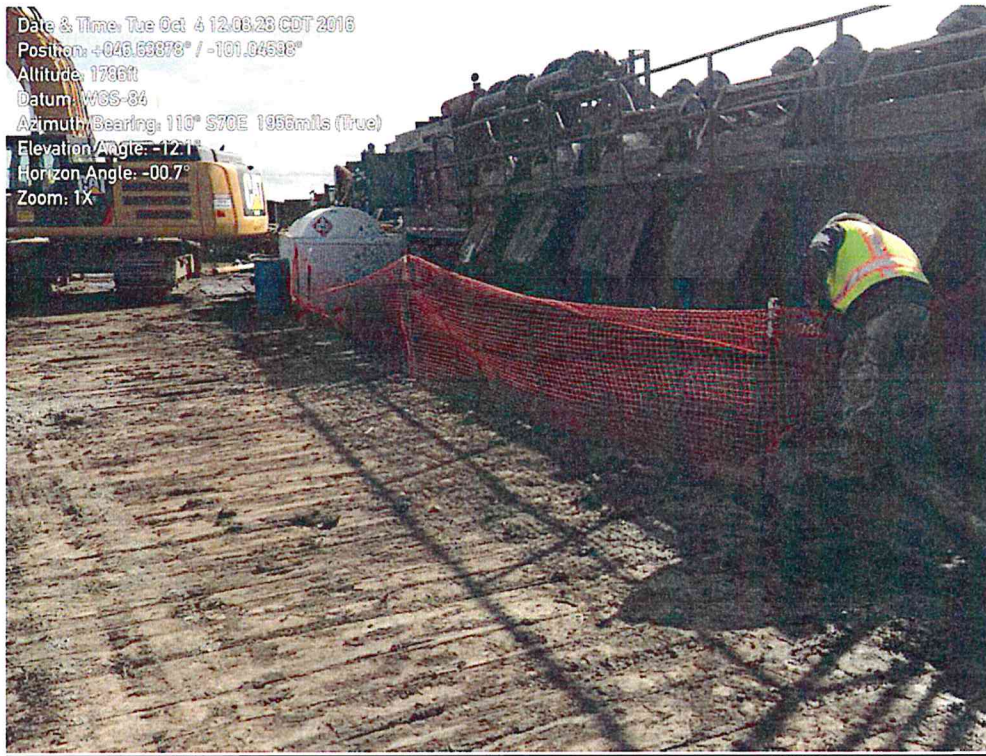
**Report Photo #1 "M.P. 139 HDD Pad - Recycle Mud Pit & Diesel Tank":**

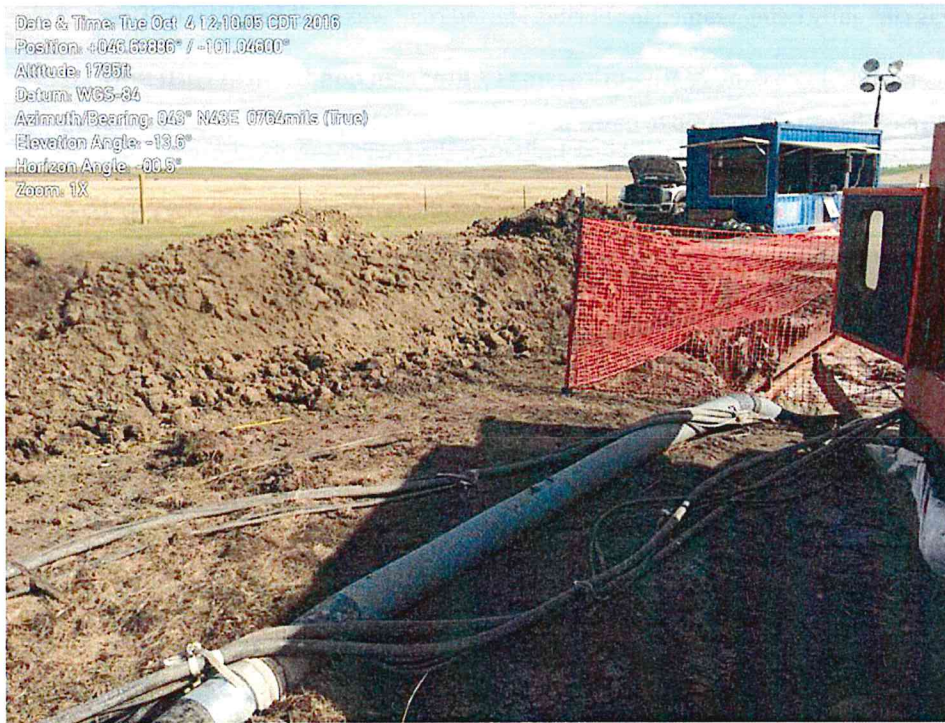
Most areas had subsoil trench pilings bordering the topsoil piles. As noted, previous day rainfall appeared to have caused some of this. A few areas had subsoil on topsoil pile most likely due to plowing, these areas were of short duration and infrequent. Small subsoil pile from bore entry pit was stored over unstripped ground. This practice is contrary to the construction's mitigation plan.

**Report Photo #2 "Subsoils from HDD Bore Entry Pit on Unstripped Ground:**

Keitu inspector advised Tie-in/Trenching Chief to practice having a definitive gap between topsoil and subsoil piles. Follow-up with the North Dakota Department of Agriculture to confirm if they advised contractor to place straw beneath subsoil stacked on topsoil.

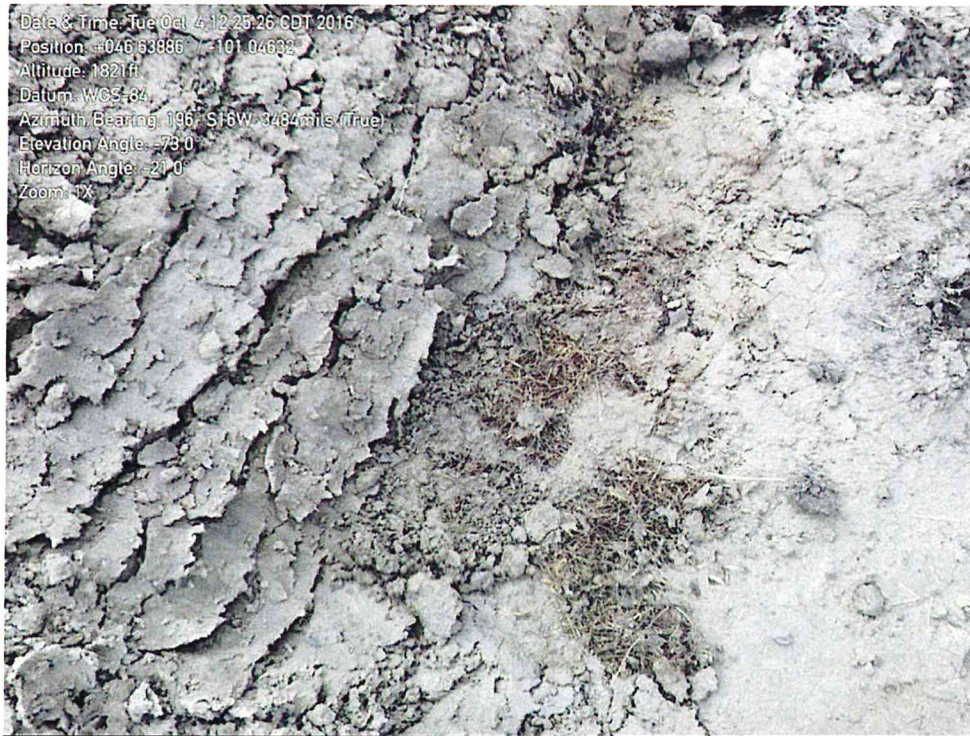
**Report Photo #3 "No Straw Mulch Visible Under Bore Pit's Subsoil Pile:**

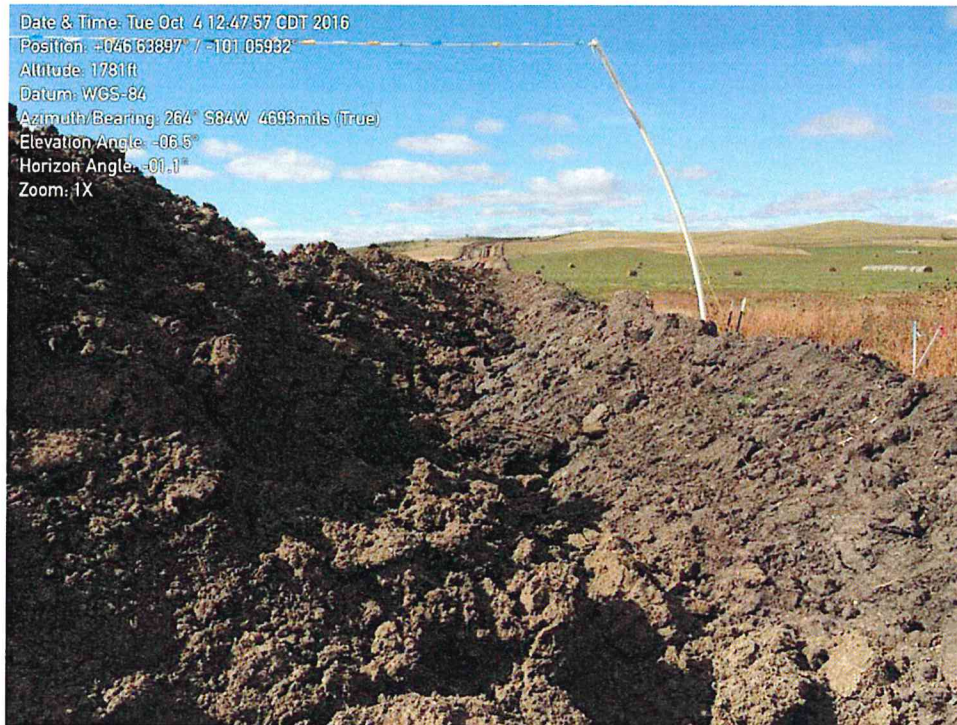
Topsoil and subsoil segregation appeared to be adequate. Topsoil depth was 3-4" on hilltops while up to 12" on the bottom of hill slopes. Subsoil piles from trenching were bordering and partly overlapping with the topsoil pile (see photo 4). Subsoil pile from HDD bore entry pit was stored over unstripped ground (photos 2-3). Lead inspector claimed he was advised by an Ag Inspector to place straw mulch under the pile when piling on topsoil. Straw mulch was not visible during site visit in these areas. Previous day's rainfall appeared to have caused most of the overlapping. Two areas had subsoil cast on or plowed onto adjacent topsoil in limited duration. Storm water BMPs remain in place and in good repair. Drainage points protected with straw bales or silt fence were cleared of silt. One area observed had a few large soil chunks roll off ROW less than one foot.

**Report Photo #4 "Trench Subsoils Bordering/Overlapping with Topsoil Pile: 46.63897°N 101.05932°W**

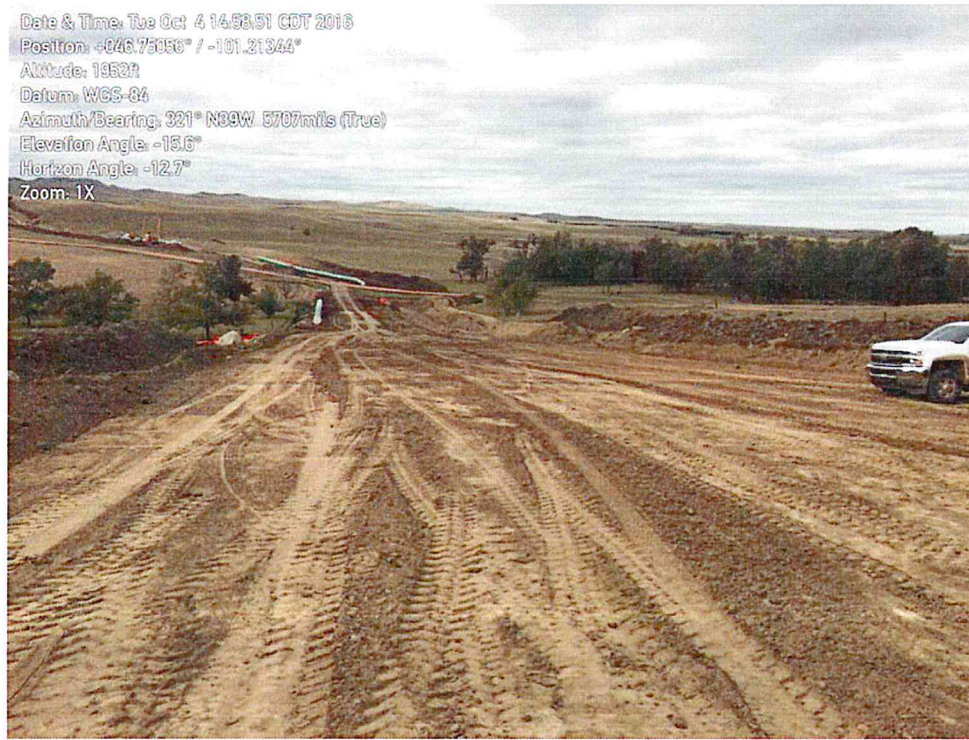
**Report Photo #5 "Soil Separation & Tree Clearing Area Adequate":**

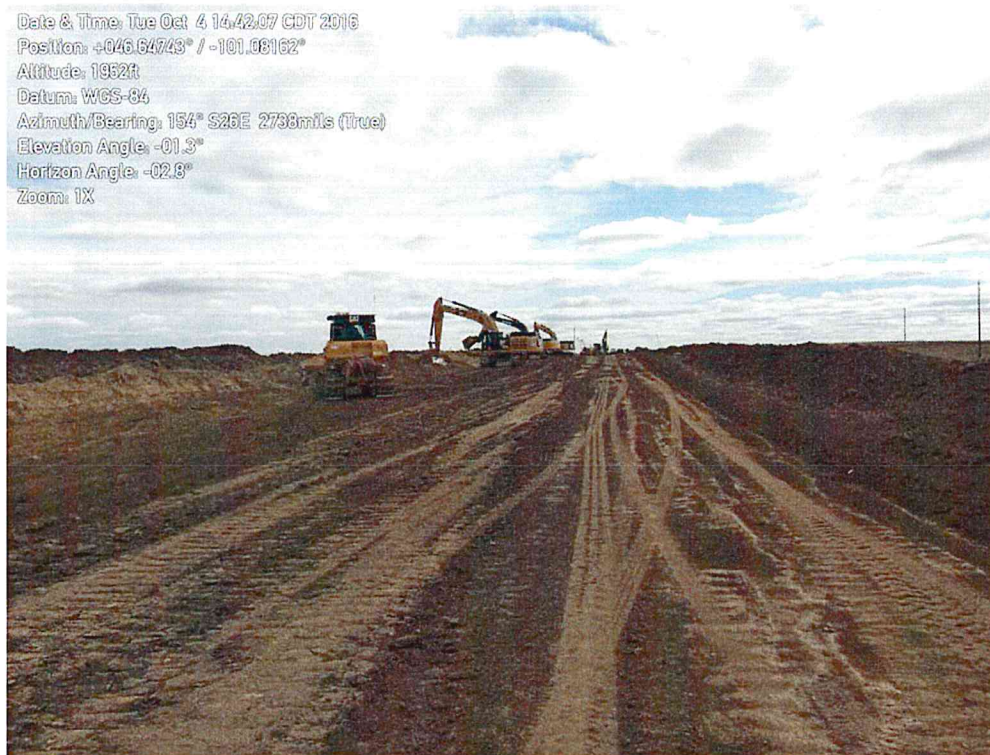
**Report Photo #6 "Trench Back-filling":**

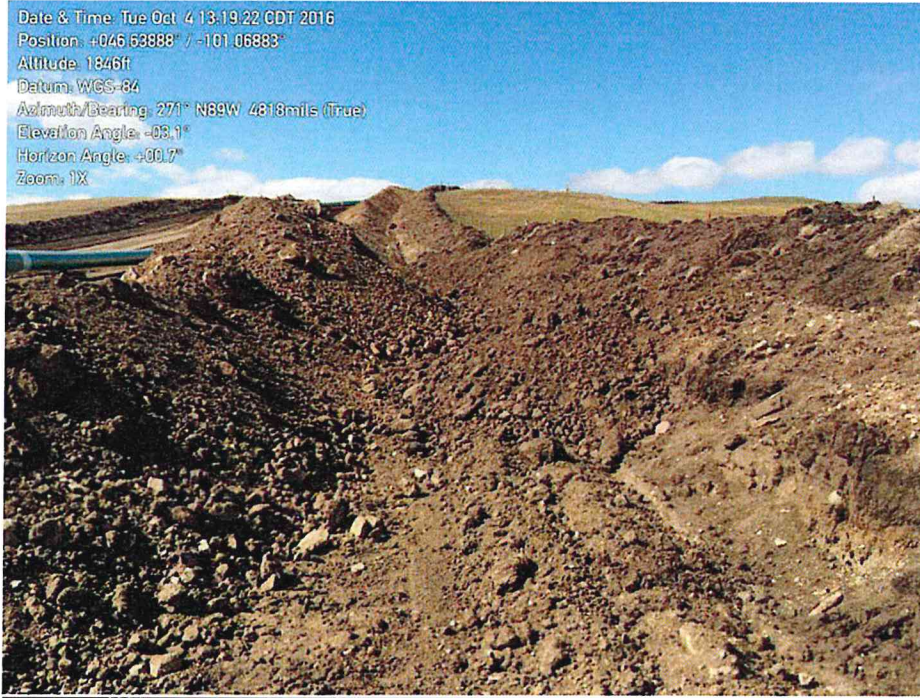
**Report Photo #7 "Topsoil & Subsoil Pile Storage Overall Adequate":**
