Executive Summary:

Site/Project Location: Spread 7-8 in Morton County

Date of Inspection: 27 October 2016

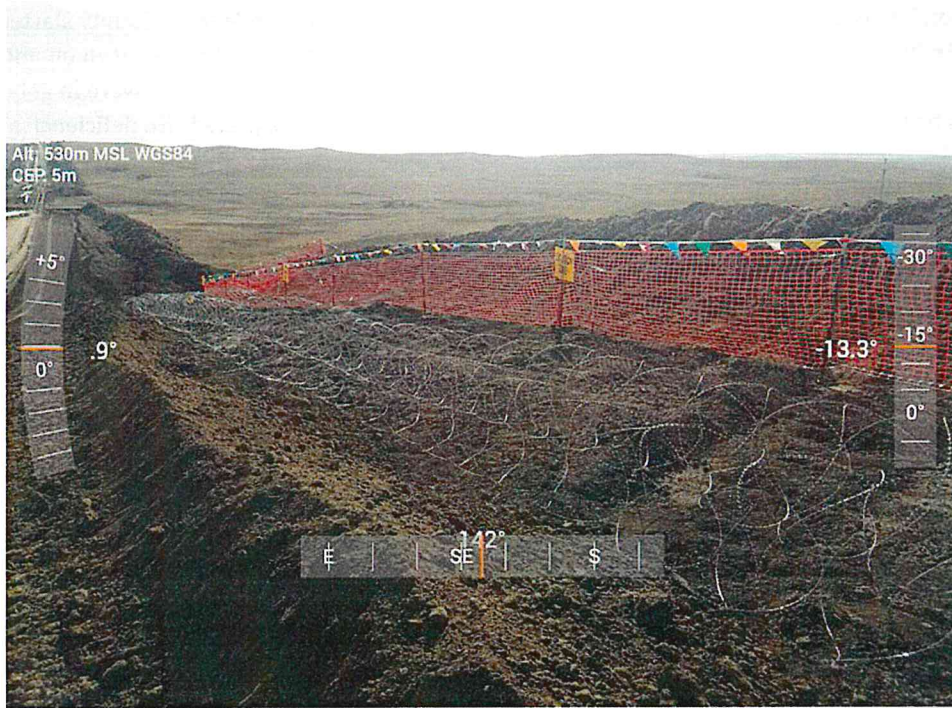
Inspection of the main area of construction, MP 161 through MP 164, was cut short due to protest activity nearby. The Keitu Inspector was escorted by Chris Grant. Shortly after beginning, Chris Grant received a phone call stating that he had to leave the area due to safety concerns. Exclusion areas were built around areas that Tribal members had deemed culturally significant during a previous visit. See photo #1.

Report Photo #1 Exclusion Zone

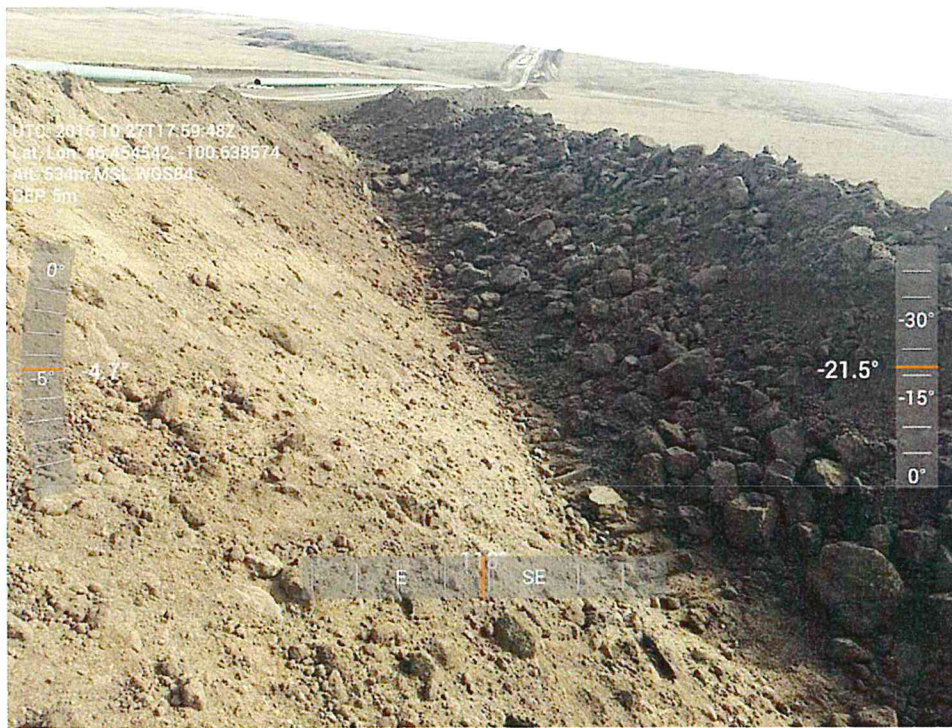
Topsoil and subsoil segregation appeared adequate. A majority of the topsoil and subsoil piles from stripping and grading showed clear separation. There were small areas where the subsoil and topsoil piles were nearly touching, but it was clear that no mixing had occurred. Storm water BMPs had not been installed east of MP 161. Chris Grant, Lead Environmental Inspector for Dakota Access Partners, stated that environmental crews had not yet been able to install BMPs east of MP 161 because of restricted access due to protestors.

Report Photo #2 Subsoil and Topsoil Segregation

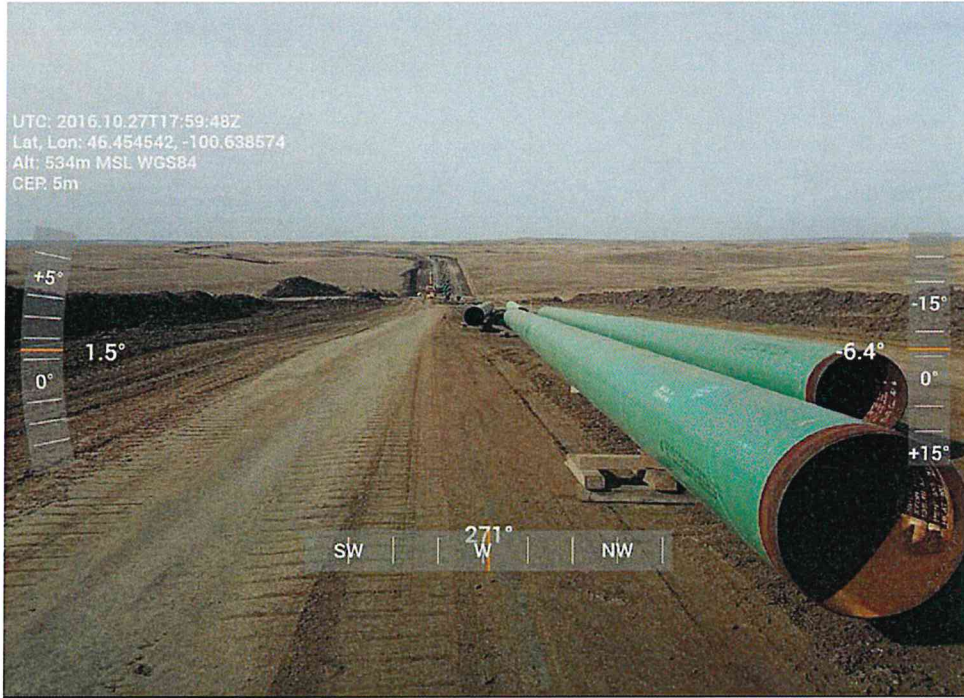
Report Photo #3 Pipe String Waiting on Welding Crew

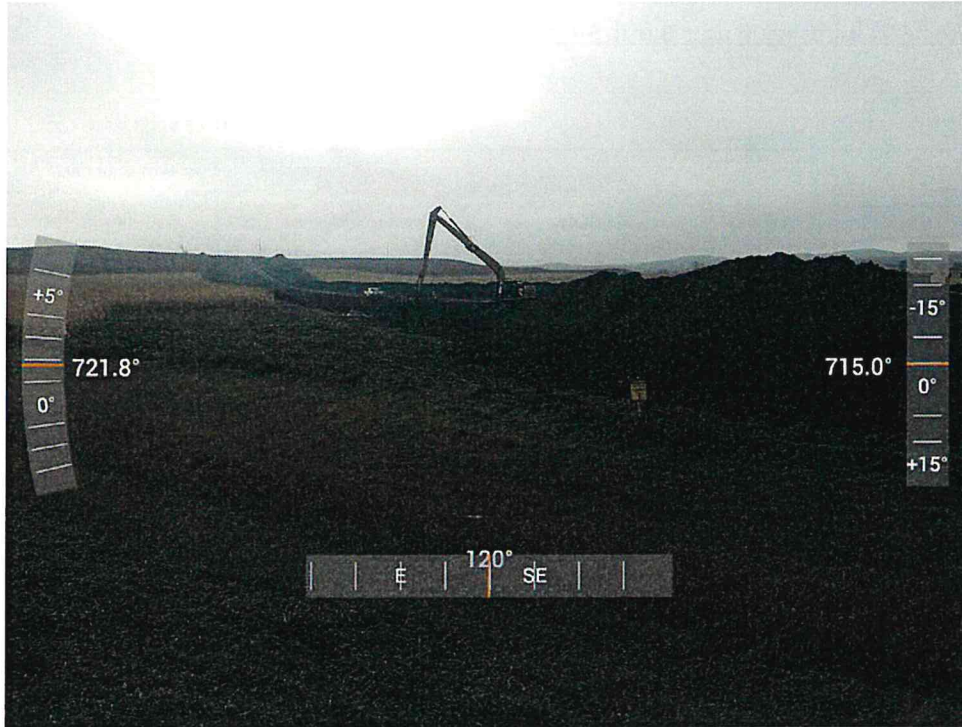
Report Photo #4 Backfilling

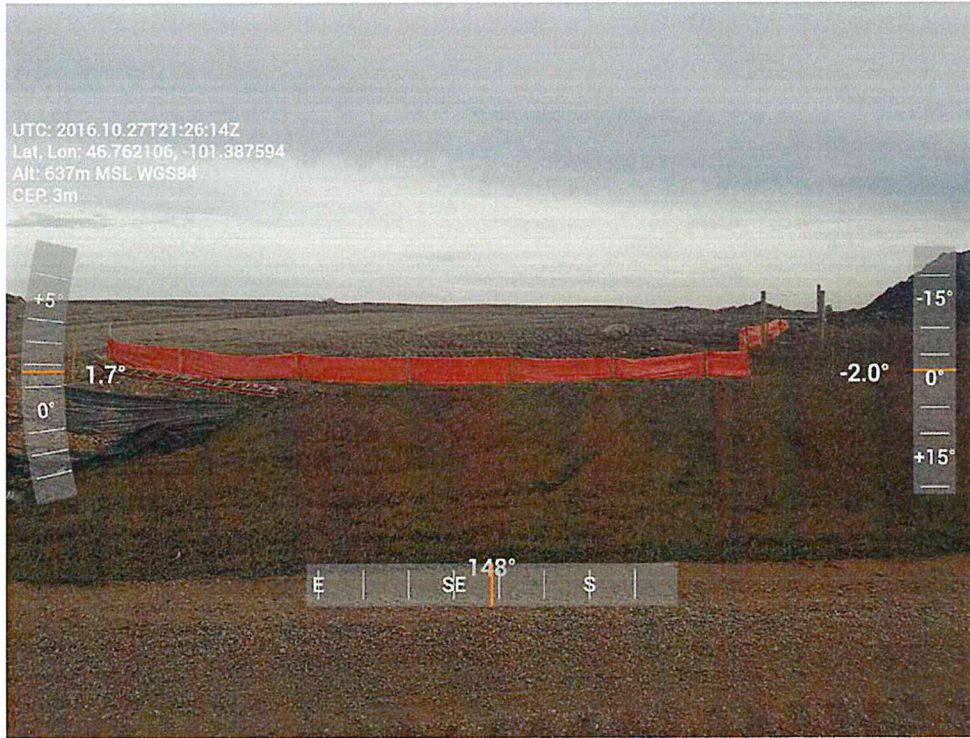
Open trench areas observed appeared to be at specified depth or deeper. Silt fence was implemented to prevent any sediment from leaving the ROW.

Report Photo #5 Silt Fence Protecting Road Ditch

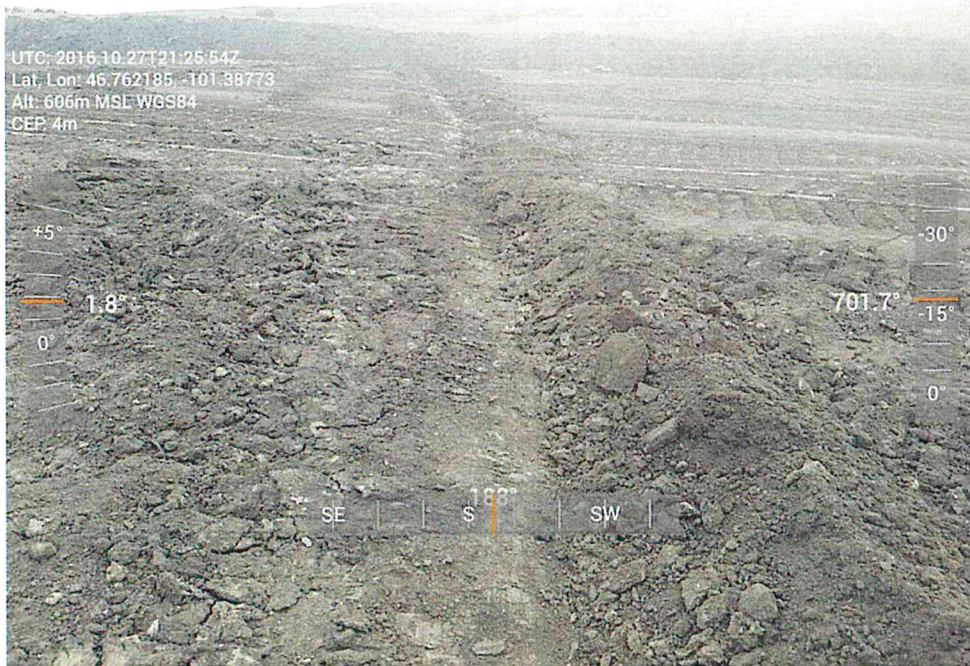
Report Photo #6 Temporary Water Bar in Subsoil

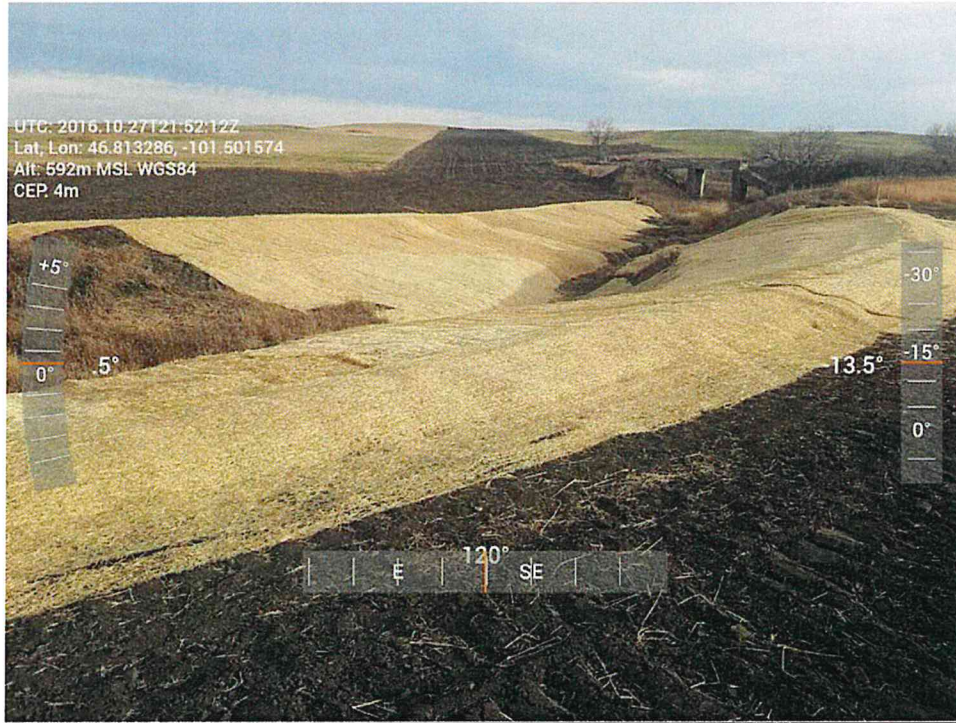
Report Photo #7 Water Bars and Erosion Matting Around Stream

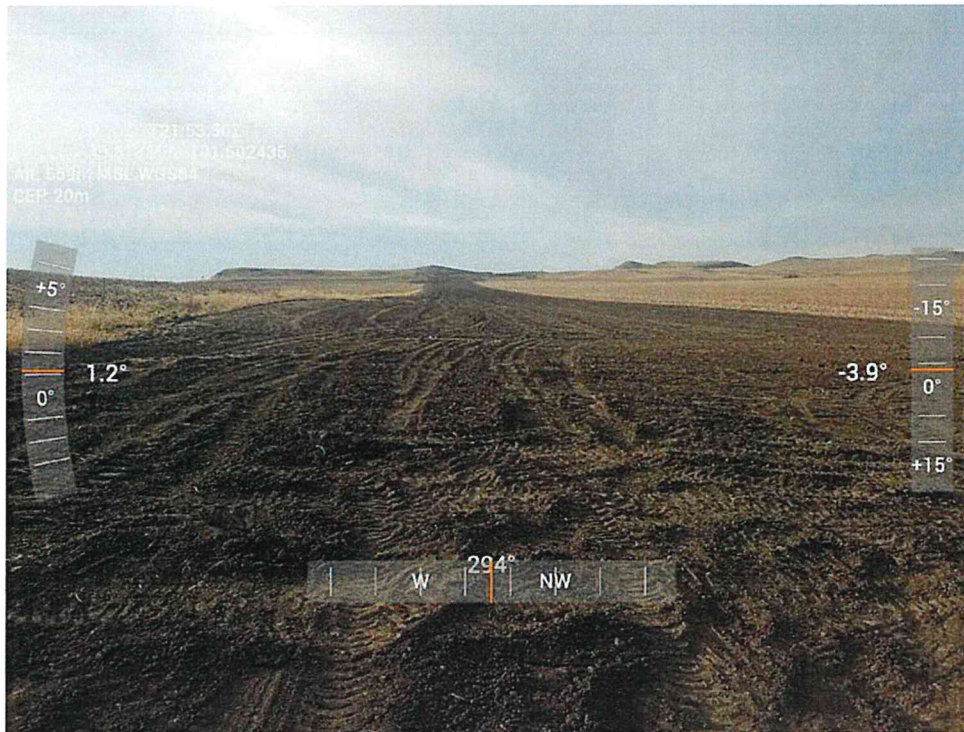
Report Photo #8 Replaced Topsoil
