Executive Summary:

Site/Project Location: Epping terminal/Epping ND

Date of Inspection: 1 November 2016

235 PU-14-842 Filed: 11/9/2016 Pages: 6
Construction Inspection Report - 1 November 2016

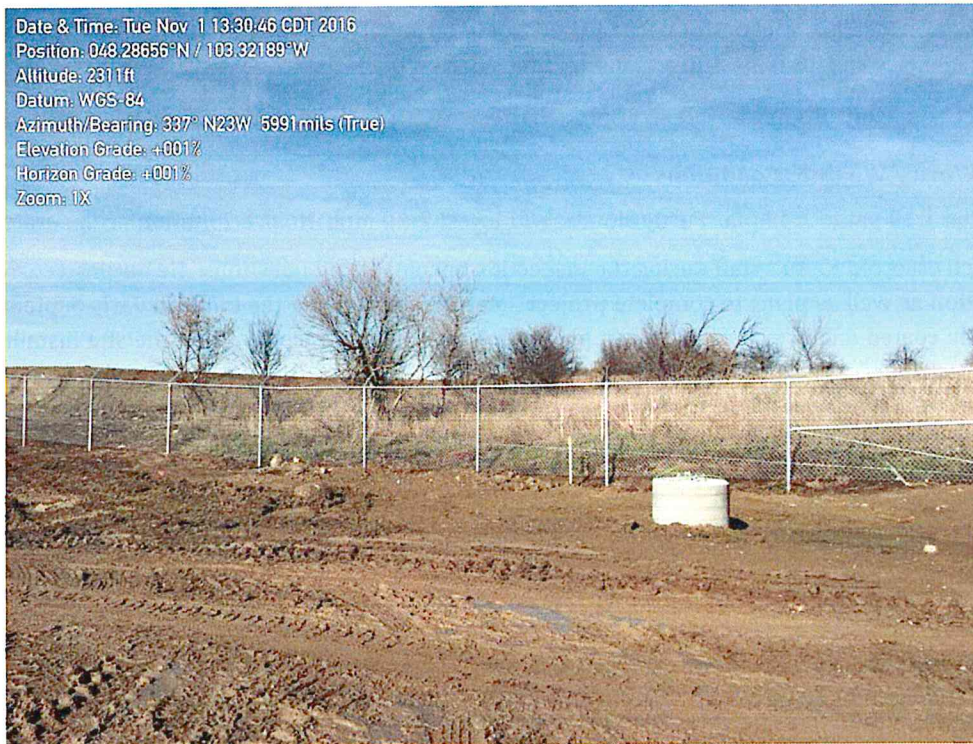
Report Photo #1 "Trees along North Property Line"

Grade work complete including north site boundary up to and through existing tree line. Per info from prior January 2016 inspection, no trees were scheduled for removal. Site rep repeated claim no trees were impacted at this site. Bare ground throughout except scoria beneath pipe alleys.

During "As Built" inspection, focus on sediment/BMP to roadside ditches; report borrow area and wetland disturbance to PSC. Verify special SW event inspection within 48 hours of 10/31/16. Verify tree mitigation.

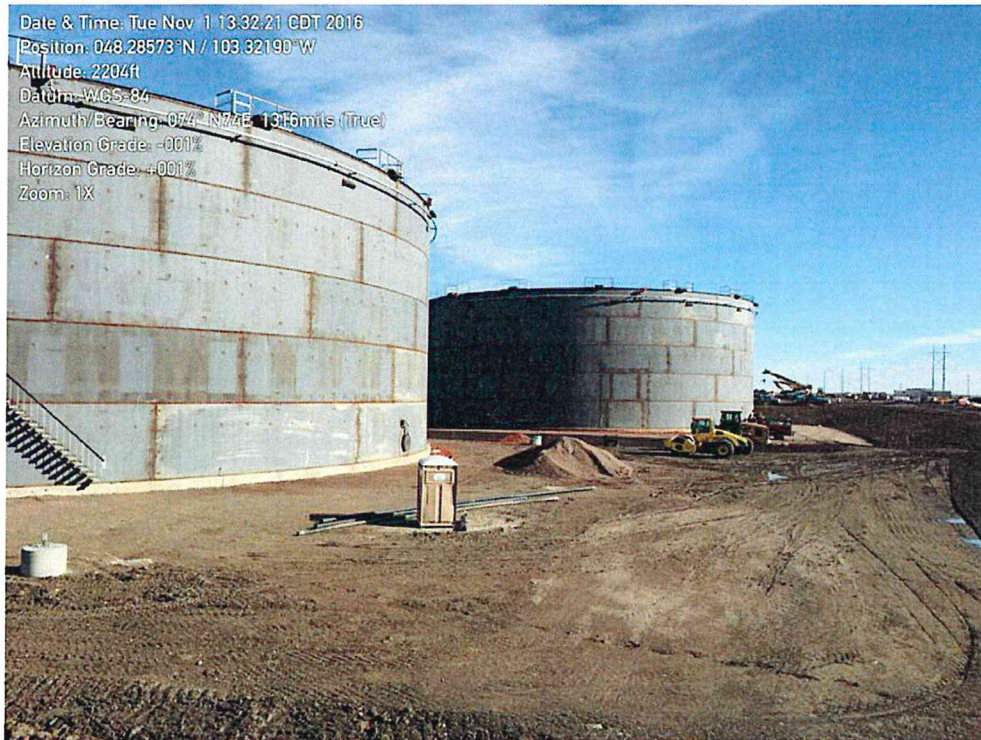
Report Photo #3 "Tanks"

Robert Welch escorted Keitu's staff during the inspection and answered questions. He outlined current status of construction as well as plans to complete project. Matrix hydro tested the tanks in early September. Both are internally coated and are considered complete. Electrical subcontractors are at the site installing power and instrumentation connections. Site layout i.e. tank locations different than submitted in application but within approved boundaries. Perimeter chain link security fence largely installed. Waiting on their clients to install connecting pipelines to the site.

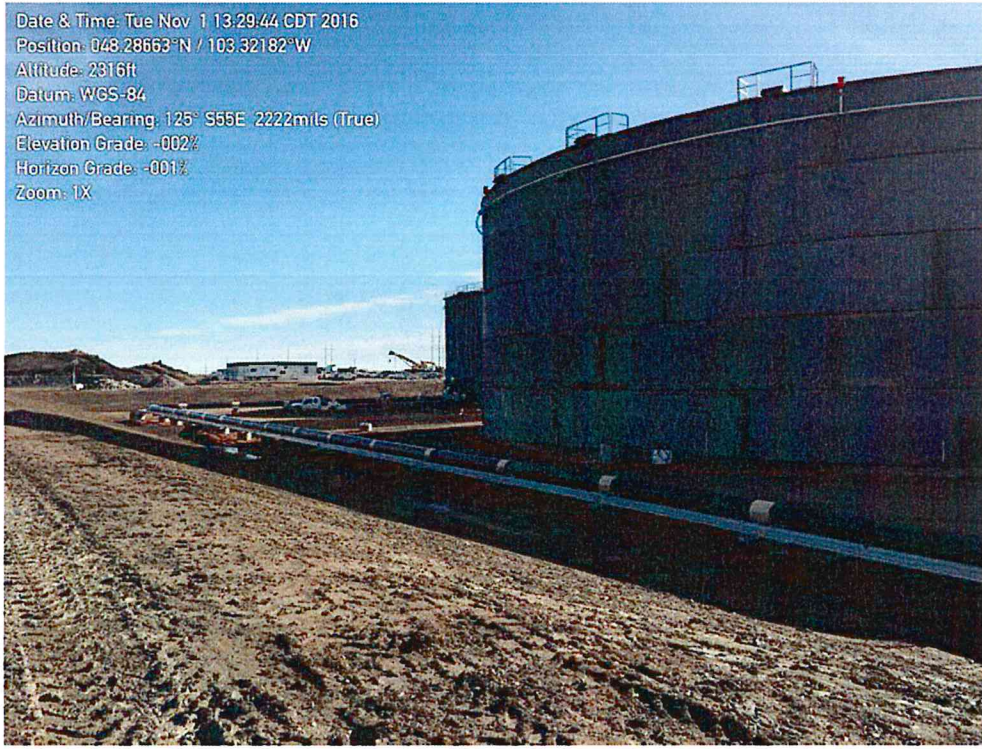
Report Photo #5 "Possible Wetland Infill" (Area Along Left Photo Border)

Based on desktop study of historical aerial photos, prior drainage to site was largely to the northeast, prior to construction. Site work appears to have altered flow toward west and south along County Road 8 / 60th St NW including permanently partially filling a prior existing wetland area, 23,800 sq ft estimated impact.

Soil borrow area outside of approved area as well as soil backfill to wetland and work zone on east side of site. Trees have also been removed despite reports to contrary. See 2016 aerial photo. If the northeast wetland is US ACE jurisdictional, a permit is required and currently not on file. Threat of sediment discharge to roadside ditches remain but "hard freeze" conditions likely in near future.

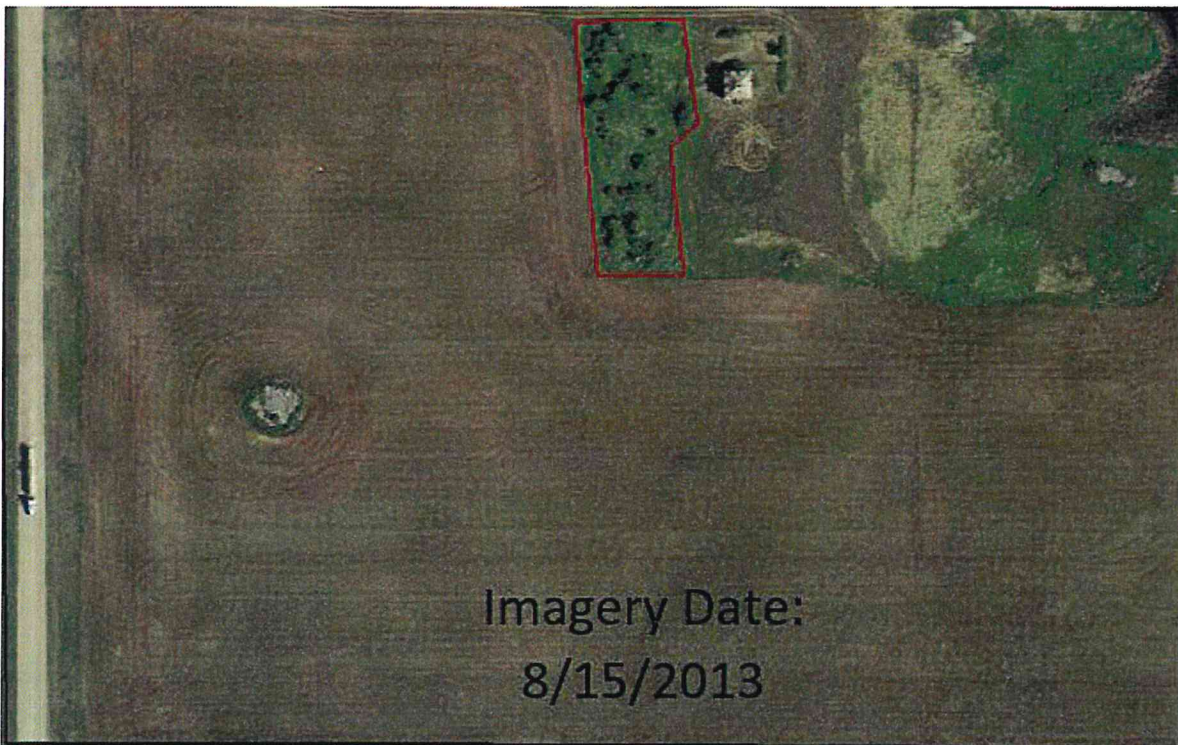
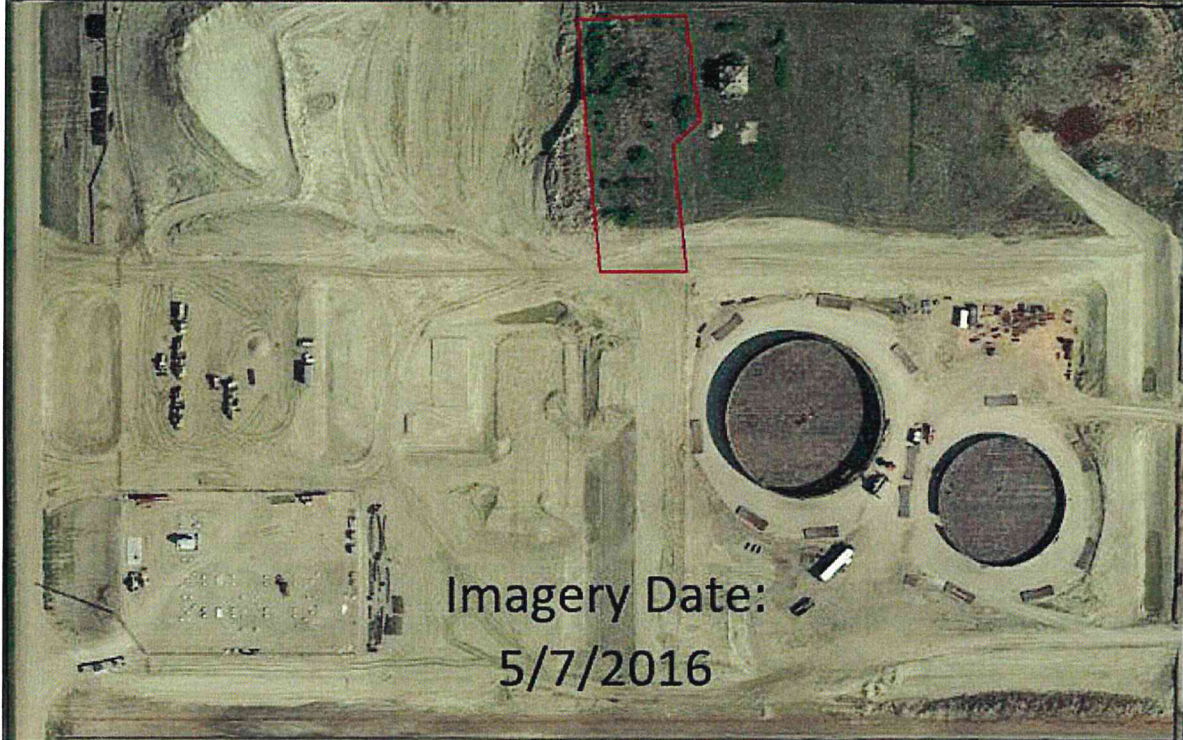
Aerial Photos of Terminal Site (Note Before and After Treed Area Shown in Red):

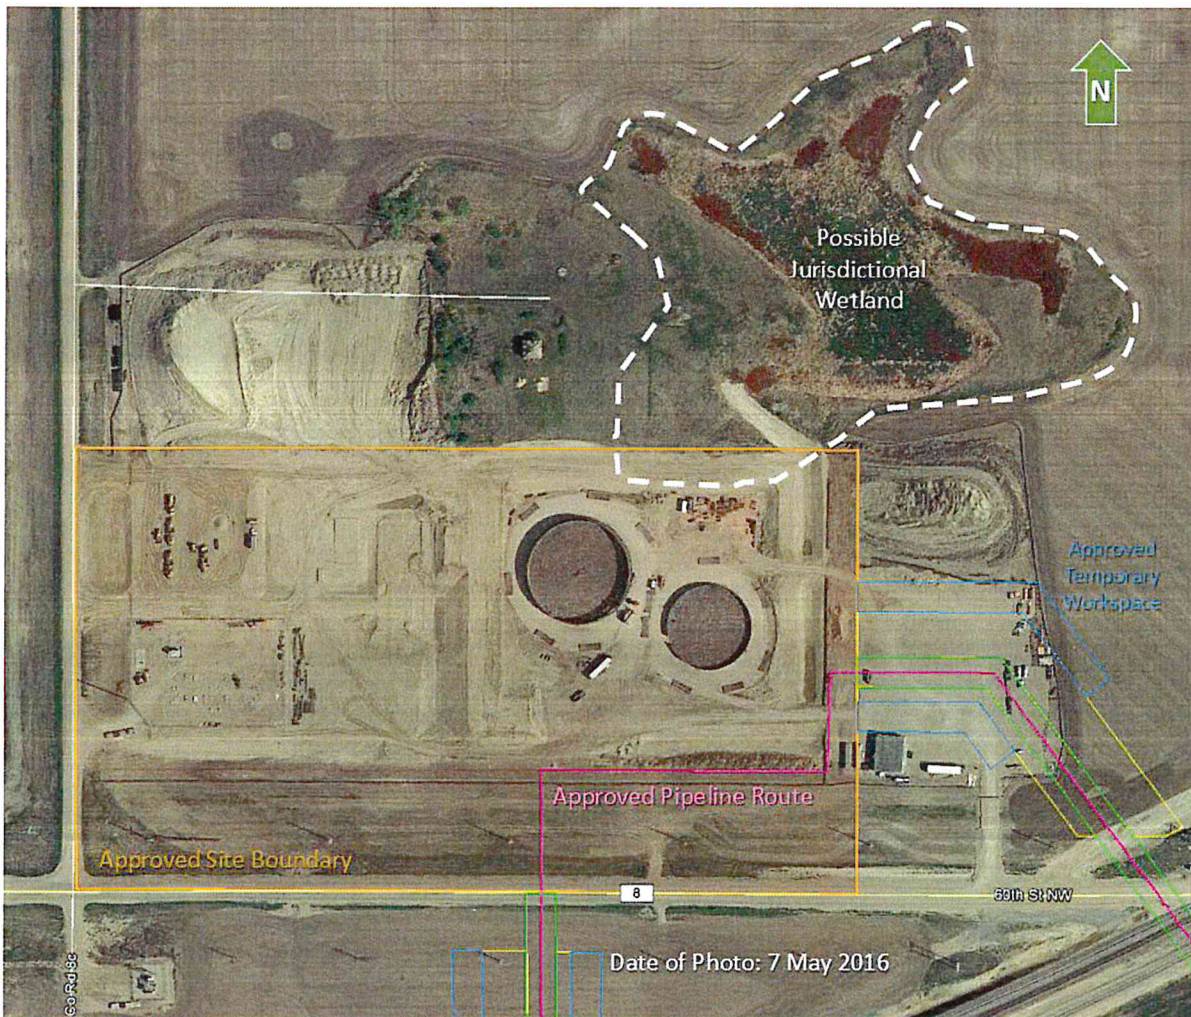
A 3+ acre disturbance immediately north of site beyond approved PSC facility boundaries noted. Site civil work contractor JMAC leased land from owner to create borrow pit to supply suitable soil for construction due to poor quality soils/failed compaction tests during project construction. All grade work was reported complete.

Aerial Photos of Terminal Site Depicting Work Areas & Disturbances Outside of Approved Area
