**Executive Summary:**

A construction inspection was conducted at the Trenton terminal 5 miles NE of Trenton, ND in Williams County. The inspection focused on confirming surface disturbance/work occurring within ND PSC-approved site and vegetation removal is consistent with tree & scrub mitigation plan. Overall the inspected areas of the Project were in good condition. No deficiencies noted.

**Site/Project Location:** Trenton terminal/Trenton ND

**Date of Inspection:** 1 November 2016

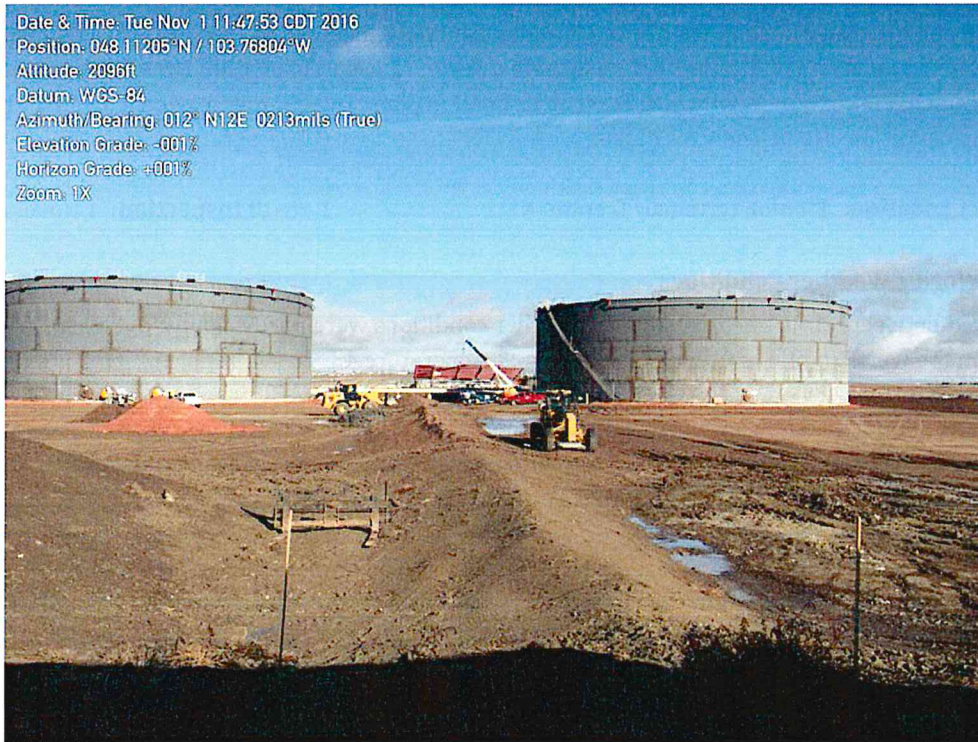
**Report Photo #1 "Tanks and On-Going Construction":**

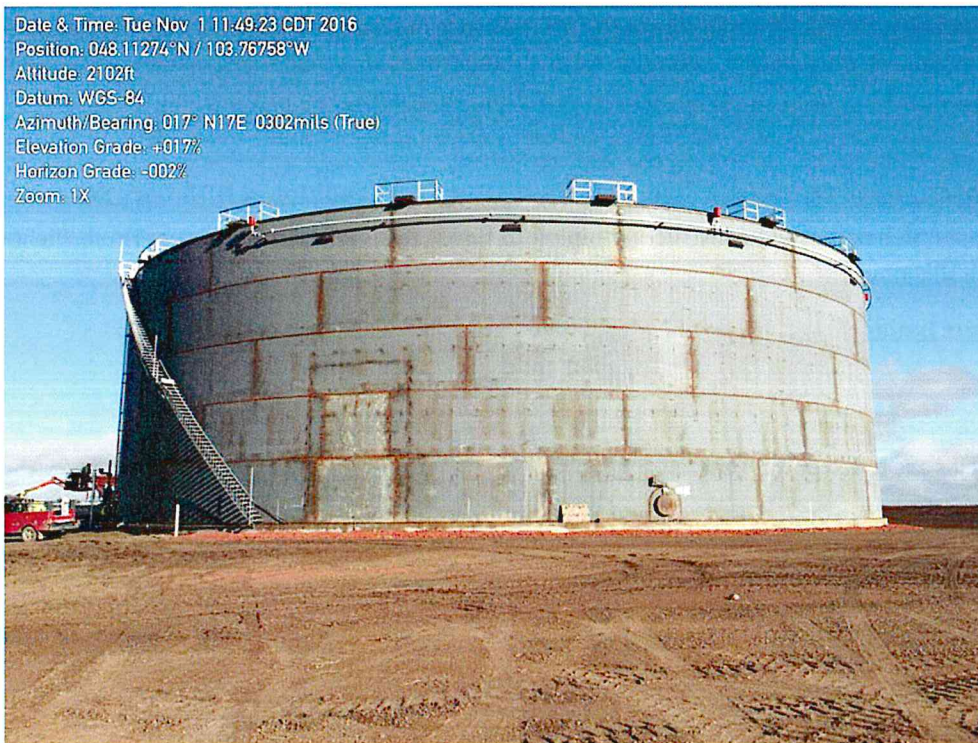
**Report Photo #2 "Tank"**

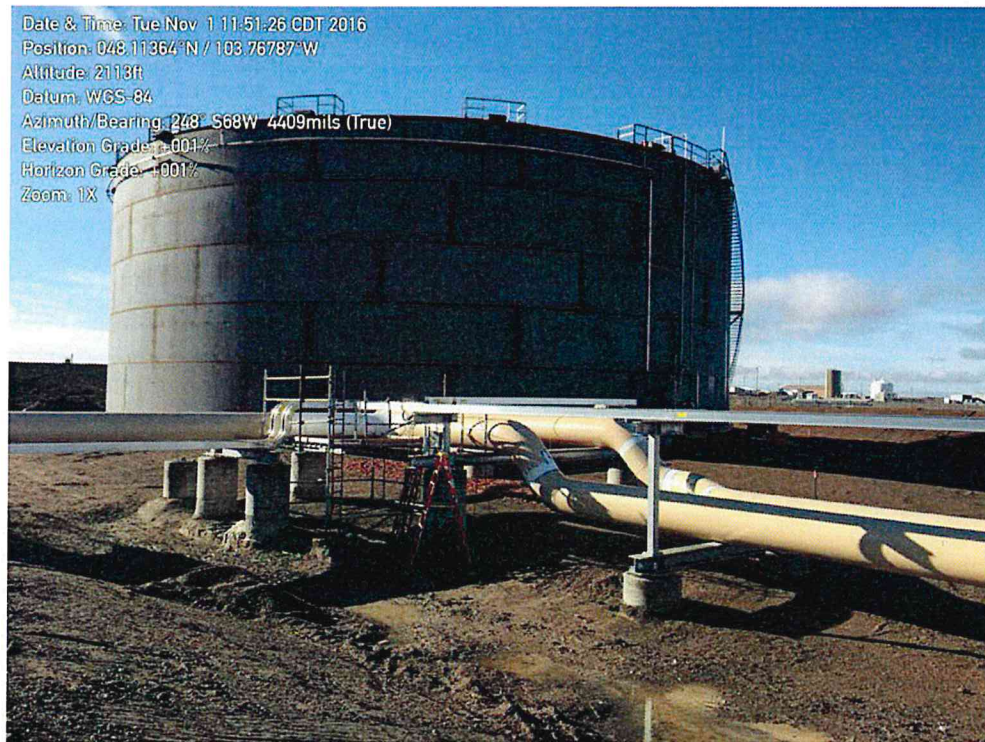
Precision Pipeline has finished constructing piping to tanks. Rose Rock is the first of three client pipelines connected at this time.

**Report Photo #3 "Piping to Tank"**
