**Site/Project Location:** Spread 7 in Morton County

**Date of Inspection:** 10 November 2016

**244 PU-14-842** Filed: 11/18/2016 Pages: 6  
**Construction Inspection Report - 10 November 2016**

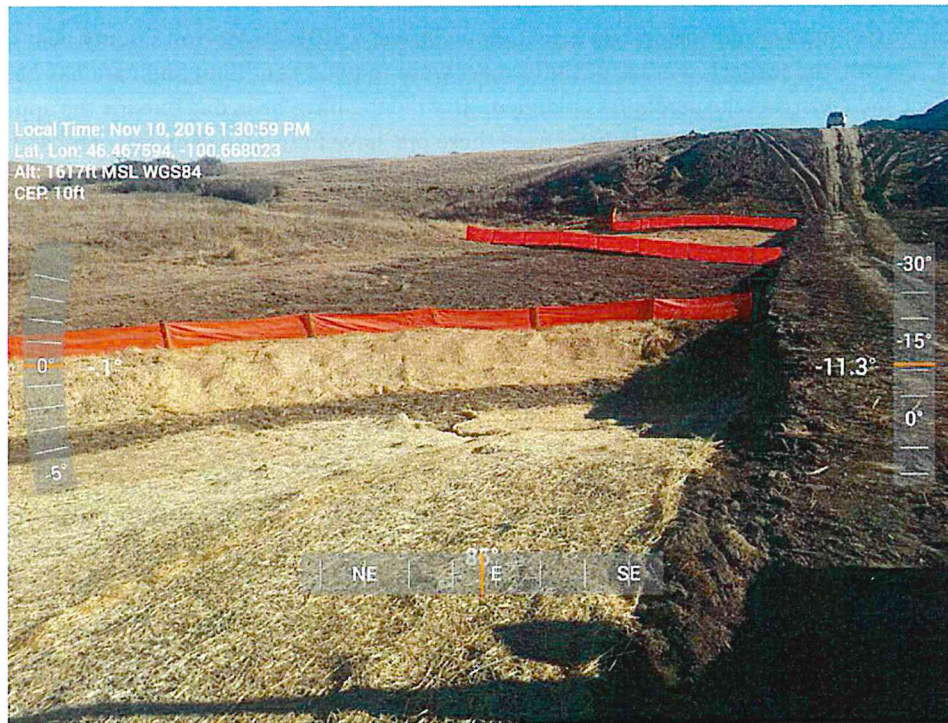
**Report Photo #1 Silt Fences and Erosion Matting Protecting Wetland**

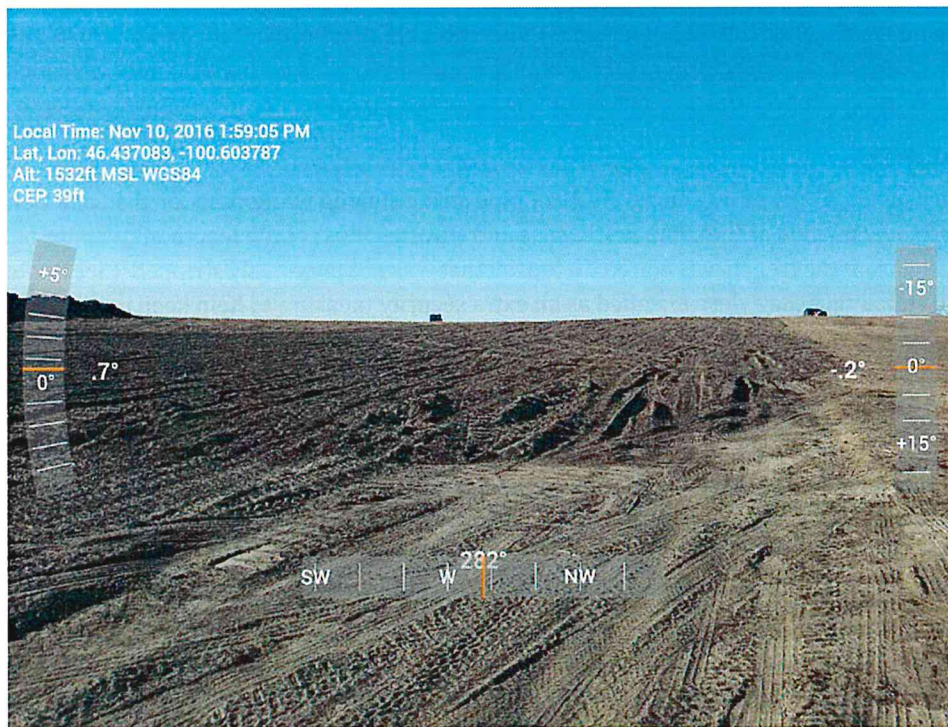
**Report Photo #2 Beginning of Topsoil Replacement**

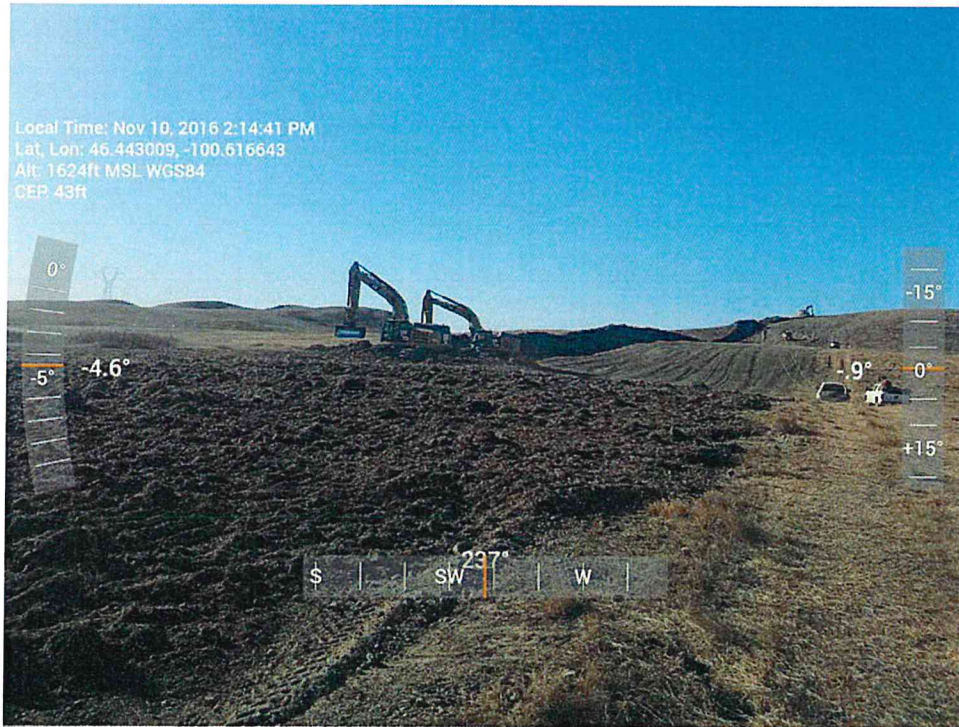
**Report Photo #3 Replacing Topsoil**

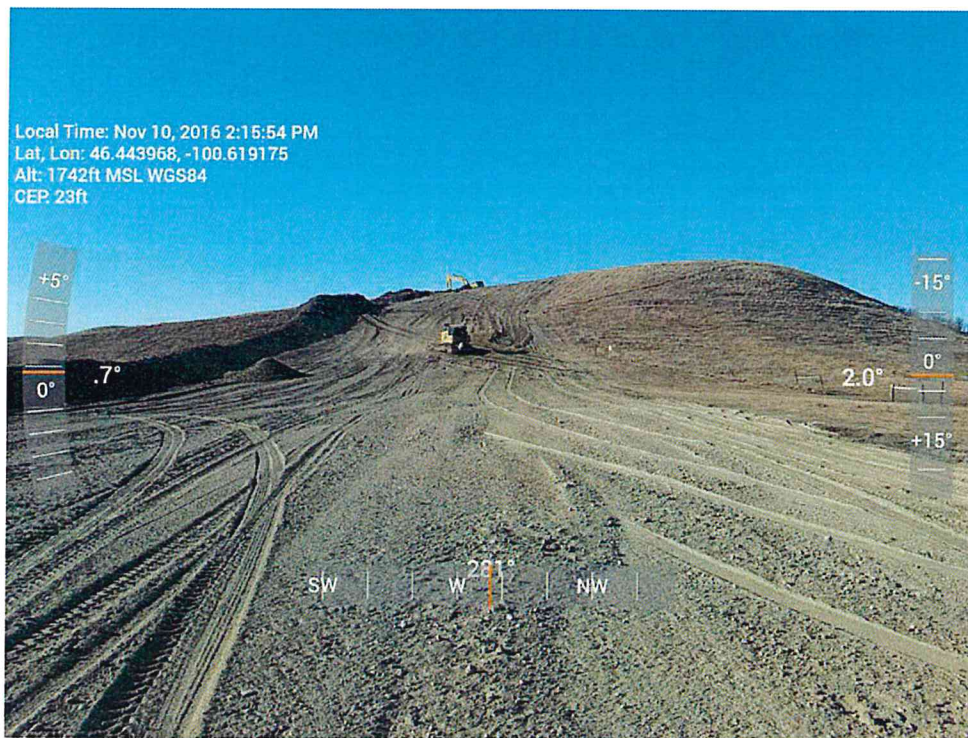
**Report Photo #4 Recontouring Hillside**

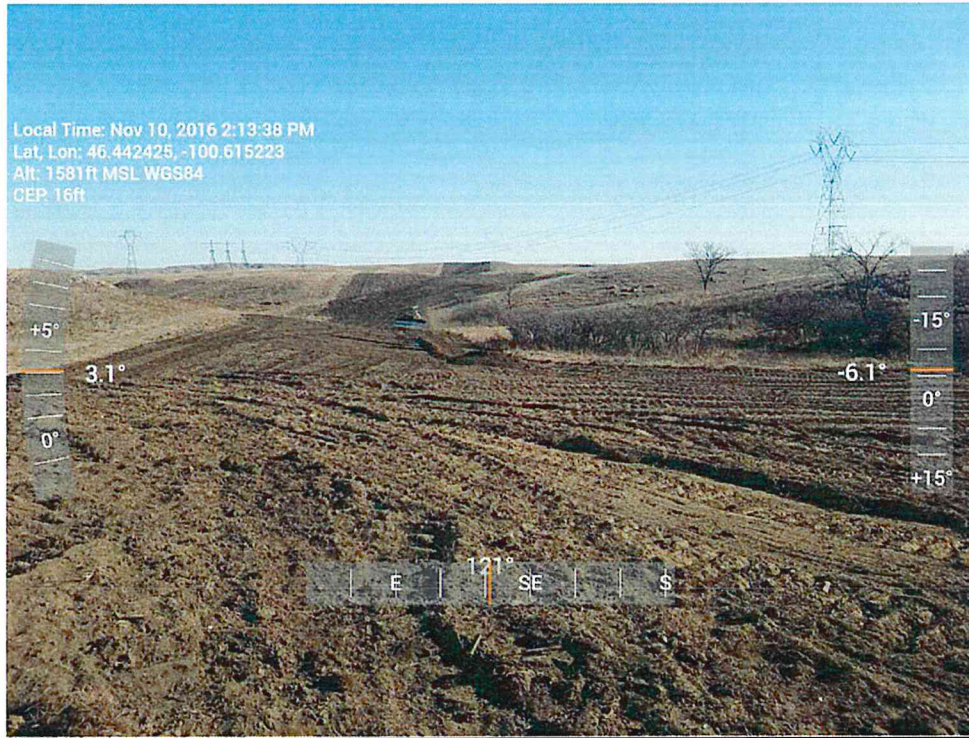
**Report Photo #5 ROW Narrowed for Wooded Area**

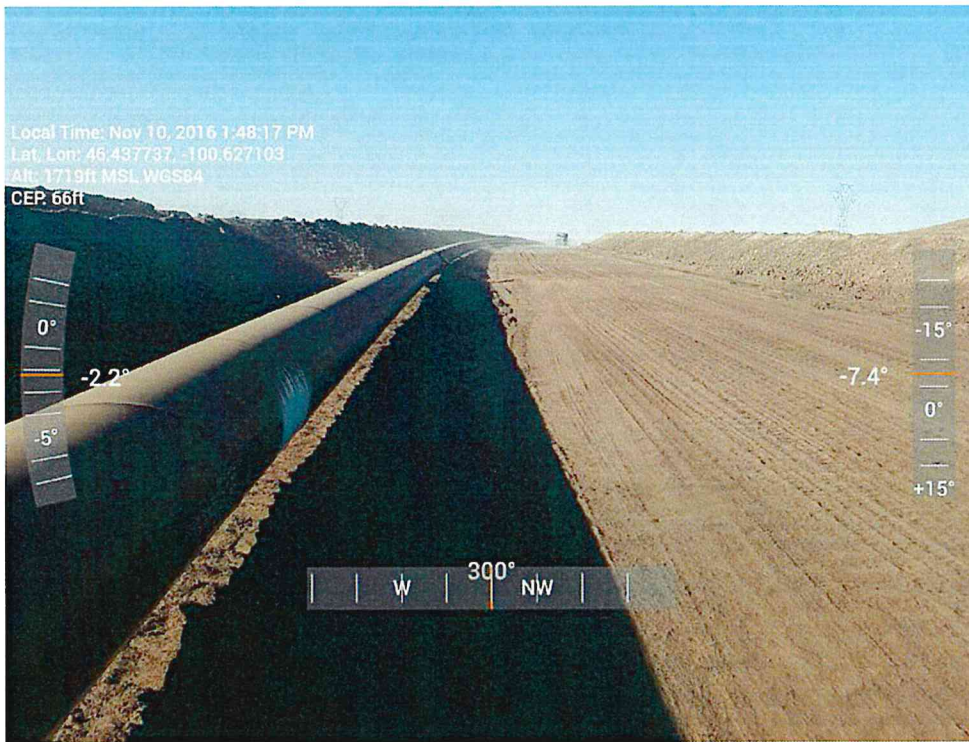
**Report Photo #6 Bore Pipe Staged for Lake Oahe HDD**

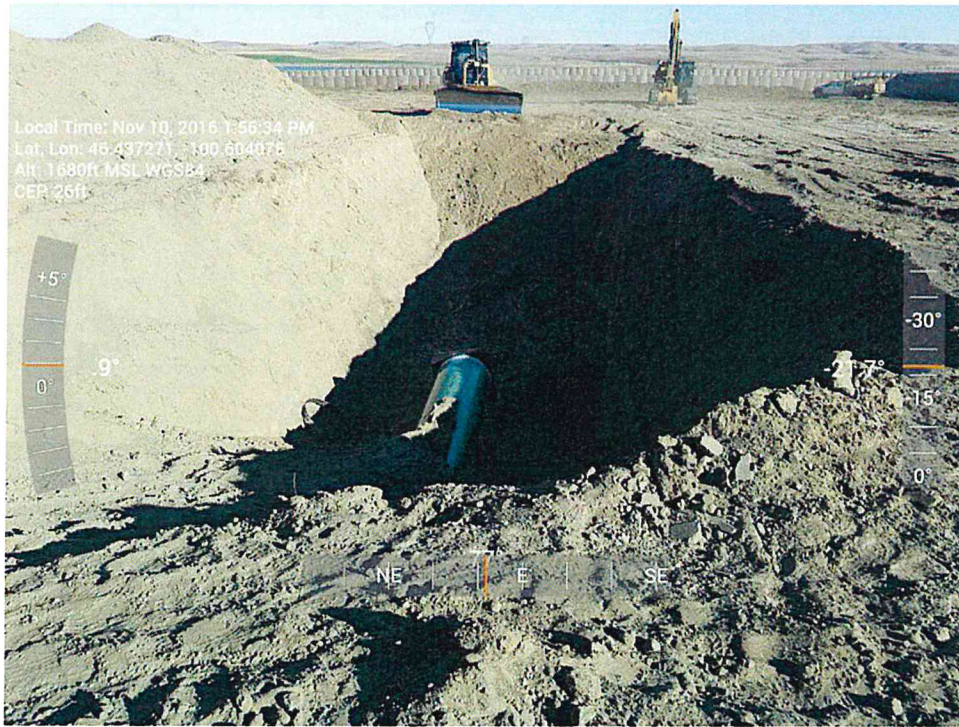
**Report Photo #7 Prepping Bore Pad and Bore Tie-in Area**

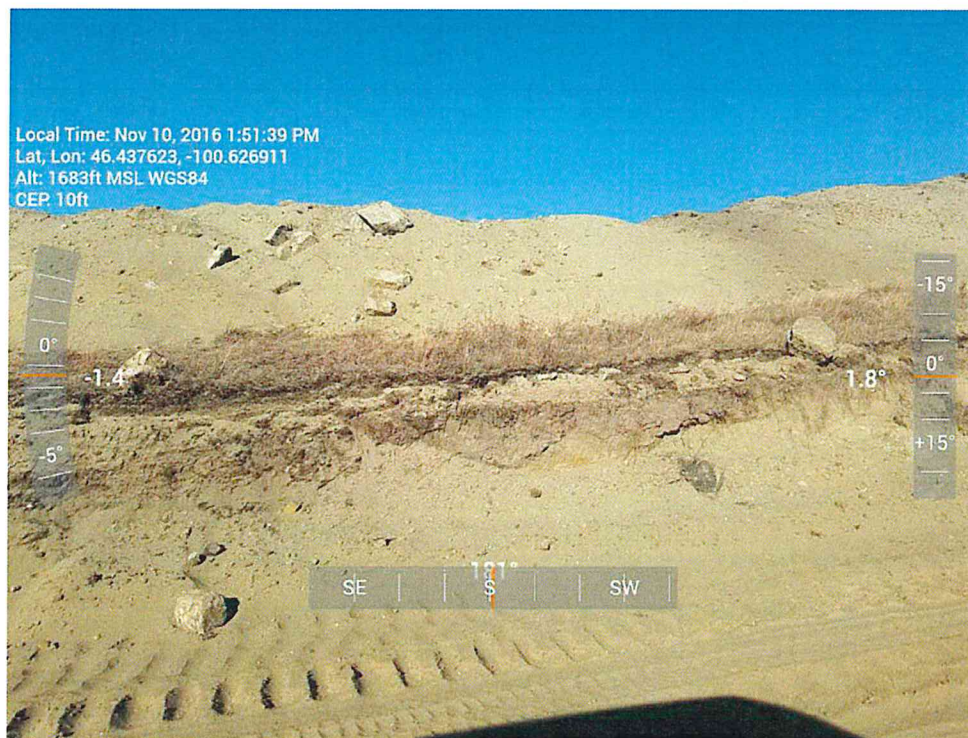
There were dry moats trenches dug along the bore pipe string staging workspace for the Lake Oahe crossing. They appeared to be outside of the temp workspace and traveled most of the length of the bore pipe. In some areas, the subsoil from the trench was placed on topsoil that was not previously stripped. (See Photo #8) Chris Grant of DAPL stated that they were installed as an extra security measure to help keep unauthorized persons from gaining access to the pipe. The trenches are located on property owned by Energy Transfer Partners.

"Dry moats" have been dug outside the approved work area for the Lake Oahe bore pipe strings. Subsoil from some of these pits have been placed on top of topsoil. All these areas are on reportedly DAPL owned land.

**Report Photo #8 Subsoil from Security Trench Placed on Topsoil**

Document items to PSC staff and complete follow-up actions as directed.
